Tree Inventory and Preservation Plan 56 and 58 Wallace Street and 1 Memorial Hill Drive, Vaughan, Ontario

09 December 2020; revised 14 January 2021, 21 December 2021, 20 January 2022,
and 20 October 2022

KUNTZ FORESTRY CONSULTING INC Project P2532

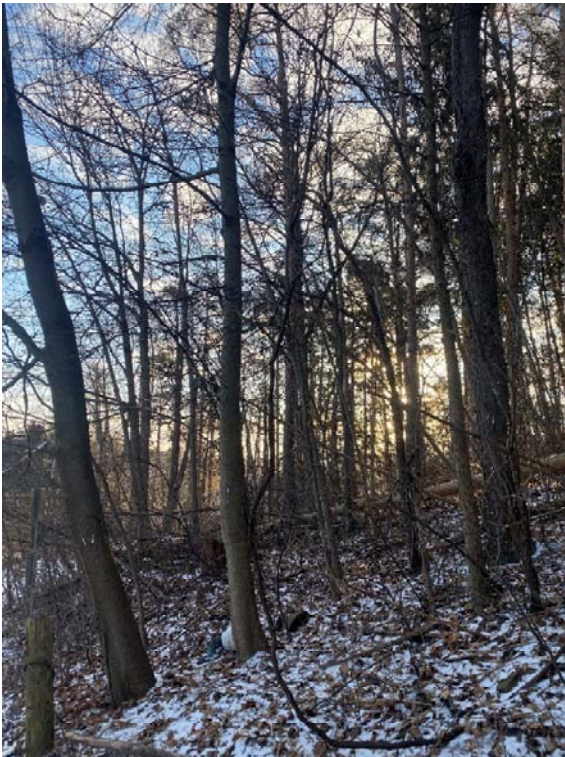
From left to right, Trees 271 – 273

Trees 271 – 275, and 277 are located south of the gravel path adjacent to the house at 1 Memorial Hill Drive. These trees require removal to accommodate a proposed swale along the south side of the gravel path.

Trees E, 271-275, 277, 535, 547, 548, and E are located within the Memorial Hill Drive right-of-way.

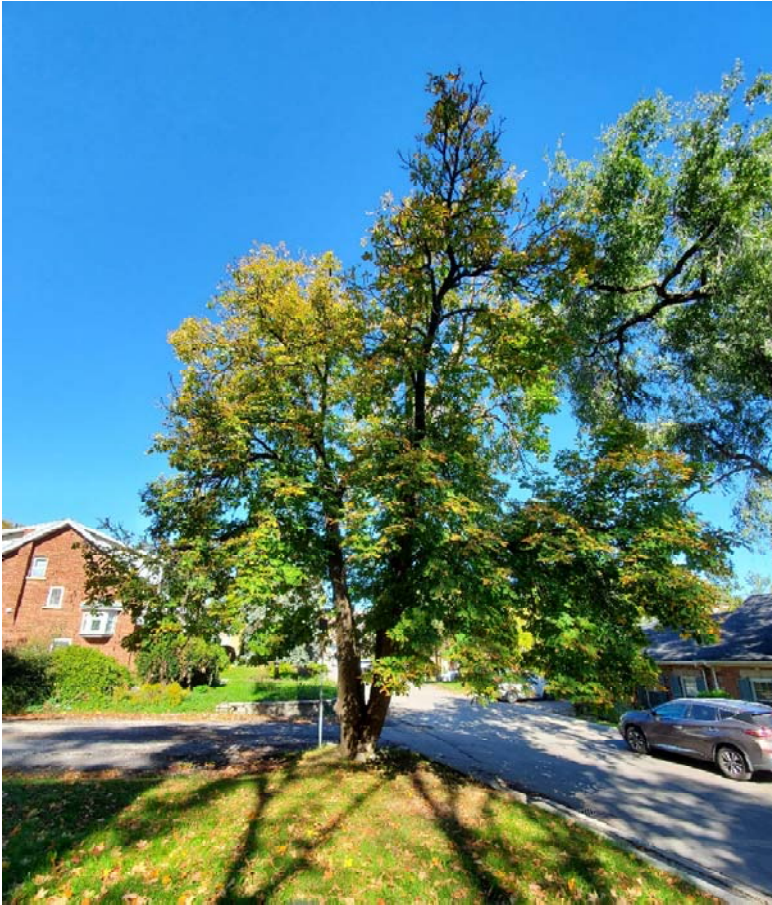
Tree 512

Trees 512 – 519, 524, and A are located at 56 Wallace Street. Trees 512, 516, and 519 would have been recommended for removal regardless of the development due to their poor condition.

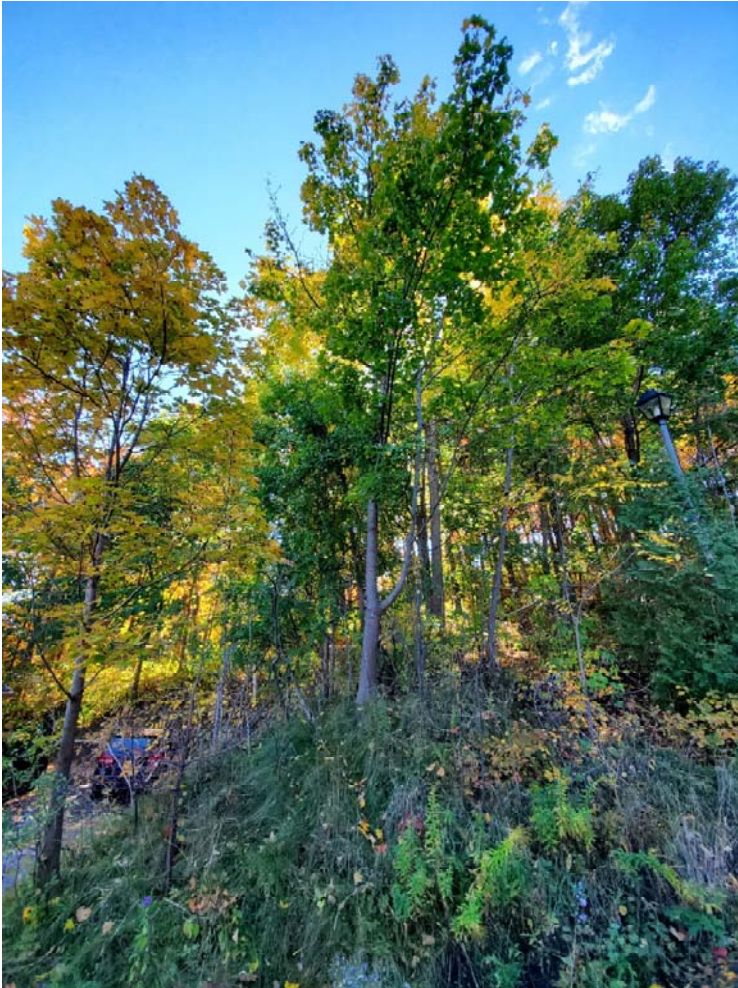
Tree 514

514	Norway Maple	<i>Acer platanoides</i>	23	F-G	F	F	20	3.6	Private	Deadwood (L), tar spots (H), asymmetric crown (L), small crown, lean (VL)	Remove	1
515	Black Walnut	<i>Juglans nigra</i>	37.5	G	F-G	F-G		4.8	Private	Previously tagged: 006, asymmetric crown (L), bow (VL), deadwood (L)	Remove	2

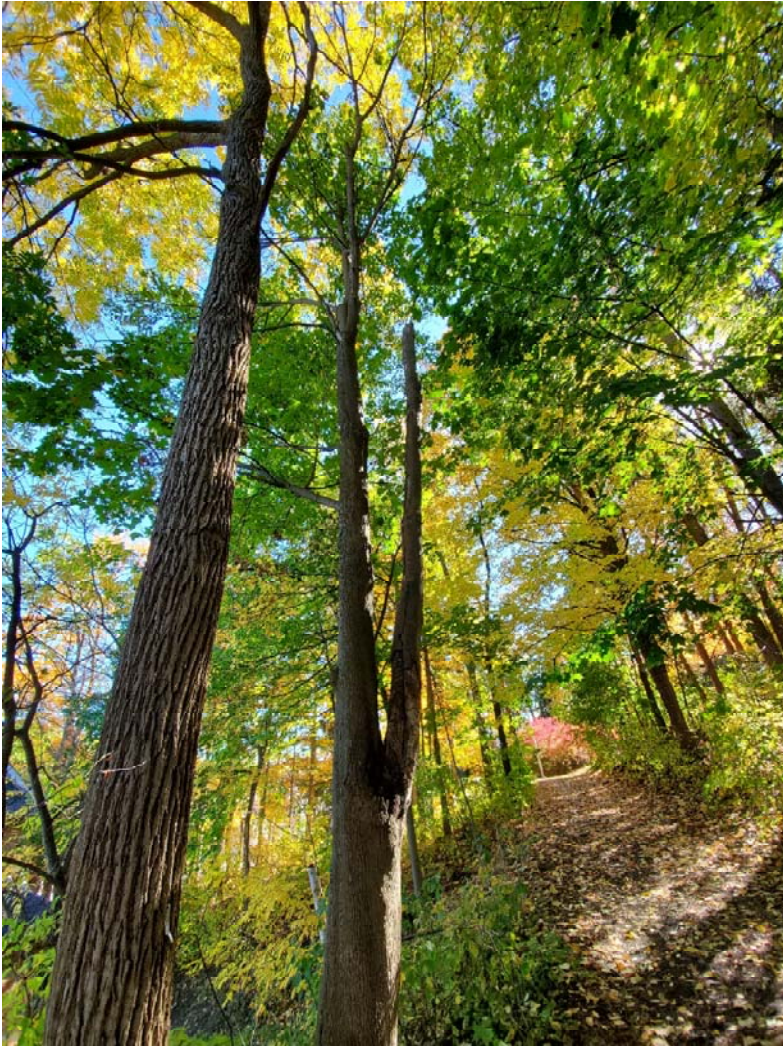
Tree 516 (right) and 517 (left)

516	Norway Maple	<i>Acer platanoides</i>	38	P	P	F	60	4.8	Private	Co-dominant at ~1.6m and ~4.0m, deadwood (H), tar spots (M), stem wounds (H) with rot, removal recommended	Remove	2
517	Black Walnut	<i>Juglans nigra</i>	4, 11, 17.5	F	F	F	30	3.6	Private	Co-dominant at base, deadwood (M), crooked stem (L), growing on a steep slope	Remove	1
518	Norway Maple	<i>Acer platanoides</i>	14	F	P-F	F	30	3.6	Private	Deadwood (M), lost leaders, hangers (L), growing a slope	Remove	
519	Norway Maple	<i>Acer platanoides</i>	37	P-F	F	F-G		4.8	Private	Previously tagged: 004, lean (L), deadwood (L), tar spots (L), growing on a steep slope, stem wounds at ~1.3m (H), growth deficit (M), removal recommended	Remove	2
520	Scots Pine	<i>Pinus sylvestris</i>	22.5	G	F	F-G		3.6	City (Park)	Small crown, deadwood (L)	Retain	
521	Black Cherry	<i>Prunus serotina</i>	25.5	P	P	P	100	3.6	City (Park)	DEAD - Remove	Retain	
522	Austrian Pine	<i>Pinus nigra</i>	34	F-G	F	F	30	4.8	City (Park)	Deadwood (M), lost leaders, crooked stem (L)	Retain

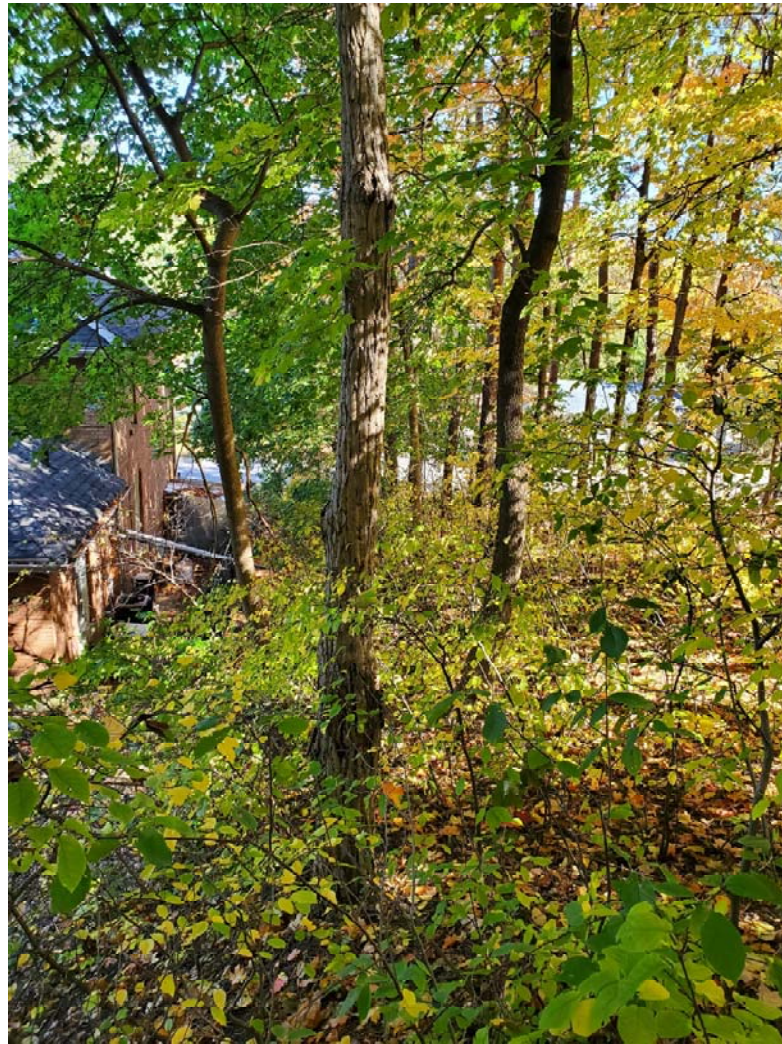
Trees A (foreground), 523 (background right) and 524 (background left)

Trees 523, 530, and 531 are located on the neighbouring property to the south (parkland). These trees, and the others in the rear yard of 66 Wallace Street, require removal due to the proposed regrading (filling of slope and swale) of the rear yard of 66 Wallace Street. Permission from this property owner is required prior to their removal.

523	Norway Maple	<i>Acer platanoides</i>	20	F	F	F-G		3.6	City (Park)	Crooked stem (M), lean (L), bow (L), asymmetric crown (L), tar spots (L)	Remove	1
524	Norway Maple	<i>Acer platanoides</i>	18.5	F	F	F-G		3.6	Private	Crooked stem (H), growing on slope, leaning over driveway (L), bow over driveway, asymmetric crown (M), tar spots (M)	Remove	
525	Scots Pine	<i>Pinus sylvestris</i>	45.5	F-G	F	F-G		6.0	City (Park)	Asymmetric crown (M), deadwood (L), crooked stem (VL)	Retain	
526	Sugar Maple	<i>Acer saccharum</i>	44.5, 48.5	F-G	F-G	F-G		7.2	City (Park)	Co-dominant at base, lean (L), sweep (L), deadwood (L)	Retain	
527	Sugar Maple	<i>Acer saccharum</i>	29.5	F-G	F-G	F-G		4.8	City (Park)	Lean (L), asymmetric crown (M), deadwood (L)	Retain	
528	Sugar Maple	<i>Acer saccharum</i>	31.5	F-G	F-G	F-G		4.8	City (Park)	Lean (L), asymmetric crown (M), deadwood (L)	Retain	
529	Scots Pine	<i>Pinus sylvestris</i>	40	F-G	F	F-G		4.8	City (Park)	Deadwood (L), crook at top, small crown, located at top of slope	Retain

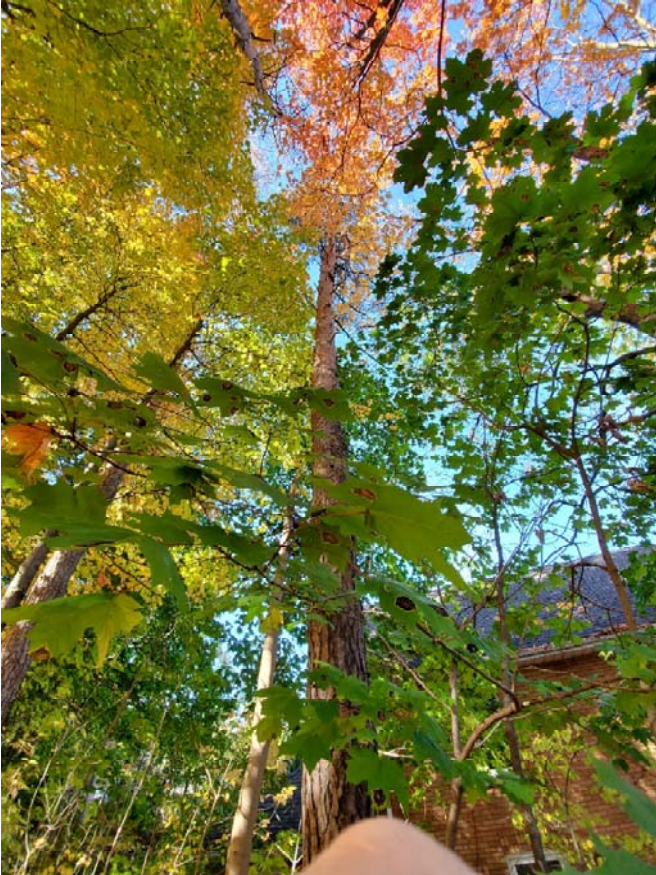
Tree 530 (left) and 531 (right)

530	Norway Maple	<i>Acer platanoides</i>	19.5	F-G	F-G	F-G		3.6	City (Park)	Asymmetric crown (L), lean (VL), bow (L), tar spots (M), located at top of slope	Remove	
531	Scots Pine	<i>Pinus sylvestris</i>	38	G	G	G		4.8	City (Park)	Located at top of slope	Remove	2
532	Norway Spruce	<i>Picea abies</i>	38	G	G	G		2.4	Private		Remove	2
533	Scots Pine	<i>Pinus sylvestris</i>	30	G	G	G		2.4	Private	Lean (VL)	Remove	1

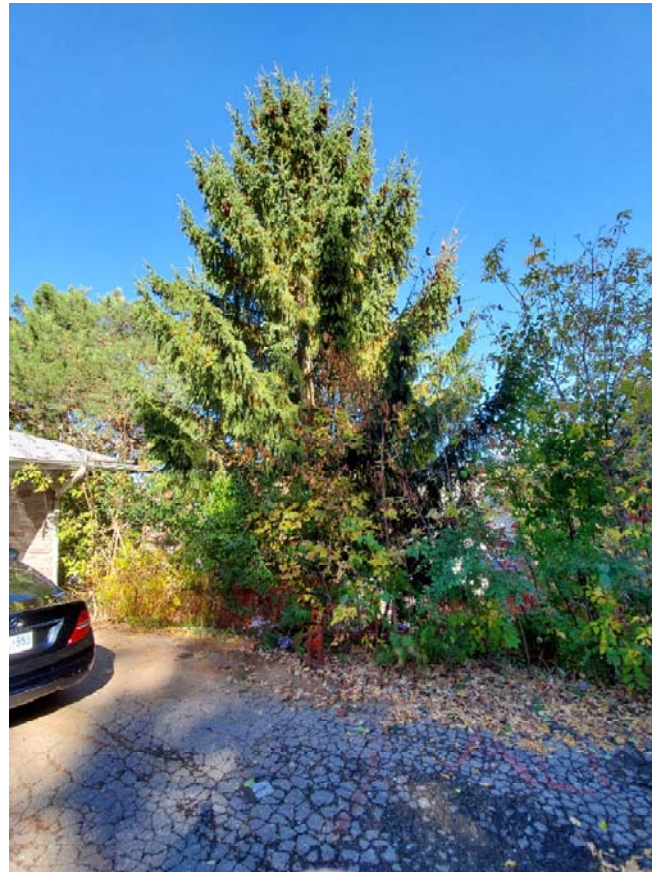
Tree 532

Trees 532, 533, and 546 are located at 66 Wallace Street.
