**Tree Inventory and Preservation Plan Report
9846 Keele Street
Vaughan, Ontario**

22 April 2022

KUNTZ FORESTRY CONSULTING INC Project P3240

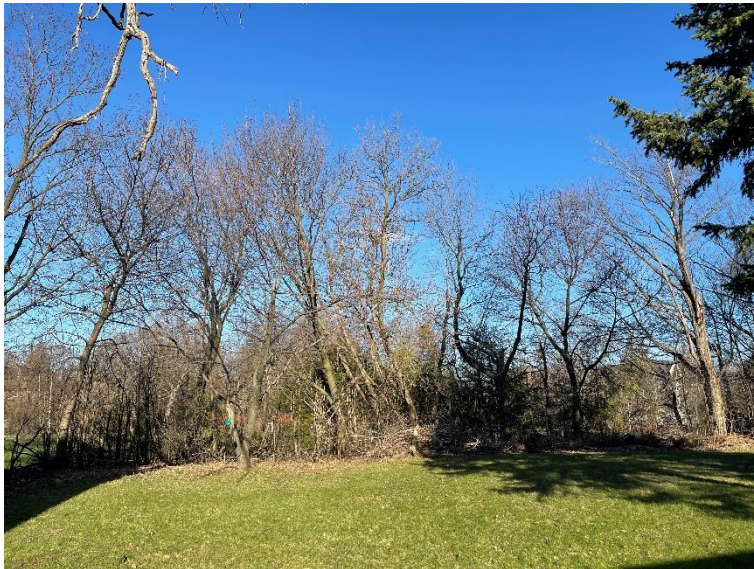
Image 1. Facing the west property line of the subject property

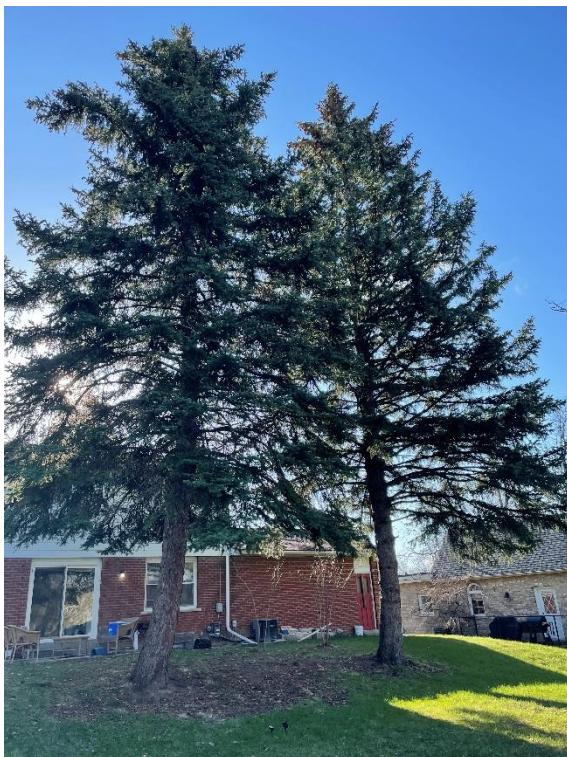
The removal of three trees, including Trees 187, 193, and 194, will be required to accommodate the proposed development. These trees directly conflict with the proposed dwellings. These trees are located on the subject property and are greater than 20cm DBH.

Image 2. Trees 193 (right) and 194 (left)

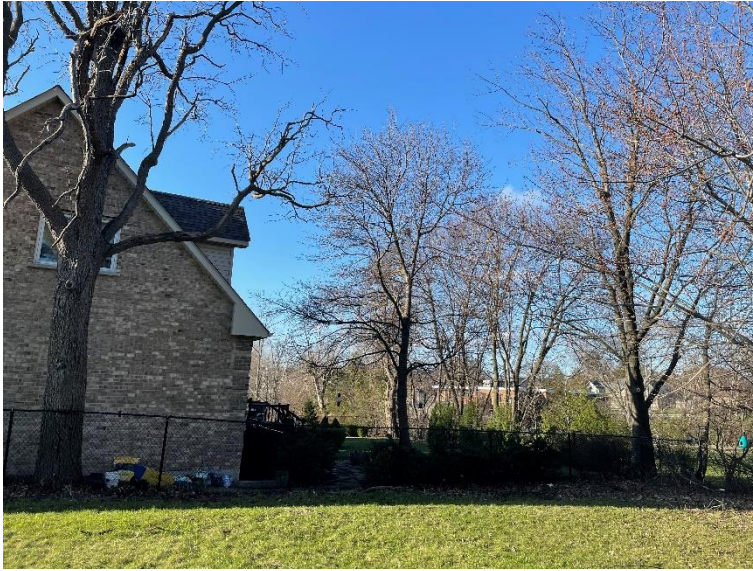
The removal of four additional trees is recommended based on their condition, including Trees 189, 190, A, and E. These trees all display considerable decay in their trunks, various amounts of deadwood, and poor to poor-fair overall condition. These trees are all greater than 20cm DBH. Trees A and E are located on neighbouring properties and as such, permission from the respective property owner will be required prior to their removal.

Image 3. From left to right, Trees A – C

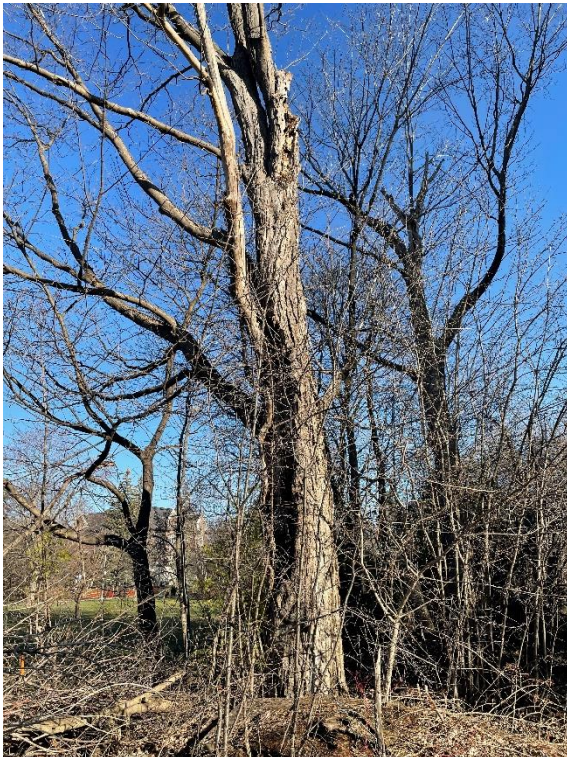
Image 4. Tree E

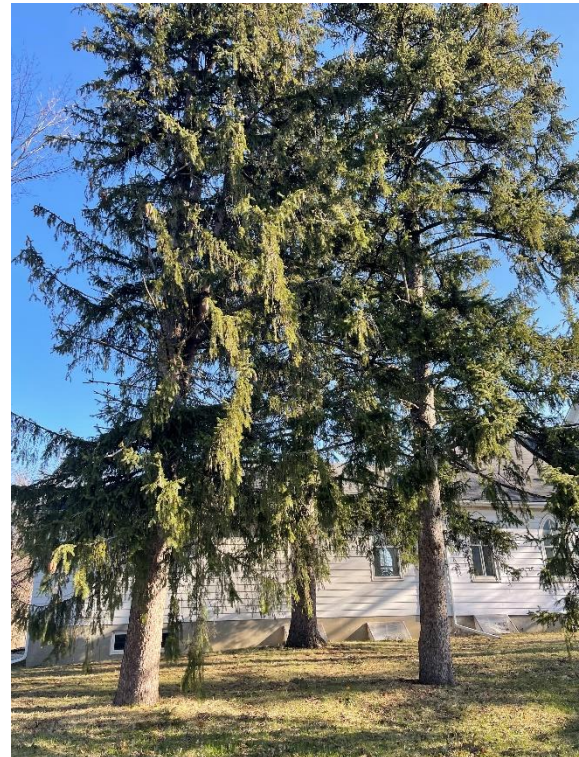
Image 5. From left to right, Trees G, I, and H

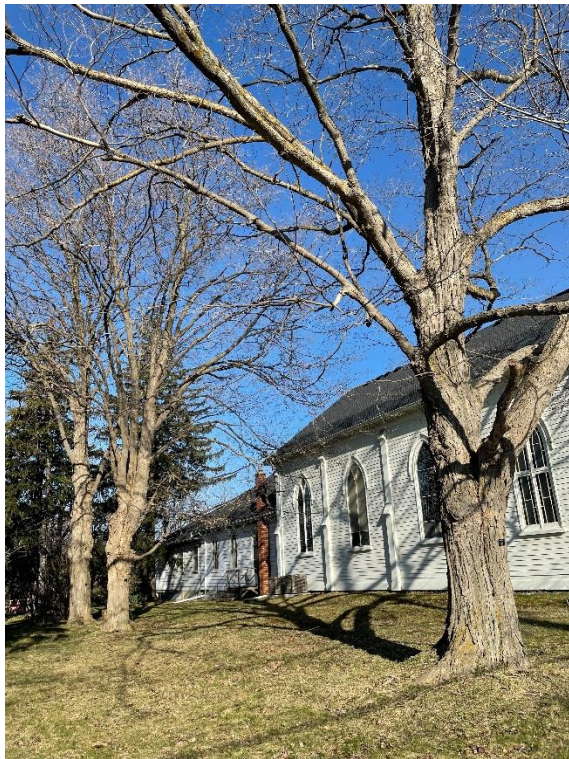
Encroachment into the mTPZs of Trees L and M will be required to accommodate the new combined laneway. Tree preservation fencing has been prescribed at the limit of encroachment of Trees L and M. If the following mitigation measures are followed, long-term adverse effects are not anticipated for these trees.

It should be noted that Trees L – N are Recognized Heritage Trees through the Ontario Heritage Tree Program and are identified as HT-2019-239-251.

Image 6. From far to near, Trees L – N

1. Prior to the commencement of the proposed work, tree protection fencing should be installed as show on Figure 1.
2. Air-spading technology should be used to excavate a trench at the limit of the proposed laneway within the mTPZs of Trees L and M, as shown in Figure 1 with solid cyan.
3. The depth of the trench will be determined by the depth of excavation required to construct the proposed laneway.
4. The roots of Trees L and M are to be pruned inside the trench by a Certified Arborist in accordance with Good Arboricultural Standards.
5. The trench is to be backfilled with clean topsoil.
6. All works should be supervised by a Certified Arborist in accordance with Good Arboricultural Standards.
7. Branches that extend into the proposed development and require pruning must be pruned by a Certified Arborist or other tree professional in accordance with Good Arboricultural Standards.

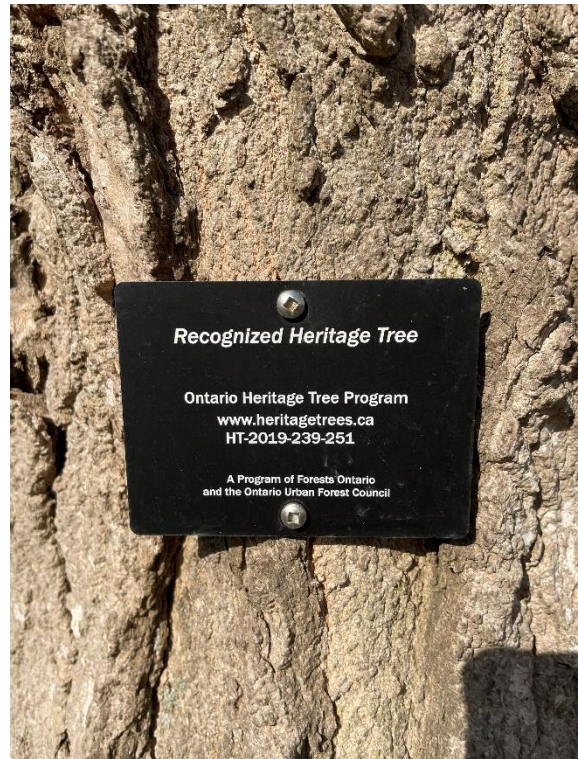
Image 7. Plaque identifying Trees L – N as being Recognized Heritage Trees

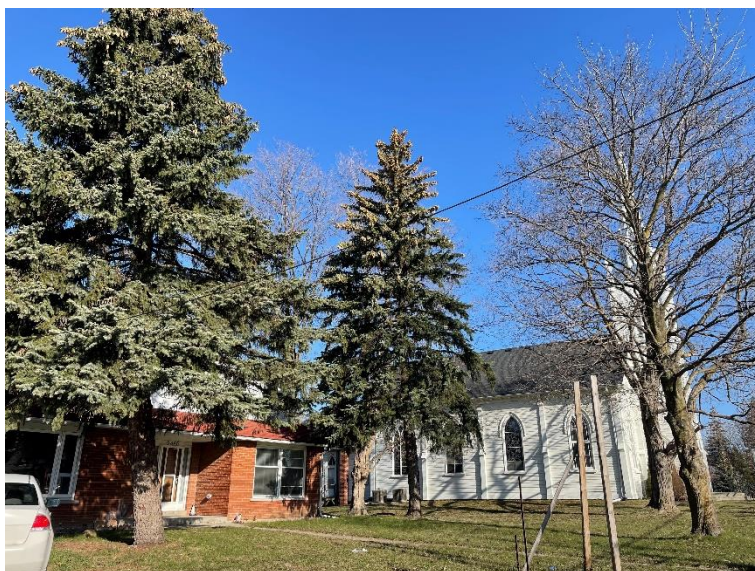
Encroachment into the mTPZ of Tree 198 is required to facilitate the removal of the existing driveway and walkway. Tree preservation fencing has been prescribed at the limit of the existing driveway and walkway. Given that a driveway and walkway exist within the area of encroachment of Tree 198, it is anticipated that few roots extend into this area. If the following mitigation measures are followed, long-term adverse effects are not anticipated for this tree.

Image 8. From right to left, Trees 196 – 198

1. Prior to the commencement of the proposed work, tree protection fencing should be installed as show on Figure 1.
2. The existing driveway and walkway should be removed during the final stages of construction.

3. The existing driveway and walkway must be removed carefully by hand or using small machinery (i.e. a skidsteer).
4. The existing subsurface and any roots encountered within the subsurface should be left intact.

5. Once the existing driveway is removed, no machinery use will be permitted within the mTPZ of Tree 198.
6. Any softscaping to occur within the mTPZ of Tree 198 must occur by hand.

7. All works should be supervised by a Certified Arborist in accordance with Good Arboricultural Standards.
8. Branches that extend into the proposed development and require pruning must be pruned by a Certified Arborist or other tree professional in accordance with Good Arboricultural Standards.

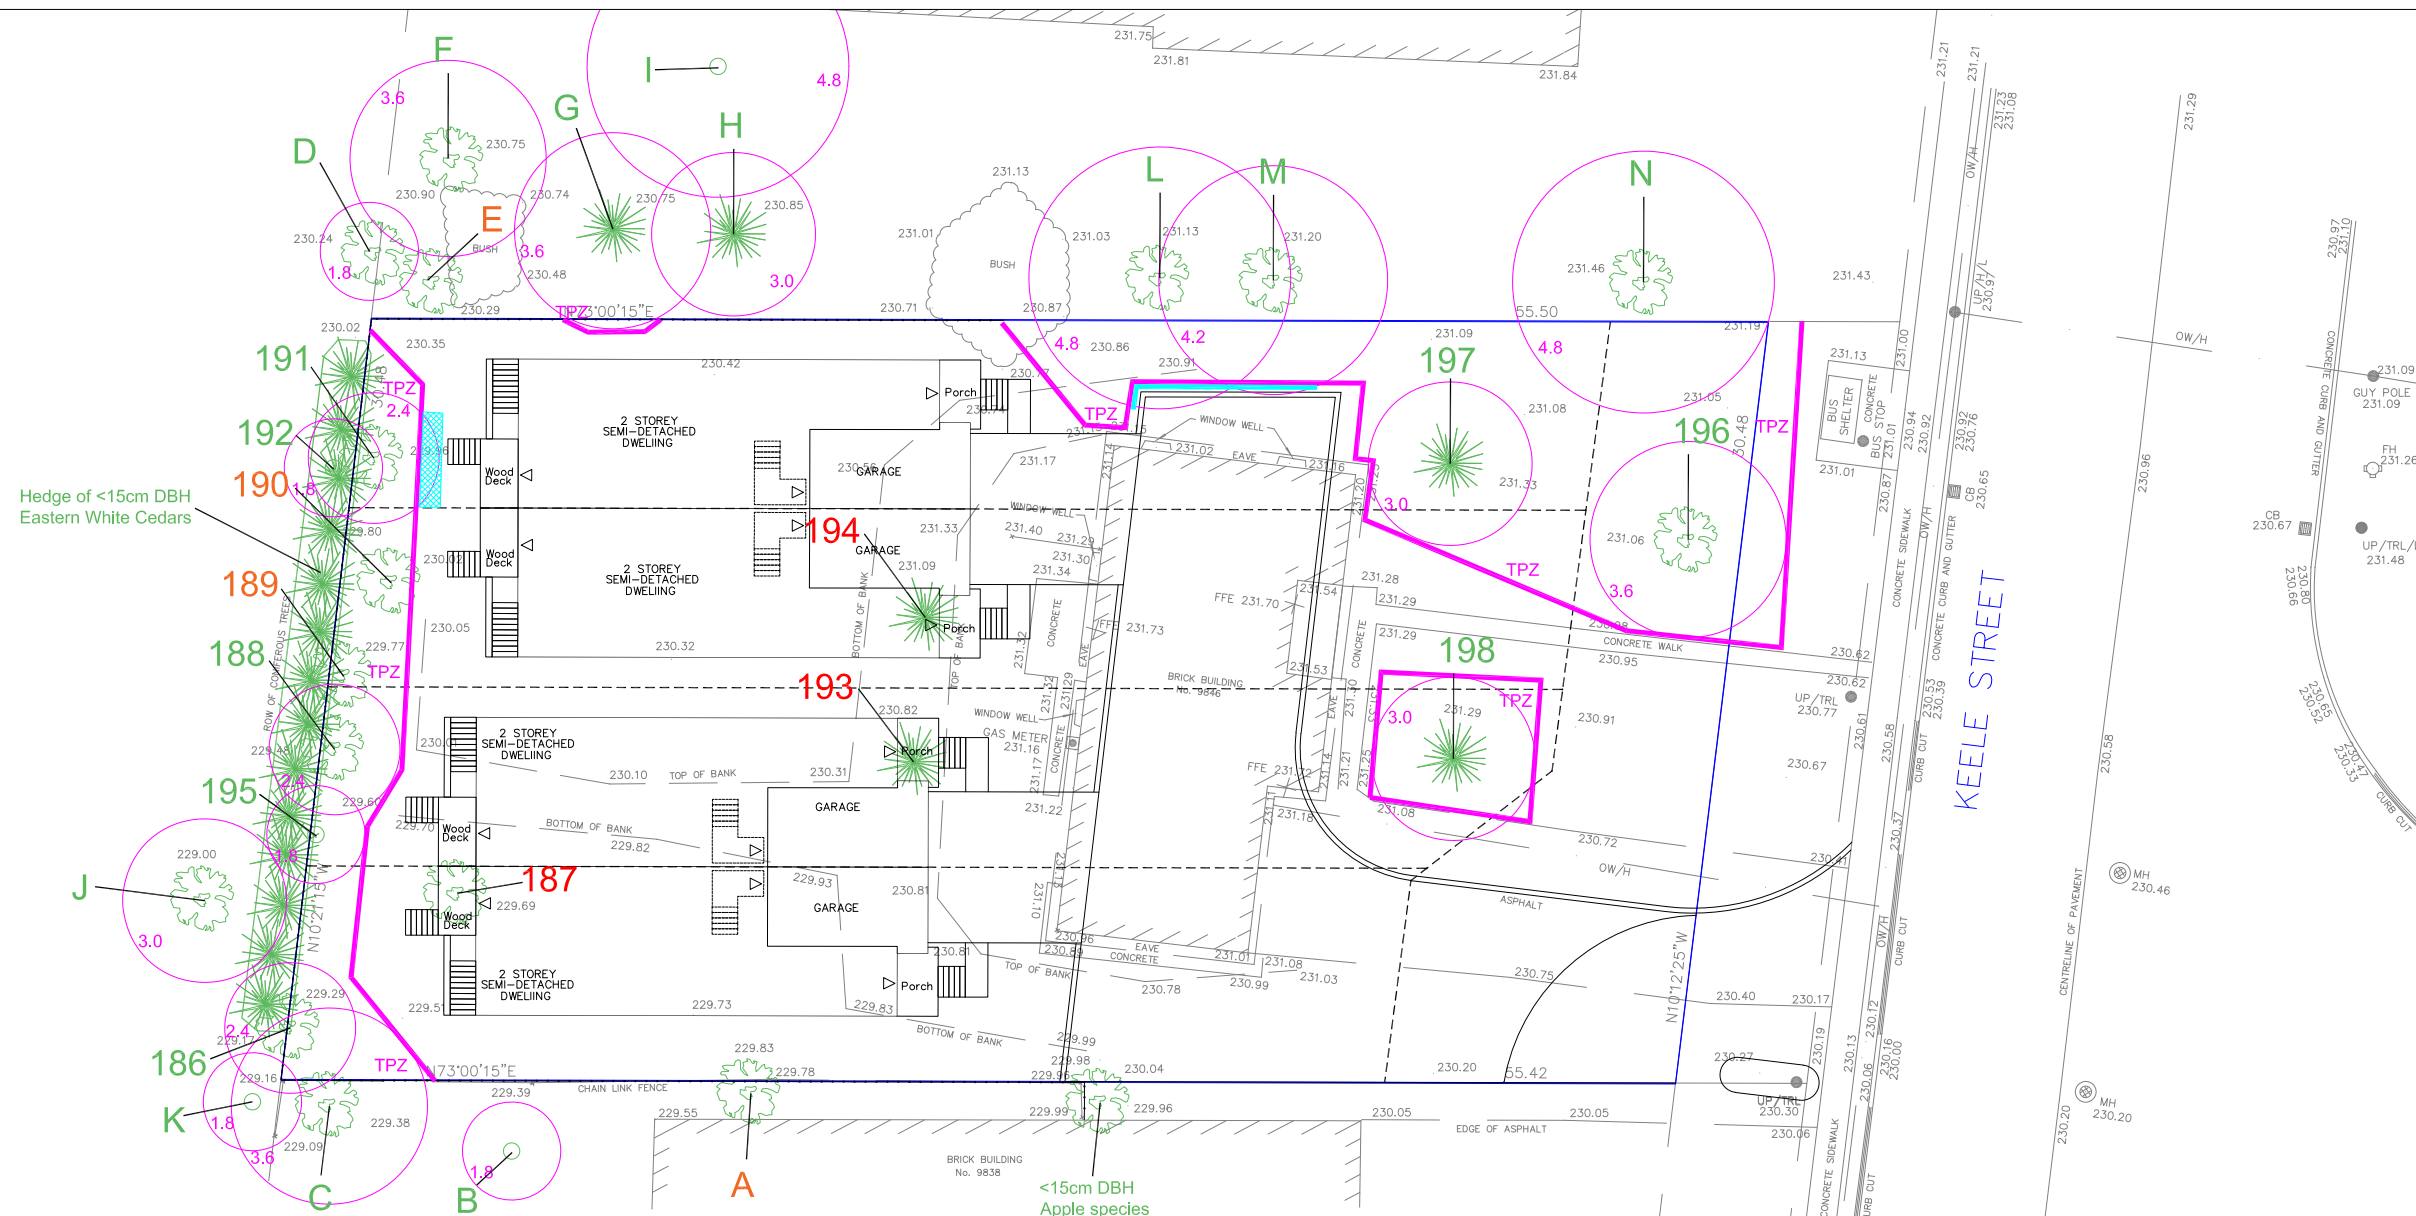
Project	P3240	Figure	1
Date	22 April 2022		
Scale	1:300

Refer to Figure 1 for the locations of trees identified for removal.

The preservation of 20 trees, including Trees 186, 188, 191, 192, 195 – 198, B – D, and F – N, will be possible with the use of appropriate tree protection measures as indicated on Figure 1. Tree protection fencing should be installed prior to demolition and construction to ensure designated trees are not impacted by construction. Refer to Figure 1 for the location of trees identified for preservation, the preservation fencing details, and further protection notes. Heavy-duty fencing should be utilized per detail MLA-107A.
