ARBORIST REPORT AND TREE PRESERVATION PLAN

717 Nashville Road
Kleinburg, ON

31 January 2023, revised 21 June 2023

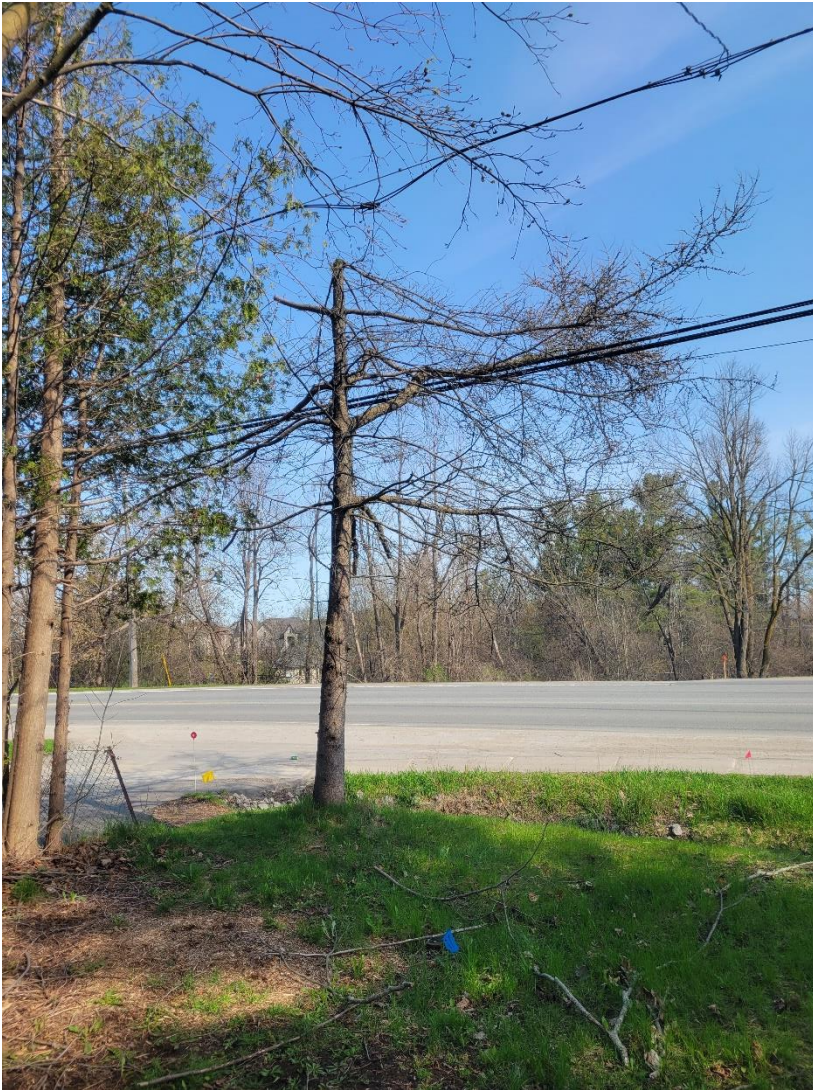
Photo 1. Tree 1, view looking northwest

Tree 1 is located within the City road allowance. This tree will be protected by light duty tree protection hoarding, as per Detail 107B on the Tree Preservation Plan (Figure 1). All remaining trees will be protected by heavy duty tree protection hoarding, as per Detail 107A on the Tree Preservation Plan (Figure 1). Any grading (including for swales) within the mTPZs of Trees 1, 5, 6, 18, 21, 23, 24, and tree polygon P19 should be completed towards the final phase of construction and using by hand or using light equipment only, under supervision of a Certified Arborist. Tree 20 is in declining condition and should be monitored to ensure it is viable for retention. Tree polygon P19 and Tree 20 has been heavily impacted by construction on the neighbouring property. These trees should be monitored to ensure they are viable for retention.

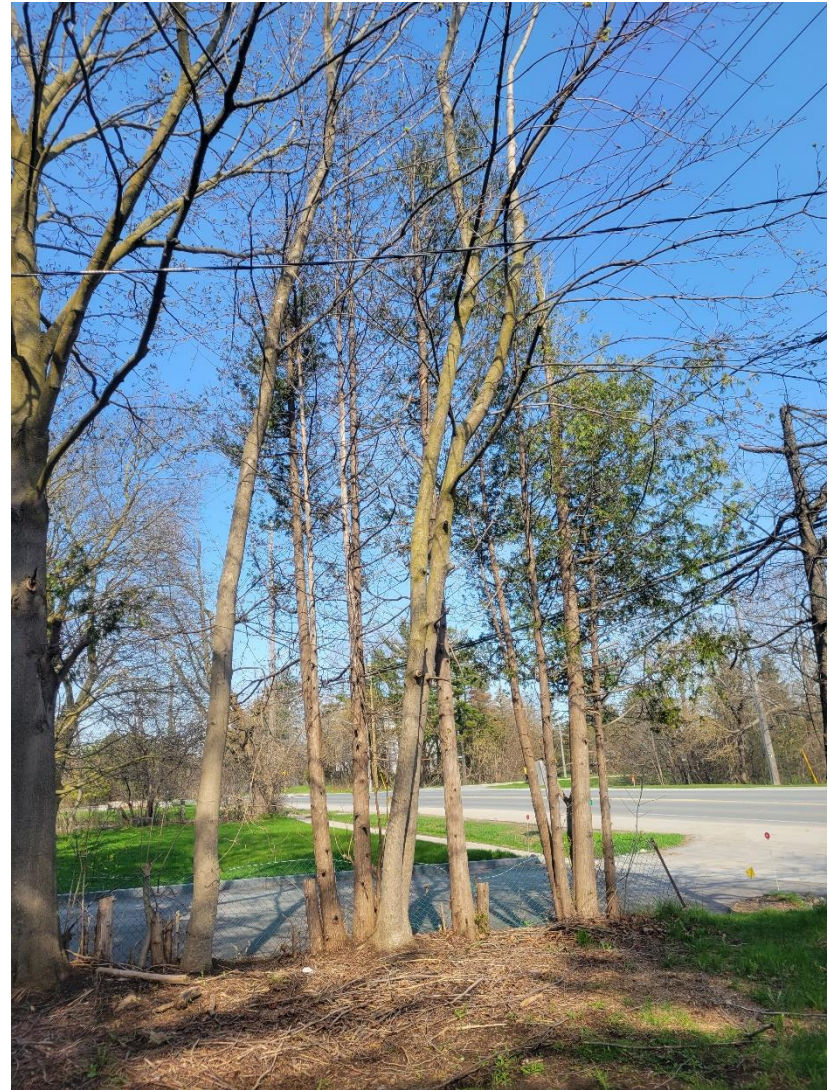
Photo 2. Tree polygon P2, Trees 3 and 4, view looking northwest

The removal 11 trees and two tree polygons will be required to accommodate the proposed works, including Trees 3, 4, 8 to 9, 11, 12, 14, 16, 17, 22, and tree polygons P2, and P7. Trees 10, 13, and 15 had failed or were deemed potentially hazardous following the storm and were recommended for removal. Tree 8 has a history of failure and is in poor and declining condition, and is recommended for removal due to hazard potential.

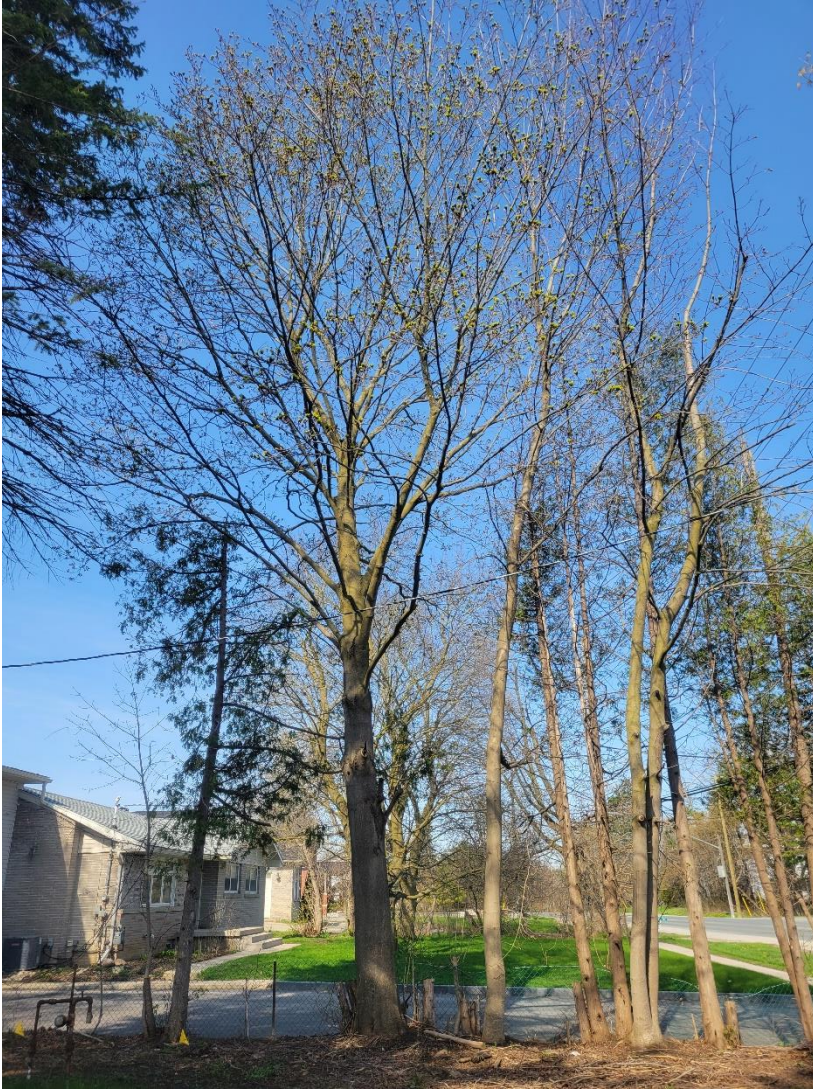
Photo 3. Tree polygon P2, Trees 3 to 6 (right to left), view looking west

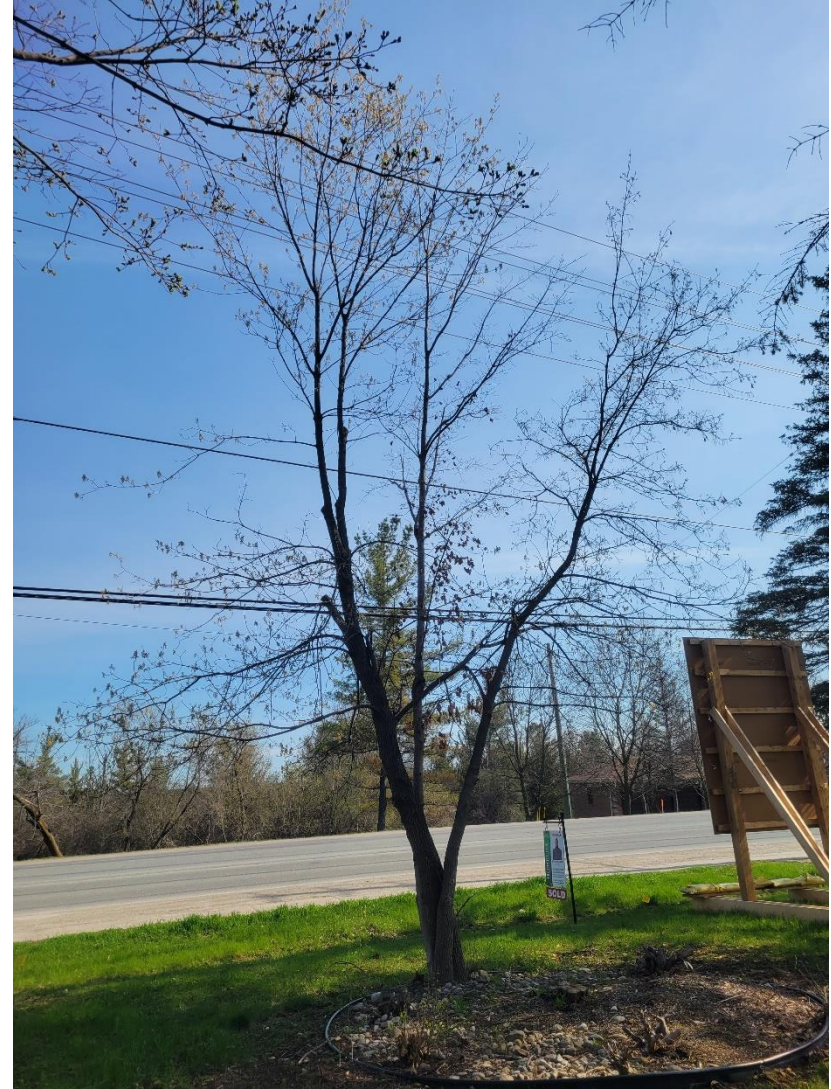
Photo 4. Tree polygon P7, view looking northeast

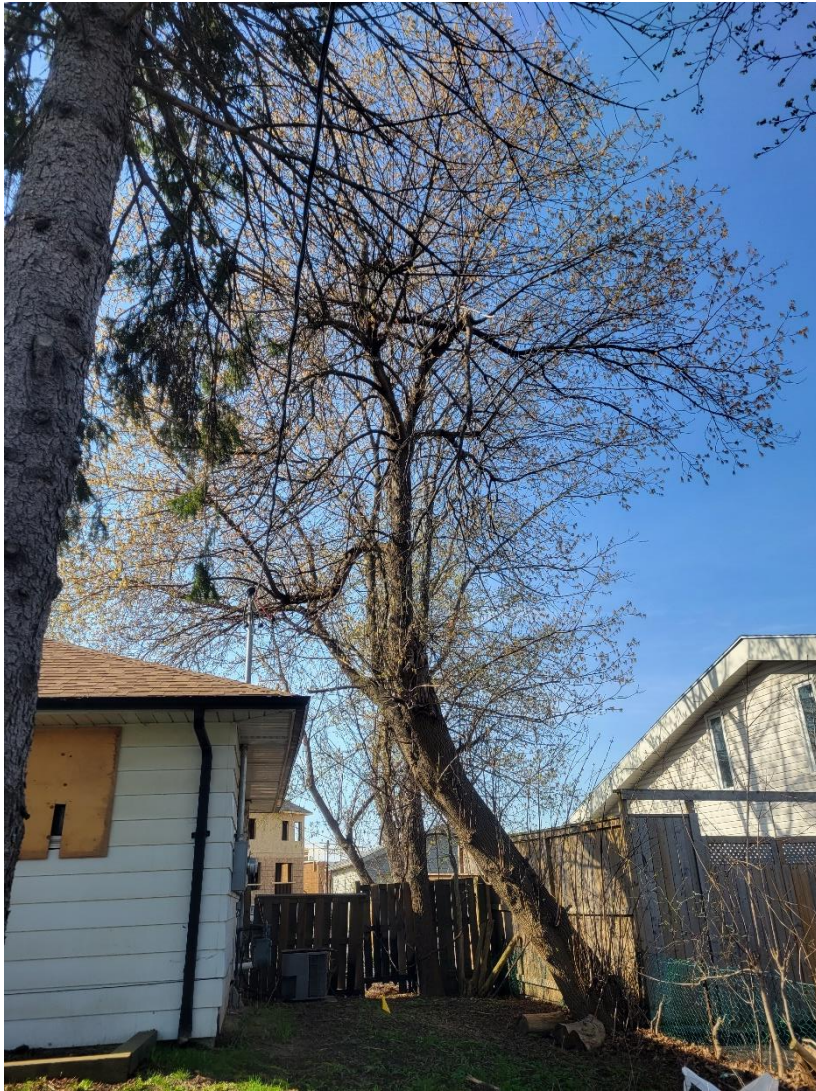
Photo 5. Trees 8 and 9, view looking southwest

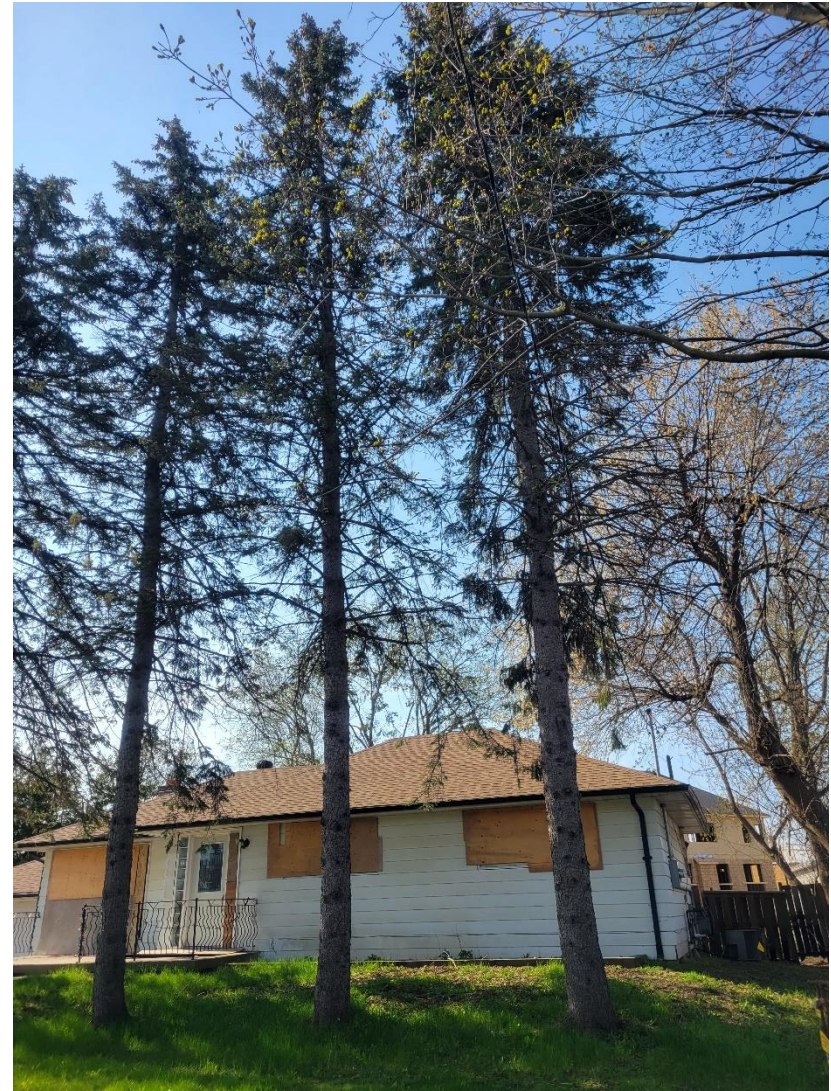
Photo 6. Trees 10 to 12, view looking southeast

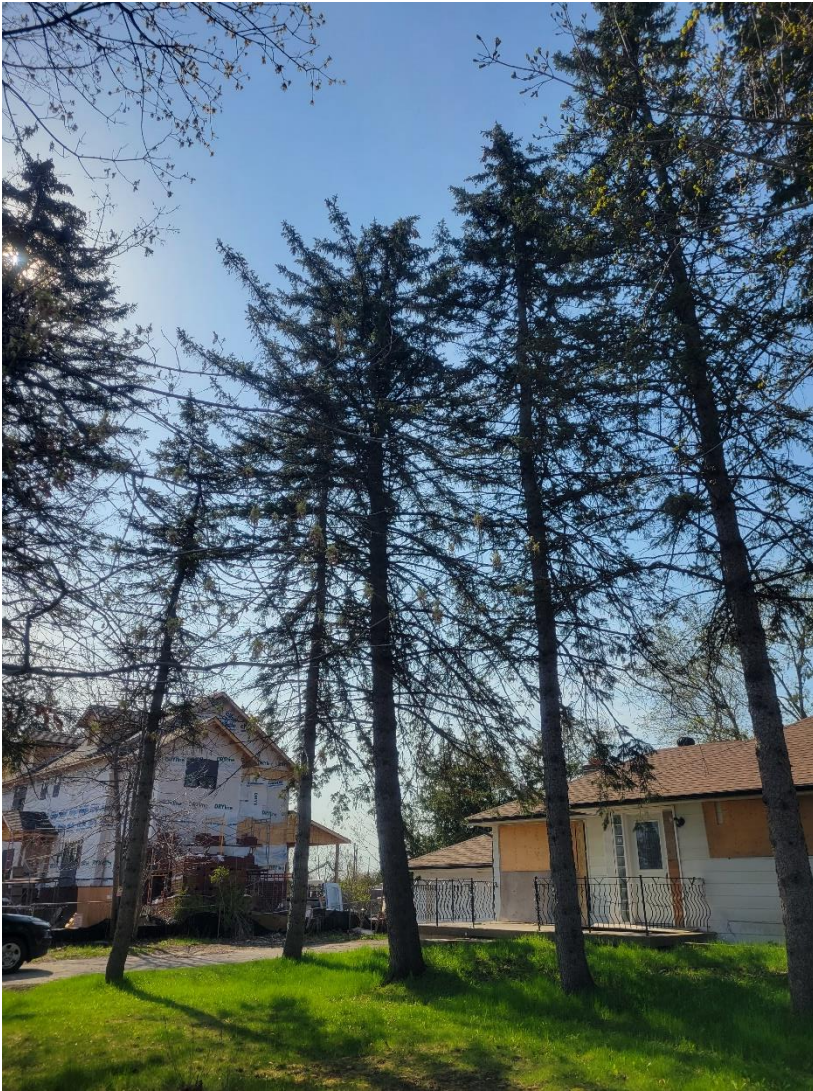
Photo 7. Trees 11 to 14, view looking southeast

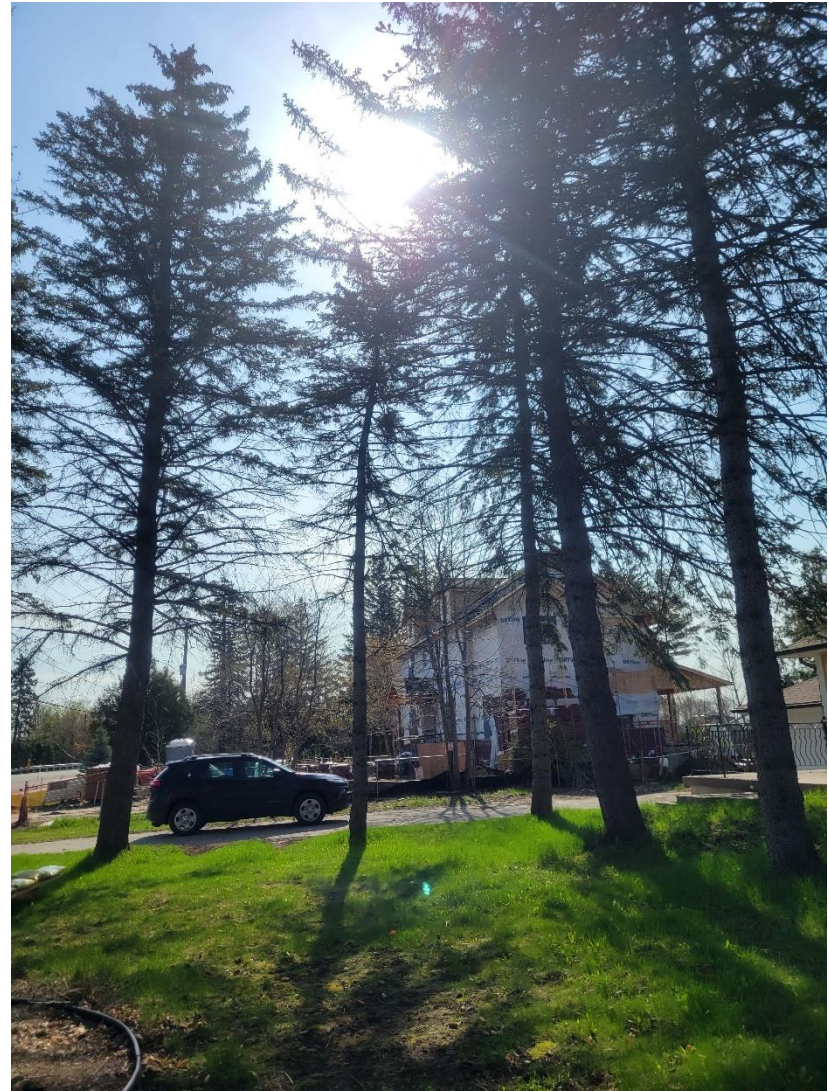
Photo 8. Trees 12 to 16, view looking east

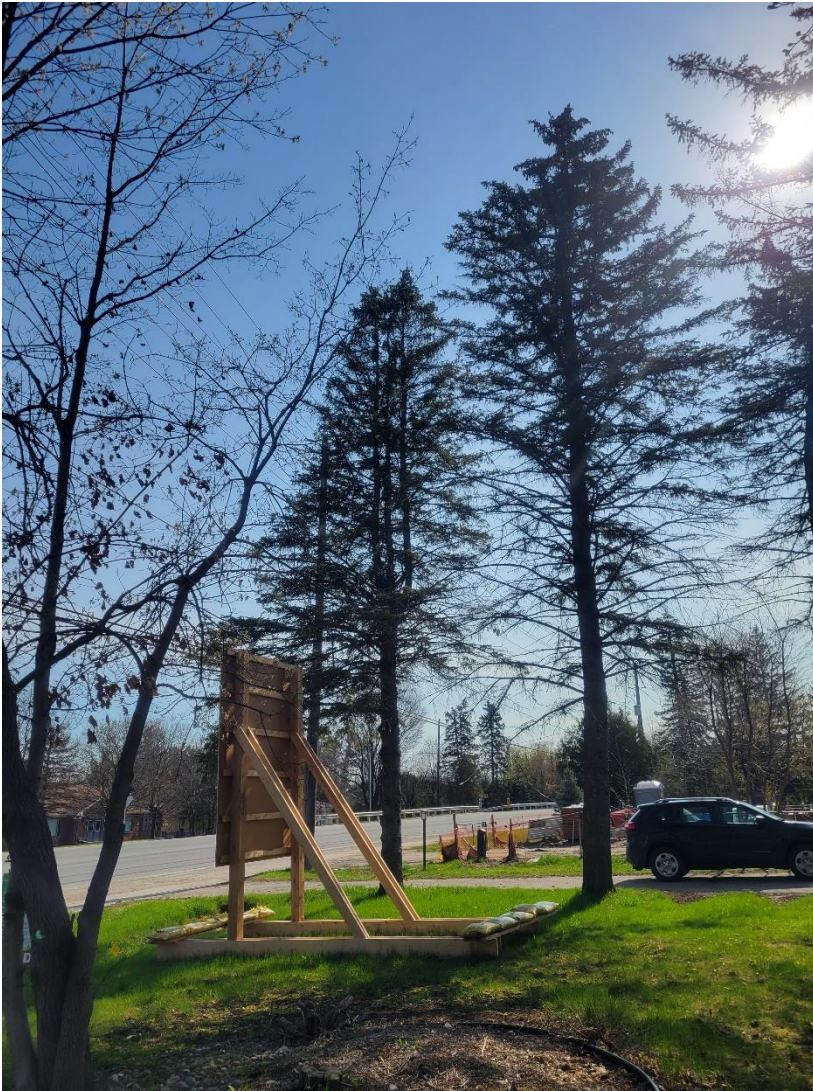
Photo 9. Trees 16 and 17, view looking northeast

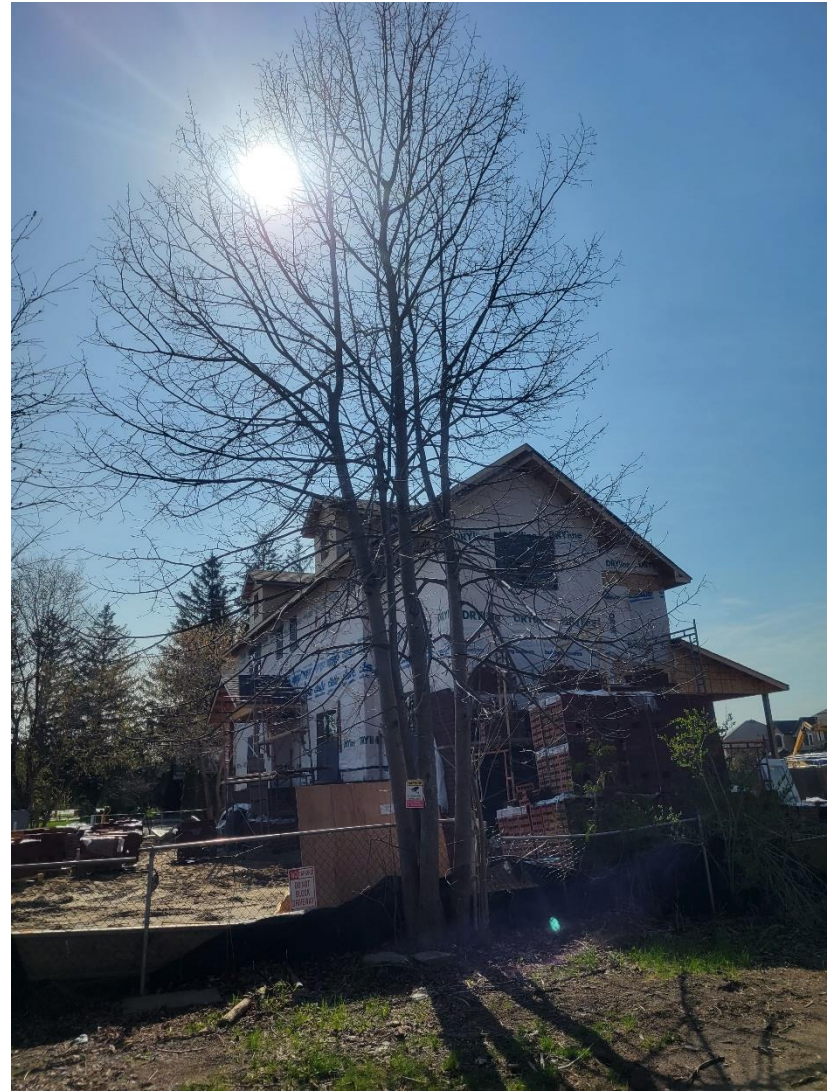
Photo 10. Tree 18, view looking southeast

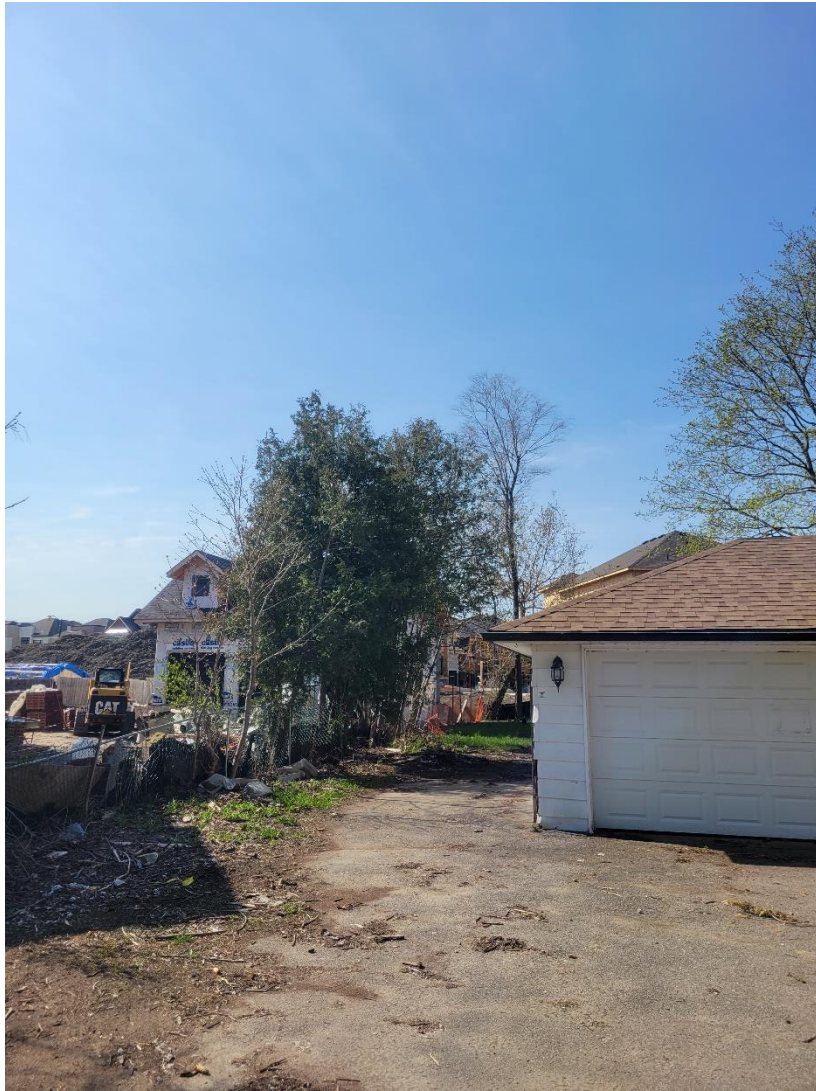
Photo 11. Tree polygon P19, view looking southeast

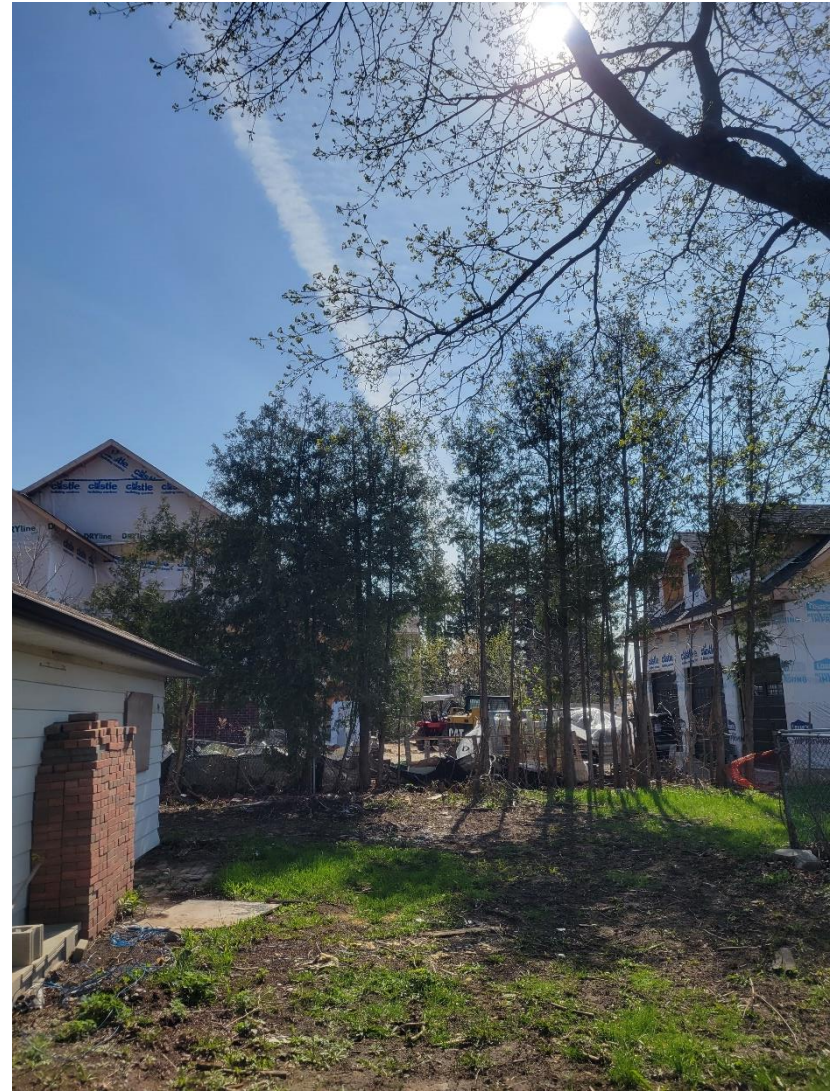
Photo 12. Tree polygon P19, view looking east

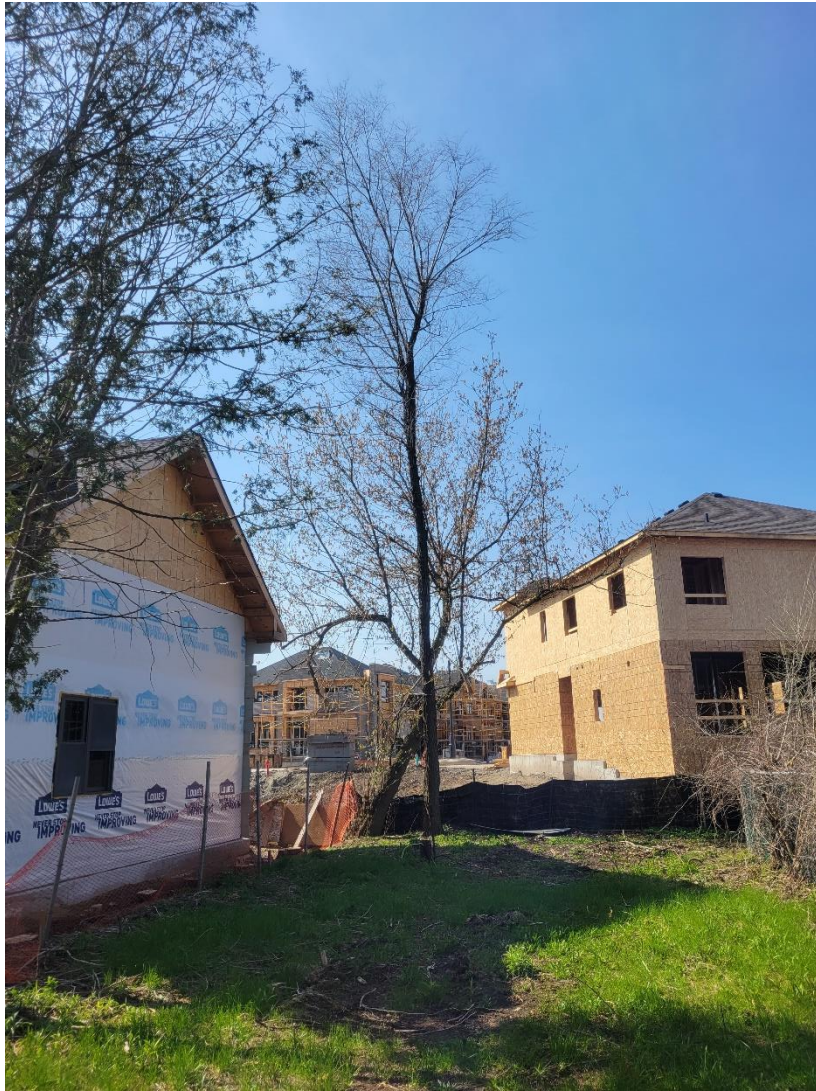
Photo 13. Trees 20 and 21, view looking southeast

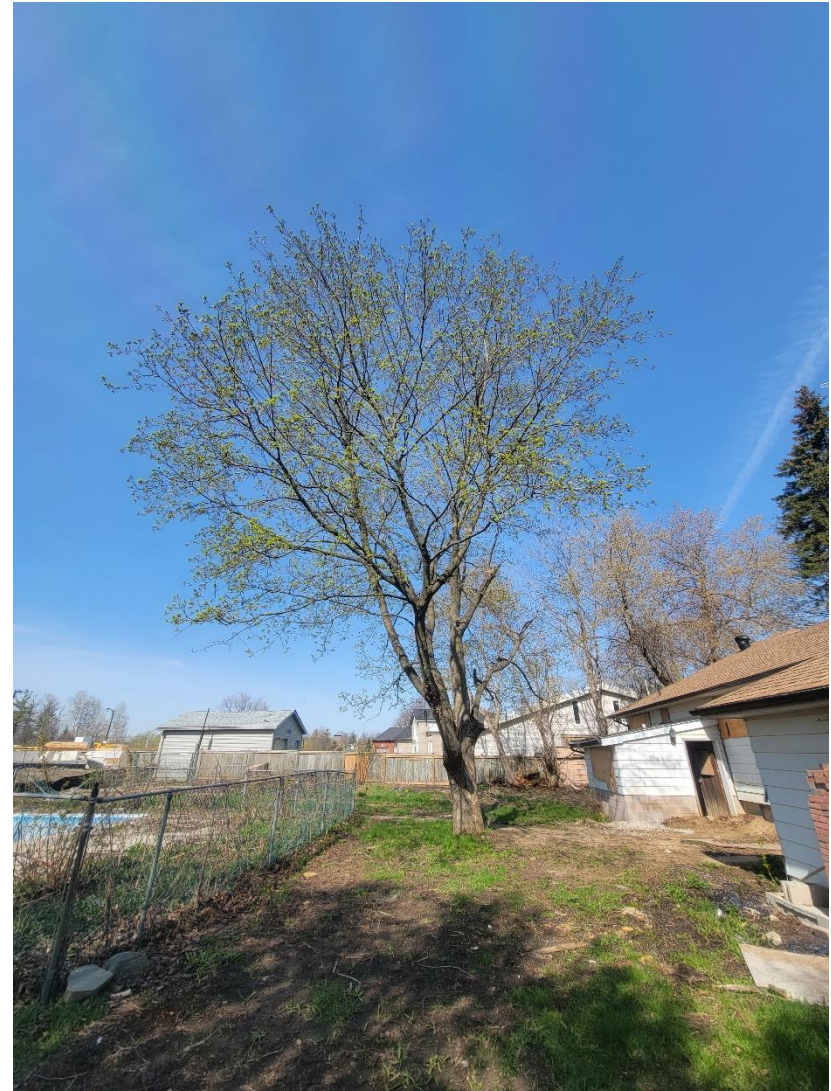
Photo 14. Tree 22, view looking west

22	Norway Maple	<i>Acer platanoides</i>	75	PF	PF	F	F	9	4.8	Moderate growth deficit, moderate seam, moderate pruning wounds with decay, moderate stem wound at base with decay and cavity, union at 2m with moderate included bark, moderate deadwood, overextended branch with moderate included bark	Remove	Private	4	
23	Manitoba Maple	<i>Acer negundo</i>	34	F	F	PF	F	4	1.8	Minor lean towards the southeast, minor pruning wounds, minor broken branches, moderate epicormic branching	Preserve - injure	Shared		
24	Manitoba Maple	<i>Acer negundo</i>	21,14.5 [25.5]	PF	F	PF	F	5	1.8	Minor stem wound, moderate epicormic branching, moderate pruning wounds, union at base with heavily included bark with decay, moderate grapevine competition, minor lean towards the east	Preserve - injure	Shared

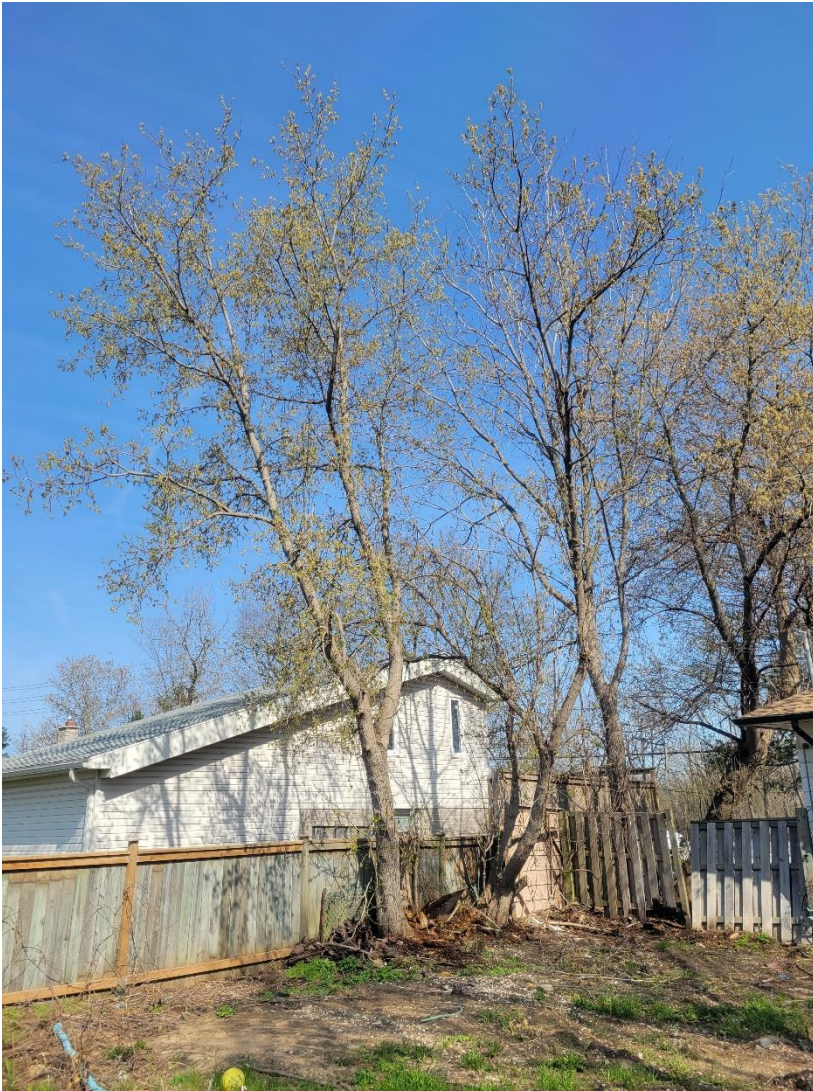
Photo 15. Trees 23, 24, 8 and 9, view looking northwest

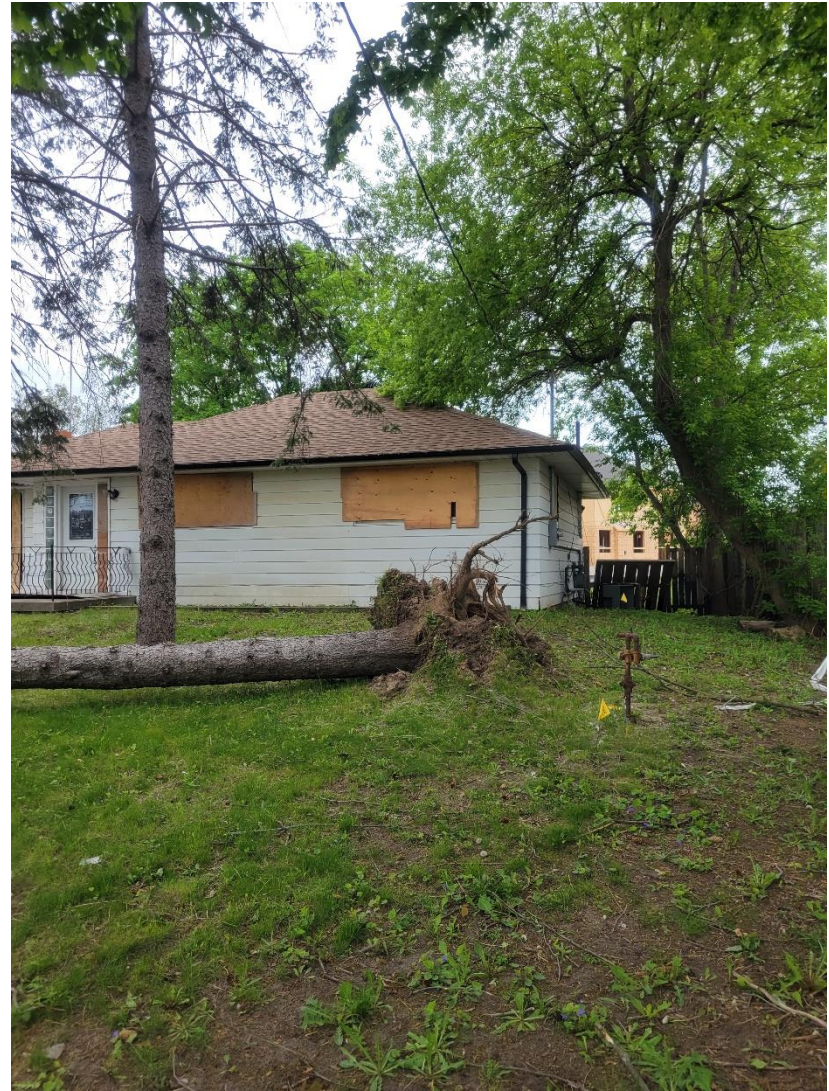
Photo 16. Tree 10 failure

10	Blue Spruce	<i>Picea pungens</i>	32	-	-	-	-	-	-	Minor pruning wounds due to raised crown, minor bow, failed at roots	Remove - dead	Private	0	
11	Blue Spruce	<i>Picea pungens</i>	41.5	FG	FG	FG	F	4	3	Minor asymmetrical crown	Remove	Private	3	
12	Blue Spruce	<i>Picea pungens</i>	35	FG	FG	FG	F	3	2.4	Crook, small crown	Remove	Private	2	
13	Blue Spruce	<i>Picea pungens</i>	49	-	-	-	-	-	-	Sweep, moderate asymmetrical crown, failed at roots, leaning against Trees 15 and 16	Remove - dead	Private	0	
14	Blue Spruce	<i>Picea pungens</i>	31	FG	F	FG	F	3	2.4	Minor pruning wounds, moderate asymmetrical crown	Remove	Private	2	
15	Blue Spruce	<i>Picea pungens</i>	27	PF	PF	F	F	15	2	1.8	Minor pruning wounds, crooks, double leader, Tree 13 in crown, heavily asymmetrical crown from damage	Remove - potentially hazardous	Private	0
16	Blue Spruce	<i>Picea pungens</i>	49.5	FG	FG	F	F	10	4	3	Minor pruning wounds, Tree 13 in crown	Remove	Private	3

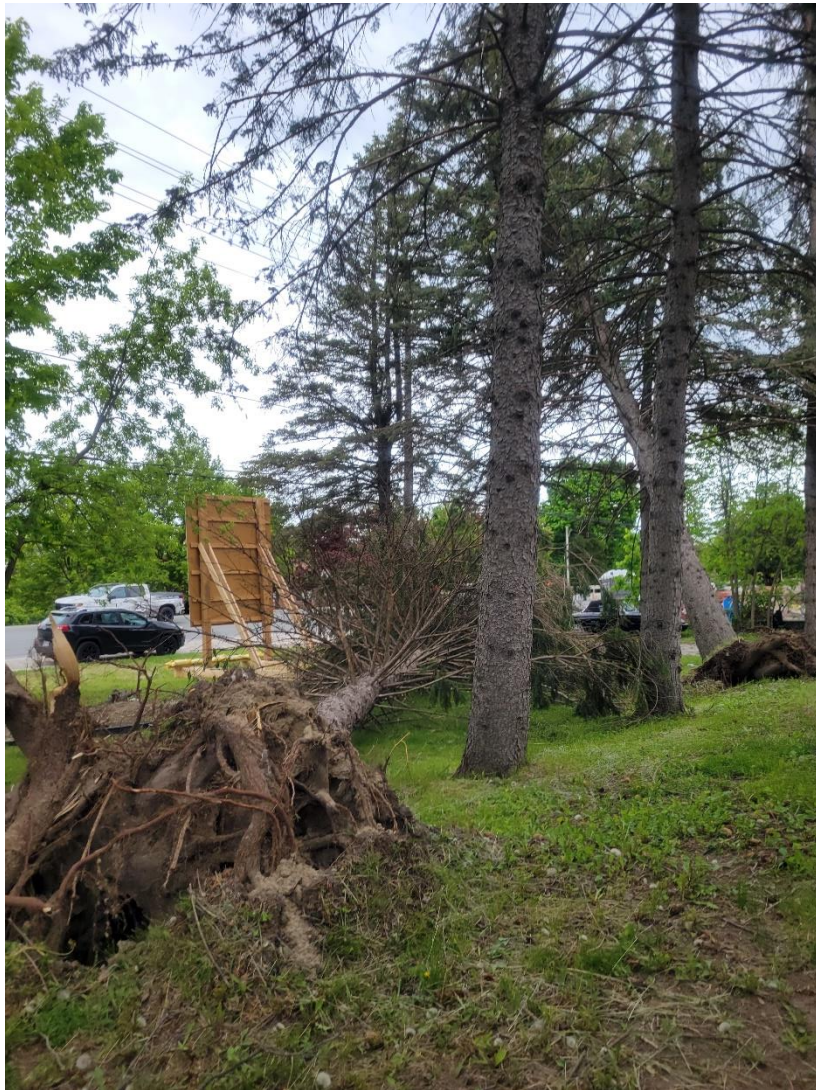
12	Blue Spruce	<i>Picea pungens</i>	35	FG	FG	FG		3	2.4	Crook, small crown	Remove	Private	2
13	Blue Spruce	<i>Picea pungens</i>	49	-	-	-		-		Sweep, moderate asymmetrical crown, failed at roots, leaning against Trees 15 and 16	Remove - dead	Private	0
14	Blue Spruce	<i>Picea pungens</i>	31	FG	F	FG		3	2.4	Minor pruning wounds, moderate asymmetrical crown	Remove	Private	2
15	Blue Spruce	<i>Picea pungens</i>	27	PF	PF	F	15	2	1.8	Minor pruning wounds, crooks, double leader, Tree 13 in crown, heavily asymmetrical crown from damage	Remove - potentially hazardous	Private	0
16	Blue Spruce	<i>Picea pungens</i>	49.5	FG	FG	F	10	4	3	Minor pruning wounds, Tree 13 in crown	Remove	Private	3
17	Blue Spruce	<i>Picea pungens</i>	46.5	FG	F	F		4	3	Minor pruning wounds, multi-stemmed at 7m, minor asymmetrical crown	Remove	City	3

Photo 17. Trees 10, and 13 failure
