# **Tree Inventory & Protection Plan**

**Subject Site:**  
60 Napier Street. Vaughan, ON L4H 3N5

**July 29, 2022**

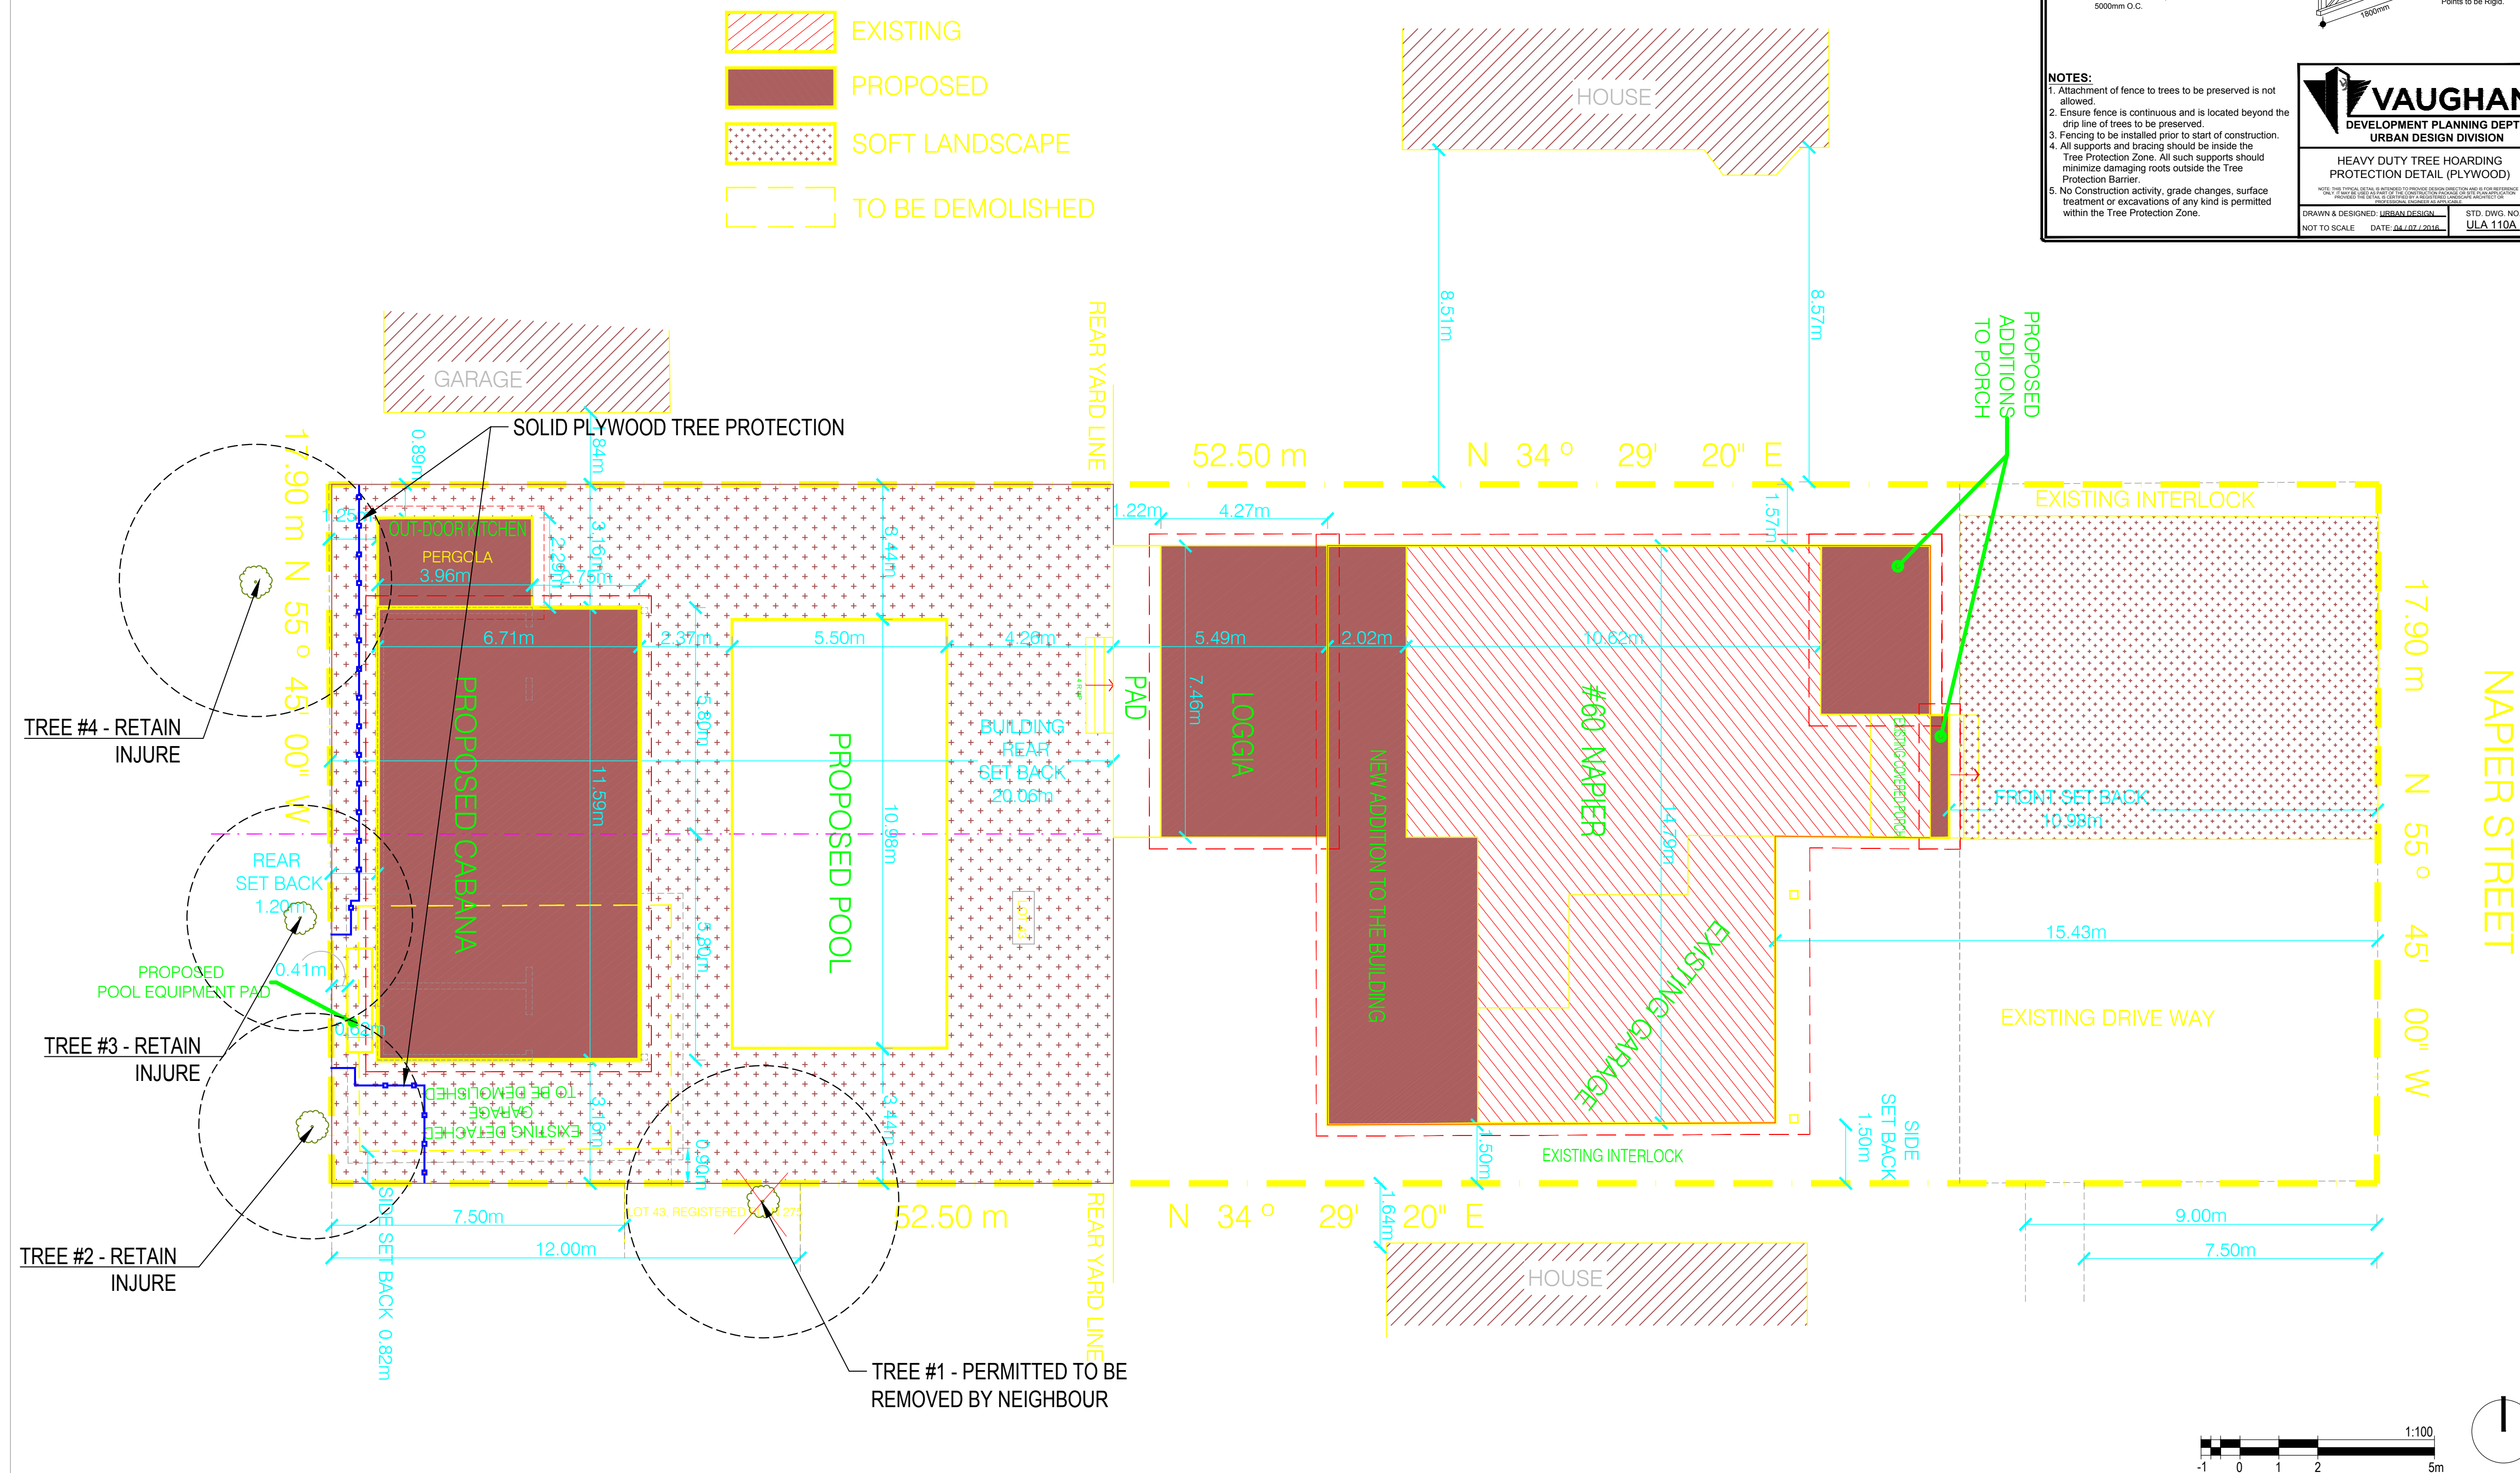
TP-1

There 3 trees to injure. All 3 trees are on neighbouring property at the rear of the property. All 3 trees are Norway Maples that have volunteered themselves along the fence line. The existing garage has been built prior to the trees being there and a large amount of the minimum tree protection zone for trees #2 and #3 are in the footprint of the garage. The proposed tree protection barriers wrap around the existing garage as a result.

Conclusions	Recommendations
3 trees are to be retained and preserved on site.	Install tree protection as shown in Site Plan / Tree Protection Plan Drawing.
The proposed development will require 3 trees to be injured.	Submit application to Injure 3 trees to City of Vaughan.
0 trees are required to be planted back onto the site.	No action required.

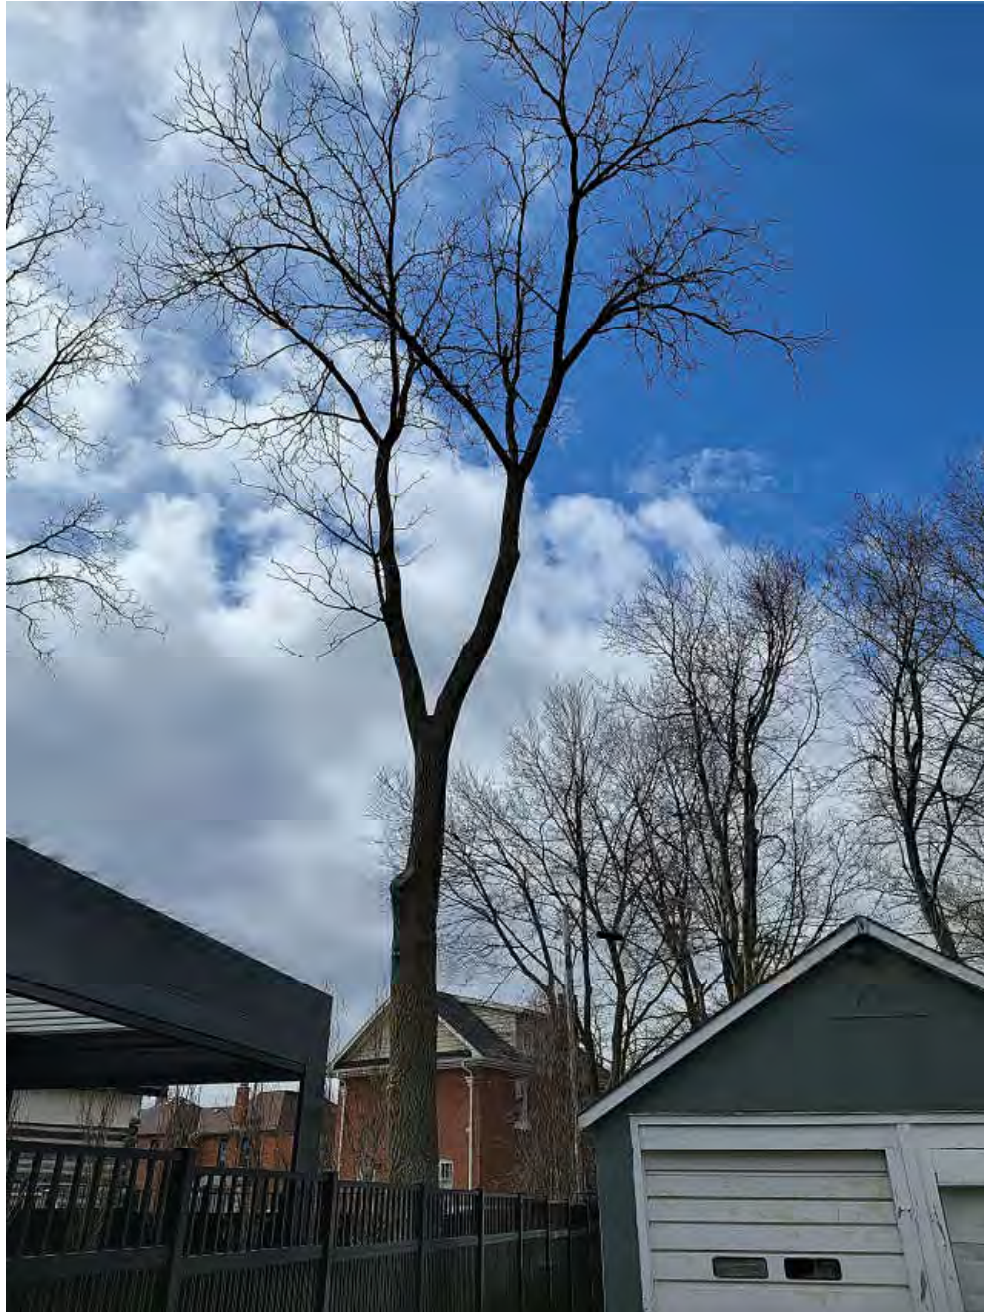
TREE 1

In the case of 60 Napier Street all trees can be preserved with the exception of tree #1. Tree #1 has been permitted by neighbour for removal.
