# **Tree Inventory & Protection Plan**

57 Napier St, Vaughan, ON L4H 3N5

**The Urban Arborist Inc.**

**November 29, 2023**

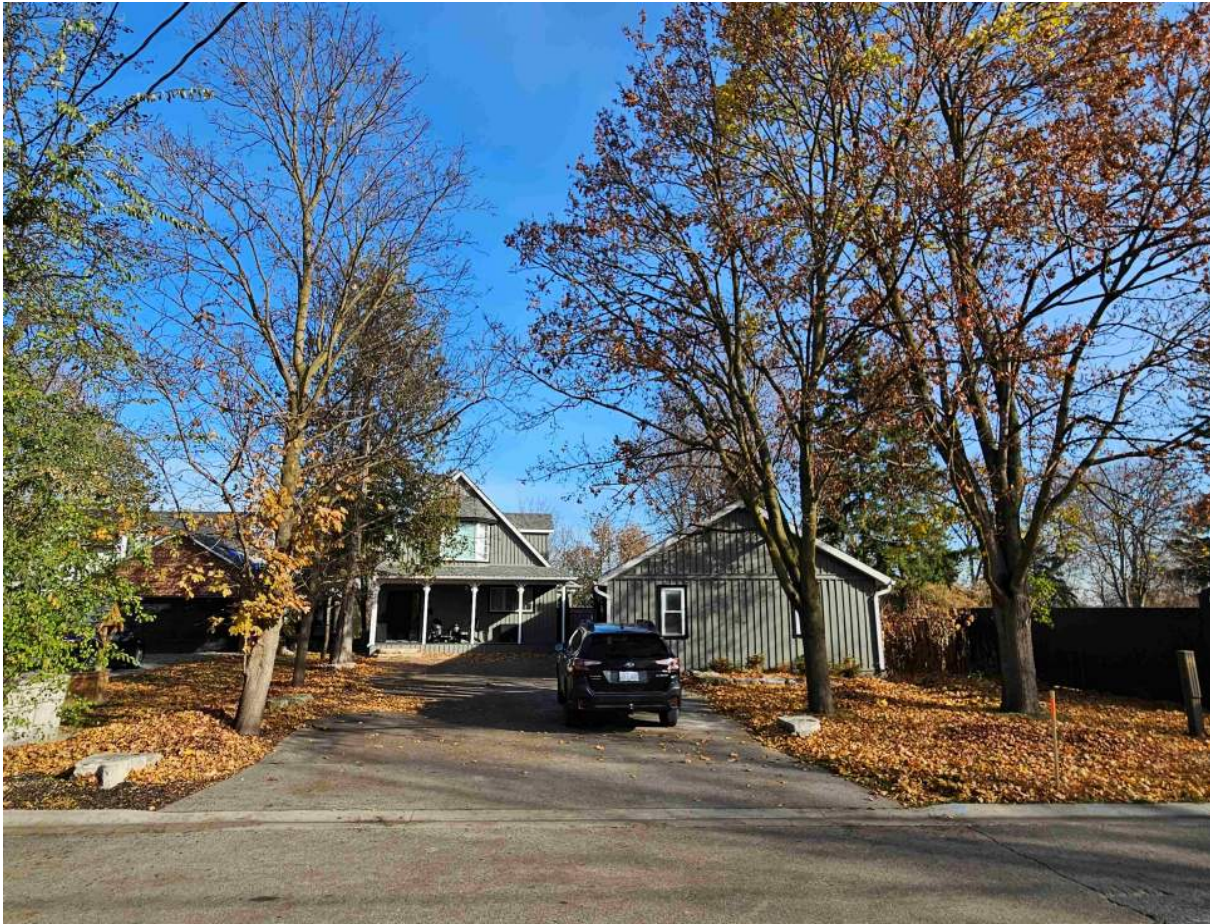
Figure 1. Front of subject site at 57 Napier St, Vaughan, ON L4H 3N5
