## CITY OF VAUGHAN

### EXTRACT FROM COUNCIL MEETING MINUTES OF JUNE 25, 2024

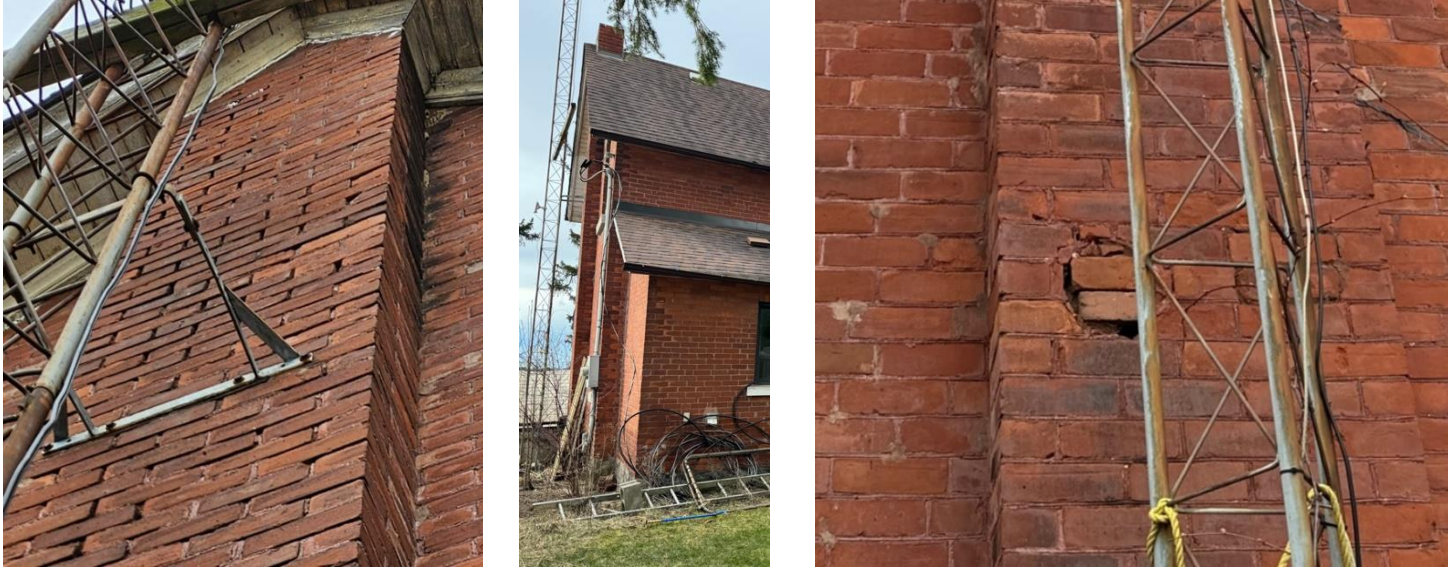
**Figure 7:** Chimney grouting between bricks eroded away with chimneys appearing to lean in-towards itself.

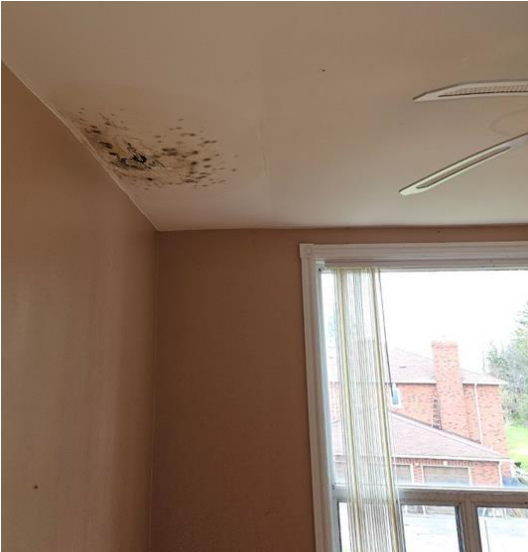
**Figure. 16:** Water damage/mold on the second-floor ceiling with fairly recent ceiling gypsum due to water leakage from roof.

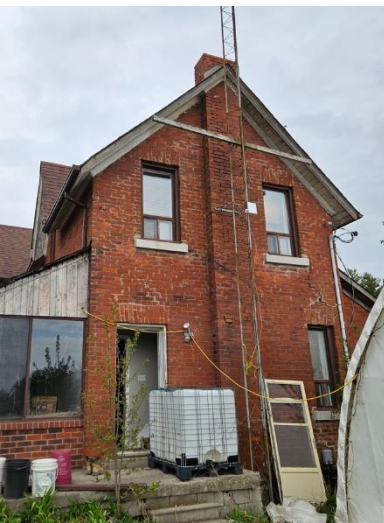
**Figure. 17:** East Chimney projected chimney with lack of interlocking and grouting to primary structure.

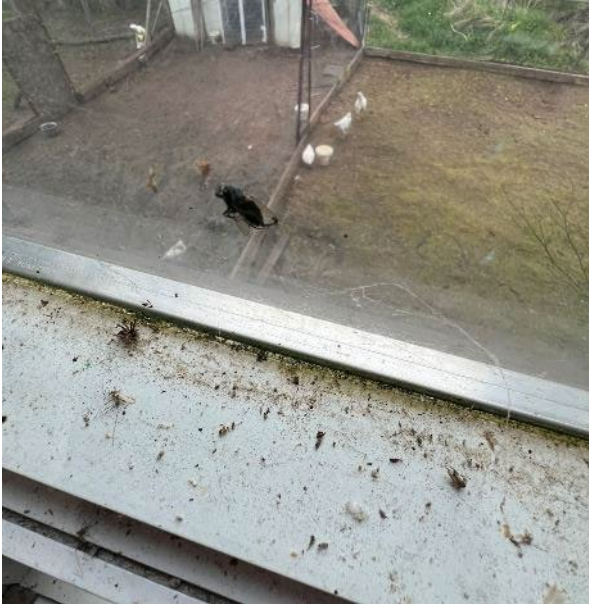
*View to North Chicken Run*

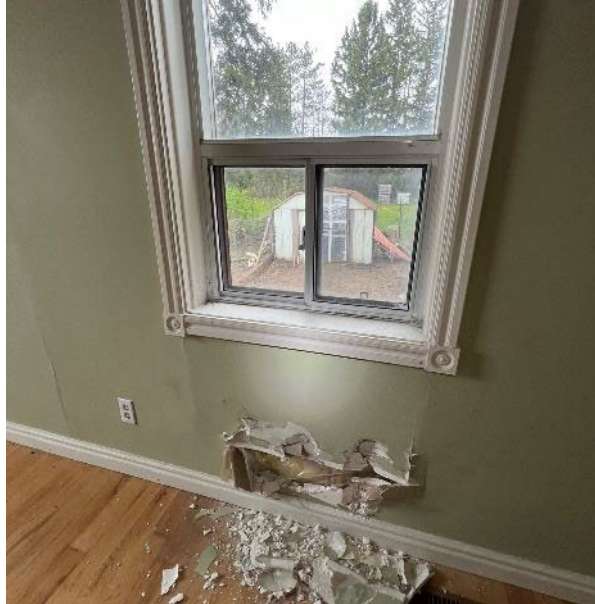
*Mold, Drywall, and Animal Feces Damage*

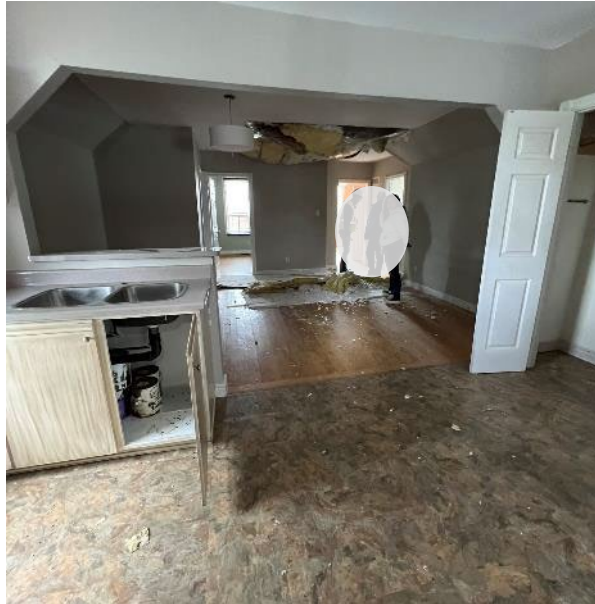
*Basement Staircase (Damaged)*

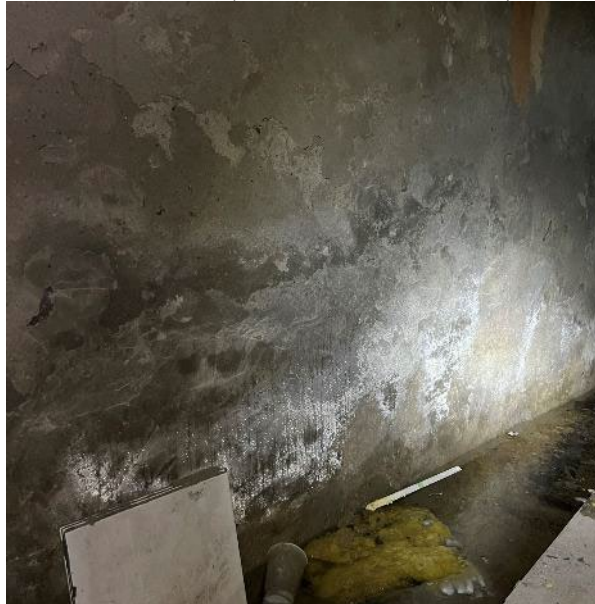
### Summary of Structural Assessment
