**Re: Request for Consideration to Lift Conservation Easement and Demolition
8811 Huntington Road, Vaughan, Ontario
Henry Burton House**

**GEI Building Relocation Review / Structural Assessment 8811 Huntington Road
(Henry Burton House)**

**Re: Building Relocation Review
Existing Heritage Building – Henry Burton House
8811 Huntington Road, Vaughan, Ontario**

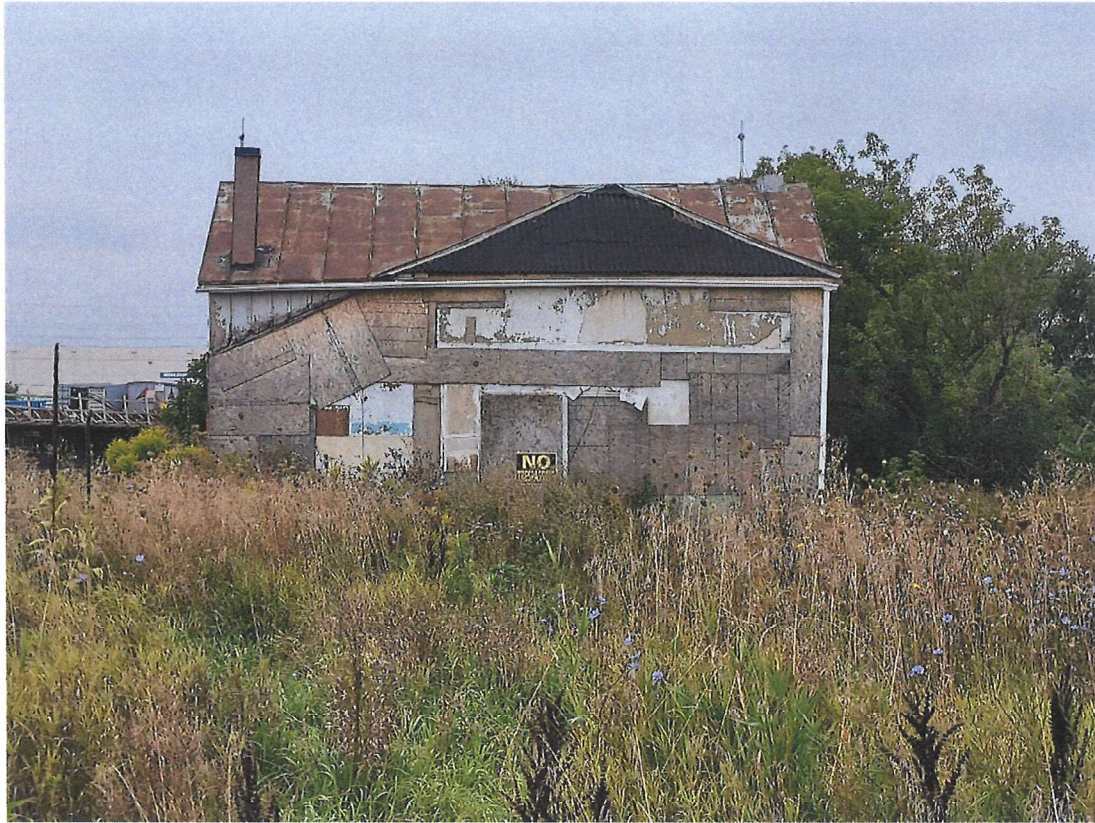
The building is known as the Henry Burton House and is located on the west half of Lot 13 Concession 9 in the former Township of Vaughan, Ontario. Photo 1 provides a typical exterior view. This building is a 1½ storey log house on a stone rubble foundation with an unfinished basement. The roof is framed with pole rafters supporting plank sheathing. It is apparent that there was a previously removed addition on the east end of the building, which is now covered with plywood. Most of the building's exterior openings were fully enclosed with plywood, but upon the time of the site visit there was an opening into the basement on the north side of the building, where the plywood covering over a window had been removed. Access to the building was available through the west side after removing one of the plywood pieces.

Photo 1 - View of building from the East

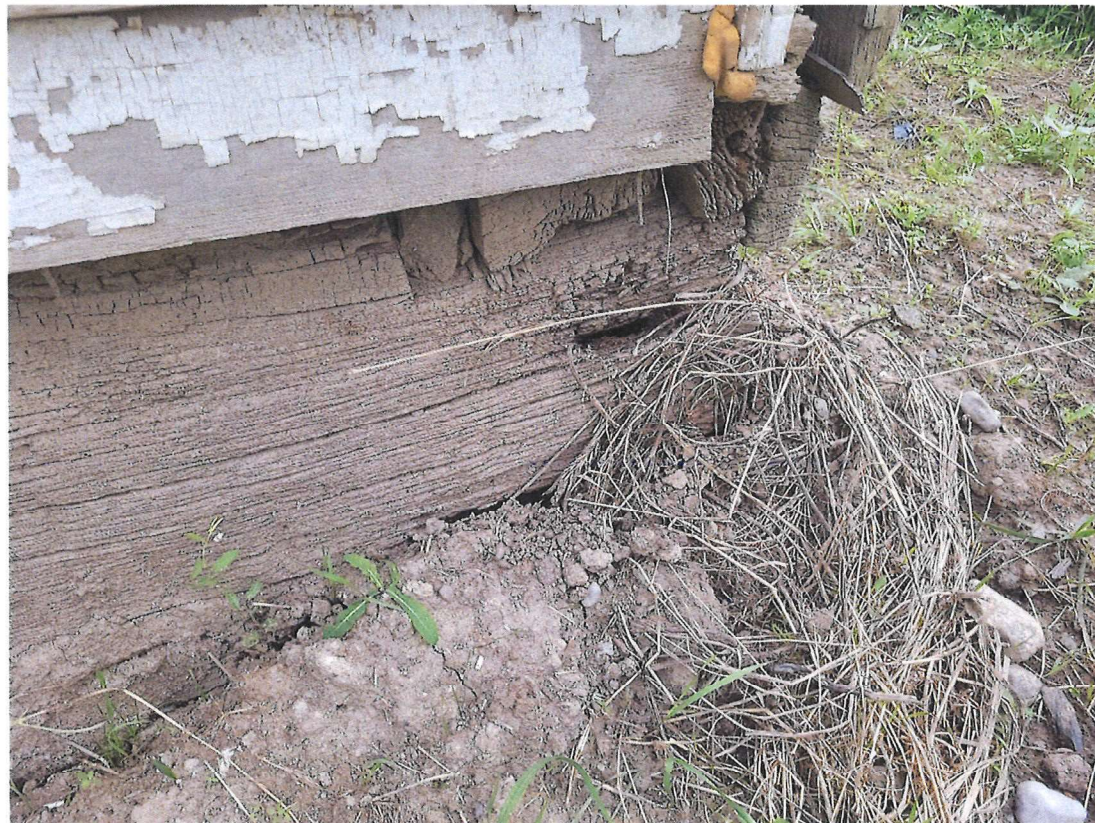
At all locations where the log frame was visible, a visual review was completed as well as a penetration test with an awl. As expected, the visible exterior portions of the logs were significantly more deteriorated than the interior portions, as they would have been more subject to water than the interior portions. Photo 2 provides a typical view of the exterior of the logs.

Overall, the interior portions of the logs appear to be in fair condition, where the exterior portions of the logs appear to be in fair to poor condition. A full investigation would need to be undertaken once the exterior and interior finishes are removed to determine the full extent of the condition of the logs. It would be expected that at a minimum some of the logs would need to be replaced or reinforced prior to moving the building.

Photo 2 - Typical view of exterior showing deterioration of exterior portions of logs

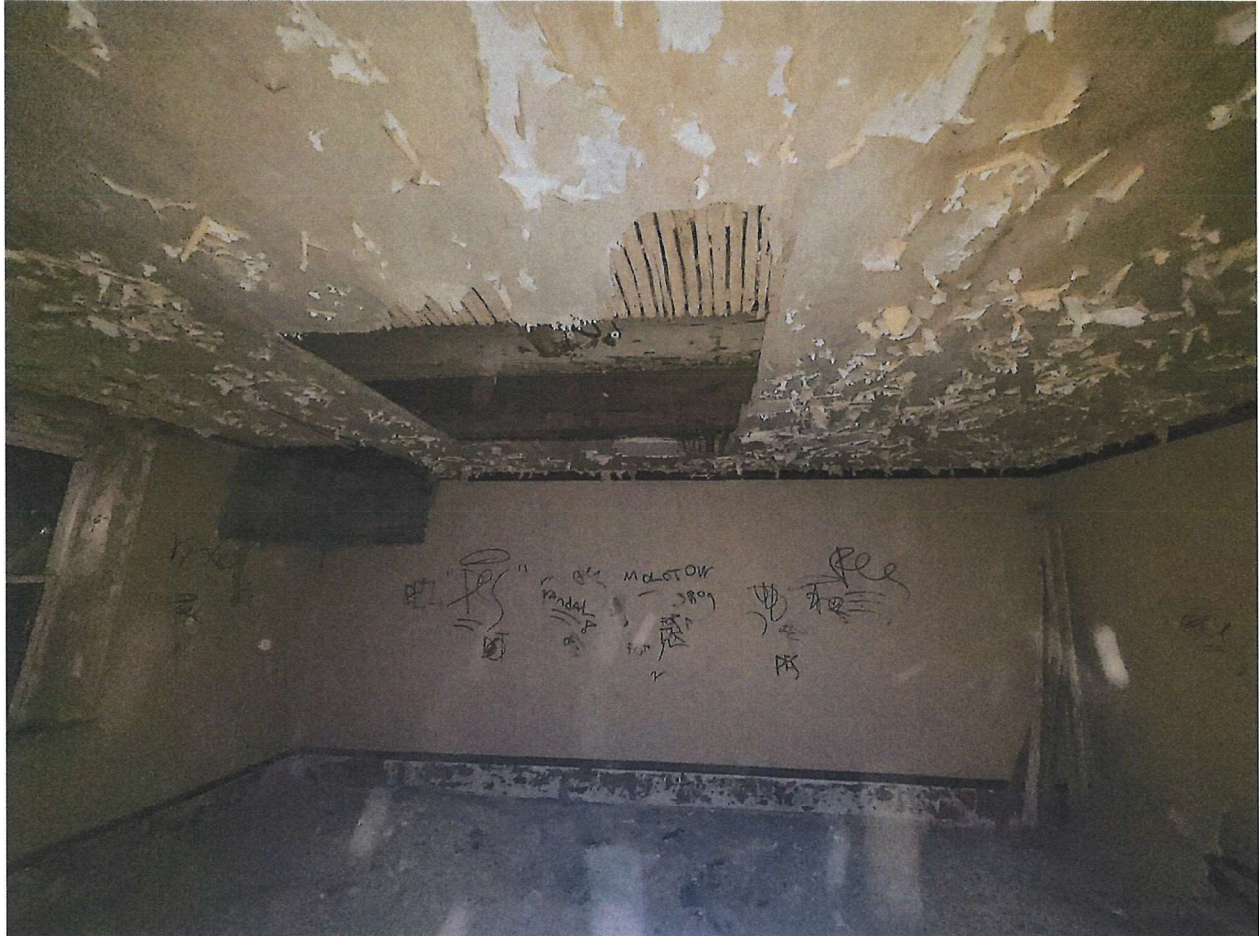
The interior finishes in this building would need to be completely replaced due to their poor condition throughout. Most of the interior finishes have already fallen or are in the process of falling off completely, or at a minimum are covered in graffiti. Refer to Photo 3 for a typical view of the interior. The finishes appear to be lath and plaster which does not match current building standards and would most likely be damaged even further in any moving operations due to its brittle nature. Due to their poor condition, it would be expected that all the interior finishes would be removed prior to moving the building and would need to be reinstated with materials that match current building practices once the building is in its final position.

It should also be noted that the application of interior finishes in this building would contravene the main purpose of preserving it, that purpose being to be able to see the log framing. Without replacing the interior finishes though, this building would not be able to meet current building code standards for insulation and vapour barrier requirements. Without meeting the current insulation requirements, the cost to keep this building habitable in the winter would be high compared to more modern buildings of a similar size. Additionally, without vapour barrier, condensation would be expected to accumulate in the walls, greatly increasing the rate of deterioration of the logs, and creating potential mould issues.

Photo 3 - Typical view of interior showing deteriorated finishes
