**Arborist Report (Updated)
10568 Islington Avenue
City of Vaughan (Kleinburg)
Regional Municipality of York**

Prepared for:
Portside Developments

Prepared by:
Azimuth Environmental
Consulting, Inc.

December 2019

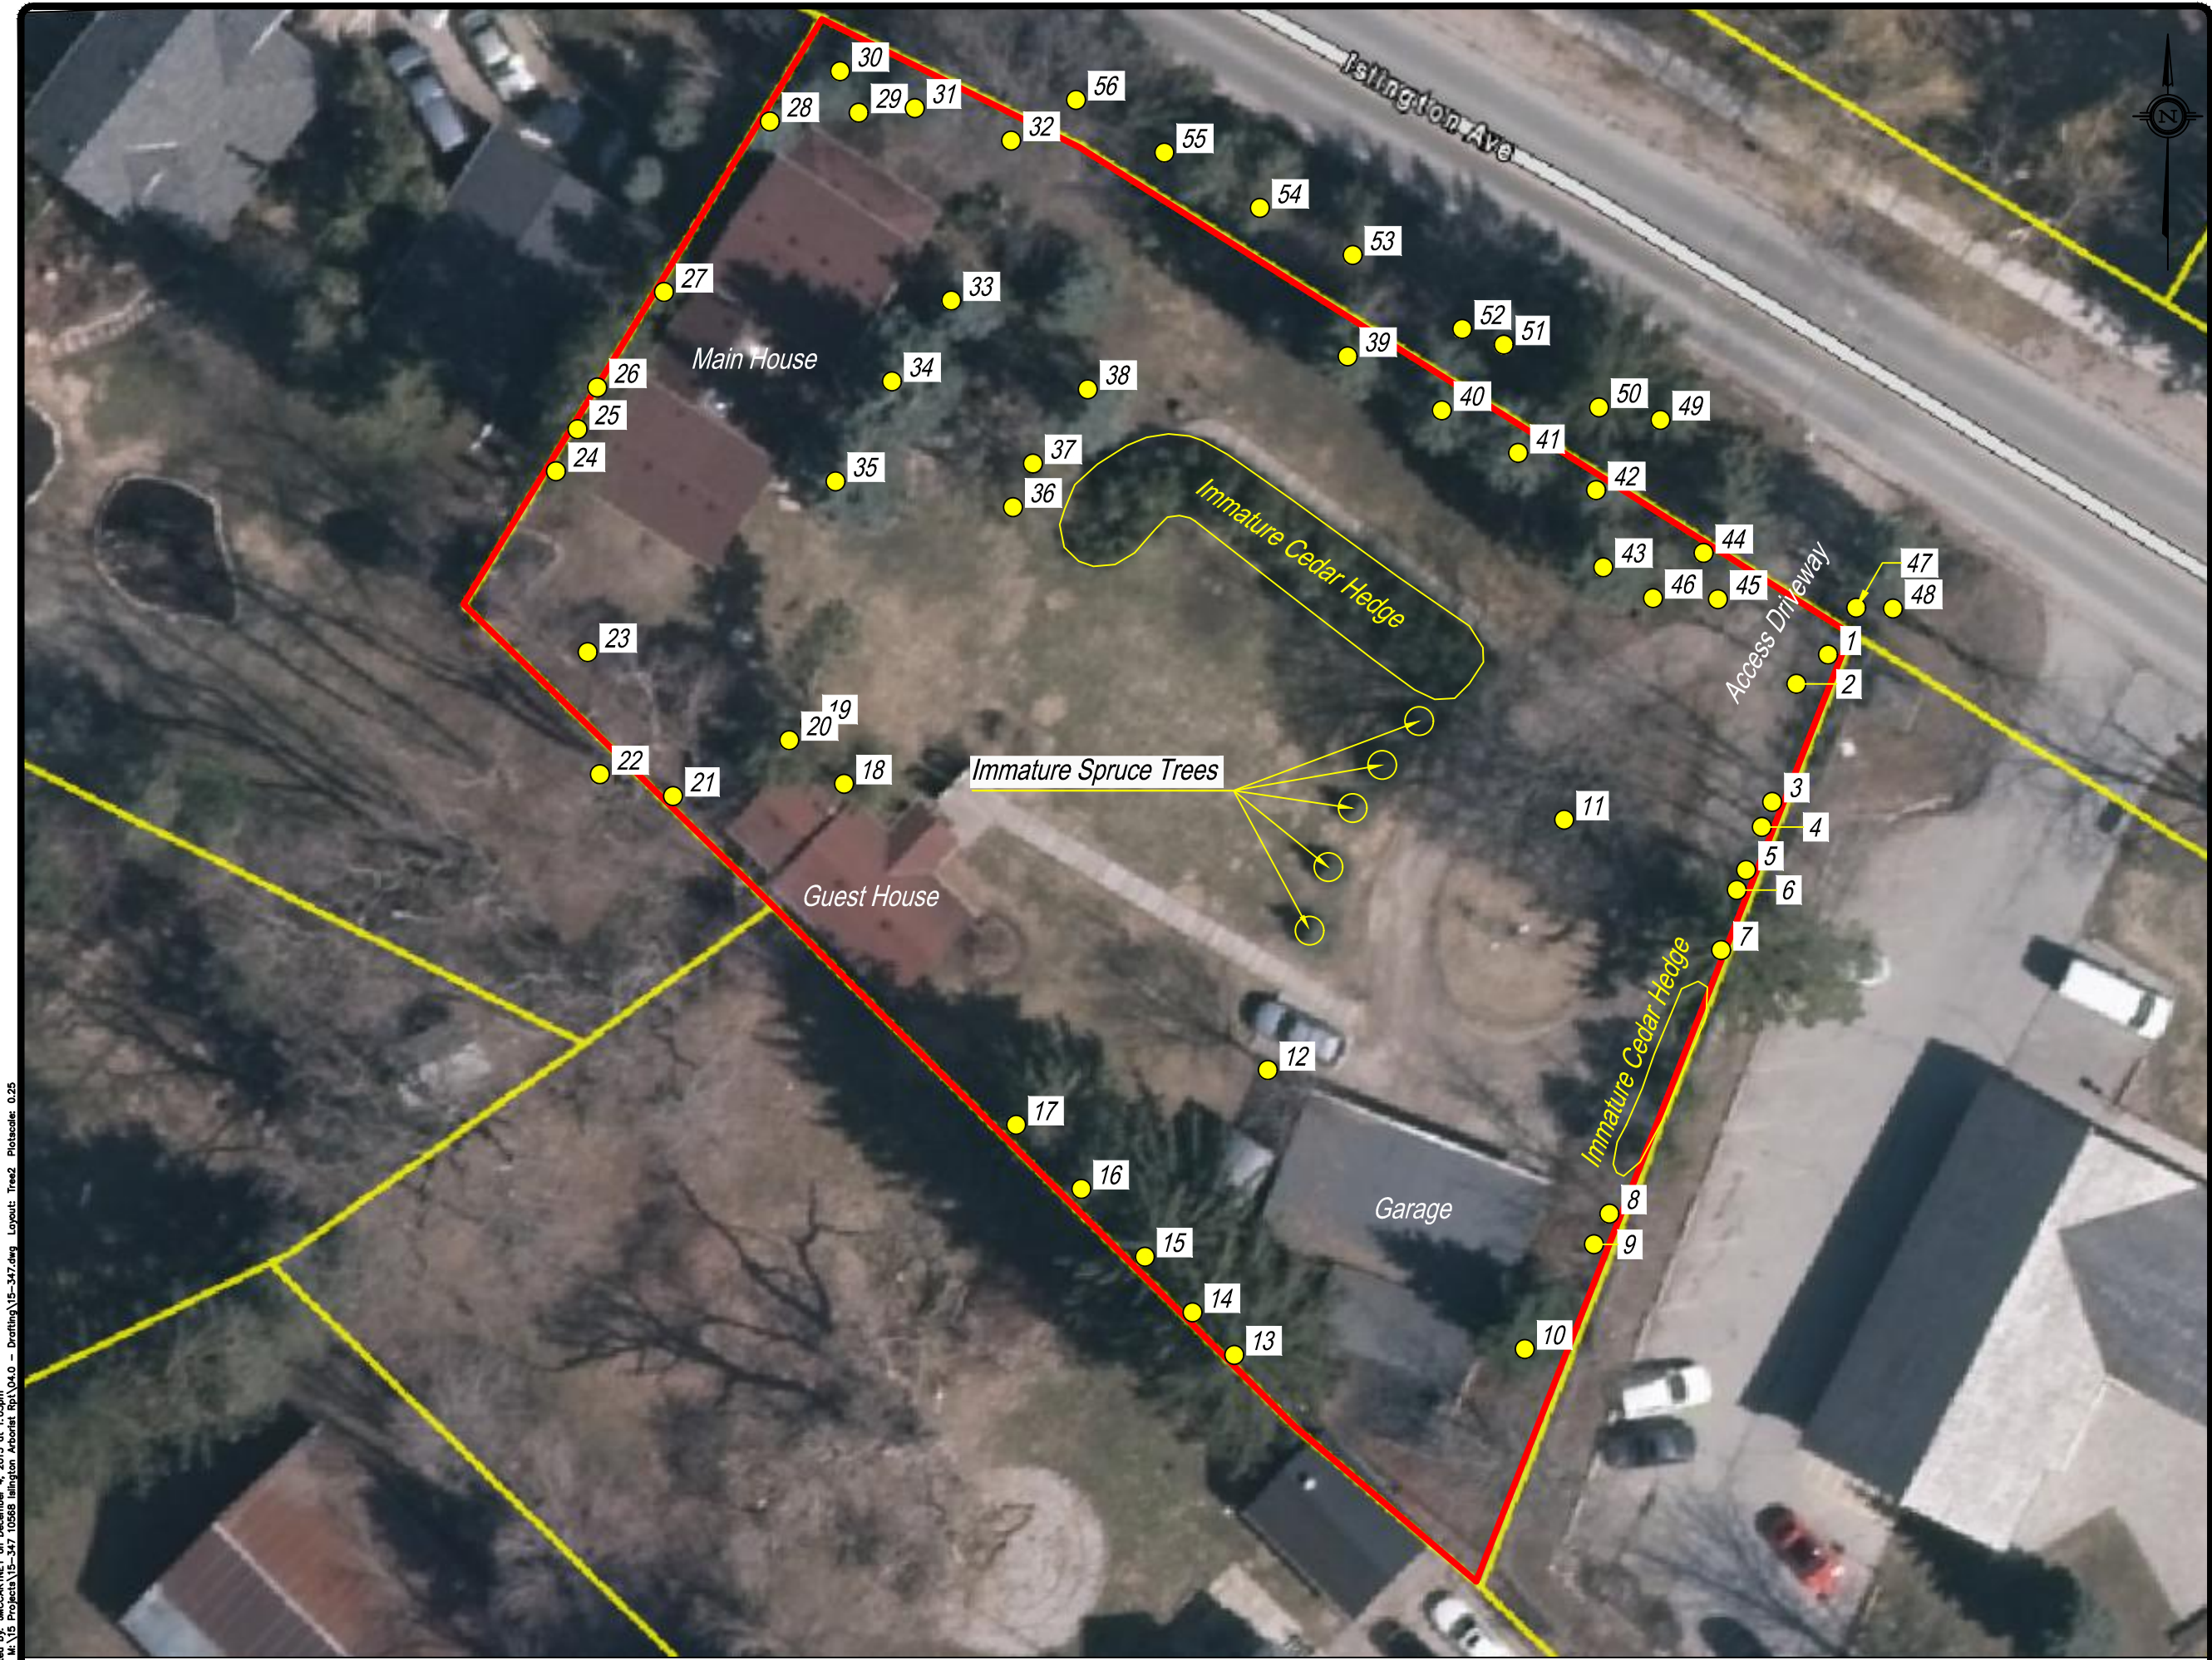
Tree Locations

Of the 56 trees inventoried, 12 were either found to be located on adjacent land (within 5 metres of property boundary) or directly on the property boundary. Trees #22 (see Figure 2) is located on the neighbouring property to the south which should be preserved. Trees #47 - #56 are located on City property (Islington Avenue right-of-way). These trees will require permission from the City to be removed. Considering Tree #22 is close on

neighbouring lands and close to the property boundary, a Certified Arborist should be onsite to supervise excavations in proximity to this tree. If roots of Tree #22 are exposed during excavations, the Arborist should be present to perform root pruning to minimize damage to the tree.

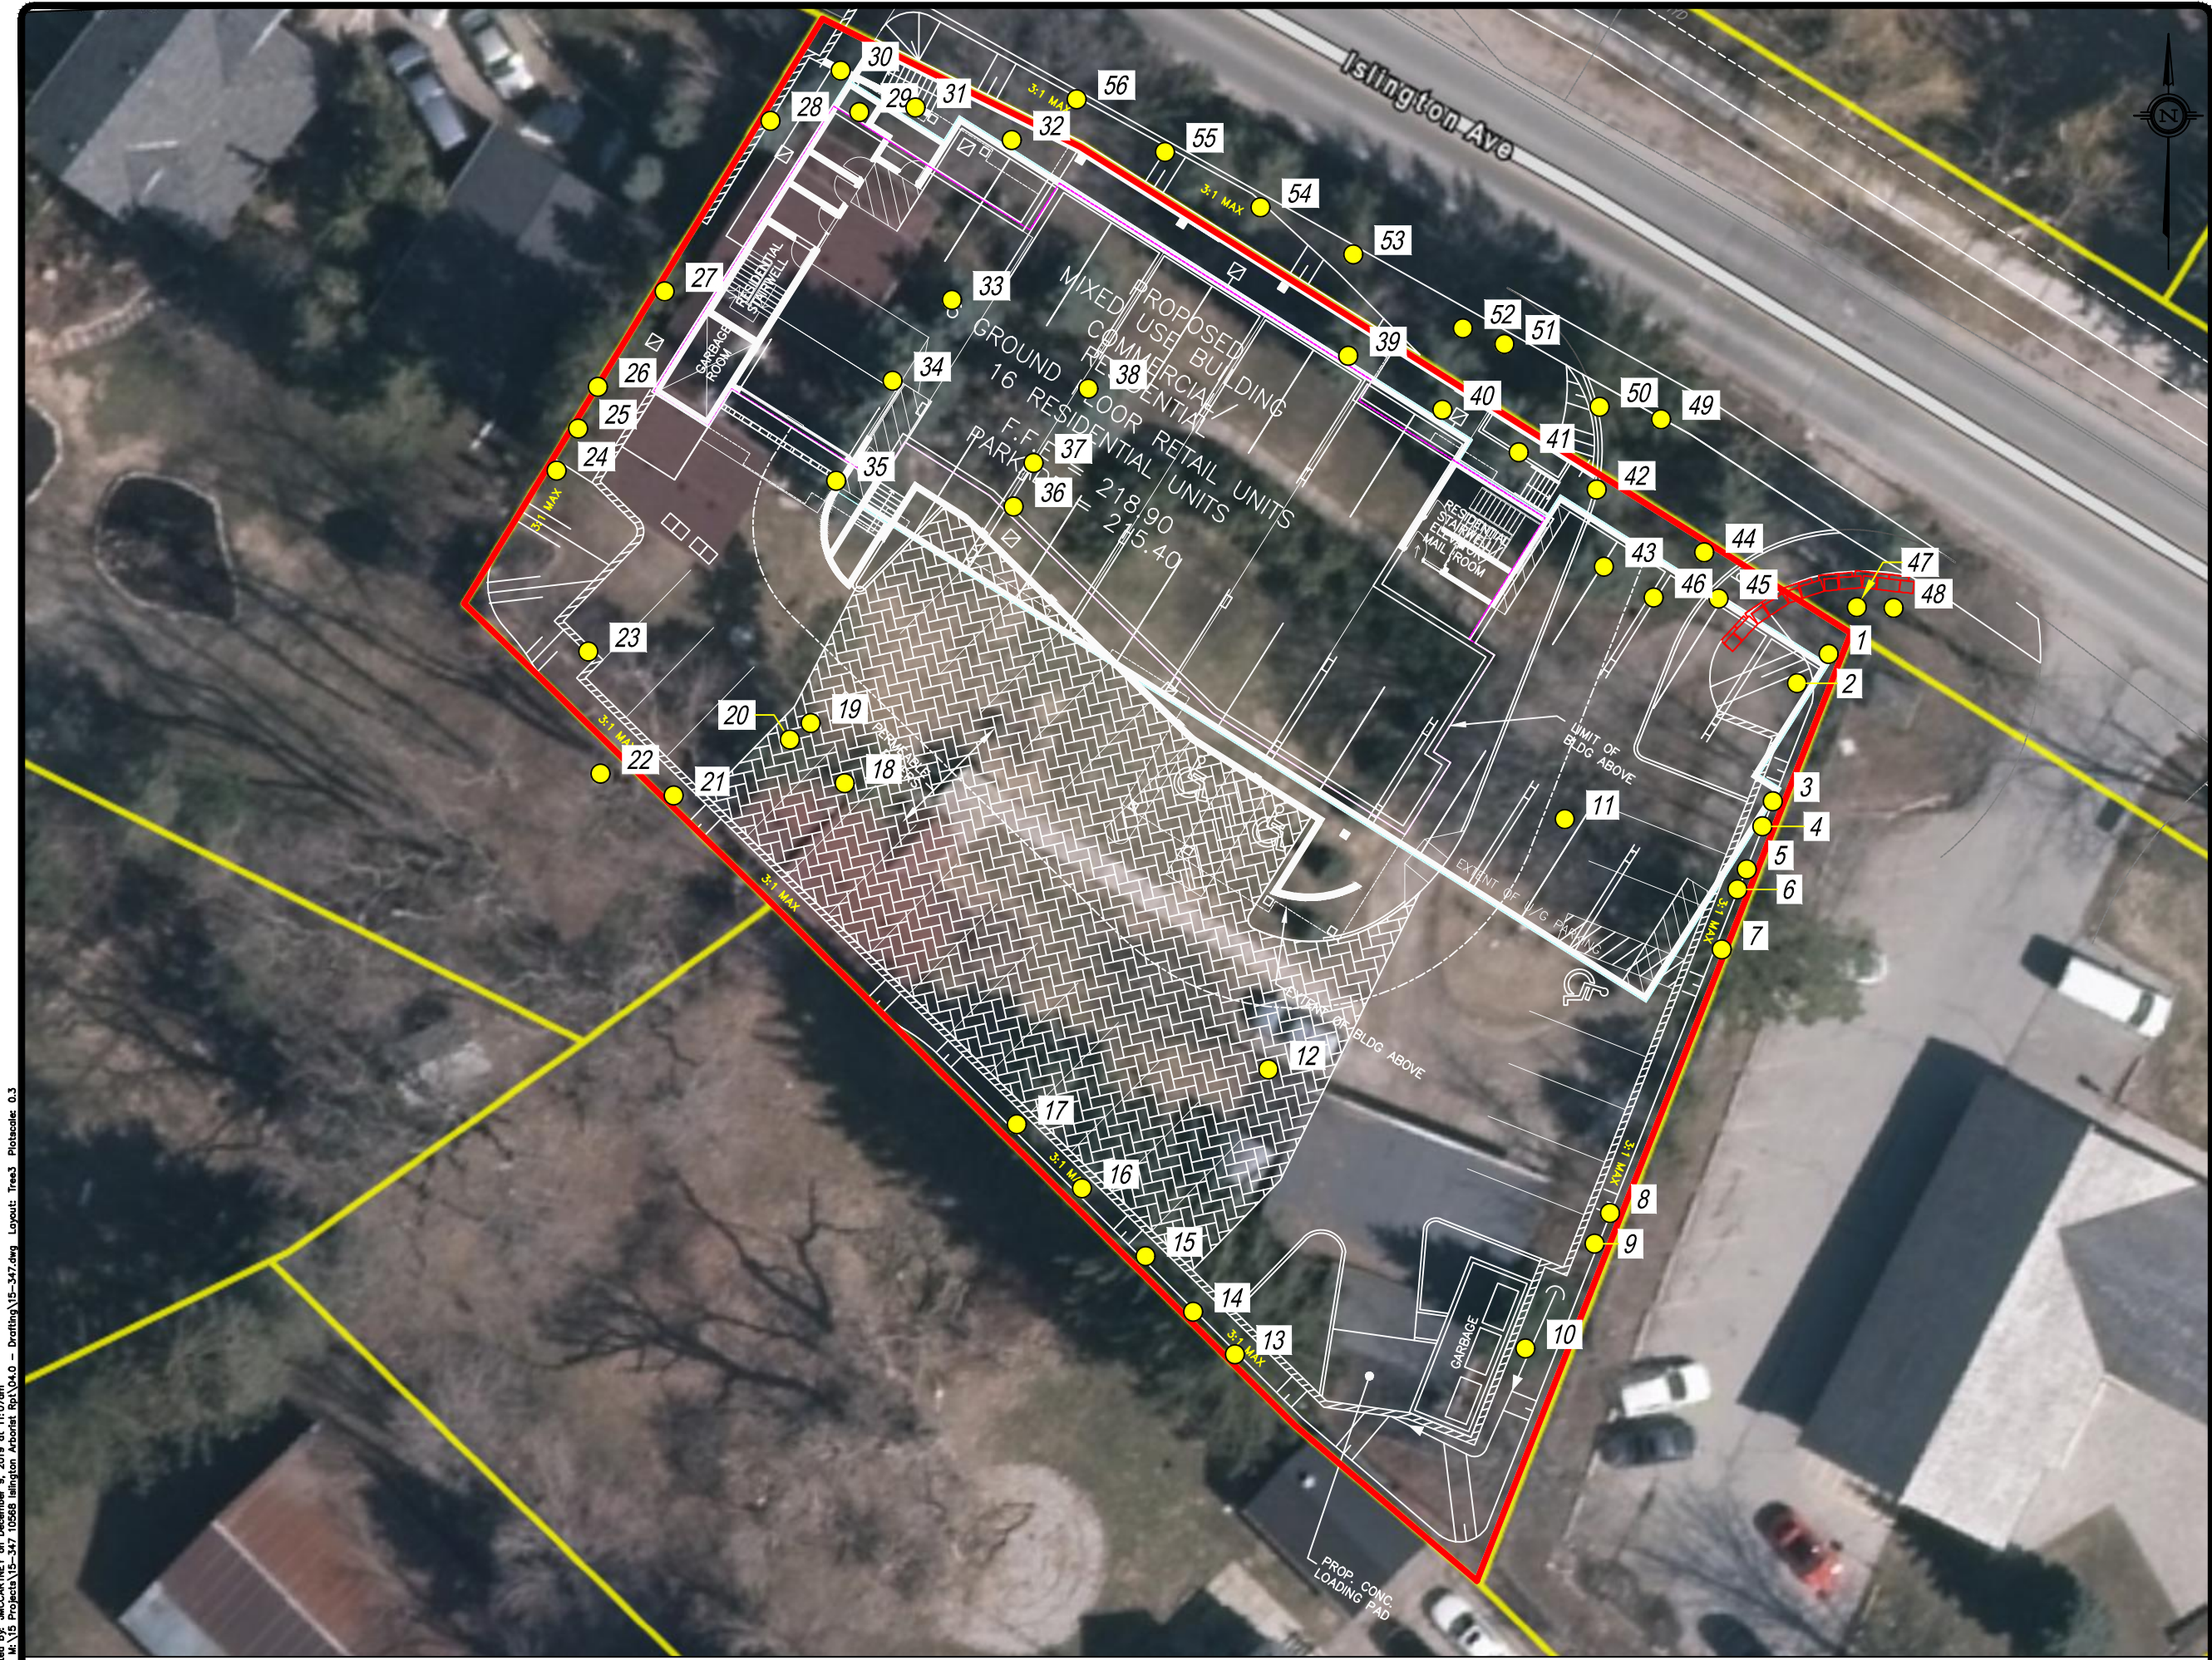
Proposed Development Plan

All of the 56 trees ($\geq 10\text{cm DBH}$) found on-site are recommended for removal due to the proposed development encompassing the entire property. Factors such as grading, excavations, paving, retaining walls and building construction will impact all trees on-site (see Figure 3). For these reasons, tree preservation is not recommended in this scenario.
