### **EXTRACT FROM COUNCIL MEETING MINUTES OF OCTOBER 21, 2020**

#### **6. PRESERVATION AND REHABILITATION OF THE HENRY BURTON HOUSE, LISTED UNDER PART IV, LOCATED AT 8811 HUNTINGTON ROAD**

In September 2018, Anatolia Capital Corporation (ACC) retained Golder Associates Ltd. (Golder) to conduct a Cultural Heritage Impact Assessment (CHIA) for the property at 8811 Huntington Road, part of the west half of Lot 13, Concession 9, in the City of Vaughan, Regional Municipality of York, Ontario. The 32.98-hectare property includes a storey-and-a-half Georgian-style vernacular log house known as Henry Burton House, two barns, the stone foundation of a barn, outbuildings, and agricultural and natural lands, and is listed on the City's *Heritage Register*.

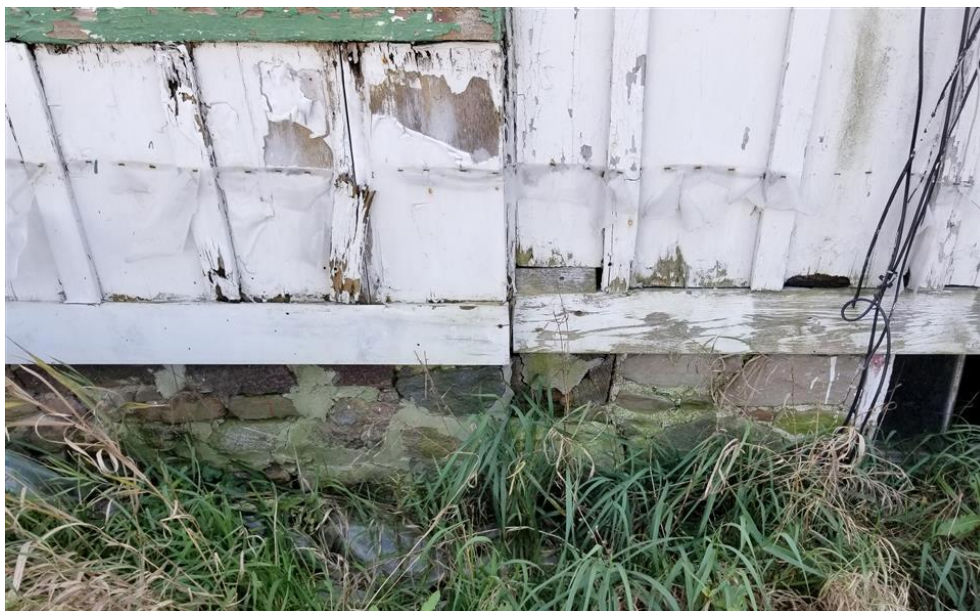
Sitting on a coursed rubble foundation similar to that of the Main Block, there is a visible joint between the two structures (Figure 48 and Figure 49). Only the north and east walls of the structure are visible from the exterior, due to its connections to the Main Block to the west and the South Addition to the south.

**Figure 49: Join visible in foundation in East Wing and Main Block.**

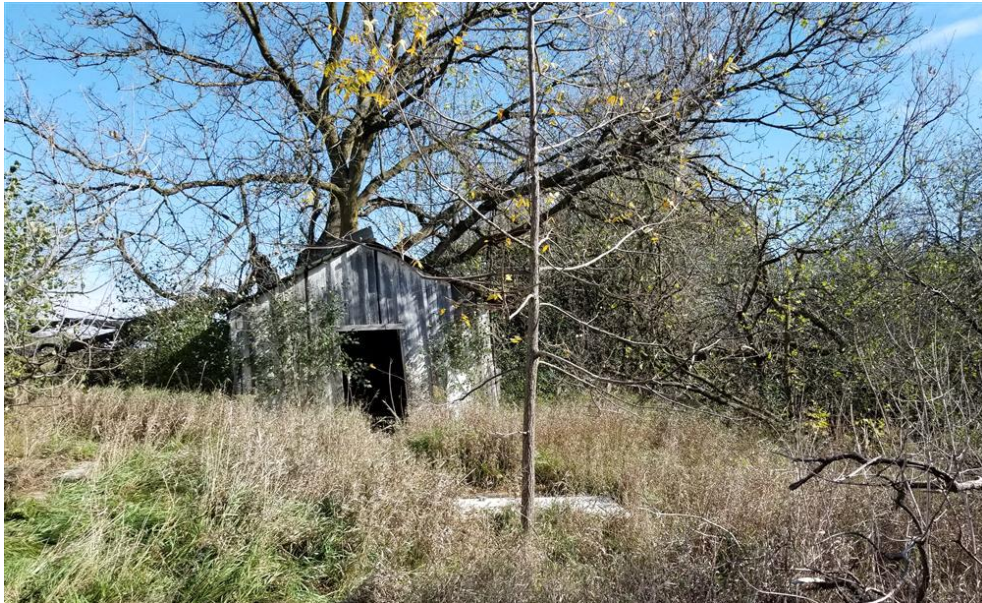
To the south of the residence is a small wood frame shed in poor physical condition. It is a one storey, one bay structure with a low gable roof covered by metal sheeting (Figure 67). The east interior wall of the structure is aluminum sheeting, and the main door on the west façade of the structure is no longer present. Vertical board and batten siding to match the majority of the residence, but has been left unpainted, and the structure appears to have been used for storage. Machined wood beams make up the interior frame, indicating that the outbuilding was constructed sometime after the main house (Figure 68).

**Figure 67: West façade of the outbuilding.**

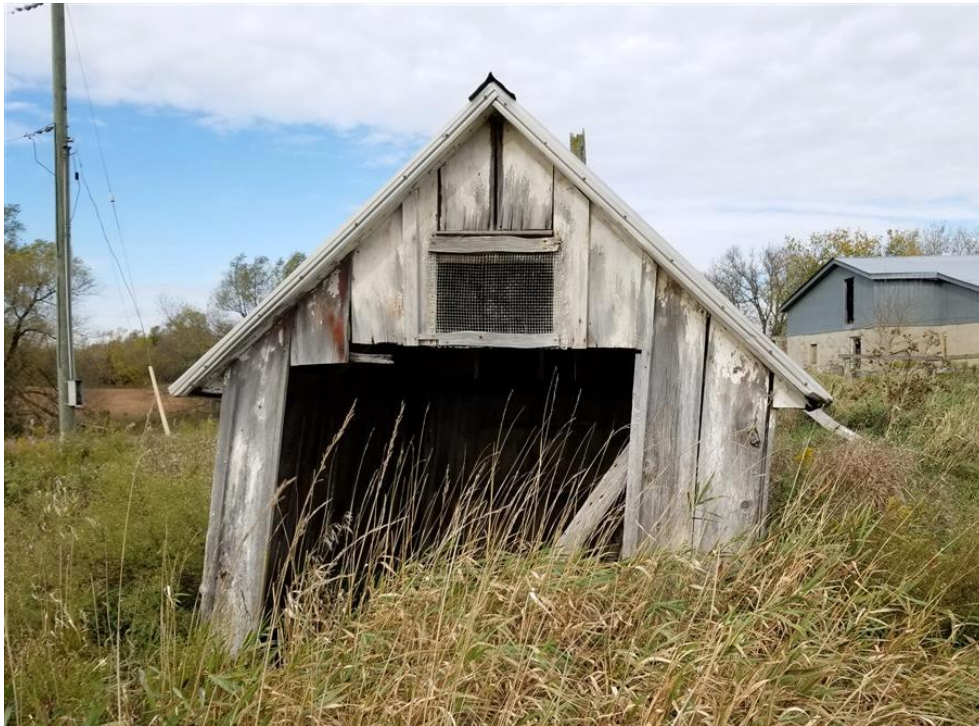
Northeast of the residence is an additional small outbuilding with vertical board and batten siding and a medium gable roof (Figure 69). The doorway is nearly as wide as the south façade of the structure with a metal mesh opening in the centre of the gable. The structure is leaning to the east.

Figure 69: South façade of Northeast outbuilding.

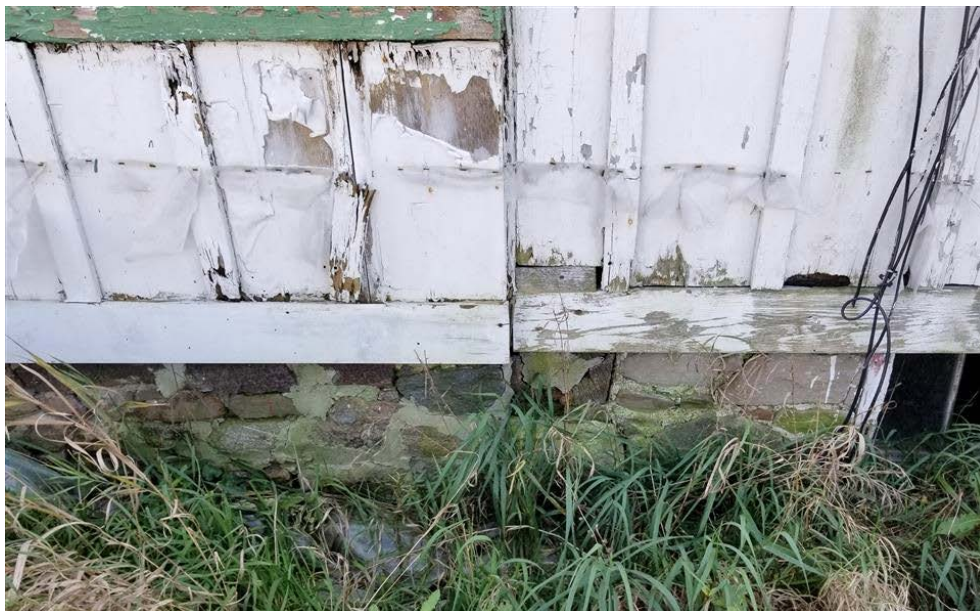
Sitting on a coursed rubble foundation similar to that of the Main Block, there is a visible joint between the two structures (Figure 20 and Figure 21). Only the north and east walls of the structure are visible from the exterior, due to its connections to the Main Block to the west and the South Addition to the south.

**Figure 21: Joint visible in foundation in East Wing and Main Block.**
