**Re: Heritage Vaughan Committee – April 21, 2021, 2298118 Ontario Inc.
7714 Yonge Street, City File DA.14.009; Reginal File SP-V-016-14**

Arborist Report

7714 Yonge Street, Vaughan, ON

7 March 2017, revised 1 April 2021

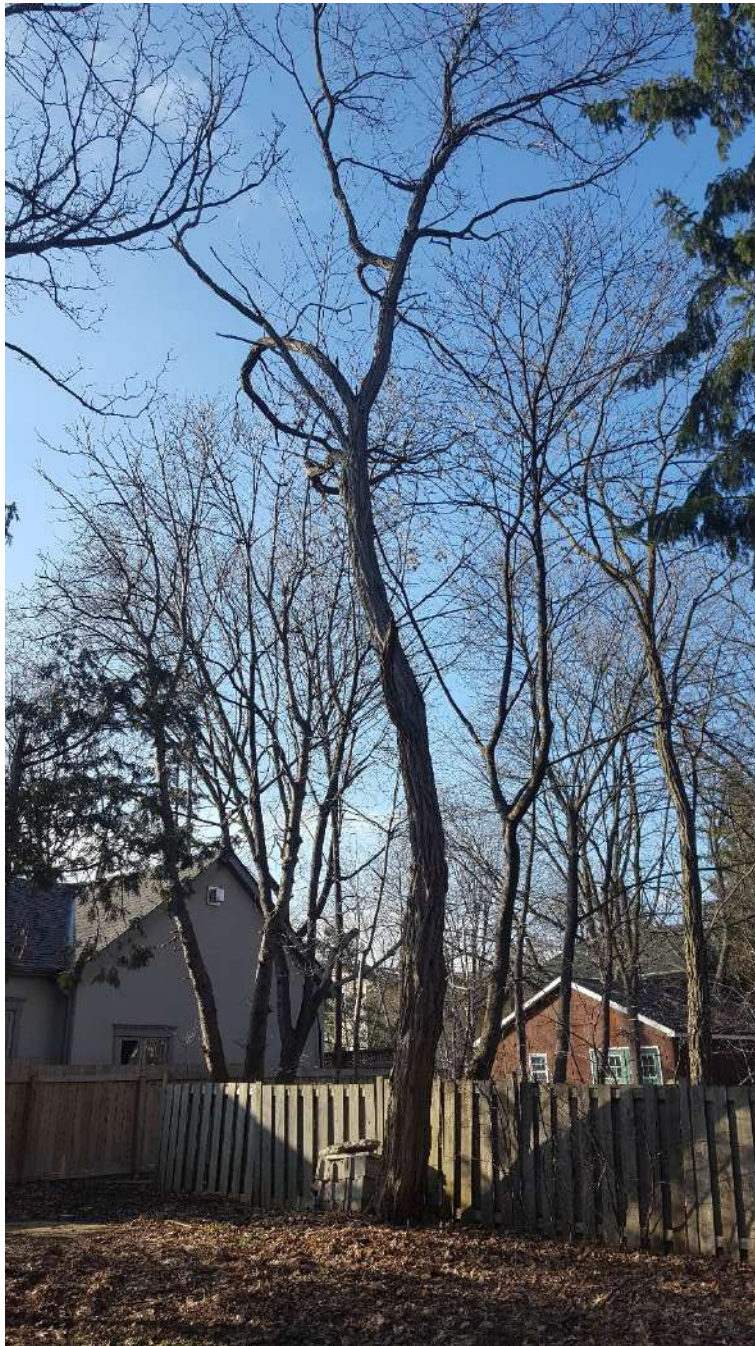
Photo 1 Trees 1, 2, 3, 4, 5 (left to right)

A concrete pad is located within the dripline of Trees 1 and is to be removed gently by hand and supervised by a Certified Arborist. Tree protection hoarding around this tree must be installed immediately following the demolition phase. Any disturbance must be mitigated, for example, stabilize and restore the disturbed area with topsoil to existing grades.

Trees 2, 11, 13, 17, 20, 22, and 28 are in poor and declining condition and are recommended for removal regardless of the proposed construction. Trees 2, 7, 11, 13, 17, and 22, are located on neighbouring property or are shared trees. Trees within striking distance of the proposed development are recommended for removal to prevent injury/damage to persons/property. The neighbouring property owner should be notified of the condition of these trees and co-ordinate their removal. The removal of neighbouring and shared trees will require permission from the neighbouring property

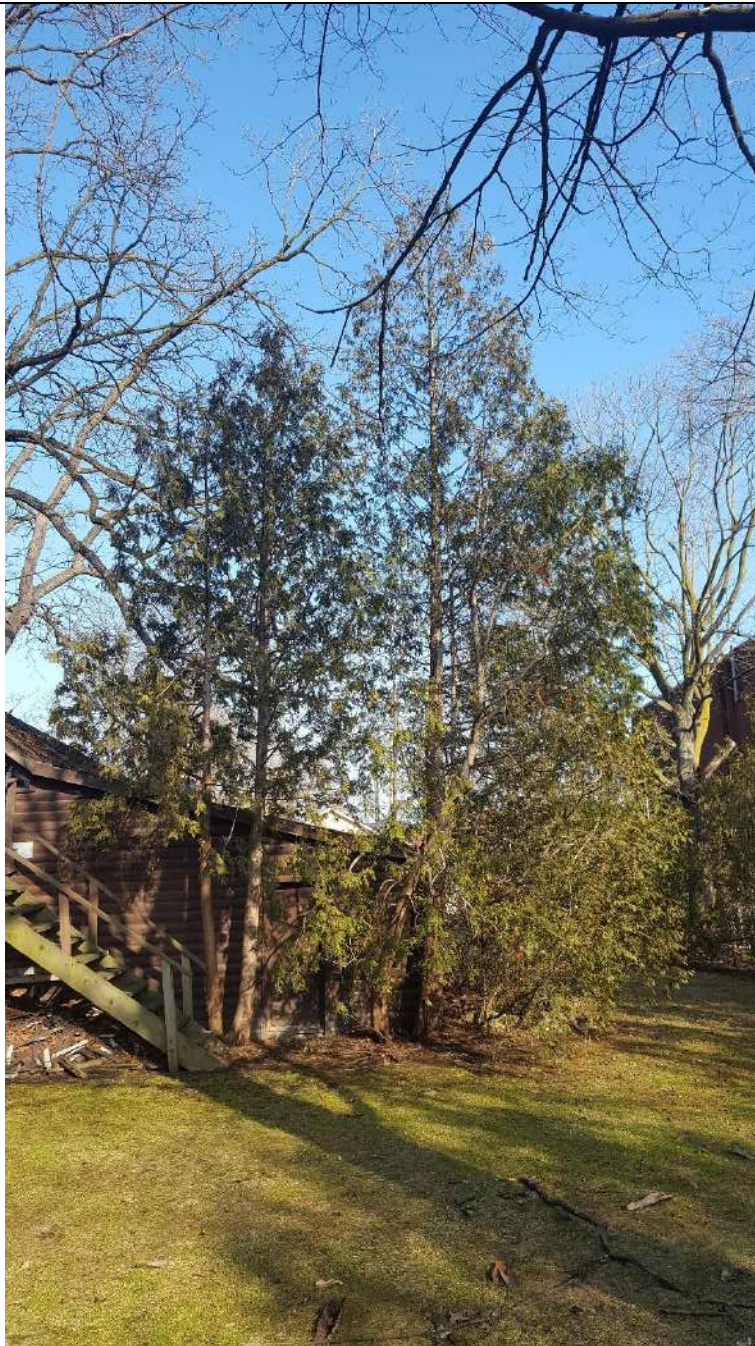
Photo 3 Tree polygon P8

The removal of Trees 3, 4, 6, 23 to 25, 27, 29, 30, 36, 43, 44, and tree polygons P8 and P26, will be required to accommodate the proposed development. A permit will be required for the removal of all trees greater than 20cm in diameter. Tree 19 is located within the City road allowance; permission from the City will be required prior to its removal. Trees 4 and 23 are located on neighbouring property or are shared.

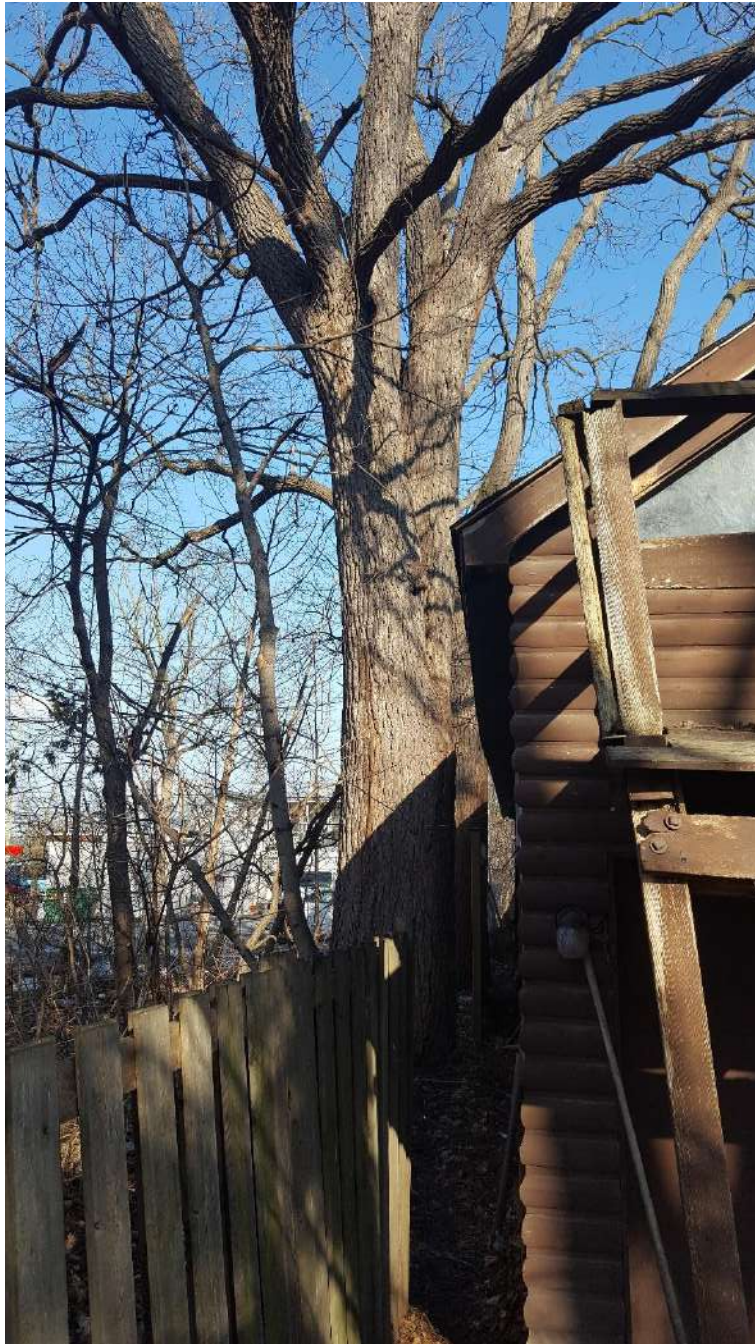
Photo 4 Trees 9 and 10 (right to left)

An existing garage is located within the driplines of Trees 9 and 12. The preservation of these trees may be possible if the existing base of the garage is used or is removed gently using hand tools only, being careful not to damage the roots. Demolition of the existing garage should be completed using hand tools or light equipment only. Tree protection hoarding around this tree must be installed immediately

It is recommended that the proposed parking area and walkway within the driplines of Trees 9 and 12 be installed using a combination of geocell and permeable materials to minimize soil compaction, and allow for water infiltration, and as close to existing grades as possible. Any work within the driplines of trees must be supervised by a Certified Arborist. These trees should be monitored for changes in health, condition and structural stability by a Certified Arborist during and following construction. The supervising Arborist must confirm that the trees are safe to be retained.

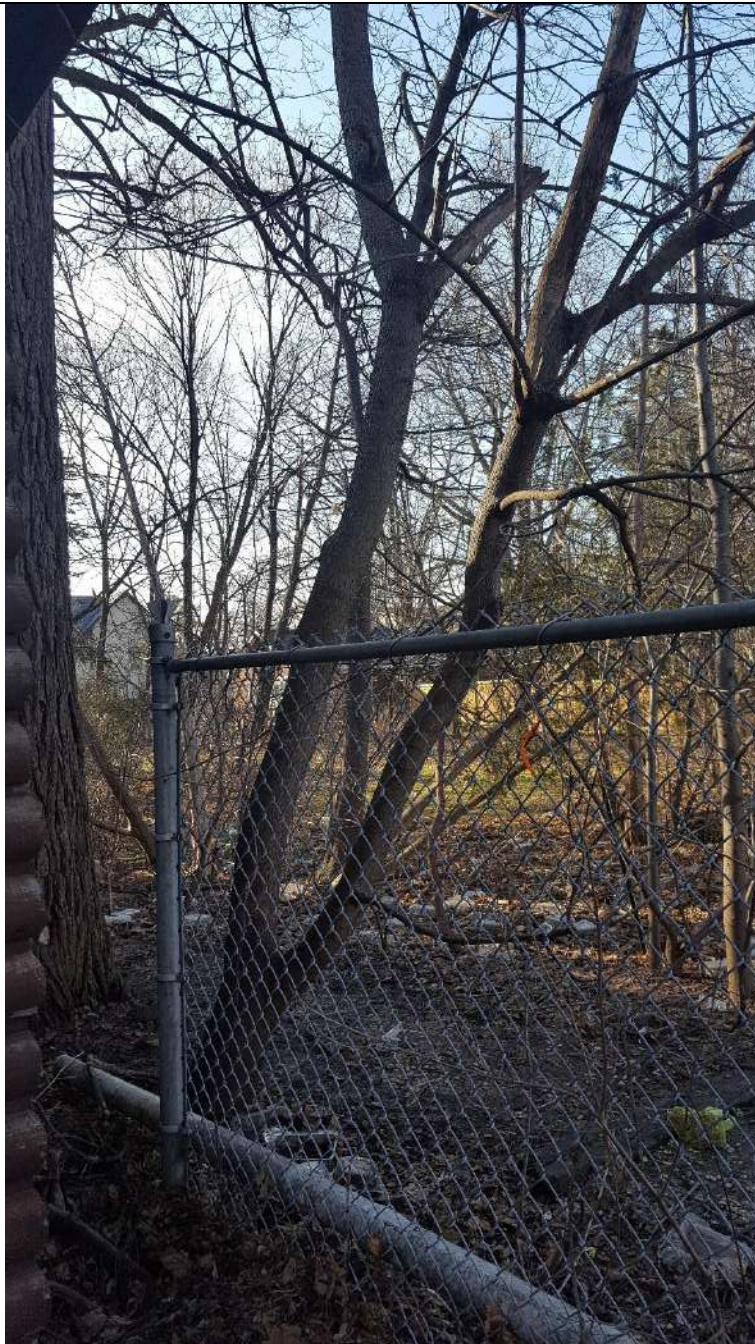
Photo 6 Tree 12

12	Norway Maple	<i>Acer platanoides</i>	~15	F	F	F		3	1.8	1 stem dead, U-union at 0.5m, small cavity, bowed due to competition	Preserve-monitor	Neighbouring

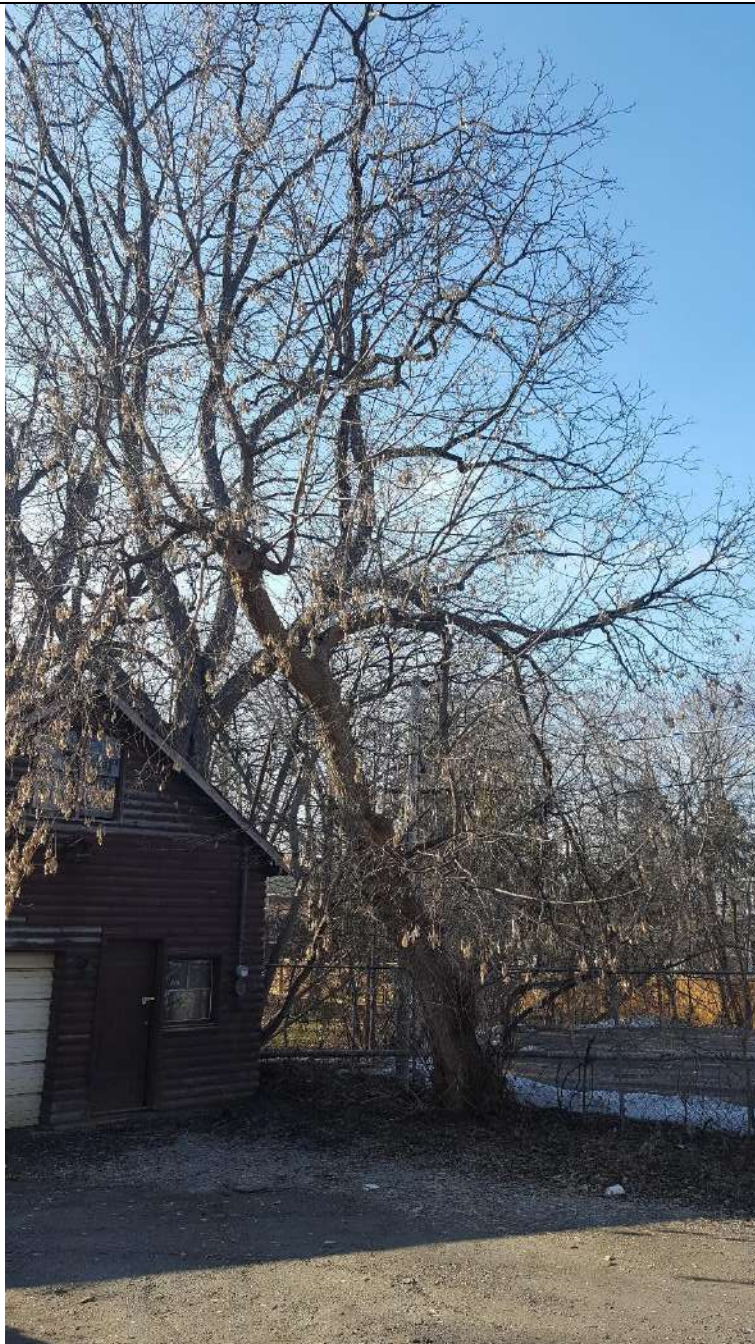
Photo 7 Tree 13

13	Manitoba Maple	<i>Acer negundo</i>	64	F	PF	PF		8	4.2	Moderate exposed roots, included chain link fence, moderate lean towards south, heavy epicormic branching, moderate growth deficit at base on south side, heavy pruning wounds, topped at 8m, major stem wound with cavity, transverse crack in branch failed, potential hazard => removal recommended	Remove-poor condition	Shared
14	Black Locust	<i>Robinia pseudoacacia</i>	~34	FG	FG	FG		3	2.4	Light lean towards north, light asymmetrical crown	Preserve-tentative	Neighbouring
15	Norway Maple	<i>Acer platanoides</i>	33	FG	F	F		6.5	2.4	Light lean towards northwest, moderate asymmetrical crown due to competition	Preserve	Shared
16	Norway Maple	<i>Acer platanoides</i>	20	G	F	F		6.5	1.8	Conflict with Tree 17, moderate asymmetrical crown due to competition	Preserve	Private
17	Manitoba Maple	<i>Acer negundo</i>	78	F	F	F		11	4.8	Moderate epicormic branching, U-union at 2.5m, light lean towards east, broken branches, stem wound at base with rot, dead branches with moderate decay, fruiting bodies, potential hazard => removal recommended	Remove-poor condition	Shared

13	Manitoba Maple	Acer negundo	84	F	PF	PF		8	4.2	Moderate exposed roots, included chain link fence, moderate lean towards south, heavy epicormic branching, moderate growth deficit at base on south side, heavy pruning wounds, topped at 8m, major stem wound with cavity, transverse crack in branch failed, potential hazard => removal recommended	Remove-poor condition	Shared
14	Black Locust	Robinia pseudoacacia	~34	FG	FG	FG		3	2.4	Light lean towards north, light asymmetrical crown	Preserve-tentative	Neighbouring
15	Norway Maple	Acer platanoides	33	FG	F	F		6.5	2.4	Light lean towards northwest, moderate asymmetrical crown due to competition	Preserve	Shared
16	Norway Maple	Acer platanoides	20	G	F	F		6.5	1.8	Conflict with Tree 17, moderate asymmetrical crown due to competition	Preserve	Private
17	Manitoba Maple	Acer negundo	78	F	F	F		11	4.8	Moderate epicormic branching, U-union at 2.5m, light lean towards east, broken branches, stem wound at base with rot, dead branches with moderate decay, futility bodies, potential hazard => removal recommended	Remove-poor condition	Shared

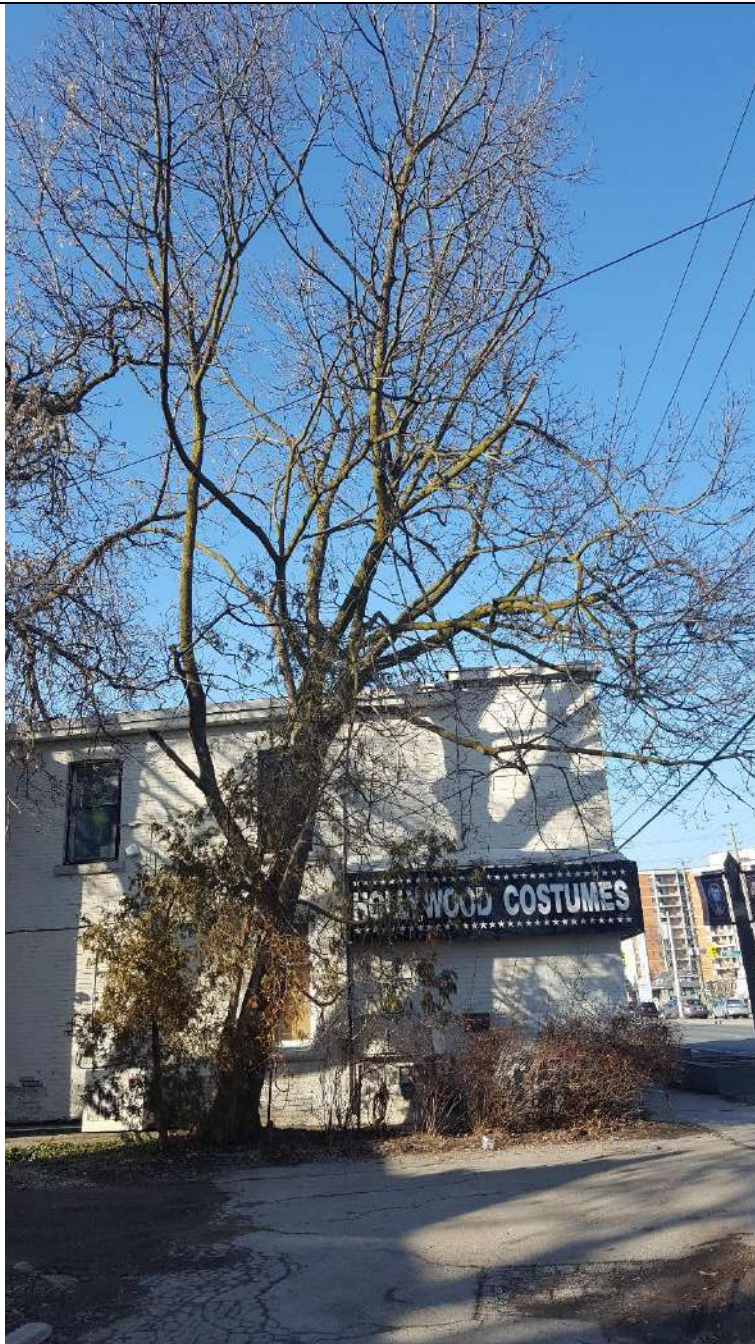
Photo 9 Tree 18

18	Norway Maple	<i>Acer platanoides</i>	~50	FG	FG	FG		8	3.0	Light lean towards east, light asymmetrical crown, union at 4m	Preserve-monitor	Shared
19	Ivory Silk	<i>Syringa reticulata</i>	14.5	F	F	F		1.5	1.8	Moderate pruning wounds, small stem flare, moderate asymmetrical crown	Remove-development	City
20	White Elm	<i>Ulmus americana</i>	16	DEAD				-	-	Dead/dying	REMOVE-DEAD	Private
21	Sugar Maple	<i>Acer saccharum</i>	33.5	P	P	P		-	-	Topped at 2m, main branch dead, epicormic branches only	REMOVED	Shared
22	Sugar Maple	<i>Acer saccharum</i>	39.5	DEAD				-	-	Topped at 2.25m, cavity/hollow stem with rot, moderate dead branches	REMOVE-DEAD	Shared
23	Black Walnut	<i>Juglans nigra</i>	46	G	FG	FG		4	3.0	Light lean towards south, moderate asymmetrical crown due to competition, moderate epicormic branching	Remove-development	Shared
24	Black Walnut	<i>Juglans nigra</i>	58	G	F	FG		7	3.6	Moderate asymmetrical crown due to competition, moderate vertical scaffold limbs, moderate epicormic branching	Remove-development	Private

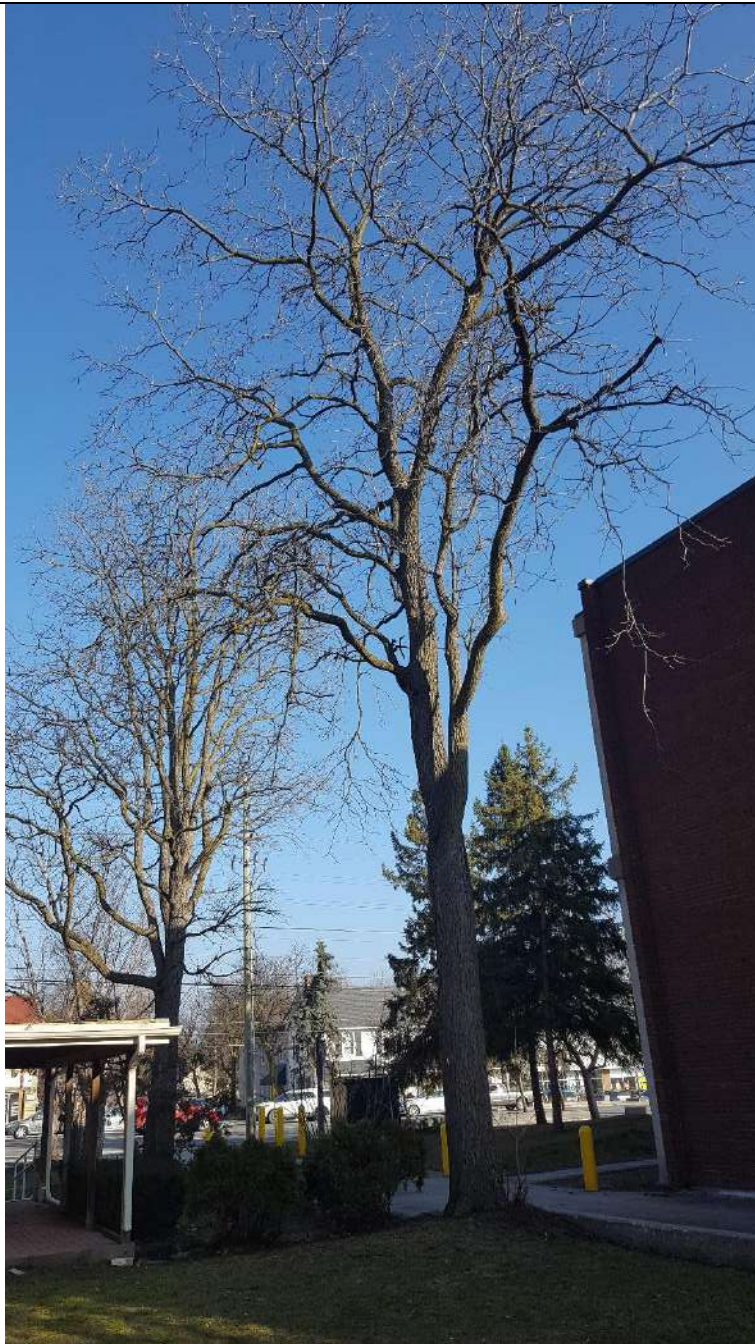
Photo 13 Tree 25

25	Black Walnut	<i>Juglans nigra</i>	61	G	F	FG		7.5	4.2	Adjacent retaining wall, moderate pruning wounds on neighbouring property side, improper arboricultural standards, light asymmetrical crown, light epicormic branching	Remove-development	Private
P26	Eastern White Cedar	<i>Thuja occidentalis</i>	17.5,13	FG	F	F		3.5	1.8	2 trees, union at base, light lean, broken leaders	Remove-development	Private
	Norway Maple	<i>Acer platanoides</i>	12	F	F	F		3.5	1.8			
27	Eastern White Cedar	<i>Thuja occidentalis</i>	16,10	FG	F	F		2.5	1.8	Light lean towards east, union at base, dead leader	Remove-development	Private
28	Norway Maple	<i>Acer platanoides</i>	59	DEAD				6	-	Moderate growth deficit on west side, moderate girdling roots, sloughing bark at base, stem wound with rot, rot/crack at branch union, moderate dead branches, moderate asymmetrical crown, dead/dying, hazard	REMOVE-DEAD	Private
29	Eastern White Cedar	<i>Thuja occidentalis</i>	15,9,5	F	F	F		3	1.8	Union at base, vertical scaffold limbs	Remove-development	Private

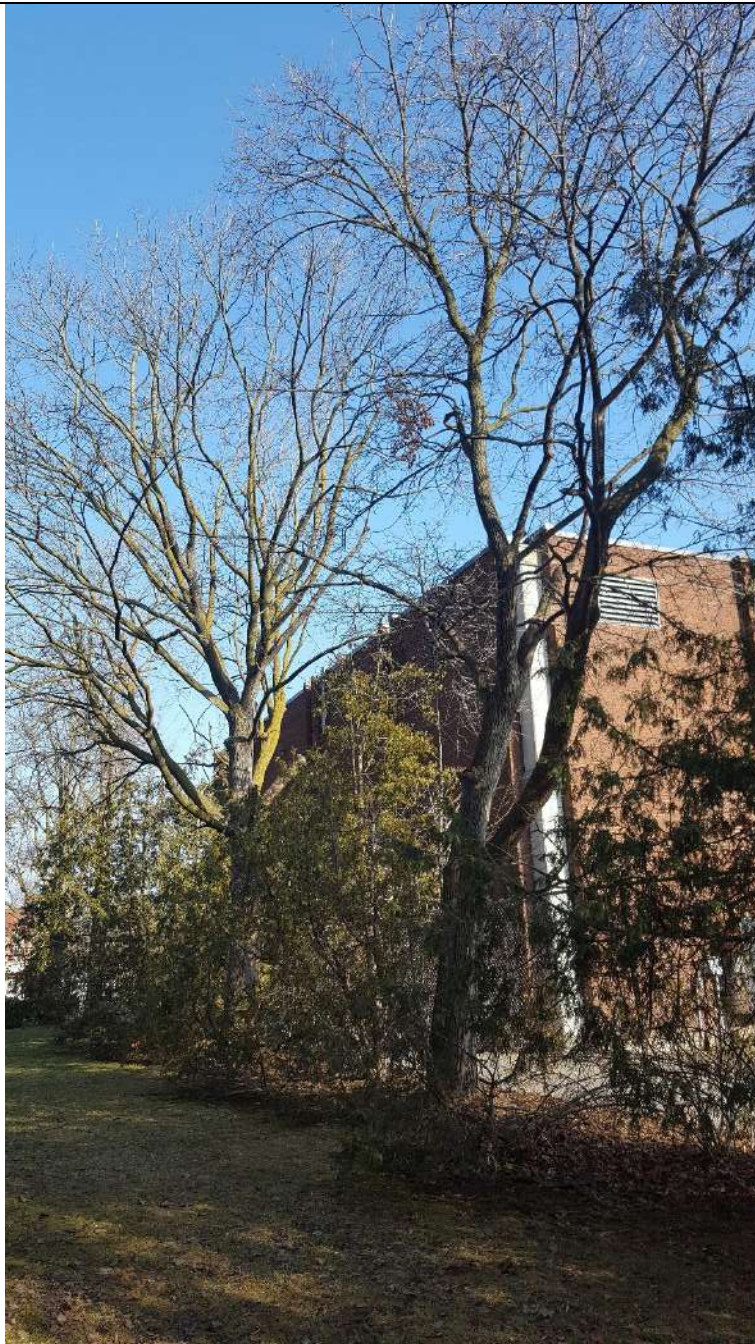
Photo 15 Tree 28, 29 and 30 (left to right)

30	Norway Maple	<i>Acer platanoides</i>	45	F	F	F		4	3.0	Growth deficits/ribbing at base, light lean towards south, moderate asymmetrical crown, moderate pruning wounds, minor dead and broken branches	Remove-development	Private
31	Eastern White Cedar	<i>Thuja occidentalis</i>	23	G	FG	PF		4	1.8	Light lean towards south	Preserve-monitor	Private

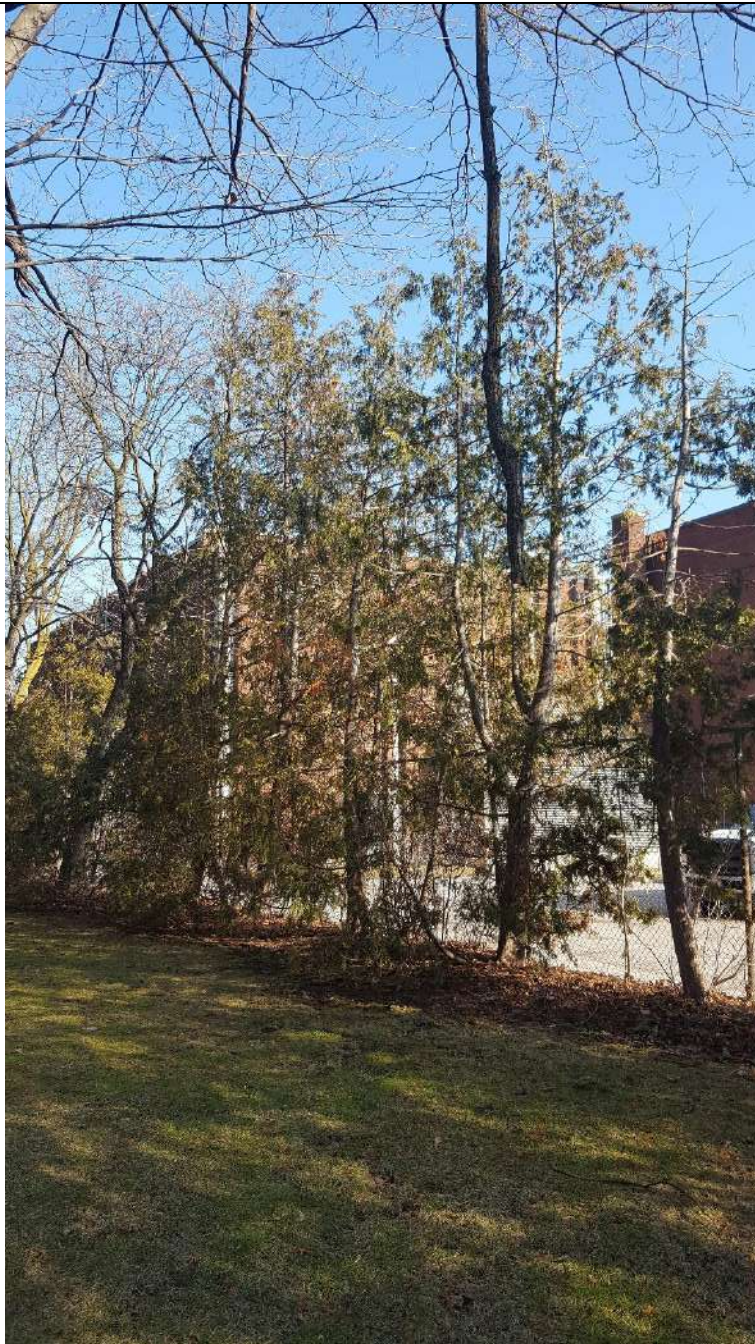
Photo 16 Trees 31, 32, 33, 34 (left to right)

32	Eastern White Cedar	<i>Thuja occidentalis</i>	25	G	FG	PF		4	1.8	Light lean towards south	Preserve-monitor	Private
33	Eastern White Cedar	<i>Thuja occidentalis</i>	21.13	F	F	PF		4	1.8	Union at base, conflict between stems	Preserve-monitor	Private
34	Eastern White Cedar	<i>Thuja occidentalis</i>	23,10	G	FG	PF		4	1.8	Co-dominant at 2m	Preserve-monitor	Private
35	Eastern White Cedar	<i>Thuja occidentalis</i>	16	FG	F	PF		2	1.8	Top of crown dead	Preserve-monitor	Private
36	Sugar Maple	<i>Acer saccharum</i>	82	F	F	PF		10	5.4	Exposed roots with moderate root wounds, light seam, co-dominant at 1.4m with heavy included bark, moderate dead branches, light asymmetrical crown, hollow cavity	Remove-development	Private
37	Eastern White Cedar	<i>Thuja occidentalis</i>	21	FG	FG	F		2	1.8	Light bow towards south, light growth deficit at base	Preserve-monitor	Private
38	Eastern White Cedar	<i>Thuja occidentalis</i>	18,10	FG	FG	F		2	1.8	Union at base, light lean towards south	Preserve-monitor	Private

Encroachment into the driplines of Trees 1, 12, 14, 18, 31 to 35, 37, and 38, will be required to accommodate the proposed parking area, walkway, and/or hardscape. Any required excavation should be conducted by hand, air spade or hydro-vac to expose roots for assessment and pruning. It is recommended that the proposed parking area within the driplines of these trees to be installed using a combination of geocell and permeable materials to minimize soil compaction, and allow for water infiltration, and as close to existing grades as possible. Any required root pruning should be conducted by a Certified Arborist following good arboricultural standards. Any work within the dripline of trees should be supervised by a Certified Arborist. These trees should be monitored for changes in health, condition and structural stability by a Certified Arborist during and following construction. The supervising Arborist must confirm that the trees are safe to be retained. Cabling of the union of Tree 42 is recommended.

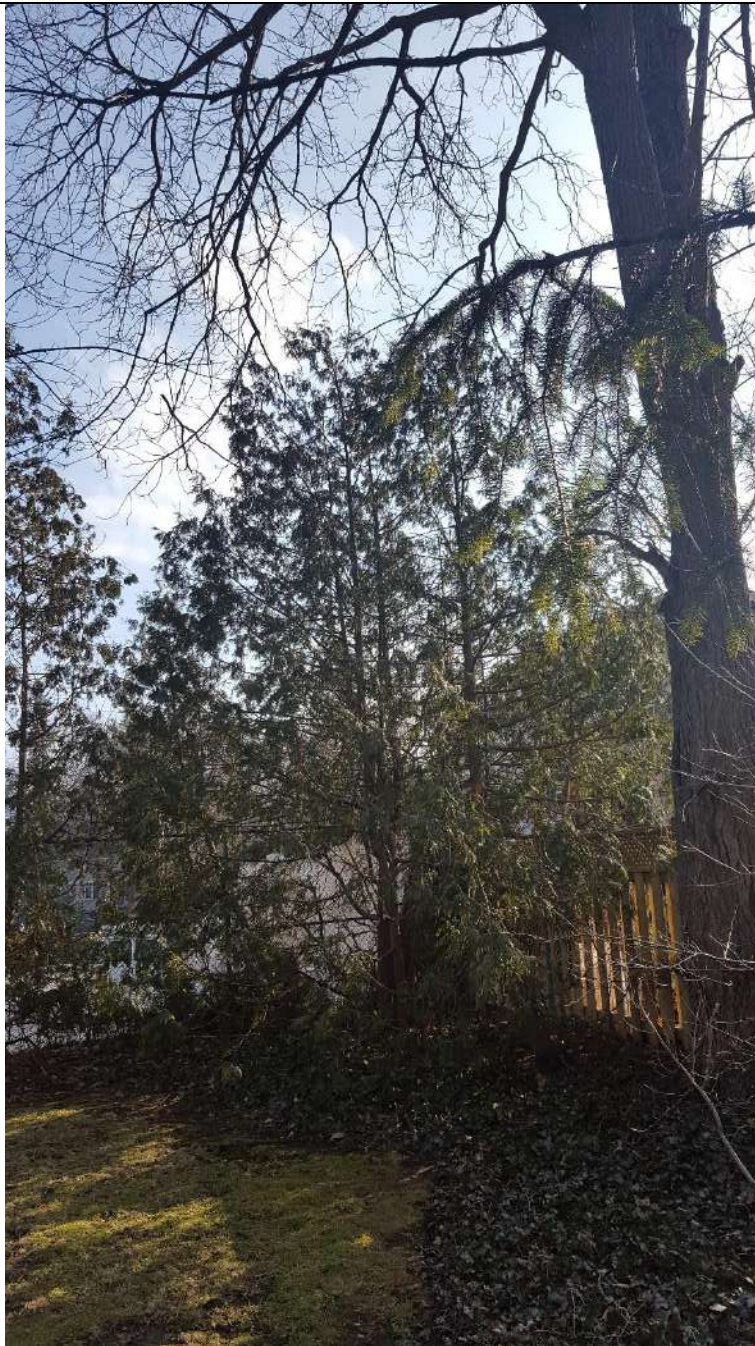
Photo 18 Trees 37, 38, 39, 40, 41

39	Manitoba Maple	<i>Acer negundo</i>	20,14	PF	F	F		2	1.8	Union at 1m, included chain link fence, moderate bow, moderate poor form	Preserve	Shared
40	Eastern White Cedar	<i>Thuja occidentalis</i>	18,10,8	F	F	FG		4	1.8	Union at base, spiral fused stems	Preserve	Private
41	Eastern White Cedar	<i>Thuja occidentalis</i>	16	FG	G	G		3	1.8	Curved stem at base	Preserve	Private
42	Black Walnut	<i>Juglans nigra</i>	79	PF	F	F		8	4.8	Conflict with fence, V-union at 1m with very heavy included bark and wetwood, heavy asymmetrical crown due to competition with Tree 43. cabling recommended	Preserve-monitor	Shared
43	Black Walnut	<i>Juglans nigra</i>	73	PF	F	F		8.25	4.8	Heavy stem wound from base to union with decay , union at 3m, broken branches, light asymmetrical crown, cabling recommended	Remove-development	Private
44	White Spruce	<i>Picea glauca</i>	22.5	F	G	G		5	1.8	Moderate stem wound, heavy exposed roots, small stem flare	Remove-development	Private

37	Eastern White Cedar	Thuja occidentalis	21	FG	FG	F		2	1.8	Light bow towards south, light growth deficit at base	Preserve-monitor	Private
38	Eastern White Cedar	Thuja occidentalis	18, 10	FG	FG	F		2	1.8	Union at base, light lean towards south	Preserve-monitor	Private
39	Manitoba Maple	Acer negundo	20, 14	PF	F	F		2	1.8	Union at 1m, included chain link fence, moderate bow, moderate poor form	Preserve	Shared
40	Eastern White Cedar	Thuja occidentalis	18, 10, 8	F	F	FG		4	1.8	Union at base, spiral fused stems	Preserve	Private
41	Eastern White Cedar	Thuja occidentalis	16	FG	G	G		3	1.8	Curved stem at base	Preserve	Private
42	Black Walnut	Juglans nigra	79	PF	F	F		8	4.8	Conflict with fence, V-union at 1m with very heavy included bark and wetwood, heavy asymmetrical crown due to competition with Tree 43, cabling recommended	Preserve-monitor	Shared
43	Black Walnut	Juglans nigra	73	PF	F	F		8.25	4.8	Heavy stem wound from base to union with decay, union at 3m, broken branches, light asymmetrical crown, cabling recommended	Remove-development	Private

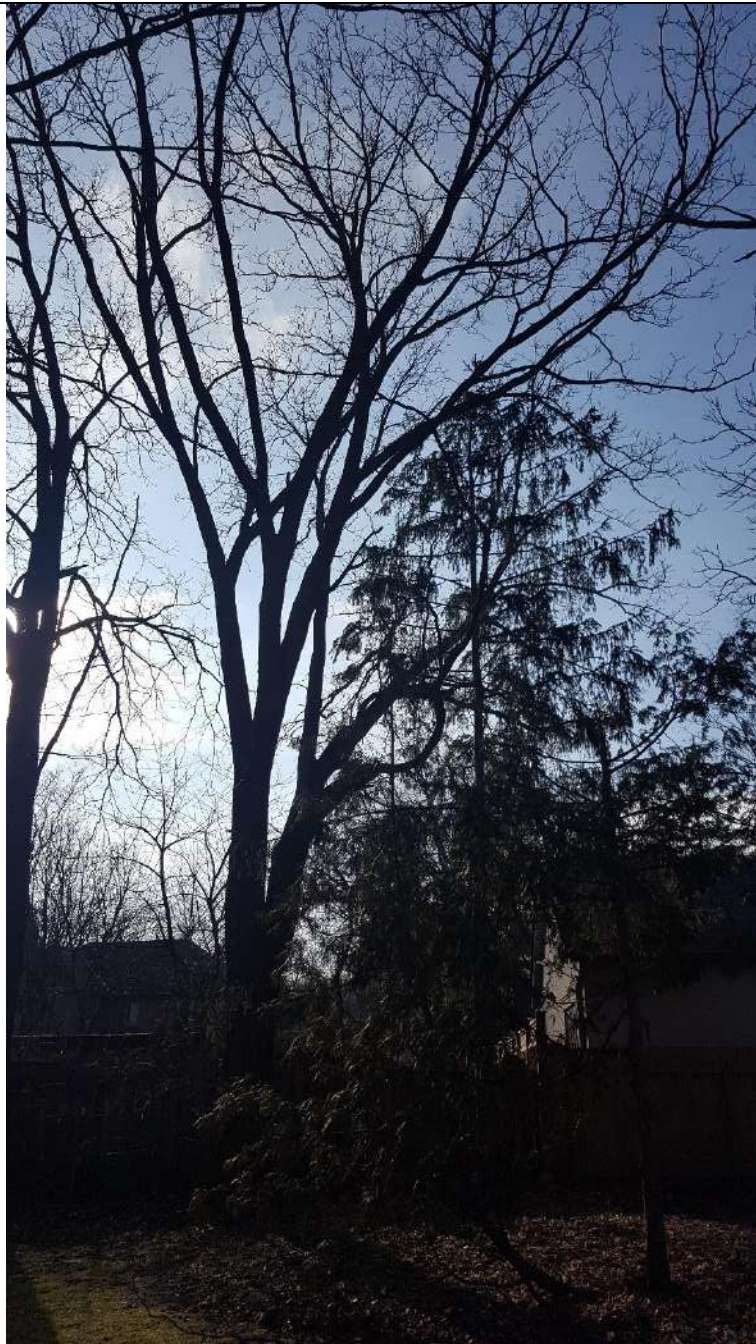
Photo 20 Trees 43 and 44 (left to right)

44	White Spruce	Picea glauca	22.5	F	G	G		5	1.8	Moderate stem wound, heavy exposed roots, small stem flare	Remove-development	Private
END
