**Tree Inventory and Preservation Plan Report
10316 Keele Street
Vaughan, Ontario**

9 December 2019, revised 13 January 2020, 11 May 2020, 5 April 2021, and 7 July 2021

KUNTZ FORESTRY CONSULTING INC Project P2275

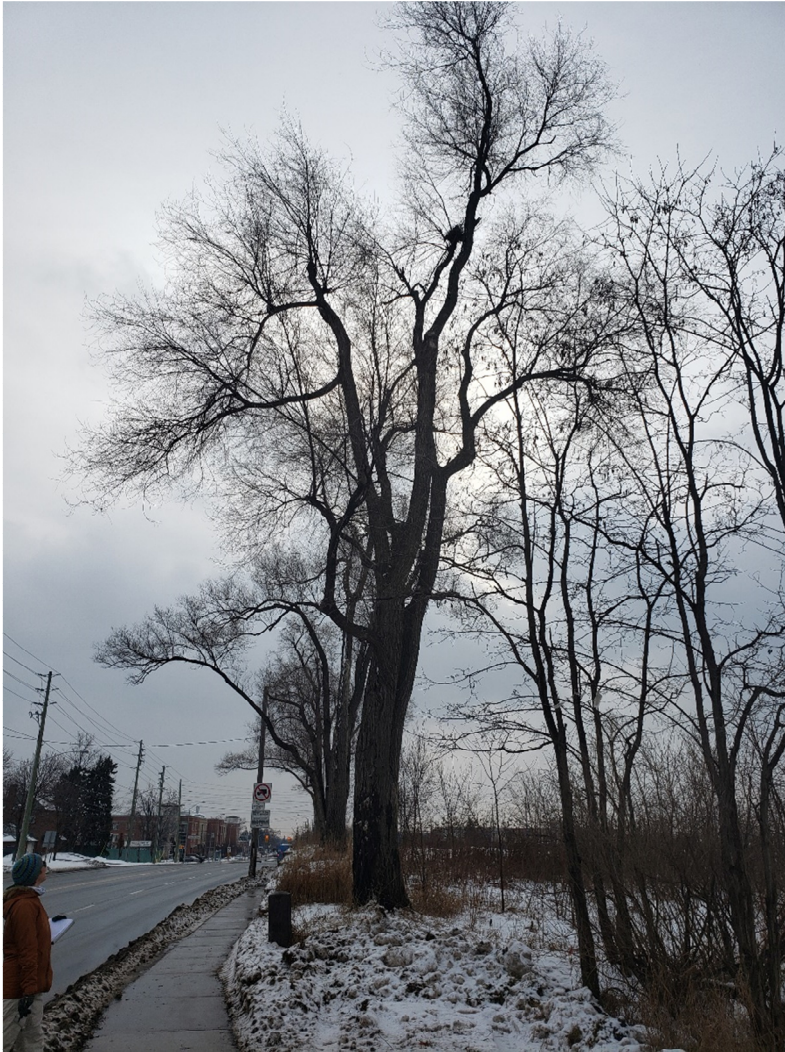
Image 1. Photo of Tree 1

Tree #	Common Name	Scientific Name	DBH	TI	CS	CV	CDB	DL	mTPZ	Comments	Action	Comp.
1	Siberian Elm	<i>Ulmus pumila</i>	74	F	F	F		6	7.4	V-union at 2m, asymmetrical crown (L), epicormic branching (M), previously tagged 765, marked yellow, pruning wounds (L)	Remove	
2	Siberian Elm	<i>Ulmus pumila</i>	53.5	F	F	F		11	5.4	Asymmetrical crown (M), epicormic branching (M), marked yellow	Remove	
3	Siberian Elm	<i>Ulmus pumila</i>	26, 27.5, 23.5, 22.5, 22	F	P-F	F		7	2.8	Previously tagged 766, marked yellow, epicormic branching (M), pruning wounds (M), deadwood (M)	Remove	
4	Siberian Elm	<i>Ulmus pumila</i>	40	F	F	F		4	4.0	Marked yellow, pruning wounds (L), epicormic branching (M), asymmetrical crown (M)	Remove	
5	Siberian Elm	<i>Ulmus pumila</i>	33, ~32, 29	F	F	F		5.5	3.3	Previously tagged 1465, marked yellow, poor union at 1 and 1.4m, fused stems, pruning wounds (M), epicormic branching (M), asymmetrical crown (L)	Remove

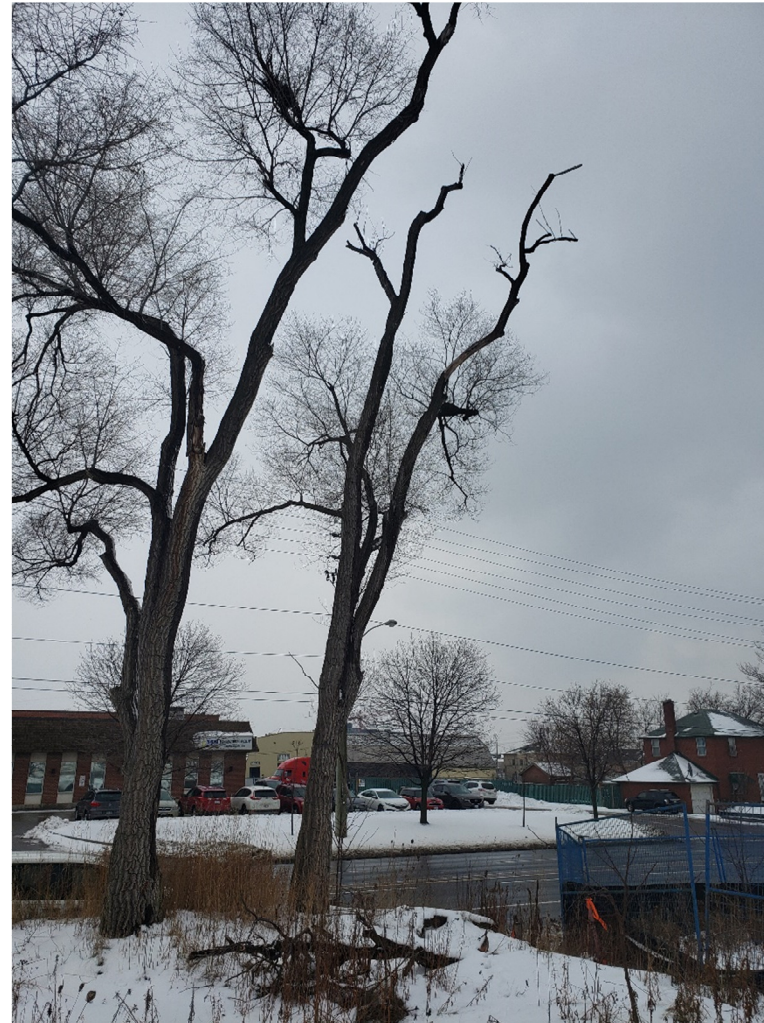
Image 6. Photo of Tree 6

6	Siberian Elm	<i>Ulmus pumila</i>	47	P-F	P-F	P	40	7	4.7	Marked yellow, previously tagged 778, deadwood (H), v-union at 1.4m	Remove	
7	Norway Spruce	<i>Picea abies</i>	48	G	F-G	F-G			3.0	Deadwood (L), asymmetrical crown (L)	Remove	3
8	Norway Spruce	<i>Picea abies</i>	43	G	F-G	F-G			3.0	Deadwood (L), sparse crown (L), asymmetrical crown (L)	Remove	3
9	Norway Spruce	<i>Picea abies</i>	19.5	F-G	P-F	P-F			1.8	Lost leader	Remove	
10	Norway Spruce	<i>Picea abies</i>	34.5	G	F-G	F-G			2.4	Asymmetrical crown (L), sparse crown (L), deadwood (L)	Remove	2
11	Norway Spruce	<i>Picea abies</i>	28.5	G	F	F-G			1.8	Asymmetrical crown (M), sparse crown (L), deadwood (L), poor form (L)	Remove	1

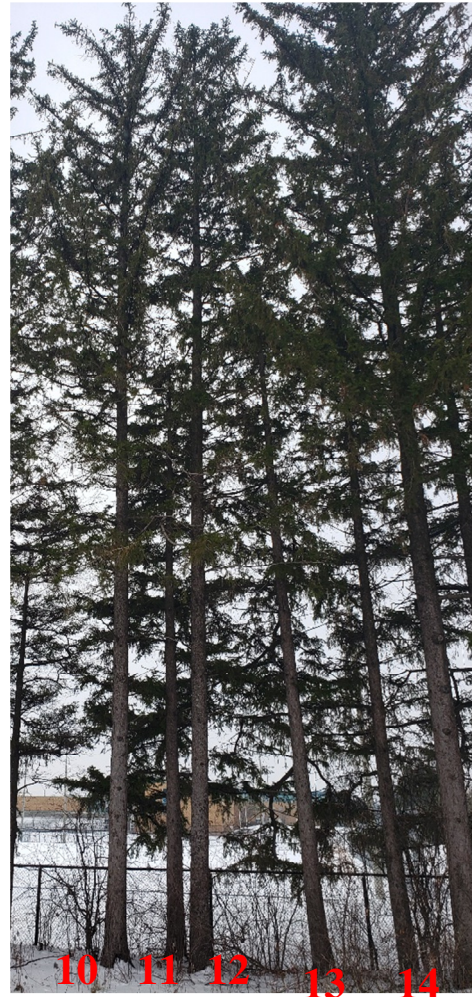
Image 8. Photo of Trees 10-14

12	Norway Spruce	<i>Picea abies</i>	33	G	F-G	F-G			2.4	Asymmetrical crown (L), sparse crown (L), deadwood (L)	Remove	2
13	Norway Spruce	<i>Picea abies</i>	30	G	F	F-G			2.4	Asymmetrical crown (M), sparse crown (L), deadwood (L)	Remove	1
14	Norway Spruce	<i>Picea abies</i>	29	G	F-G	F-G			1.8	Asymmetrical crown (L), sparse crown (L), deadwood (L)	Remove	1
15	Norway Spruce	<i>Picea abies</i>	44	G	F-G	F-G			3.0	Asymmetrical crown (M), deadwood (L), pruning wounds (L)	Remove	3
16	Norway Spruce	<i>Picea abies</i>	36.5	G	F-G	F-G			2.4	Asymmetrical crown (M), deadwood (L)	Remove	2
17	Norway Spruce	<i>Picea abies</i>	18	G	F-G	F			1.8	Asymmetrical crown (L), understory tree	Remove	
18	Norway Spruce	<i>Picea abies</i>	31.5	G	F-G	F-G			2.4	Asymmetrical crown (L), deadwood (L), sparse crown (L)	Remove	2
19	Norway Spruce	<i>Picea abies</i>	23	G	F-G	F-G			1.8	Asymmetrical crown (L), deadwood (L), pruning wounds (L)	Remove	1

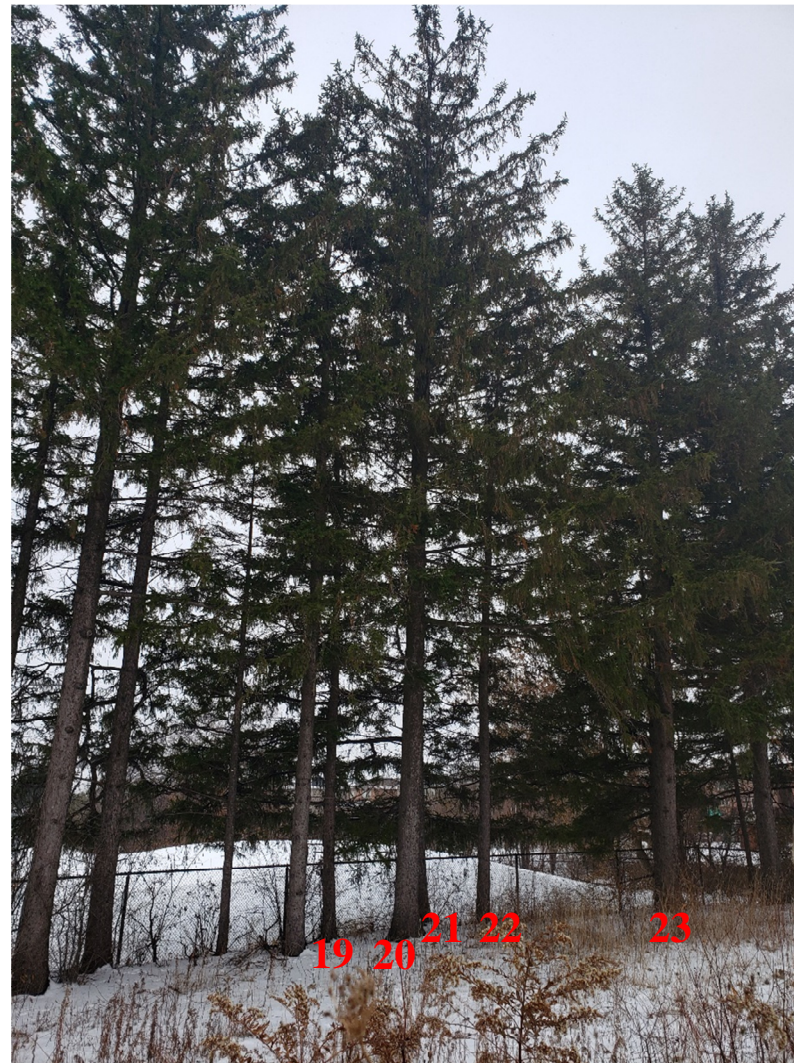
Image 10. Photo of Trees 19-23

20	Norway Spruce	<i>Picea abies</i>	44.5	G	F-G	F-G			3.0	Asymmetrical crown (L), deadwood (L)	Remove	3
21	Norway Spruce	<i>Picea abies</i>	43.5	G	F-G	F-G			3.0	Asymmetrical crown (L), deadwood (L)	Remove	3
22	Norway Spruce	<i>Picea abies</i>	28	G	F-G	F-G			1.8	Asymmetrical crown (L), deadwood (L)	Remove	1
23	Norway Spruce	<i>Picea abies</i>	44	G	F-G	F-G			3.0	Lean (VL), poor form (L), pruning wounds (L), asymmetrical crown (L)	Remove	3
24	Norway Spruce	<i>Picea abies</i>	29	F	P-F	F			1.8	Dead leader, lateral branch assuming dominant position, poor form (H)	Remove	1
25	Norway Spruce	<i>Picea abies</i>	45.5	G	F-G	G			3.0	Poor form (L), pruning wounds (L), asymmetrical crown (L)	Remove	3
26	Norway Spruce	<i>Picea abies</i>	13.5	F	P-F	P-F			1.8	Poor form (M), dead leader, sweep (L)	Remove	
27	Norway Spruce	<i>Picea abies</i>	26	G	G	G			1.8	Deadwood (L)	Remove	1
28	Norway Spruce	<i>Picea abies</i>	33	G	F	F-G			2.4	Asymmetrical crown (M), poor form (L)	Remove	2

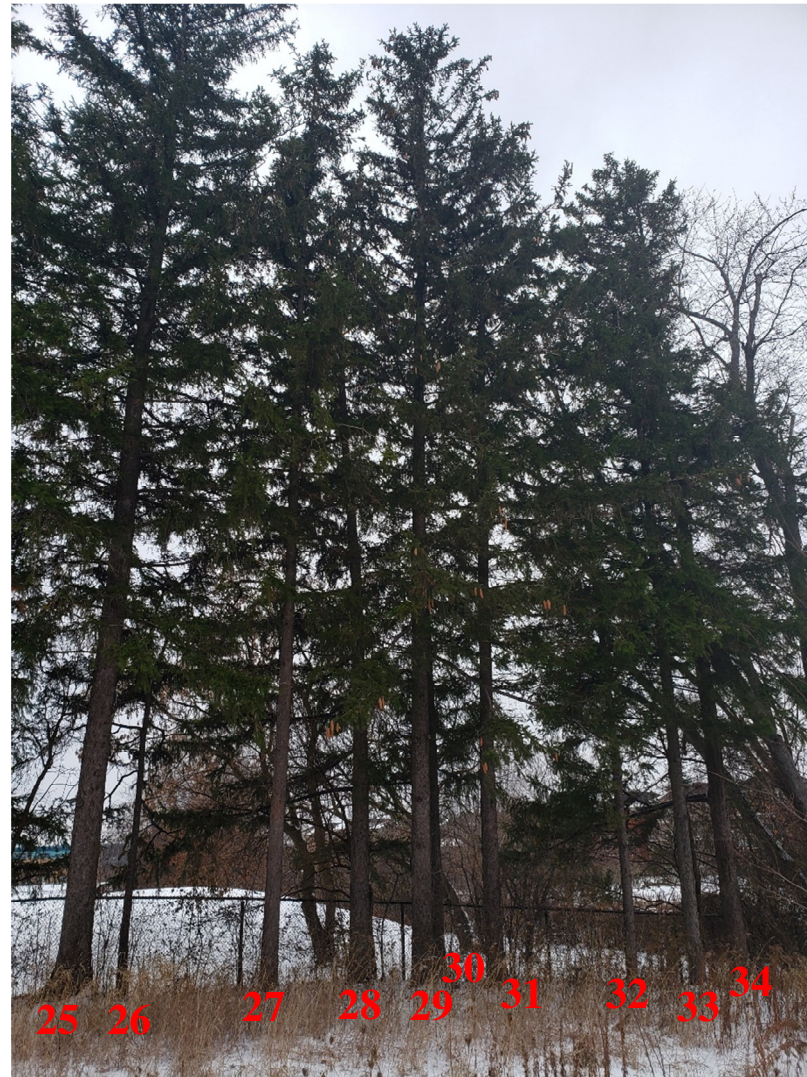
Image 12. Photo of Trees 25-34

29	Norway Spruce	<i>Picea abies</i>	35.5	G	F-G	F-G			2.4	Asymmetrical crown (L), pruning wounds (L), deadwood (L)	Remove	2
30	Norway Spruce	<i>Picea abies</i>	22	G	F-G	F-G			1.8	Asymmetrical crown (L), deadwood (L)	Remove	1

31	Norway Spruce	<i>Picea abies</i>	29.5	G	F-G	F-G			1.8	Asymmetrical crown (L)	Remove	1
32	Norway Spruce	<i>Picea abies</i>	19	G	F	F			1.8	Pruning wounds (L), asymmetrical crown (L)	Remove	
33	Norway Spruce	<i>Picea abies</i>	26.5	G	F-G	G			1.8	Asymmetrical crown (L)	Remove	1
34	Norway Spruce	<i>Picea abies</i>	38	G	F-G	F-G			2.4	Asymmetrical crown (L), deadwood (L)	Remove	2
35	Silver Maple	<i>Acer saccharinum</i>	~144	F	F	F	20		8.6	Dead leaders, broken branches (M), epicormic branching (M), poor form (M), union at 1.4 and 1.6m	Remove	4
36	Norway Maple	<i>Acer platanoides</i>	18.5	G	G	G			1.8		Remove	
A	Norway Maple	<i>Acer platanoides</i>	~20	G	G	G			1.8		Retain	
B	Black Locust	<i>Robinia pseudoacacia</i>	22	G	G	G			1.8	Asymmetrical crown (L)	Remove	1
C	Norway Maple	<i>Acer platanoides</i>	17	G	G	G			1.8	Sweep (L)	Retain	
PD	Manitoba Maple	<i>Acer negundo</i>	~5-12	F	F	F			1.8	53 trees, poor form (M)	Remove

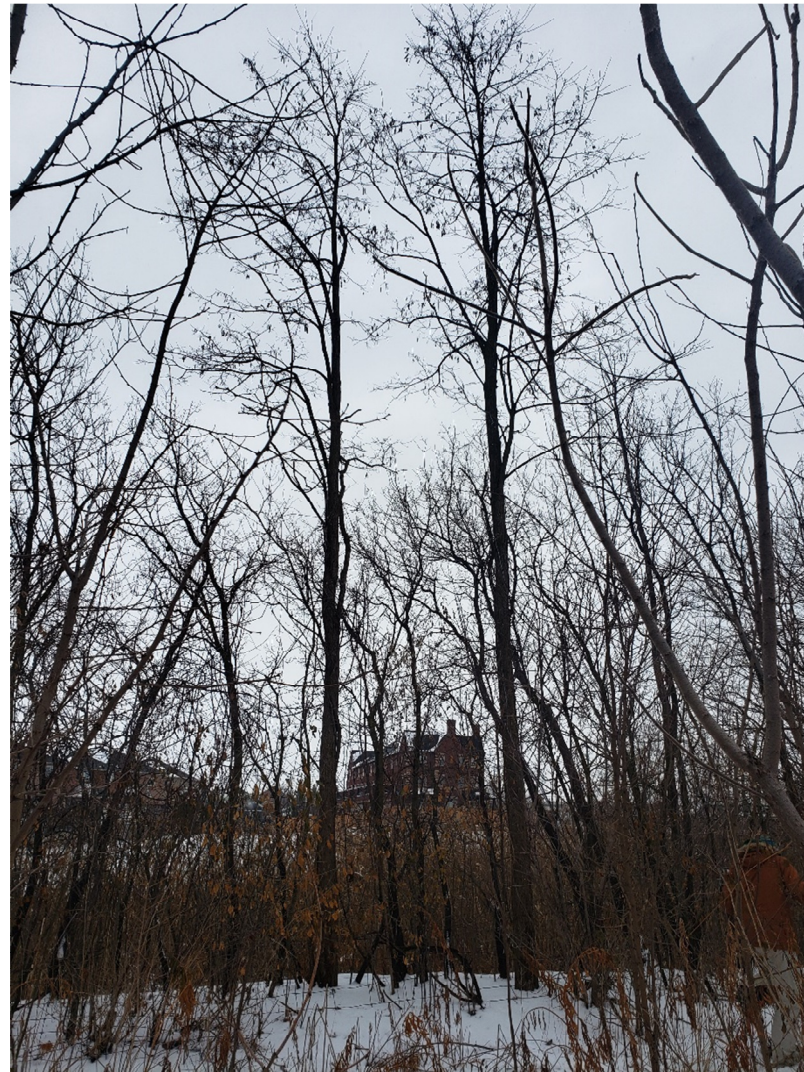
Image 18. Photo of Trees F and G

E	Black Locust	<i>Robinia pseudoacacia</i>	~24	G	G	G			1.8		Retain	
F	Black Locust	<i>Robinia pseudoacacia</i>	~15	G	F-G	G			1.8	Asymmetrical crown (L)	Remove	
G	Black Locust	<i>Robinia pseudoacacia</i>	~16	G	F-G	G			1.8	Asymmetrical crown (L)	Remove	
H	Silver Maple	<i>Acer saccharinum</i>	20	G	G	G			1.8		Remove	1
PI	Silver Maple	<i>Acer saccharinum</i>	~8-12	F	G	F			1.8	6 trees, stem wounds (M)	Remove	
J	Manitoba Maple	<i>Acer negundo</i>	~14	G	F	F-G			1.8		Remove	
PK	Silver Maple	<i>Acer saccharinum</i>	~8-13	G	G	G			1.8	4 trees	Remove	
PL	Black Locust	<i>Robinia pseudoacacia</i>	~8-15	G	G	G			1.8	7 trees	Remove	
M	Black Locust	<i>Robinia pseudoacacia</i>	11, 10, 8.5, 7	G	G	G		3	2.4	Union at base	Remove
