**Tree Inventory and Preservation Plan Report  
9929 Keele Street  
Vaughan, Ontario**

16 April 2020, revised 1 December 2020

KUNTZ FORESTRY CONSULTING Inc. Project P2374

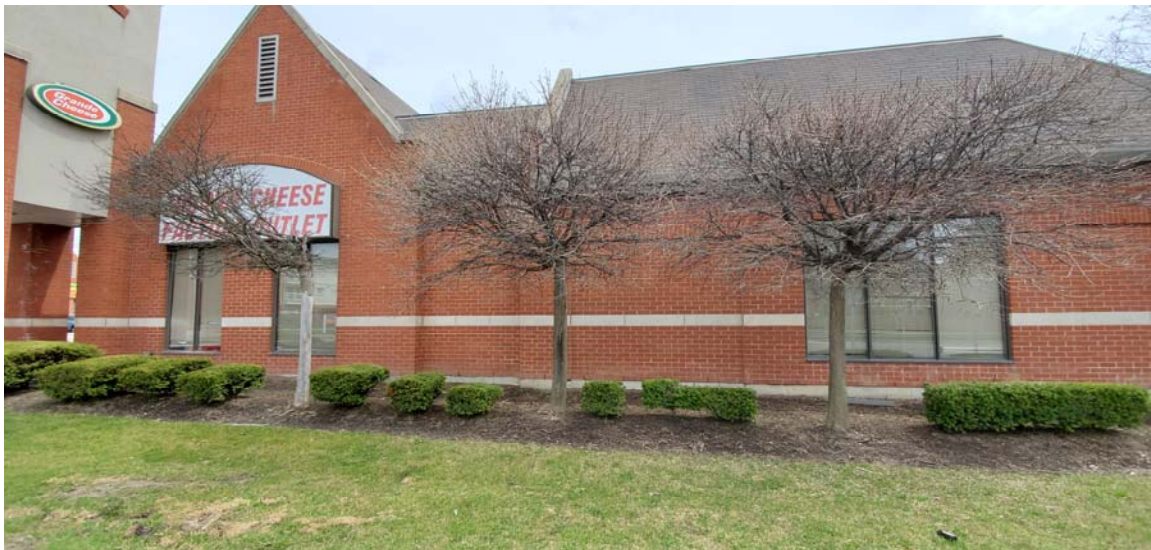
In addition, the removal of four dead trees on the subject property is recommended regardless of the site plan, including three Ash trees and one Norway Maple. Refer to Figure 1 for the location of required tree removals.

Image 6. Dead Maple, Trees 11 and 12 (from left)
