**CITY OF VAUGHAN
HERITAGE VAUGHAN COMMITTEE AGENDA**

TITLE: NOTICE OF APPLICATION TO REPEAL THE HERITAGE DESIGNATION BY-LAW OF JAMES DALZIEL HERITAGE HOUSE AT 7230 NASHVILLE ROAD IN KLEINBURG

STRUCTURAL CONDITION ASSESSMENT

7230 Nashville Road, Kleinburg, Vaughan

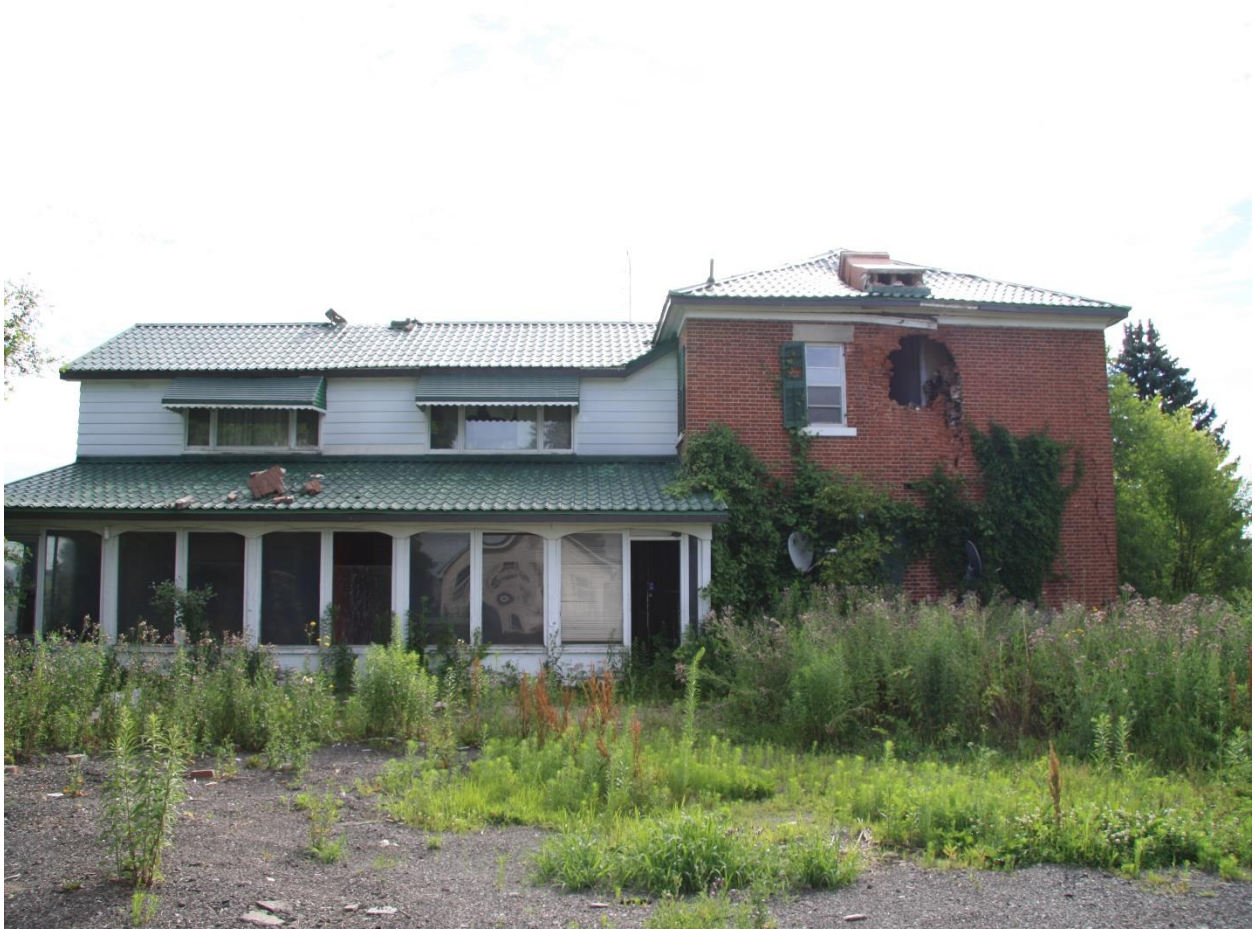
WEST ELEVATION

- **West Elevation** we have a new window that is not in the context of the house, and the major chimney has fallen and resting on the roof. This created a displacement on the wall having a major hole on the façade. Also, evident vertical cracks on the RH of the house **(Photo attached)**

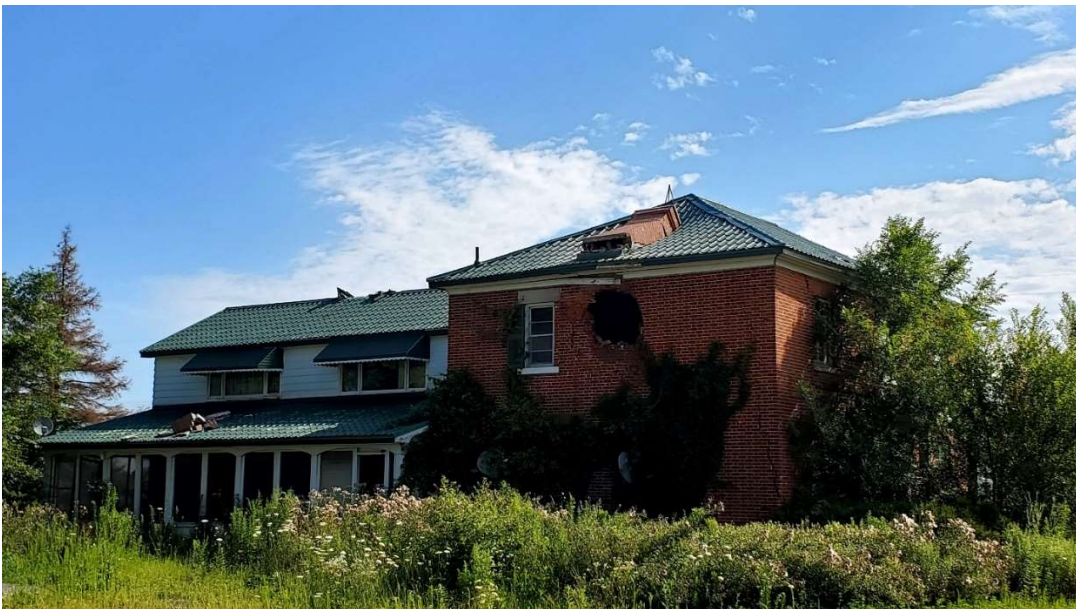
The existing building addition (Pic. 2, Pic. 9) along the north side of the main building (house) has a rectangular footprint and is one-and-a-half-storey with a basement. It has a side-gable roof, a chimney in the center, which is damaged/broken and fallen over onto the existing roof, and a concrete block wall foundation with wooden floors. The building addition has an exterior brick facade on the first floor and wooden siding on the second floor. There are two fully glazed windows on the front and back of the second floor, each with a chajja on top. The first floor has glazed windows on the north and east sides. The building has a one-story front verandah with wood-framed glazed windows and doors at both ends. The shed roof is green metal. Currently, the building addition is abandoned and unoccupied.

Pic. 2: Westview of the House showing Northside Addition

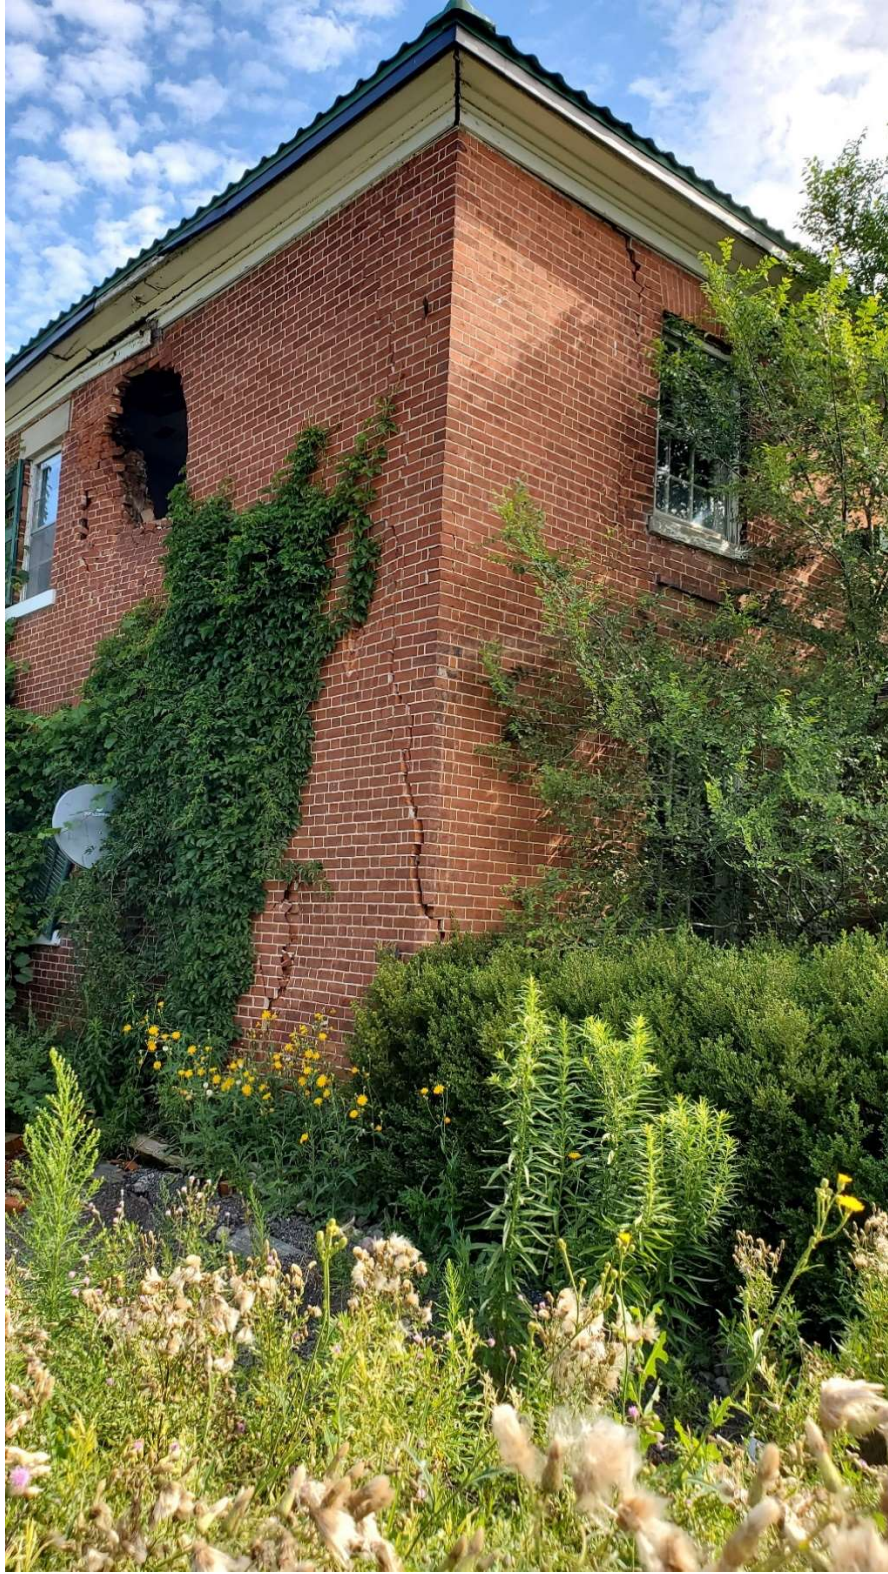
1. Extensive vertically inclined crack, wide at the bottom and narrow at the top, was observed on the exterior load-bearing masonry wall on the west side from the southwest corner, travelling up from the bottom to the top of the building (Pic. 2, Pic. 3, Pic. 5). Another sizable fissure was also observed on the same wall some distance away from the long crack (Pic. 5).

2. A very large round collapsed area on the load-bearing masonry wall was observed on the west side near the top center of the wall, wide and large cracks surrounding the fallen section. It appears this fallen section caved in towards the inside of the building. (Pic. 3, Pic. 5).

3. A wide vertical crack was noticed on the left side, near the window, from the top of the load-bearing masonry wall on the southside (Pic. 5). Some disintegrated bricks with long vertical cracks were also seen on the same wall on the right side at the southeast corner (Pic. 6).

Pic. 5: Southwest view of the House-Cracks and Damage in the Load-bearing Masonry Wall

In conclusion, the extent of the structural deficiencies are significant, and additional movement and cracking of the bearing wall is likely to continue to a point of complete failure and collapse of the building. The current state of the building is dire, and poses a severe risk of complete collapse resulting in public safety and health concerns. Therefore, with public safety being paramount, we recommend that pro-active safety measures be implemented immediately to secure the building by installing security fencing/hoarding and warning signs around the perimeter building at an appropriate distance or offset from the building to protect the public or trespassers from falling debris and prevent entry into the unsafe building (house). In addition, we strongly recommend that the house be condemned and demolished as soon as possible, with proper demolition permit approvals in place from the City of Vaughan.

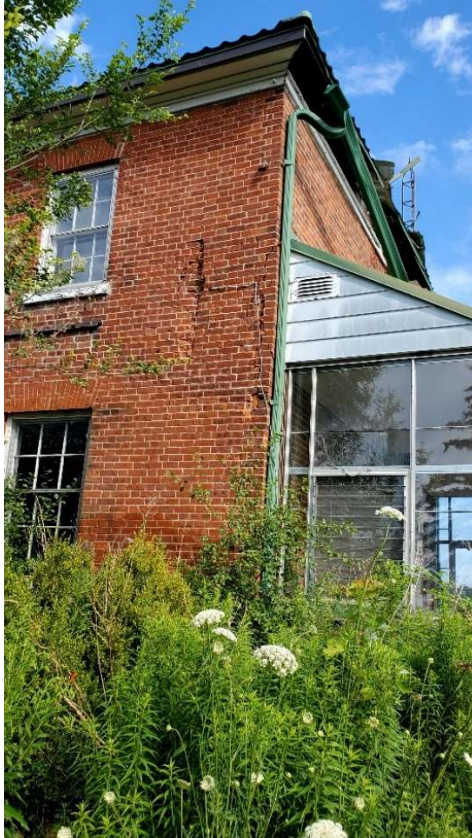
Pic. 6: Cracks and Damage on the Southside Masonry Wall of the House

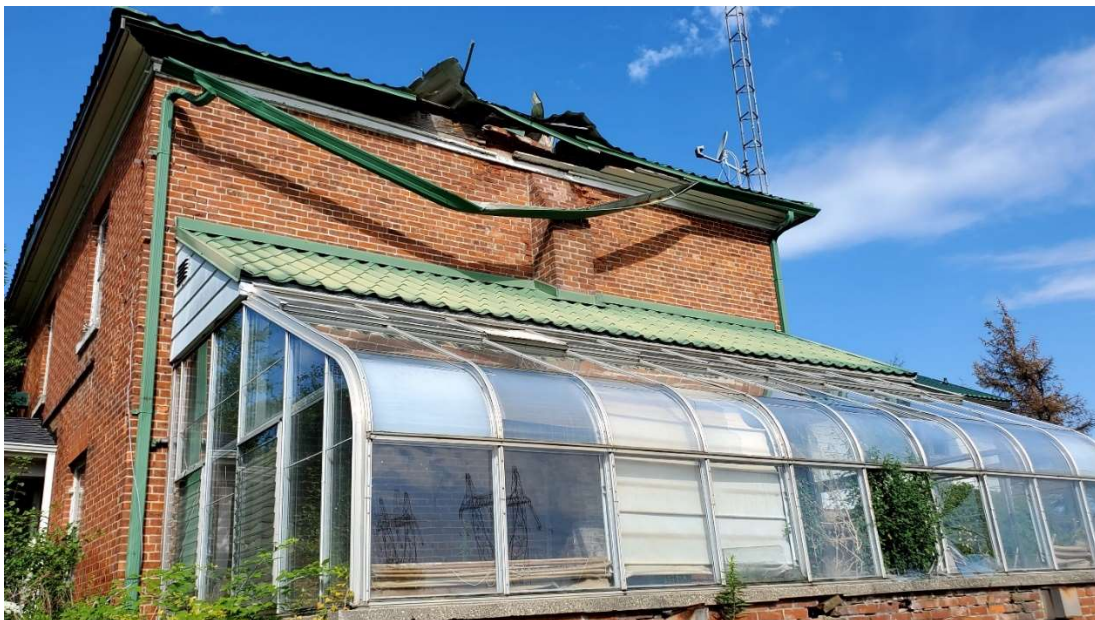
4. The Chimneys were broken above the roof line and damaged the roof structure, including the metal edge, fascia, and soffit (Pic. 2, Pic. 3, Pic. 7).
5. The metal roof was damaged and lifted in many areas including at the locations of the fallen chimneys (Pic. 2, Pic. 3, Pic. 7). The damaged roof offers no protection to the interior of the building from the elements (rain, snow etc.) resulting in further deterioration of the interior of the building, including flooding, rotting and damage to flooring, walls and ceilings, and environmental issues such as mold.

Pic. 7: Eastside View of the House showing Damaged Roof at Broken Chimney and Greenhouse Addition

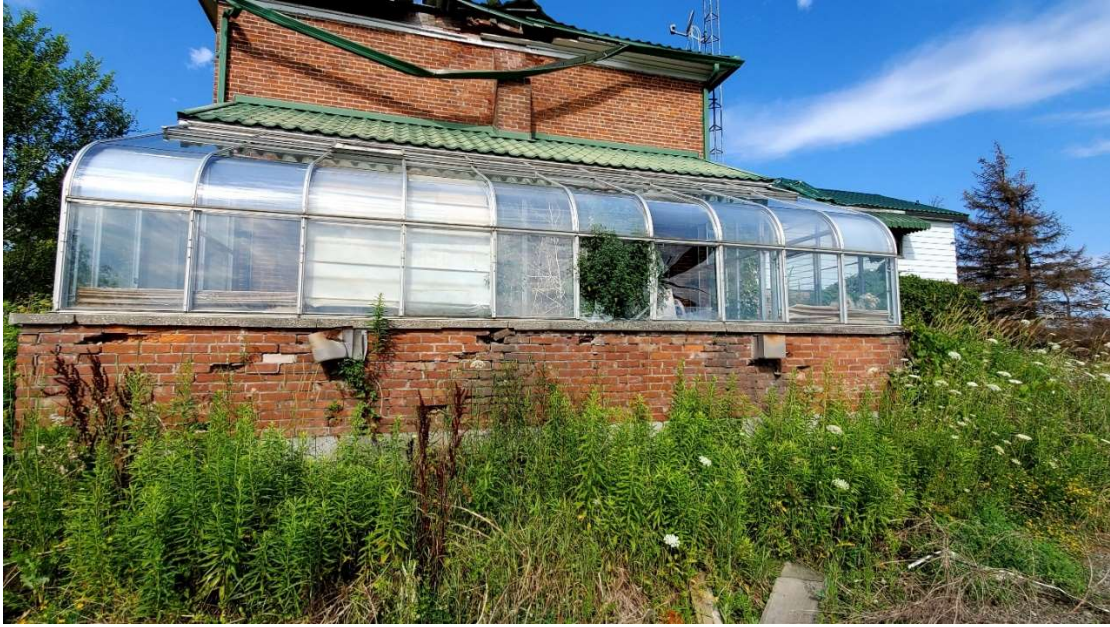
7. The brick masonry wall of the greenhouse addition appeared disintegrated, and vegetation growth was observed in the greenhouse with a broken few pane (Pic. 8).

Pic. 8: Eastview showing disintegrated Masonry Wall, Vegetation growth in the Greenhouse with Broken Panes

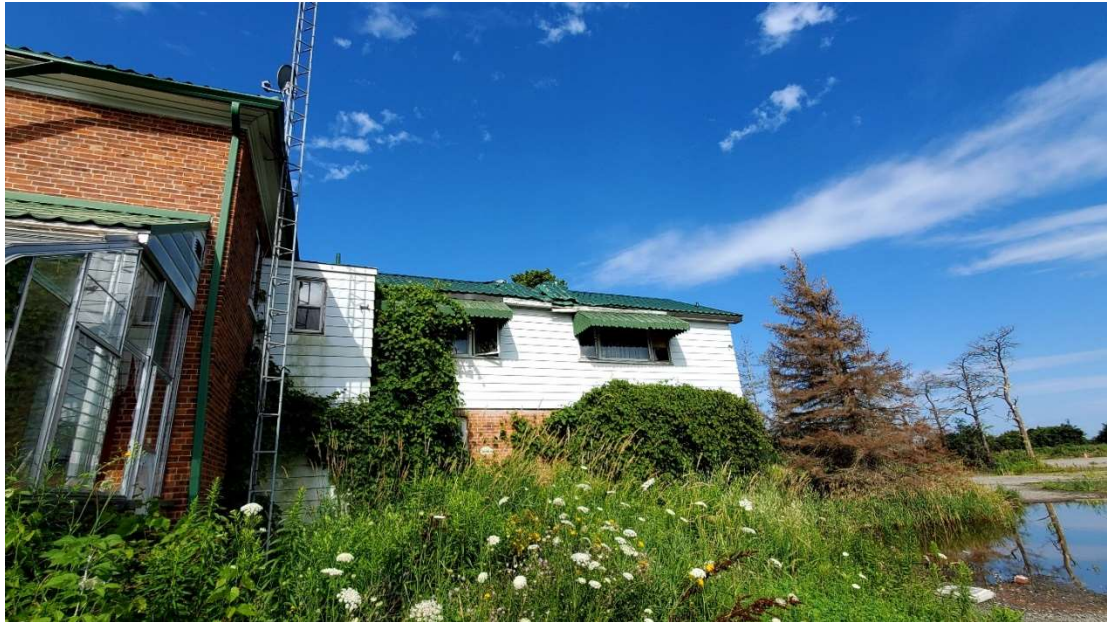
Pic. 9: House Addition on Northside

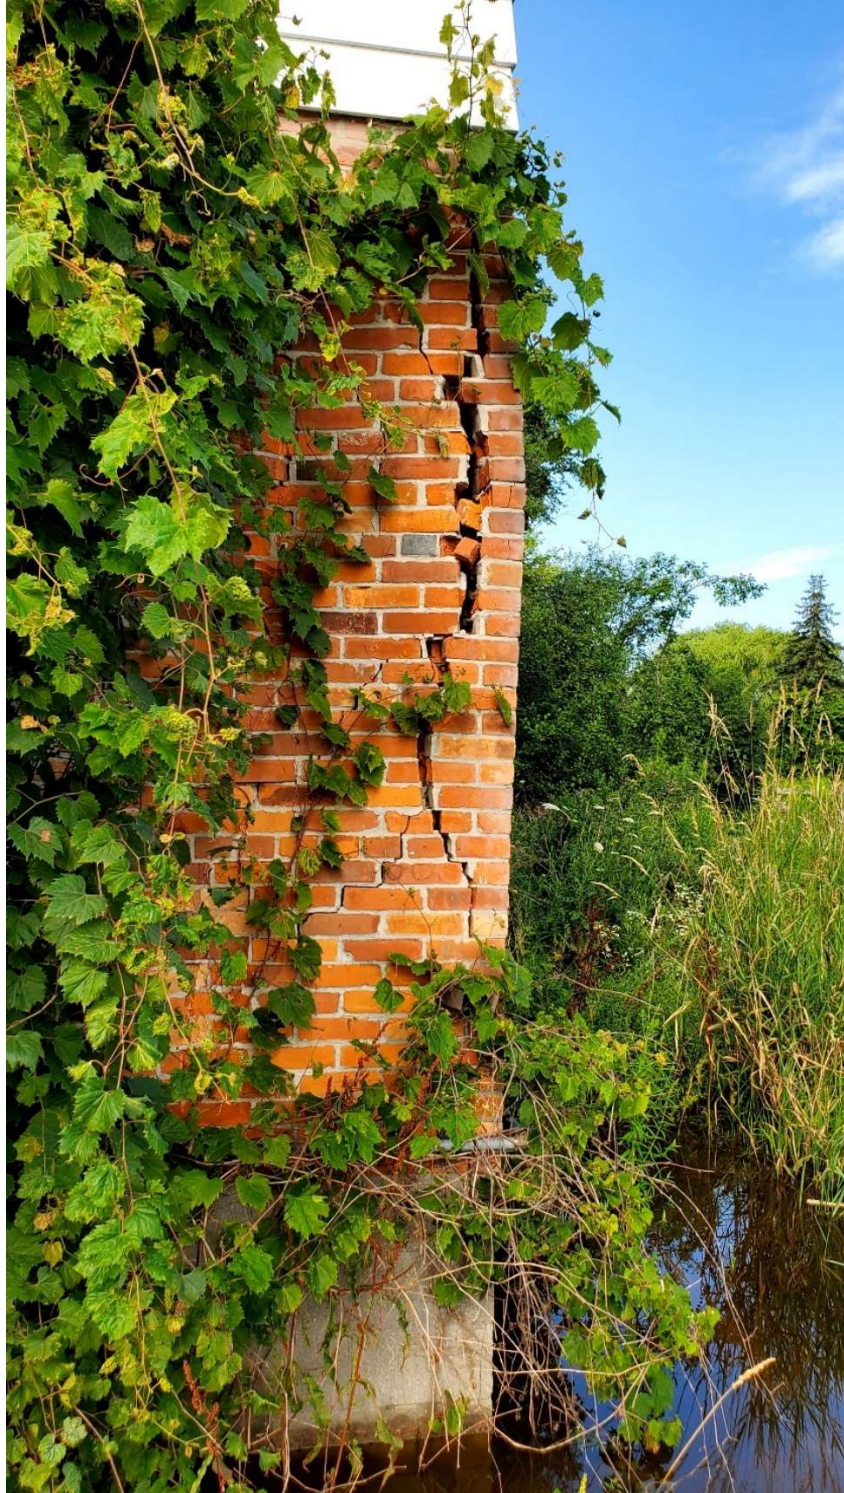
8. Wide and long vertical cracks were also observed in the load-bearing masonry wall at the northeast corner of the house addition on the northside (Pic. 10).

Pic. 10: Wide and Long Vertical Crack on the Northside House Addition and Water Pool Outside

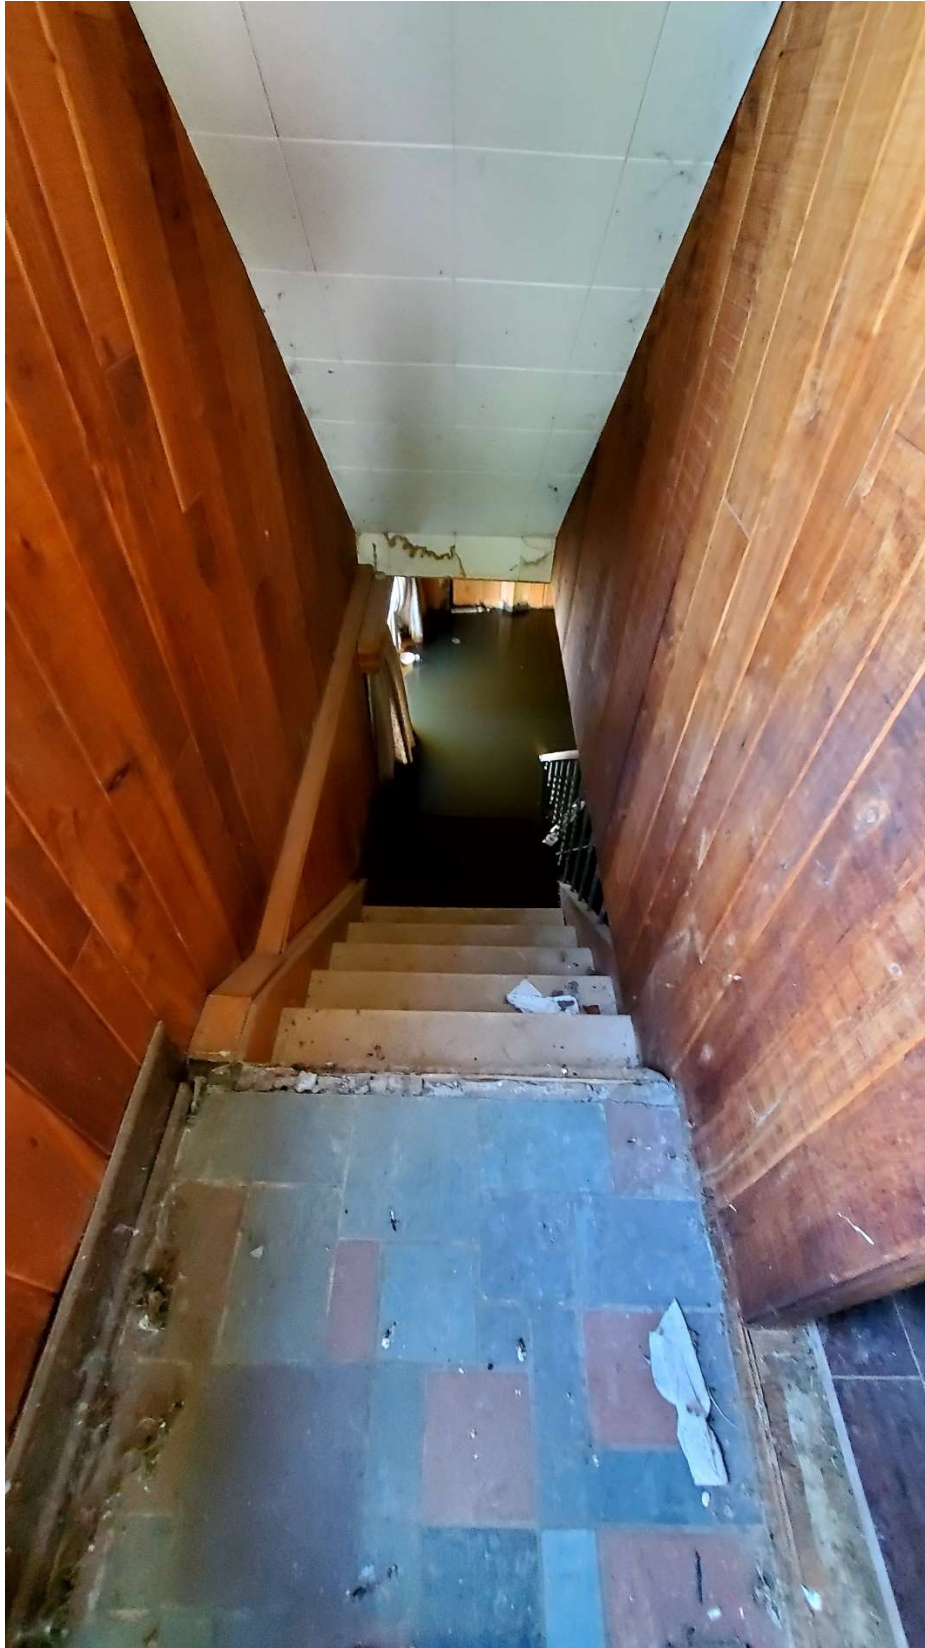
9. The house's crawl space was not inspected due to safety concerns and health hazards; however, the basement of the house addition on the north side is visible from the ground floor and is fully submerged in dirty water up to the windowsill (Pic. 11). That makes it inaccessible to inspect the structure's foundation condition from the basement.

Pic. 11: Submerged Basement of the House Addition on the Northside
