**CITY OF VAUGHAN  
HERITAGE VAUGHAN COMMITTEE  
AGENDA**

## Heritage Vaughan Committee Report

**TITLE: NEW DEVELOPMENT – PROPOSED DEMOLITION OF TWO EXISTING SINGLE DETACHED DWELLINGS AND CONSTRUCTION OF 16 RESIDENTIAL UNITS COMPRISED OF 8 SEMI-DETACHED UNITS AND 8 TOWNHOUSE UNITS LOCATED AT 9785/9797 KEELE STREET, VICINITY OF KEELE STREET AND BARRHILL ROAD**

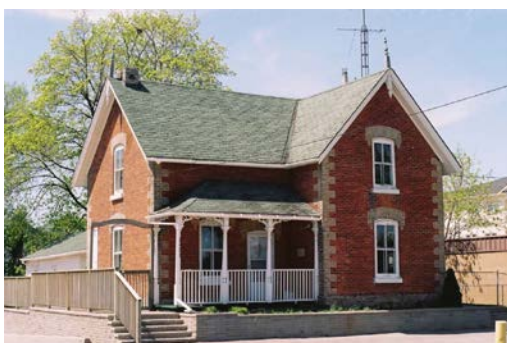
Figure 42 – Brick Quoins on Heritage Structure at 9920 Keele Street, (north of subject properties) from Maple HCD Vol.1

String course banding and quoins in a contrasting (accent) brick colour is found in most of the historic brick buildings of Maple (Figures 42, 44 & 45), including the adjacent Keffer House (Figure 39). The double string courses were incorporated on the base level of each storey and on the gable end of the proposal. This placement of string courses incorporated a somewhat similar height distance between them, thereby creating a unifying and rhythmical banding across the townhouse elevations. The quoins provide a variation in the façade planes and thereby reduce the mass of the townhouse blocks.

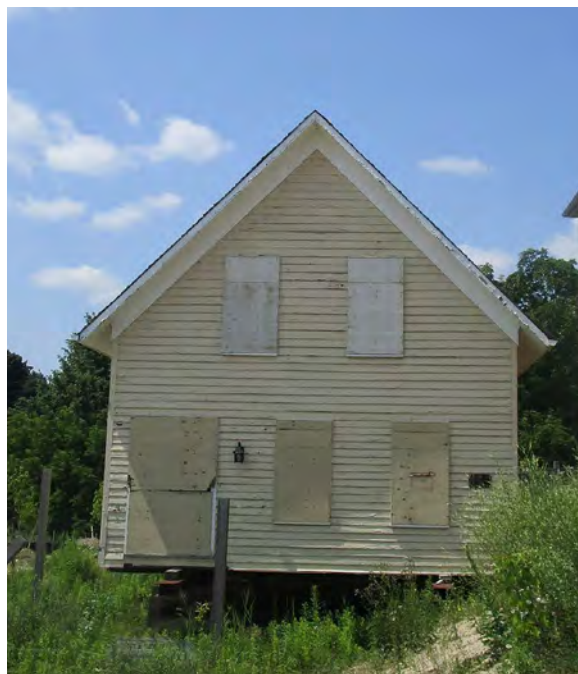
16. East elevation (ERA, 2019).

Overall, the Munshaw house is in fair to poor condition with areas of defective condition. It is currently sitting on temporary structure - steel beams and wood cribs. The area at the seam of the two storey and one storey structure appears to be in poor condition and is bowing in this location. This section should be repaired and levelled as soon as possible to prevent further deterioration to the structure.

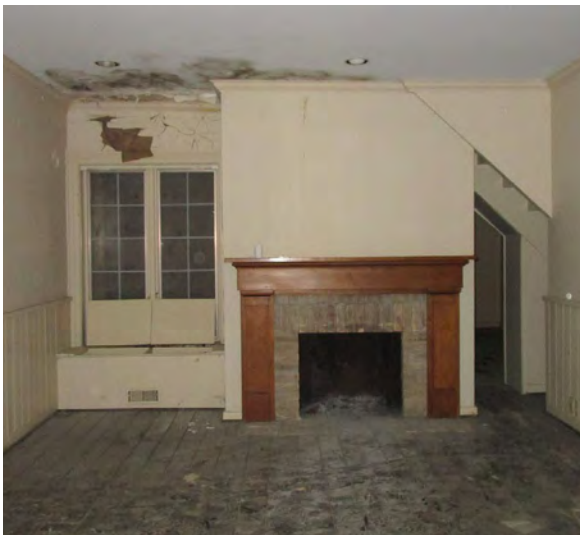
30. View of dining room, with evidence of mould on the ceiling and wall from defective roofing area (ERA, 2019).

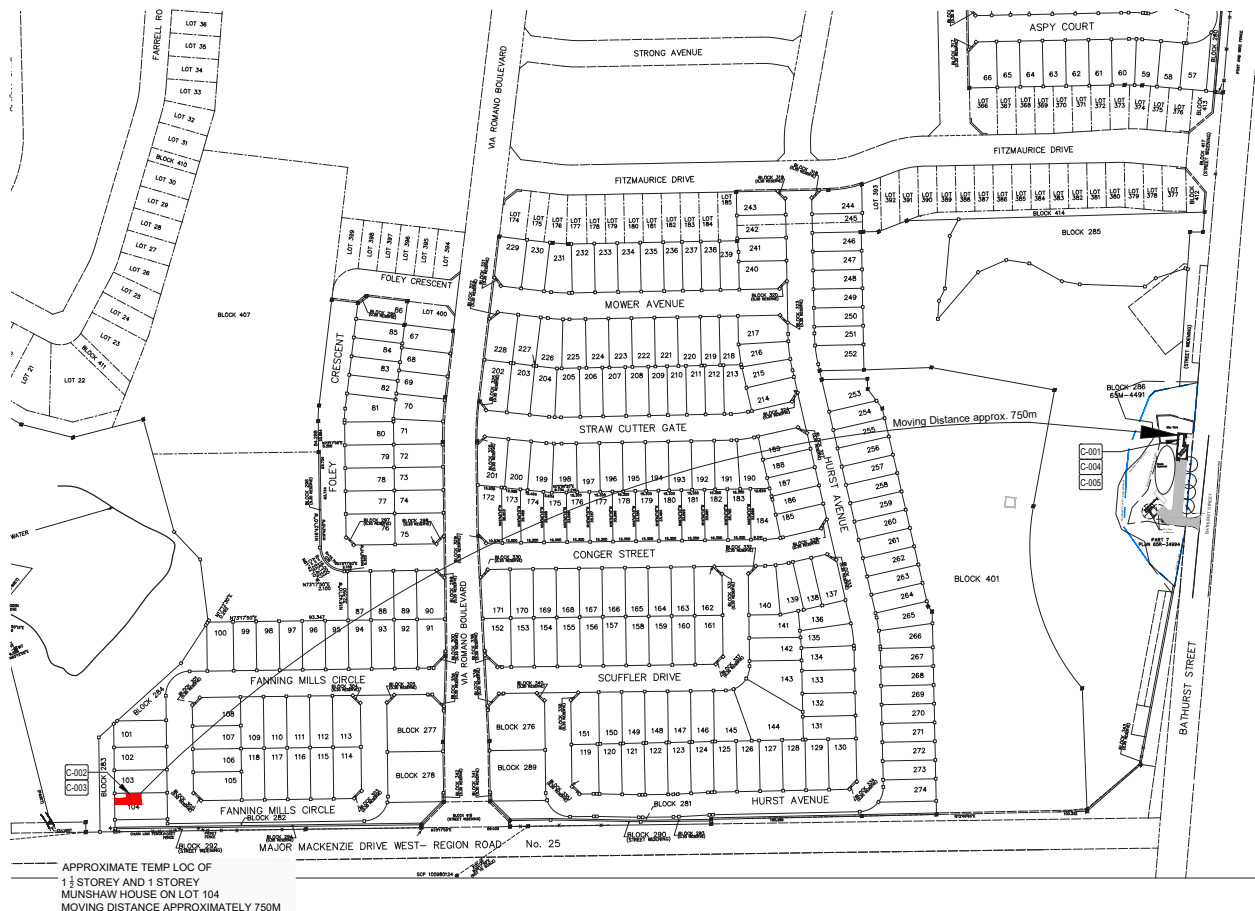
Site plan drawing (HA001) showing the relocation of Munshaw House from its current position (in red) approximately 750 metres to its proposed location at the municipal address of 10090 Bathurst Street (ERA, 2019).

This report addresses the conservation work needed to relocate and stabilize the Munshaw House in accordance with the City of Vaughan's requirements. Future exterior conservation is detailed in the "Conservation Notes" section of this document (Notes 1-000 onwards), noting that these are future works. It does not include instruction for rehabilitation of the existing one-and-a-half-storey building and one-storey rear addition of the Munshaw House, including future interior conservation and additions or alterations. A supplemental Heritage Permit will be required for future work.

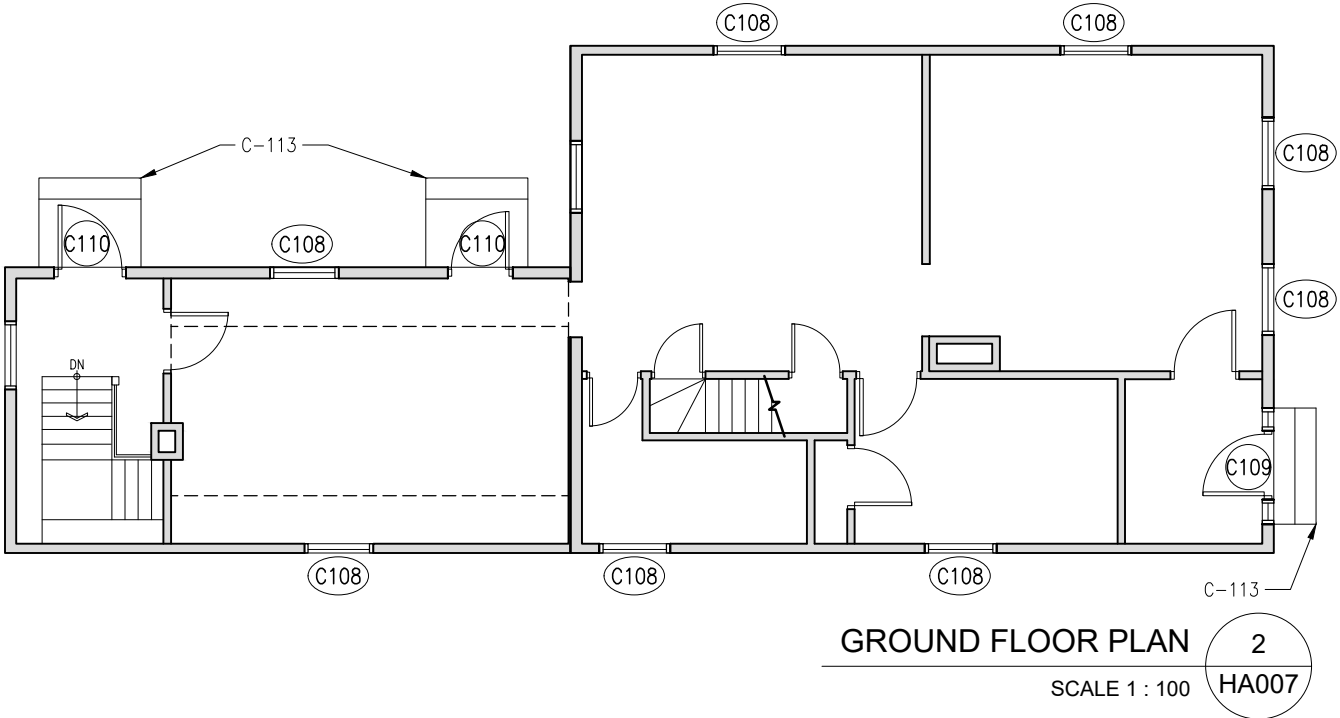
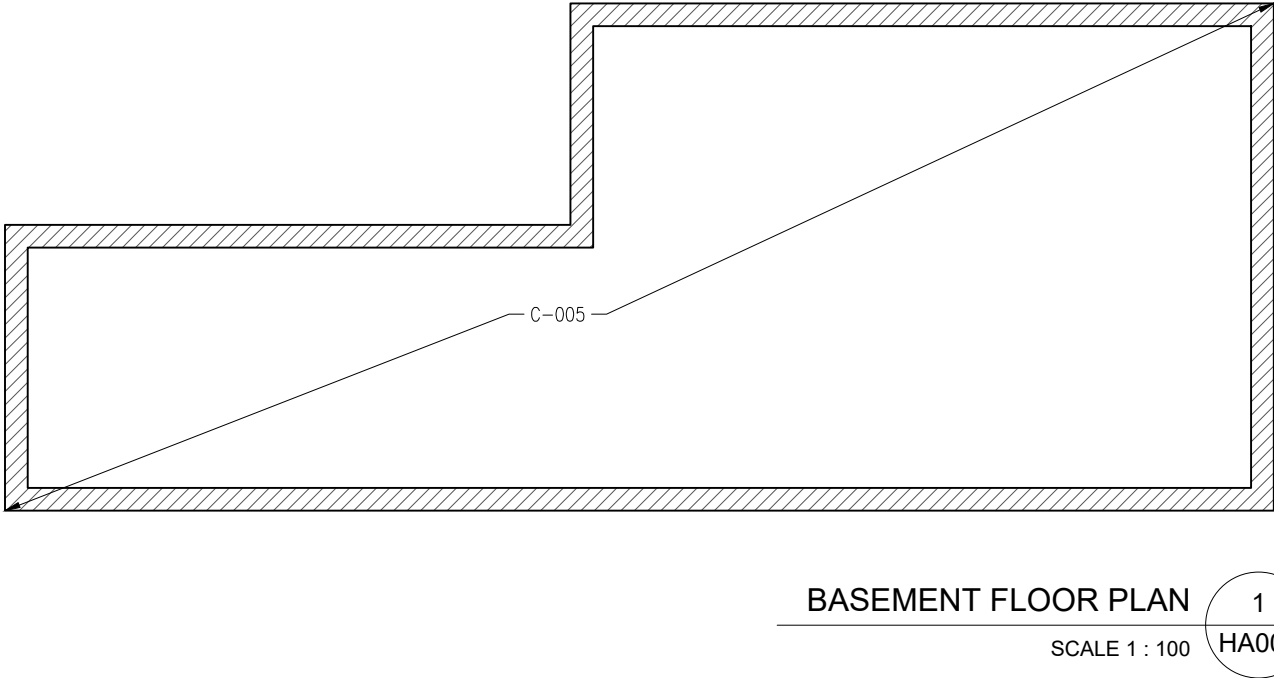
C-005: EXCAVATE AND CONSTRUCT NEW STRIP FOOTINGS AND FOUNDATION WALLS IN NEW LOCATION.
