**CITY OF VAUGHAN
HERITAGE VAUGHAN COMMITTEE
AGENDA**

Heritage Vaughan Committee Report

**TITLE: DE-LISTING APPLICATION FOR PROPERTY AT 7141 HWY.50,
VICINITY OF HWY.50 AND HWY.407**

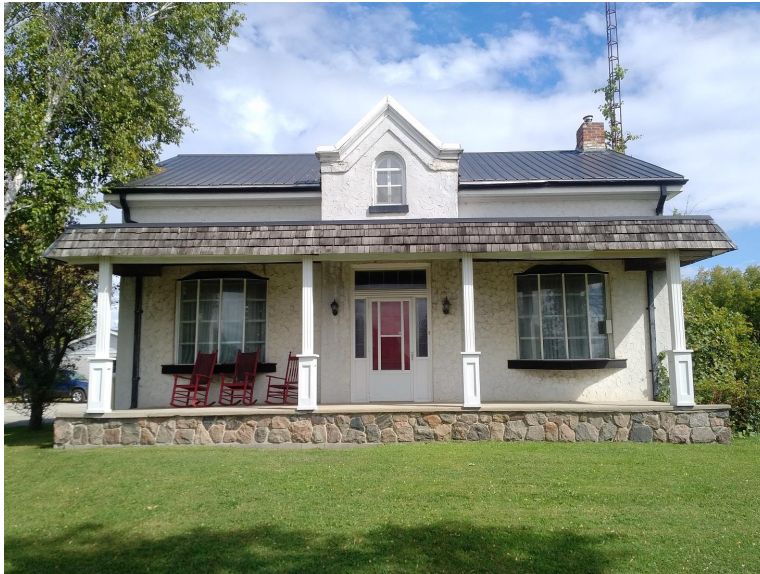
3.1.5.1.A – Existing West (Front) Elevation

The home was fully renovated in 1967-8 when the second generation of the family moved into the home. The front windows were replaced with bow windows; The rear porch was enclosed; a new kitchen was built internally; a fireplace was added in the rear addition; a front porch was (re)built in a non-original neo-classical style with wood shingles; The central dormer was rebuilt in a non-original neo-classical style; a metal roof was installed; the entire home was stuccoed,

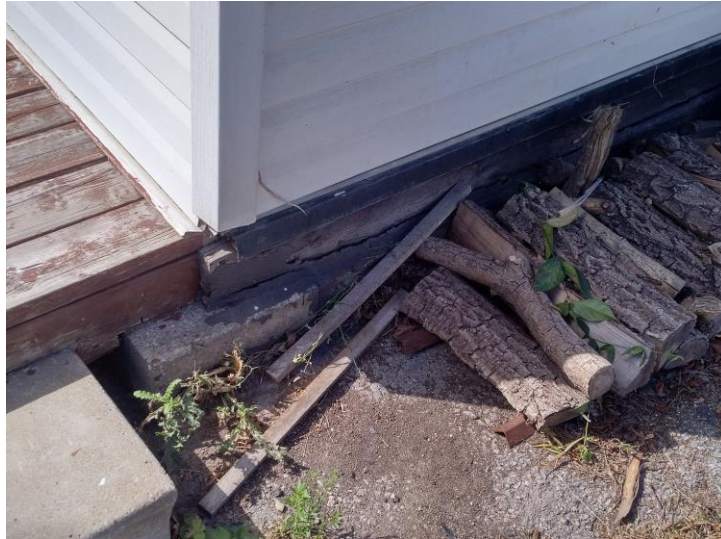
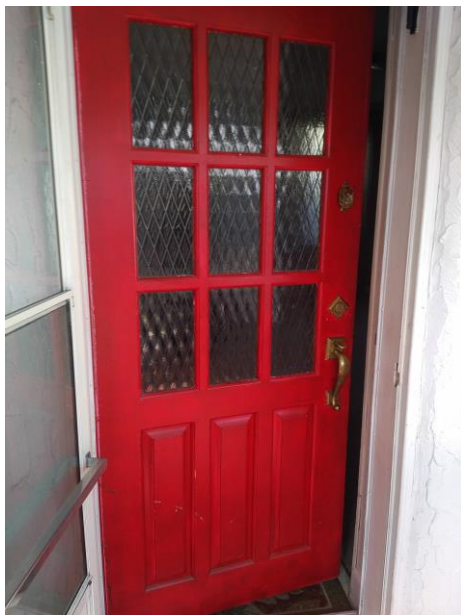
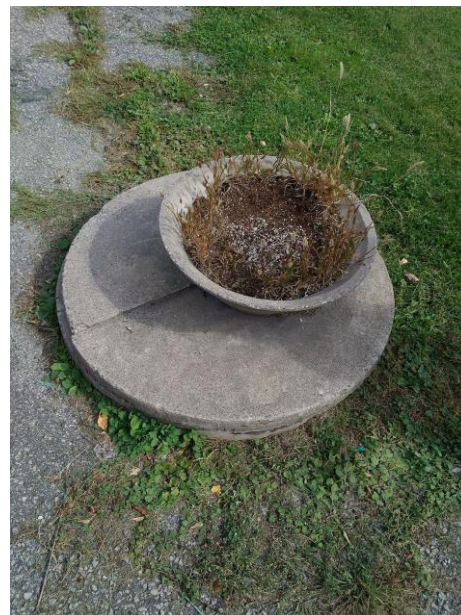
3.1.5.1.H - Exterior Details

Cladding - the original masonry has been covered with stucco	- poor
Windows – not original; replaced by wood and aluminum windows and aluminum storms; bow windows	- poor
Interiors – interior plan floor plan has been largely altered	- poor
Finishes – interior is mid-20th century materials	- poor
Stairs – mid-20 th century detailing	- poor
Flooring – non-original, mid-20 th century	- poor
Structure – original, but not compliant with local design standards	– fair
Foundation – rubble wall foundation/underpinned	- poor
Roof – non-original – metal roof installed in 1960's	- poor
Example of Heritage Architectural Ontario Farmhouse/ Gothic Revival style – neo classical styled dormer not in keeping with heritage style	- poor
Contribution to the neighbourhood character	- poor

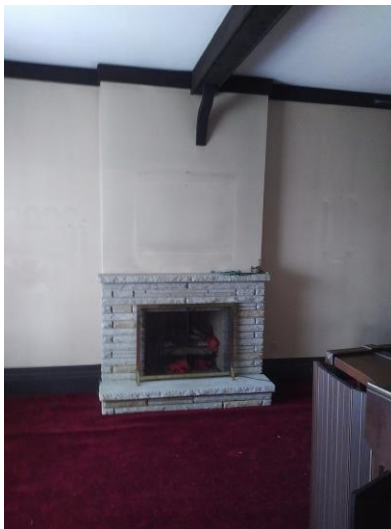
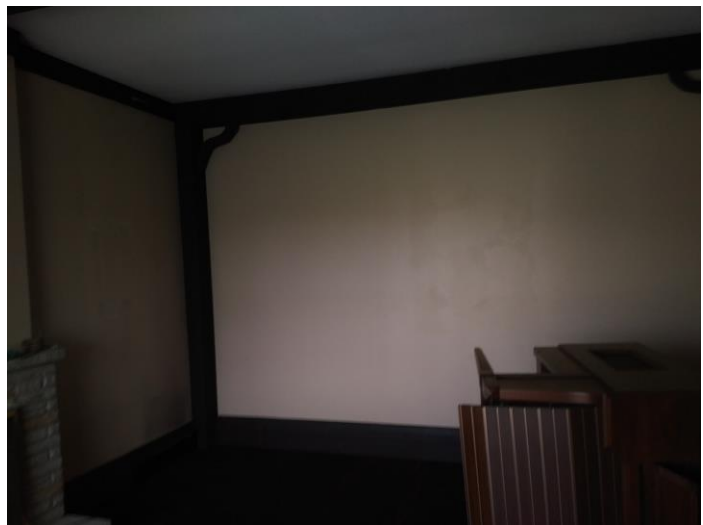
3.1.5.1.G – Original Home – Ground Floor Details

The floor plan is a 3-bay plan with a central front door and bow windows on either side. A dormer with a circle top window sits directly above the front door. A masonry fireplace with a projecting exterior masonry chimney on the south side was added at a later date which was also stuccoed over. Then northerly chimney was removed when a new furnace system was installed. The floor plan is symmetrical with a central hall and internal stair leading up to a second floor within the roof which housed 4 small bedrooms.

The interior floor plan of the overall building has been largely altered due to the major renovation in the 1960's. The kitchen has been re-located to the front part of the home; a study has been subdivided out of the parlour room.

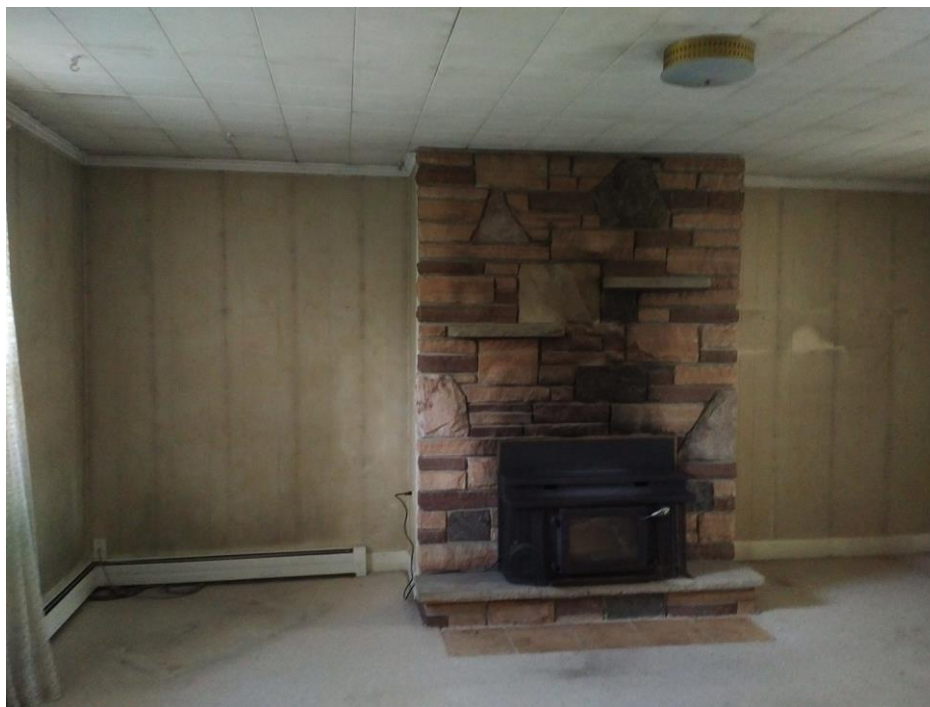
3.1.5.1.H – Addition – Ground Floor Details

The addition – typically a country kitchen - consists of a large family room with a powder room and an added fireplace. Upstairs, a washroom was added.

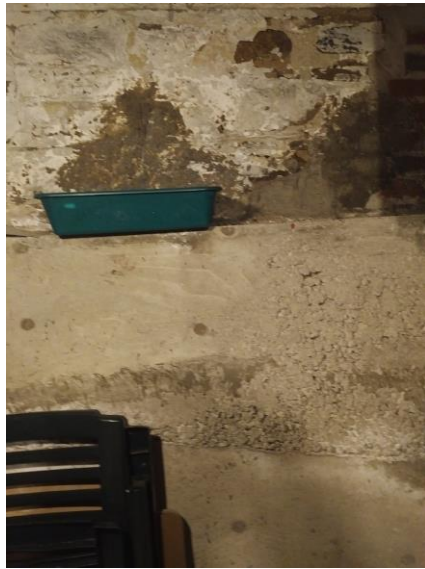
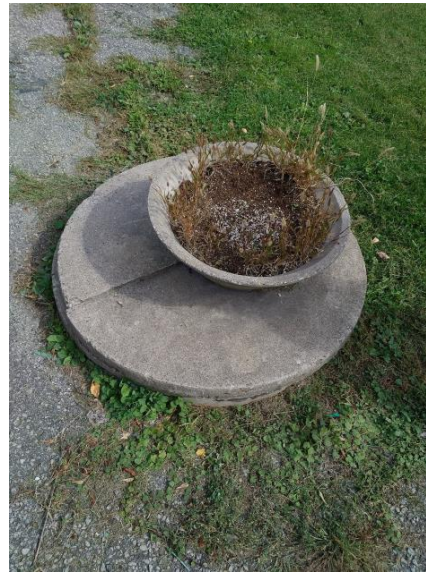
3.1.5.1.K – Basement

The house is on well water and septic bed. The heating system is oil and hot water radiators.

A rubble foundation wall, partially parged, underpinned with concrete
A 2 x 4 wood frame stud walls with veneer masonry stuccoed over
a combination of painted plaster and lath on the interior,
(It was not possible to confirm the existence of any insulation in the walls.)
Floors of 2 x 8 cedar floor joists and 1" T & G wood sheathing,

The cellar area has a simple stair leading to it from under the main stairs. It is unfinished, and of rubble wall construction. The basement has also been lowered as shown by the concrete foundation wall extension/underpinning. It houses electrical service and heating equipment. The ceiling height is approximately 7'-0" clear.

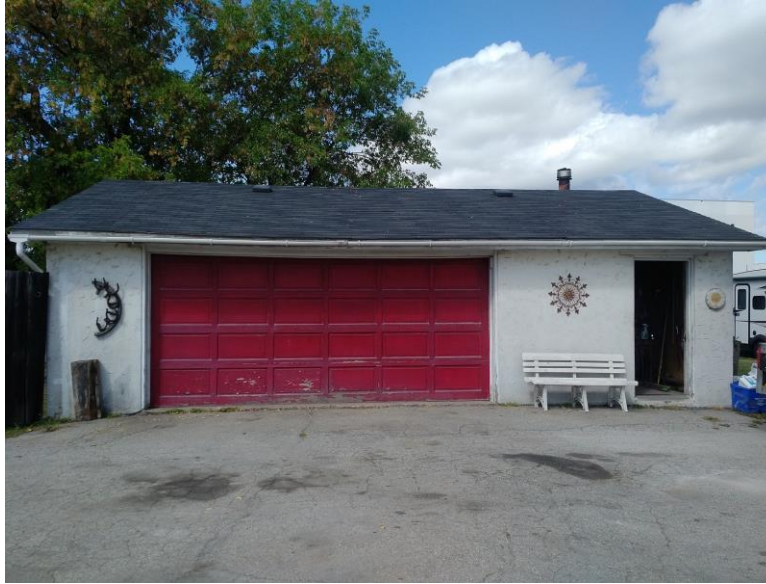
3.1.5.2.A – Garage/Accessory Building – Existing South (Front) Elevation

A review of aerial photography over the past 60 years reveals a variety of smaller out buildings on the site. A small barn was demolished in the 1940's. A garage was predominant in the northern rear yard. All the outbuildings have been demolished over time. The current garage was built in the mid 1960's when the house was renovated. It is constructed of stuccoed concrete block walls and wood frame roof structure.

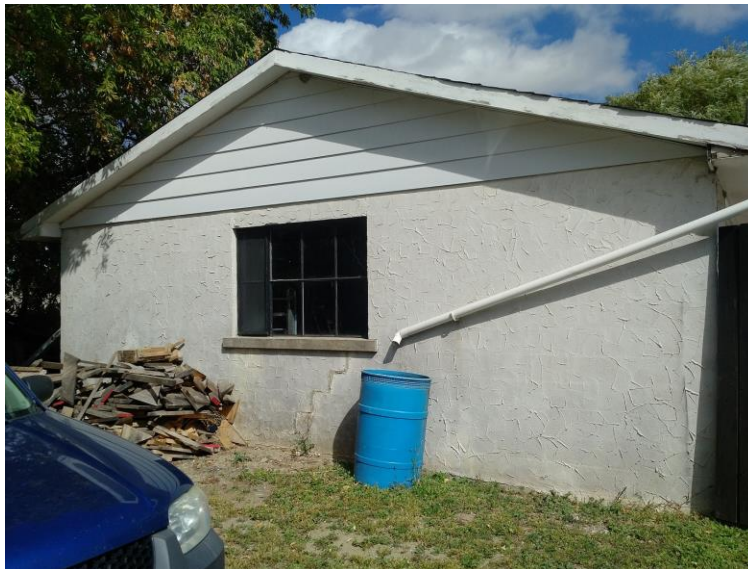
3.1.5.2.B – Garage/Accessory Building – Existing West (Left) Elevation

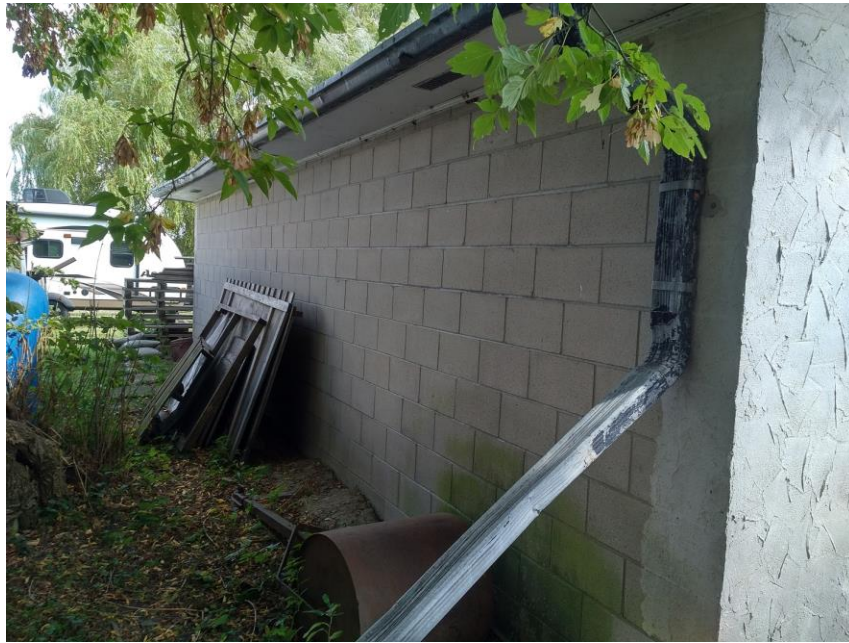
3.1.5.2.C – Accessory Building – Existing North (Rear) Elevation

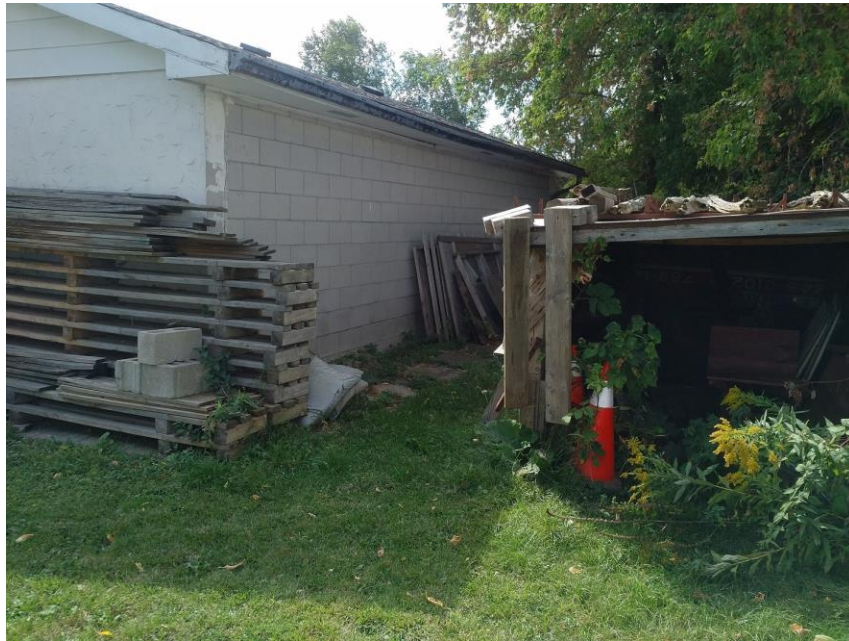
3.1.5.2.D – Accessory Building – Existing North (Rear) Elevation

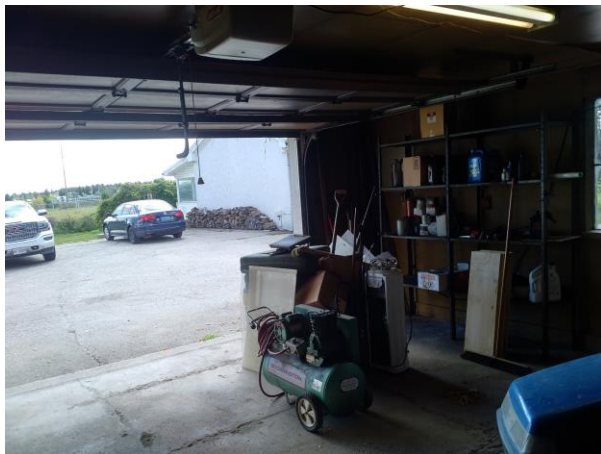
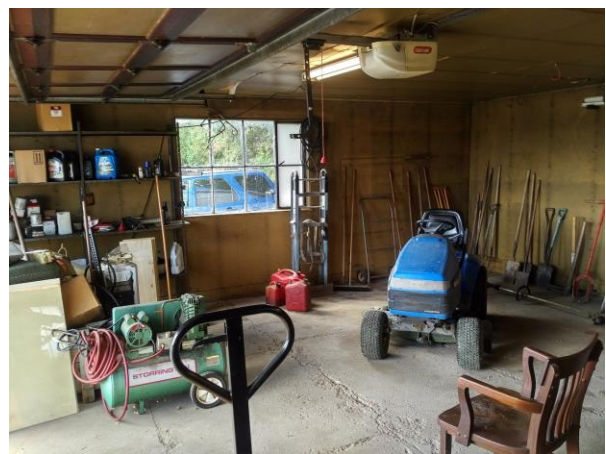
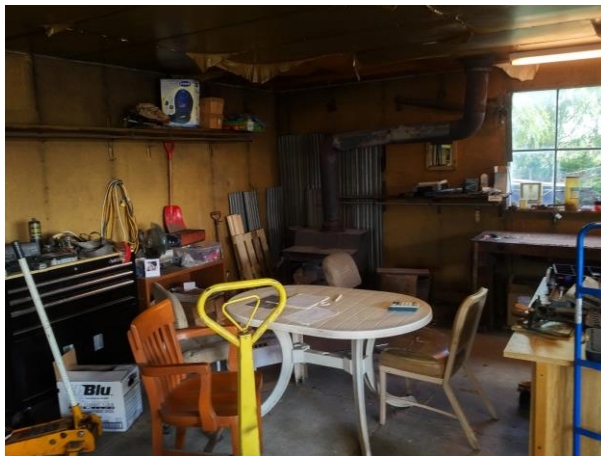
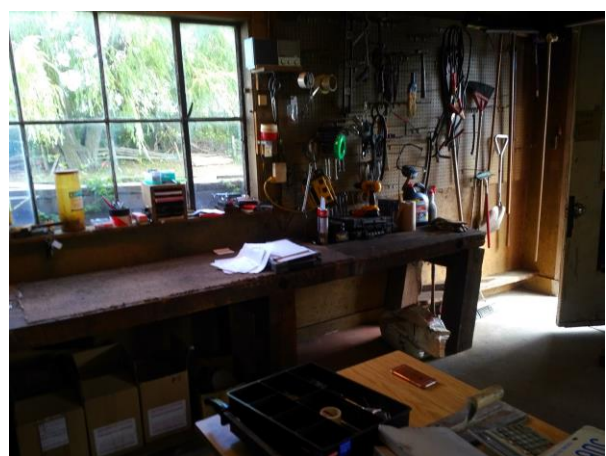
3.1.5.2.F – Accessory Building – Interior

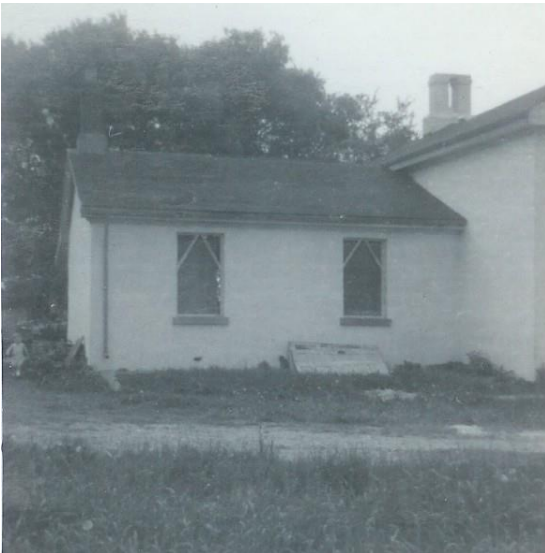
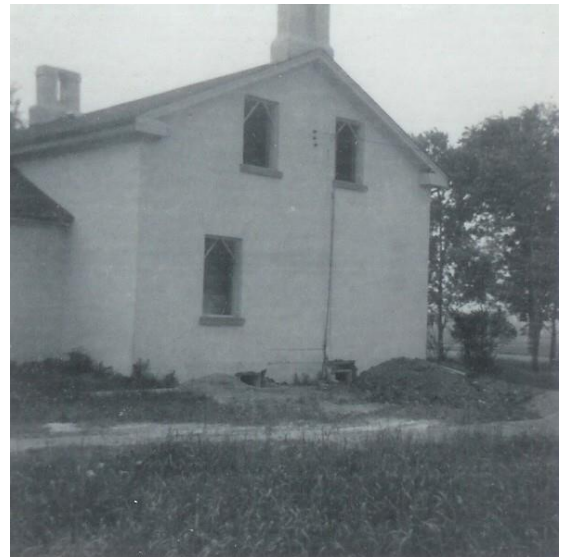
3.2.2.E. Renovation of the House 1967/8

- The basement was dug out
- Foundation walls were reinforced with concrete
- The second floor was gutted to the bare walls
- New plumbing was installed
- One fireplace was removed for a new furnace's chimney
- New doors and windows
- Wall in kitchen and dining room removed
- A wall installed in living room to create office
- A new verandah was built on the back of the house
- A new chimney, fireplace and powder room was built in the family room
- A new front porch was added at the front.

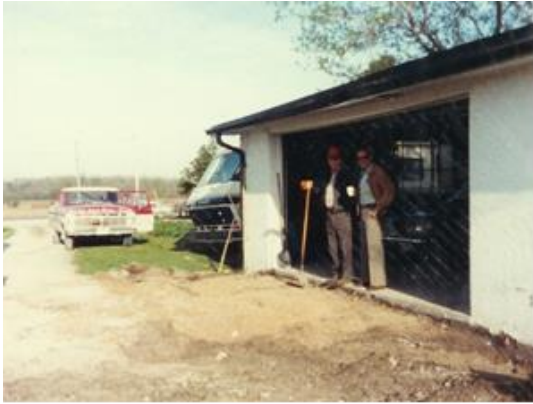
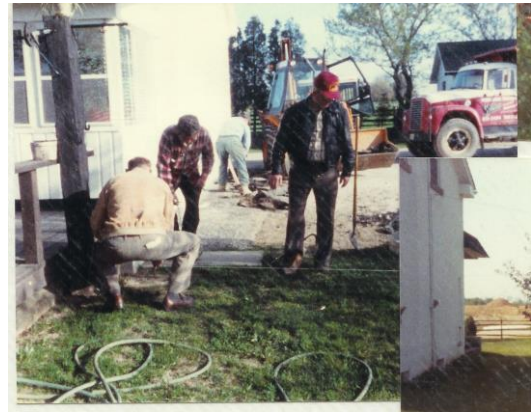
3.2.2.F. Construction of garage 1967/8

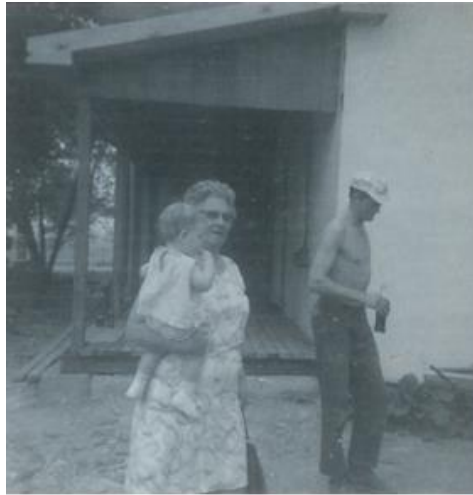
3.2.2. G. Enclosing the porch

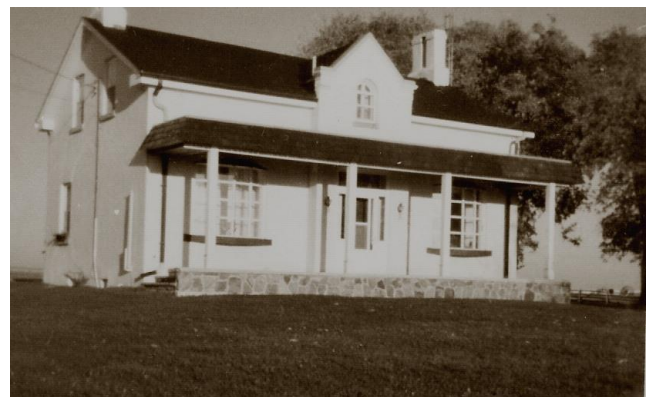
3.2.2.I. Finished House 1968

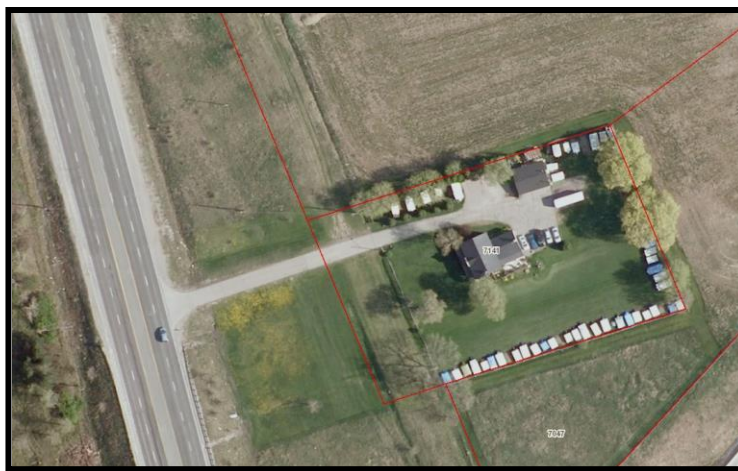
3.2.3.N. Mapping, Region of York, Aerial Photograph, 2007 – Enlargement

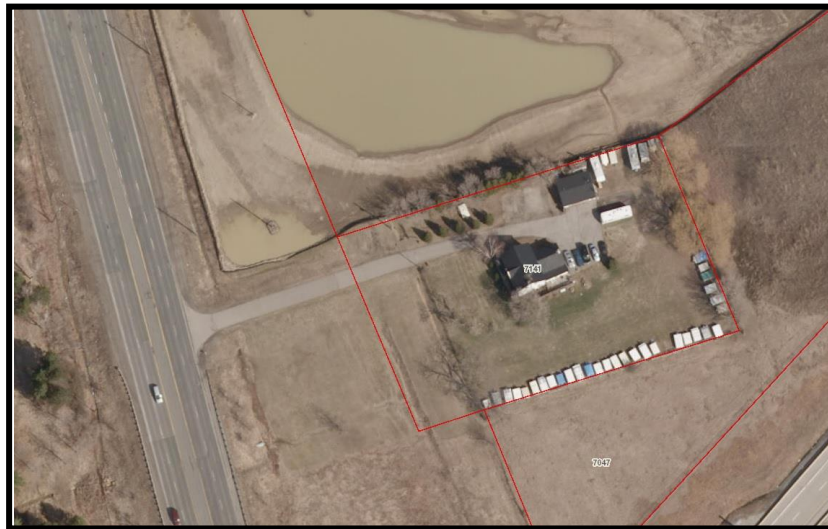
3.2.3.P. Mapping, Region of York, Aerial Photograph, 2009 – Enlargement

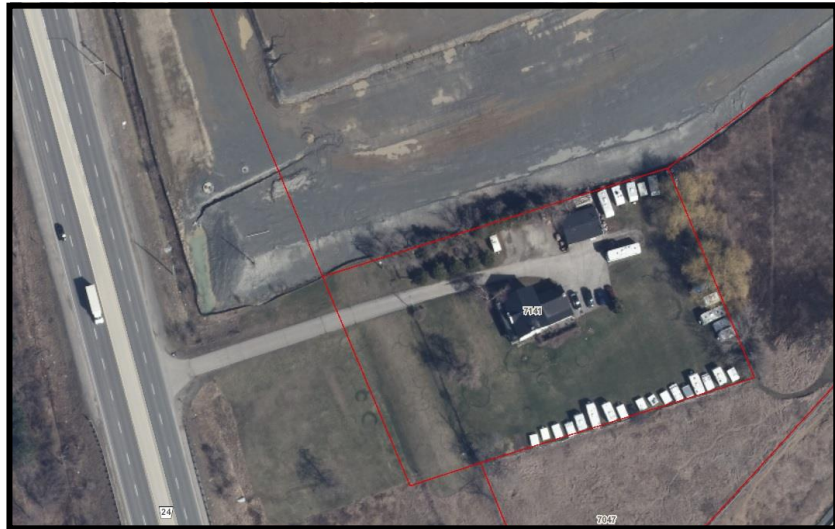
3.2.3.R. Mapping, Region of York, Aerial Photograph, 2016 – Enlargement

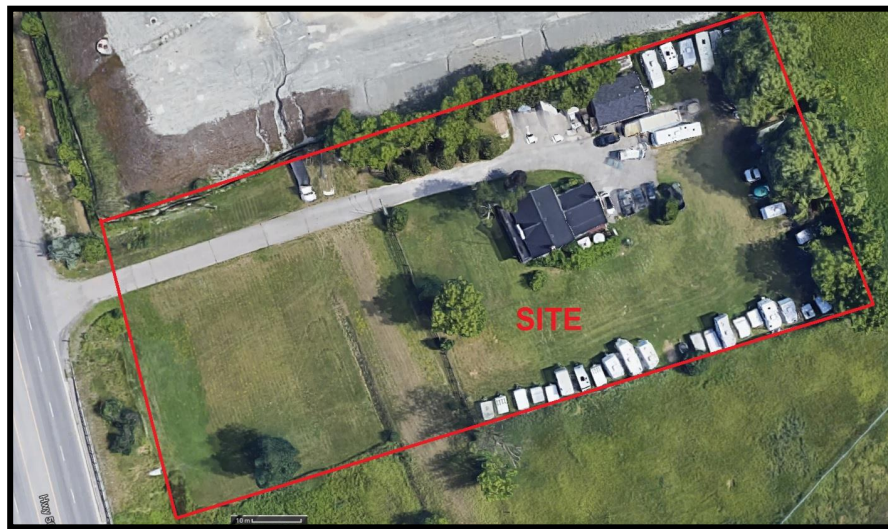
3.2.3.T. Mapping, Google Earth, Aerial Photograph, 2019 – Enlargement

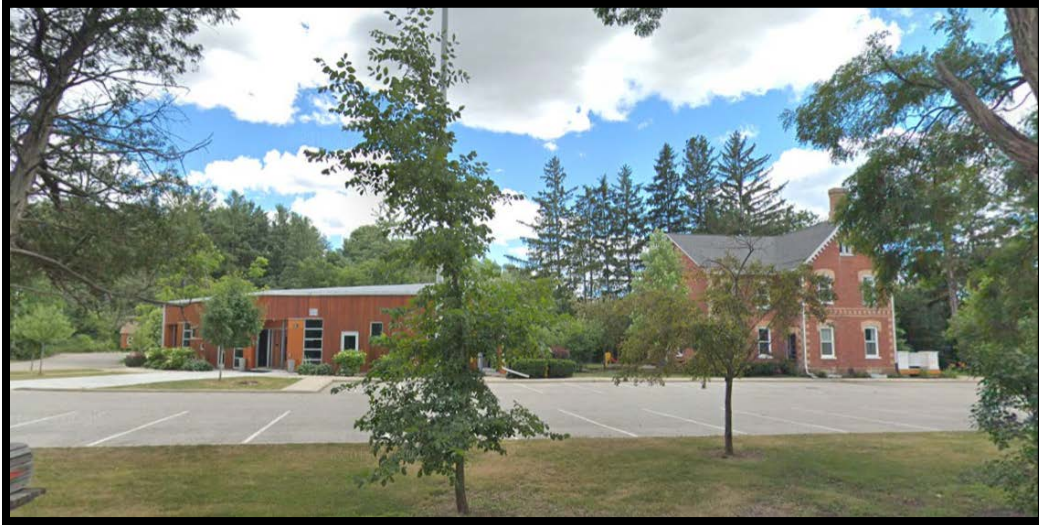
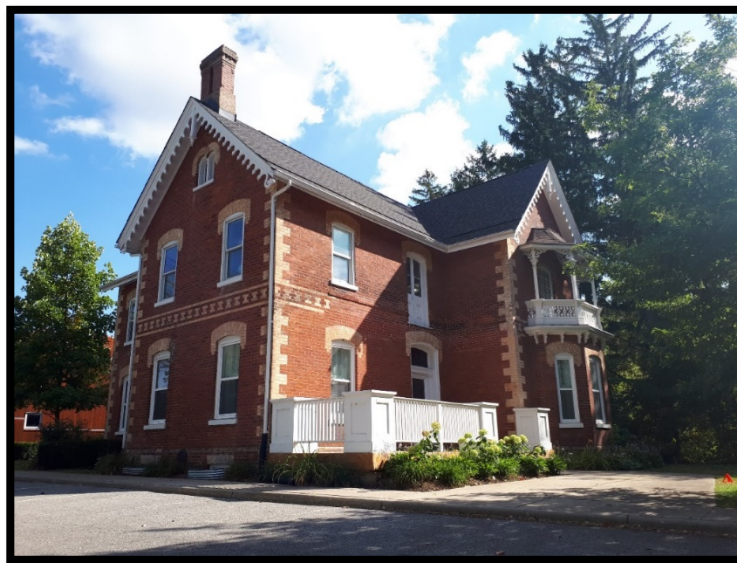
*Figures 4 & 5: (Above) View of heritage house and Rock Community Church looking southwards on Mounsey Street;
(Below) Perspective view of heritage house (MHBC, 2019))*

The property consists of a 2.5 storey, Gothic Revival house built between 1850 and 1875 as described in the *Woodbridge Heritage Conservation District Study and Plan* (2009) (p 55-57). A more detailed analysis of the heritage building's architectural features is discussed in Section 4.2 of this report. The property also includes a contemporary building that facilitates the Rock Community Church. This building is to the rear of the heritage house.

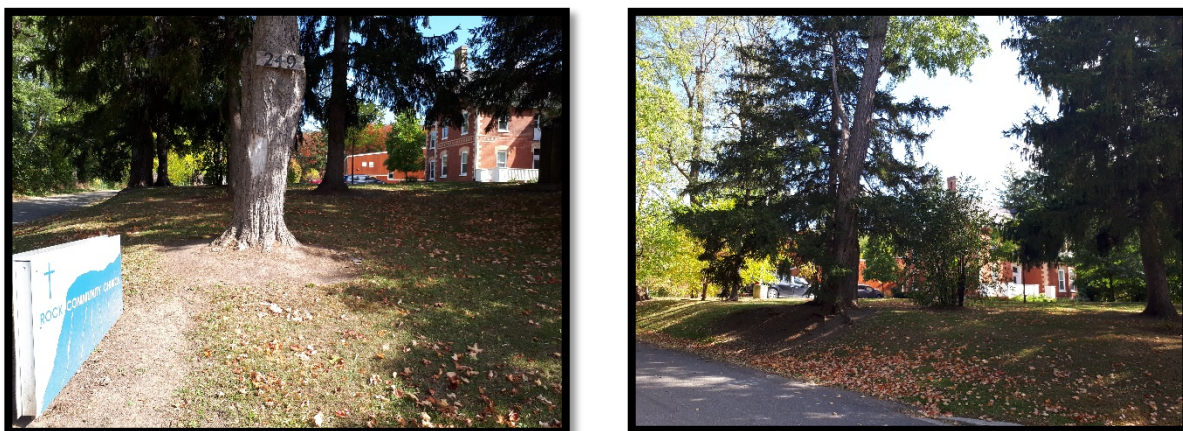
Figures 11 & 12: (Left) View of the heritage house from east side of Clarence Street; (Right) View of heritage house from north side of Mounsey Street (MHBC, 2019)

The views of the heritage house are sporadic along the Clarence Streetscape due to the obstruction made by mature vegetation as well as the topographical elevation. Figure 11 demonstrates the pedestrian view of the house from Clarence Street while Figure 12 demonstrates the kinetic (pedestrian and vehicular) view of the heritage house along Mounsey Street (a rendering of this view is included in Appendix B of this report).

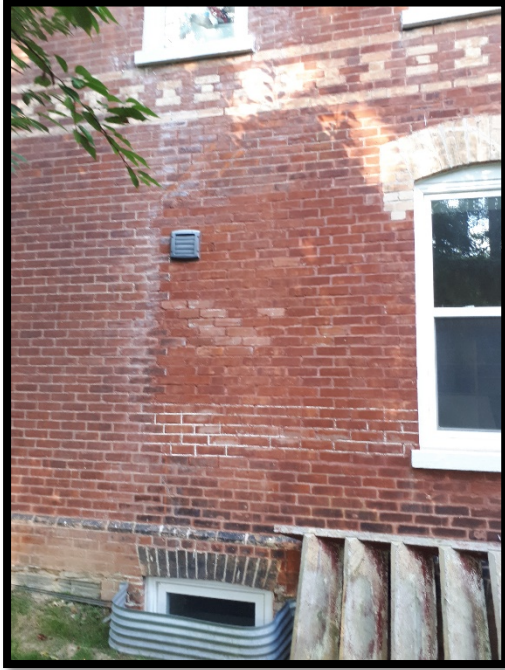
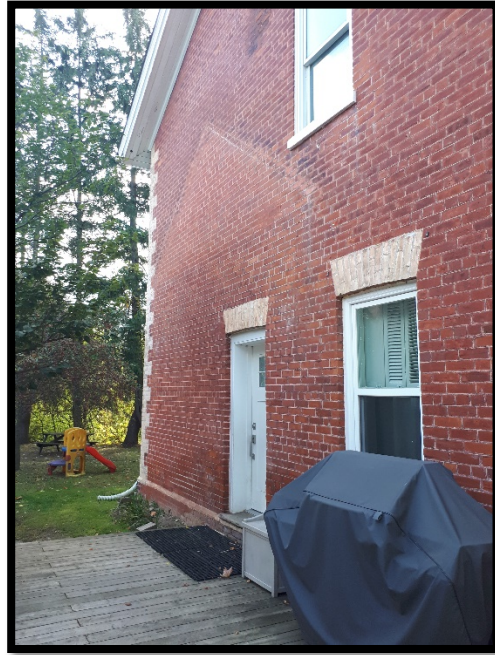
Figures 13 & 14: (Left) View of markings of former addition on the south elevation (Right) Markings on east elevation from former addition (MHBC, 2019)

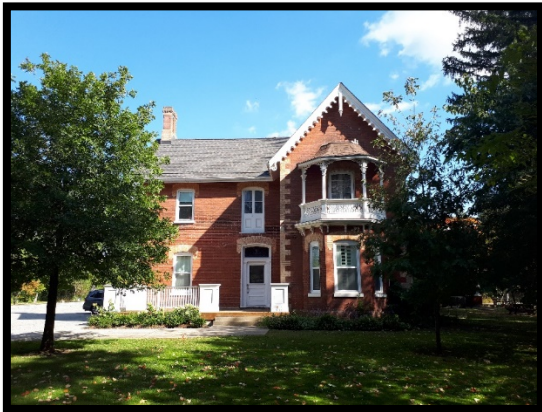
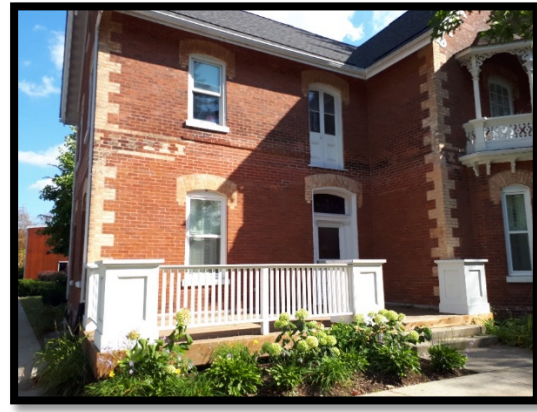
The second bay includes a bay window (3 window openings) and wooden decorative brackets and corncicing that support the balcony above. The balcony is embellished with various woodwork design and includes one door opening. The balcony is composed of four bases with capitals which support four columns with decorative brackets. The open gabled roof includes decorative wooden trim moulding and lower half of a finial. There is alternating brick detailing in the form of yellow brick quoins and a portion of yellow brick ribbons with 'X' detailing. The current porch is a basic construction of large capitals with basic spandrel handrails.

Figures 15 & 16: (Left) View of front façade including bay window and balcony;(Right) Close view of reconstructed porch on front façade; (MHBC, 2019)

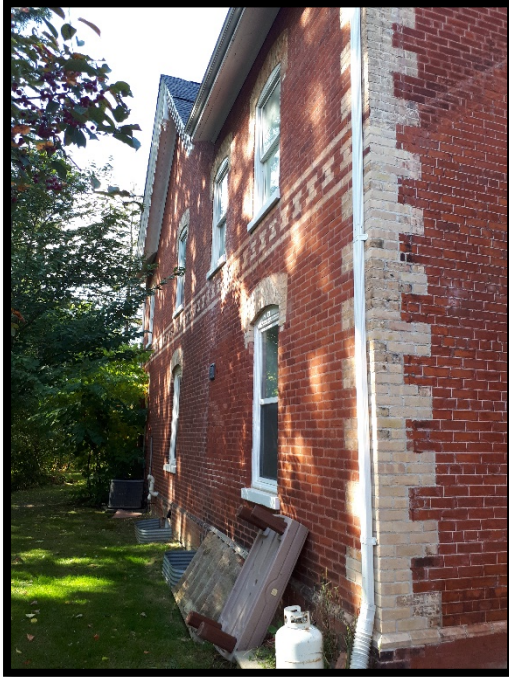
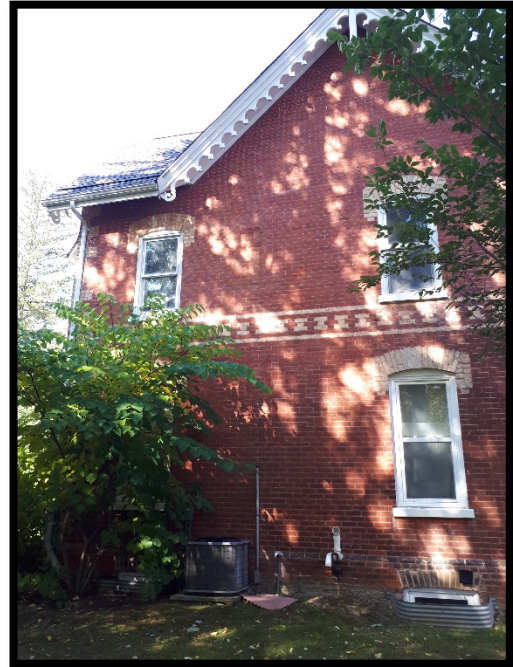
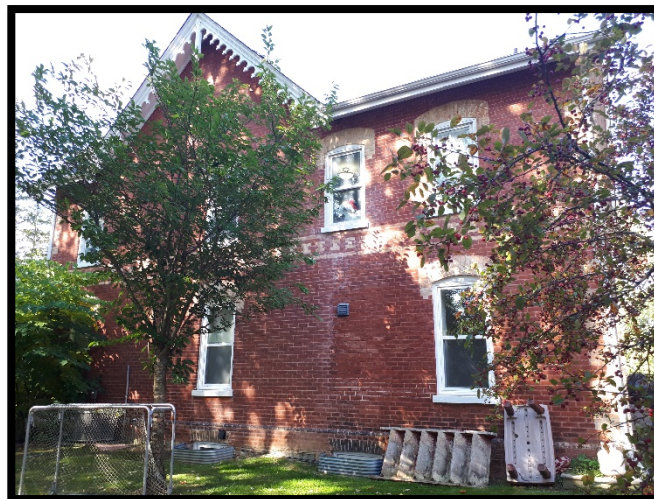
The south elevation consists of an open gable roof with similar decorative trim mouldings as the front façade as well as finial. A yellow brick ribbon course divides the first and second storey levels. Yellow brick headers are above each window. Windows have been replaced with contemporary, single, double hung windows. Either side of the façade is adorned with a yellow brick quoin. There are three (3) window sills at the basement level, three (3) window openings on the first storey and four (4) window opening on the second storey level. The window sill openings include brick headers. Part of the brick foundation sill is apparent on this elevation.

Figures 17, 18: & 19 (Left) View of south elevation from the south-east corner of the house; (Right) View of the left side of the south elevation including gabled roof detail; (Below) View of entirety of south elevation from south yard (MHBC, 2019)

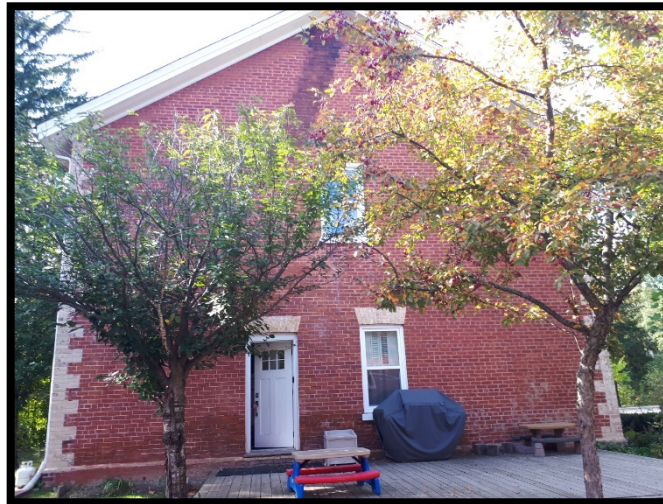
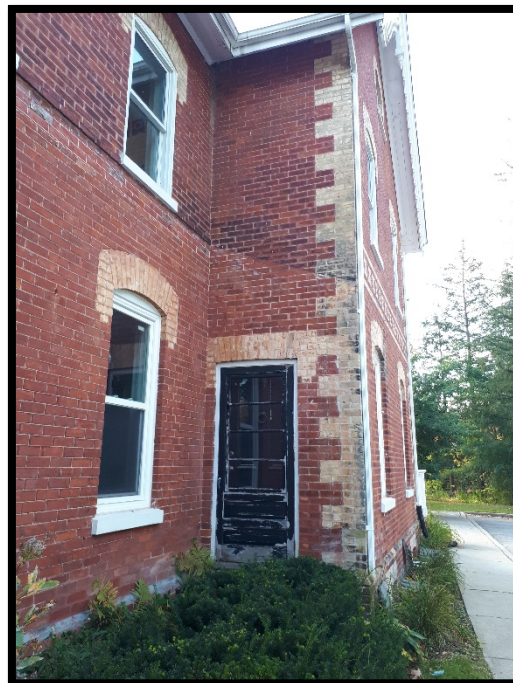
The east elevation includes one door opening and one window opening on the first storey level and one window on the second storey level. Both windows have been replaced with contemporary, single, double-hung windows and the original door has also replaced. The window and door opening have vertical brick headings which are less elaborate than those on the other three elevations. Both sides of the façade are adorned with yellow brick quoins. The low-rise gabled roof is simplistic in design including plain soffits and corncicing which contrasts with the detailing of the gables on all other elevations. There is also a door opening as part of the east elevation between the main house and rear portion which includes an arched, yellow brick header.

Figure 20 & 21: (Above) View of east elevation from Rock Community Church west elevation; (Below) Door opening on east elevation (MHBC, 2019)

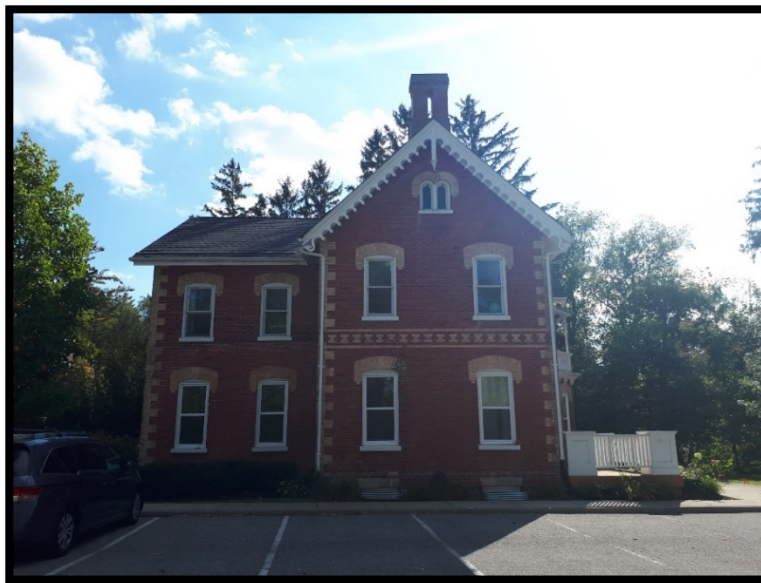
Figure 22: View of north elevation from parking lot to the north of the property.

The north elevation consists of two bays. The bay closest to the front façade includes two window openings with arched yellow brick headers divided from the second storey by a yellow brick ribbon course with 'X' brick motifs. The second storey includes two window openings with yellow brick headers. The upper half storey includes a paired arched window with yellow arched headers. Either side of the bay includes a yellow brick quoin. The open gabled roof includes decorative trim moulding. The stone chimney can be viewed along this elevation. The second bay to the rear of the building includes two window openings on the first floor and two window openings on the second floor; all have arched, yellow brick headers. There is a yellow brick quoin to the left of this bay. This elevation shows the contrast between the medium pitched gabled roof of the main portion of the house versus the low pitched gable at the rear.

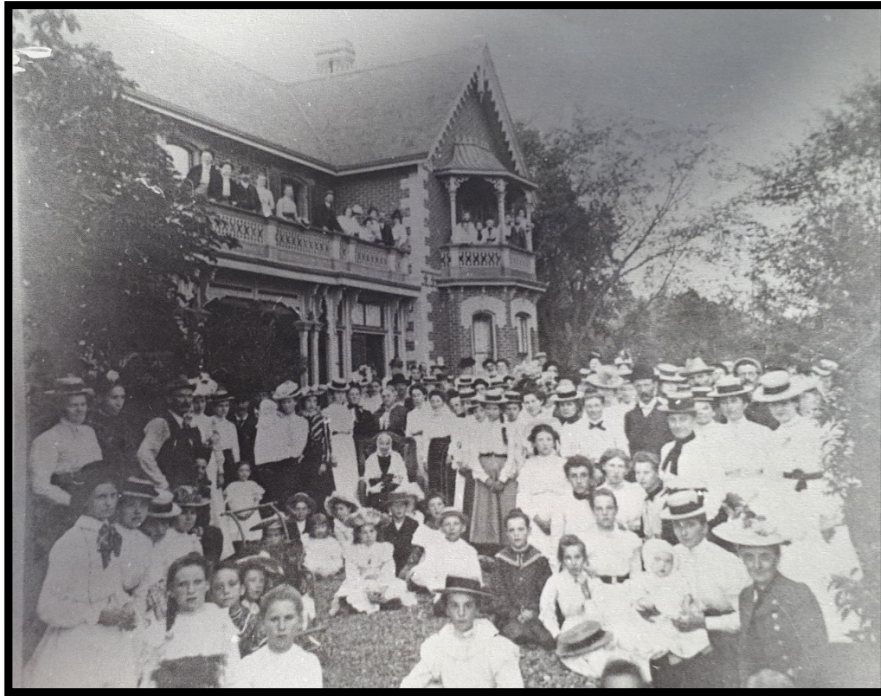
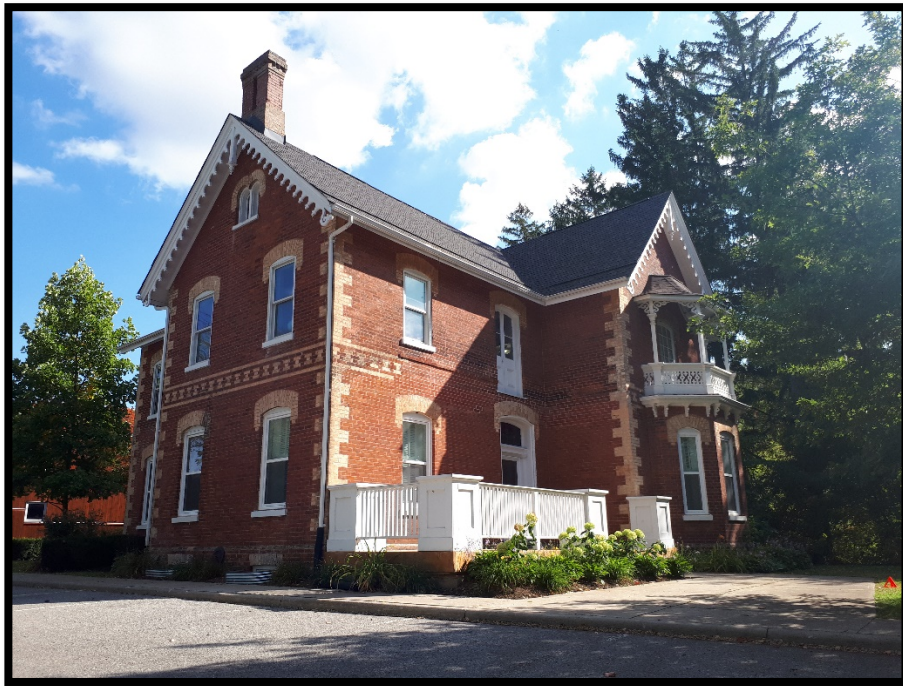
Figures 26: & 27: (Above) Photograph of the house at 249 Clarence Street, "Wallace Farm Home" from Wood's Pictorial Woodbridge c. 1915 (Below) Perspective view of heritage home from parking lot (MHBC, 2019).

The Wallace Family had considerable amount of influence on the local community. The house stayed in the Wallace Family for several years. The photograph in Figure 26, demonstrates the original aesthetic appearance of the house in the early 20th century including the front verandah with upper balcony which has since been removed (see Figure 27).

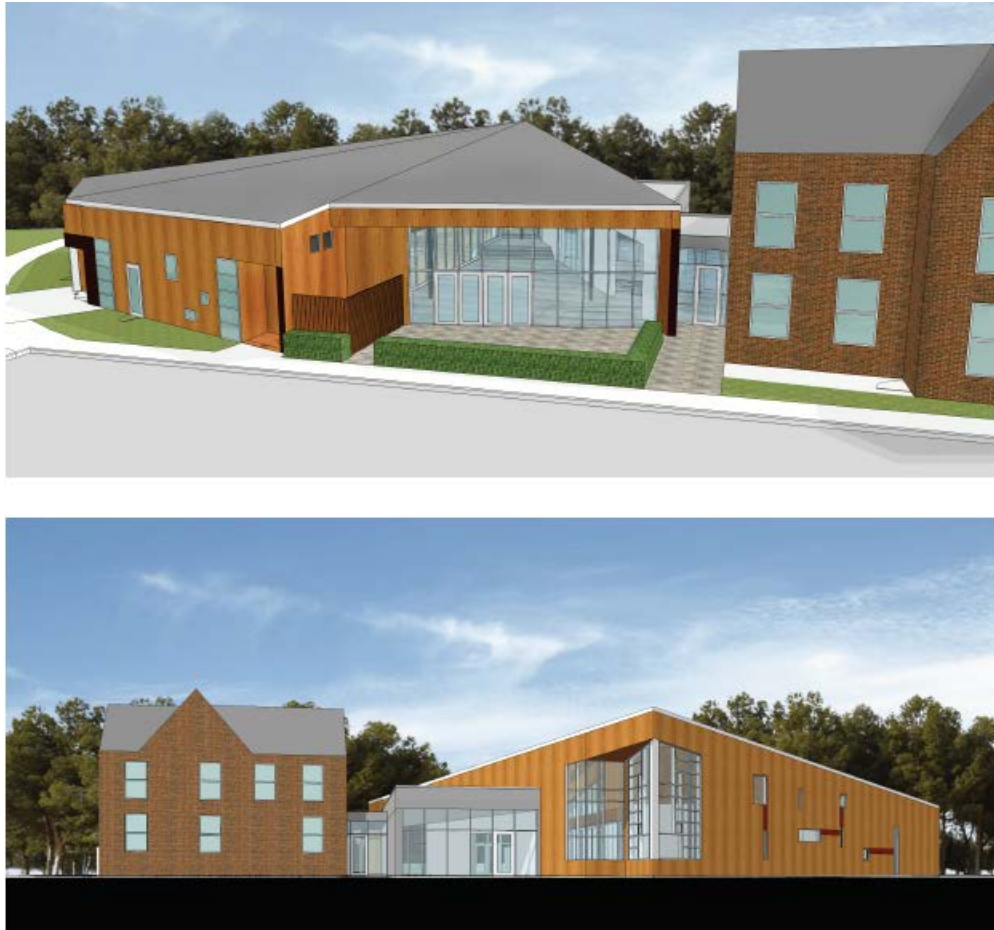
The proposed development consists of a combination of materials including Cedar panelling and glass. The vestibule is primarily glazing to allow for a subtle transition to the heritage building.

Figures 32 & 33: (Above) Rendering of proposed development looking south-east; (Below) Rendering of the proposed development looking north (C.Y. Lee Architect Inc., 2019)

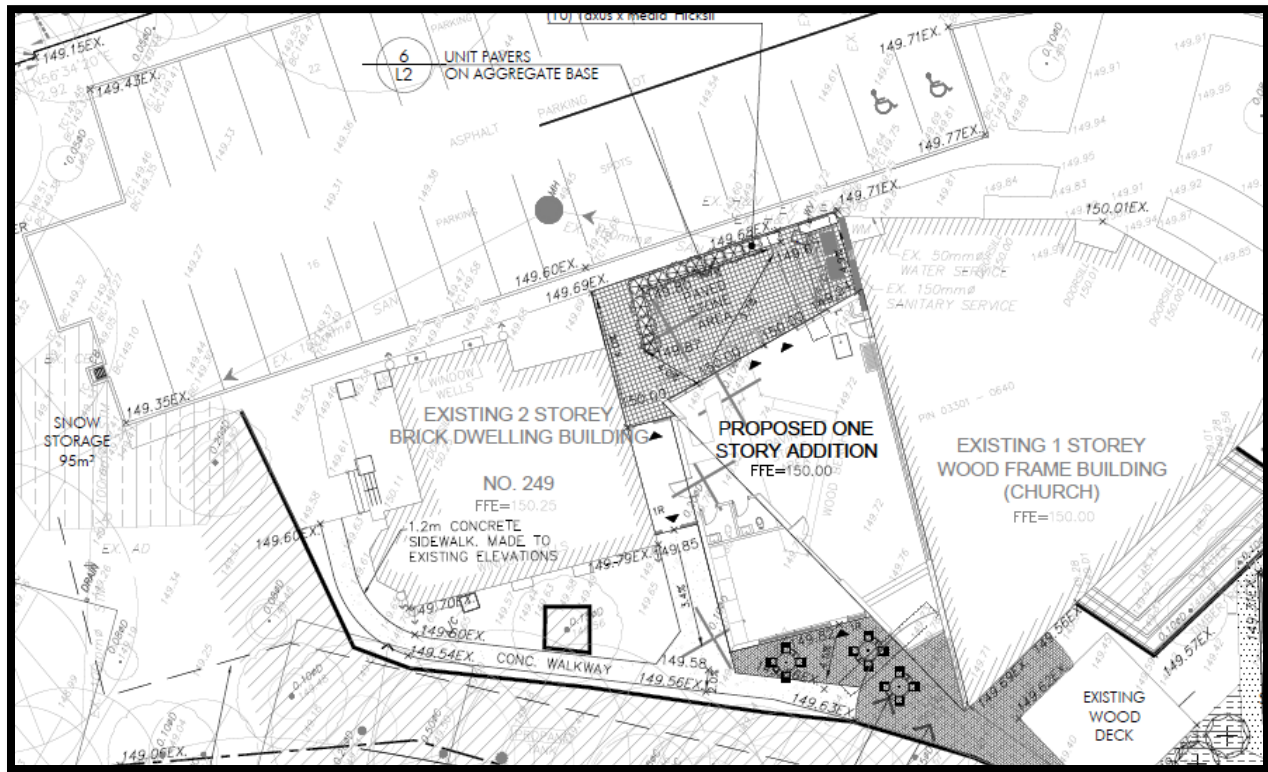
The existing vegetation between the current church building and heritage house will be removed and will be replaced with a walkway to the vestibule. The proposed landscaping for the new addition and associated vestibule includes a courtyard which will delineate the church from the adjacent heritage building. There will also be tables on unit pavers to the rear (south elevation) of the proposed one storey addition. Current landscape to the front and side yards of the heritage house will remain as is.

Figure 34: Proposed landscape plan (C.Y. Lee Architect Inc., 2019)

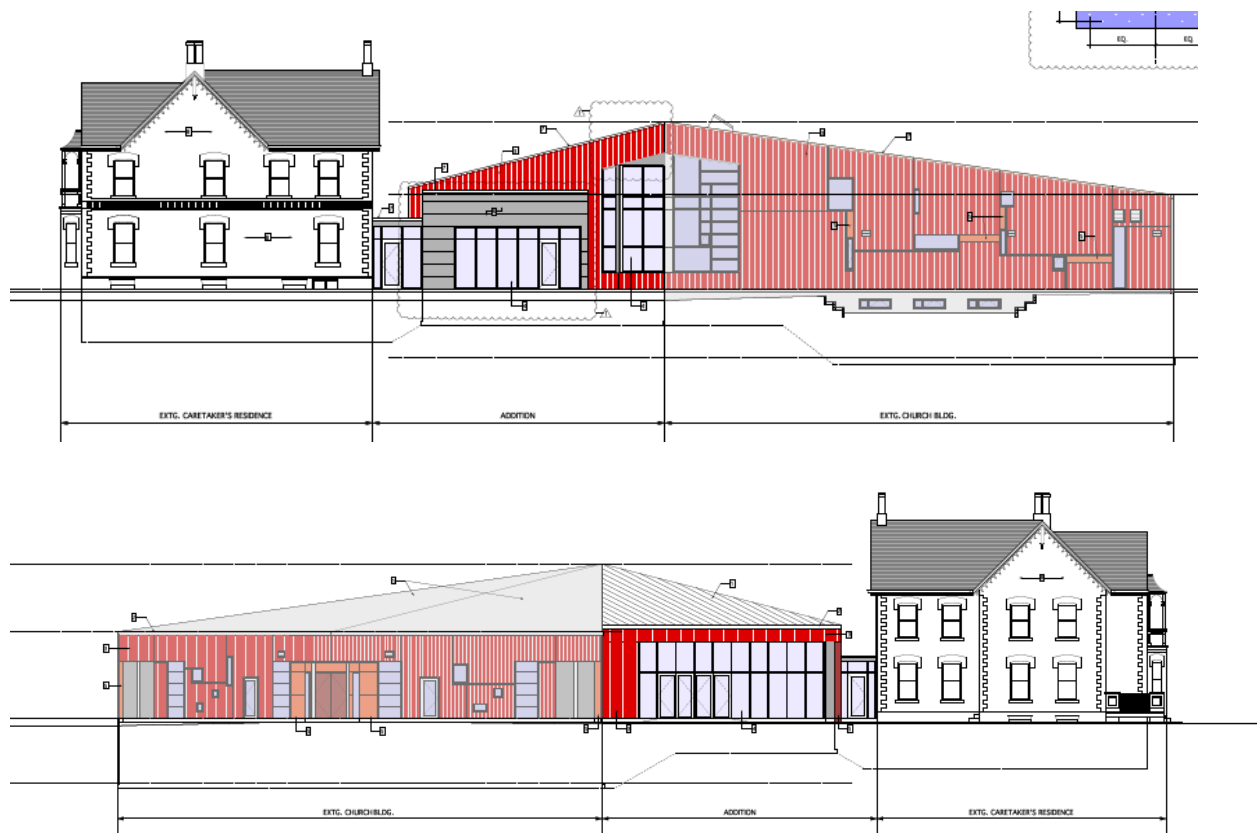
Figure 35 & 36: (Above) Architectural drawing of the south elevation of Rock Community Church (proposed development in deeper red colour) in relation to the heritage building; (Below) Architectural drawing of the north elevation of the Rock Community Church (proposed development in deeper red colour) in relation to the heritage building (C.Y. Lee Architect Inc, 2019)

The architectural elevations of the proposed development demonstrate that while, the new construction is abutting the heritage house, it is lower in height and subordinate to the building (see Figures 35 & 36). Furthermore, due to its linkage at the rear of the building, the new construction does not impact the overall presence of the building from the Clarence Street streetscape.

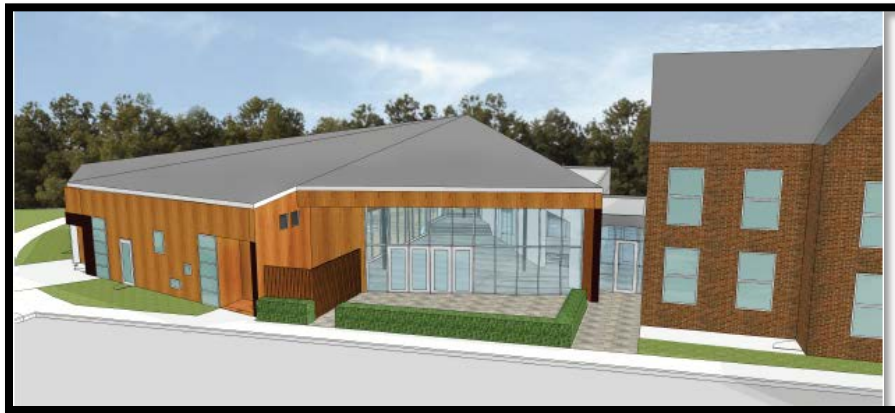
Figure 37: Rendering of addition and vestibule looking south-east (C.Y. Lee Architect Inc., 2019)

The proposed development is of a “Contemporary Design”; the new Fellowship Hall addition includes the use of Cedar siding and aluminium and glass window curtain wall with a galvanized standing seam metal roof. The proposed glass vestibule is contemporary but “fits” into the character of the context and does not attempt to inappropriately borrow historical details Sub-section 6.3.2. of the HCD Study and Plan, 2009).

The vestibule is one storey and is subordinate and distinguishable from the heritage building. The proposed vestibule is primarily composed of glazing, however, it is not in the view of the public realm and the glazing allows for building elements of the north elevation to be visible (i.e. door brick header). The vestibule is of a smaller scale and mass than both the church and heritage building and includes simplistic details so as to not detract from the heritage building as being a point of focal interest.
