**CITY OF VAUGHAN
HERITAGE VAUGHAN COMMITTEE
AGENDA**

Heritage Vaughan Committee Report

**TITLE: DE-LISTING APPLICATION FOR PROPERTY AT 7141 HWY.50,
VICINITY OF HWY.50 AND HWY.407**

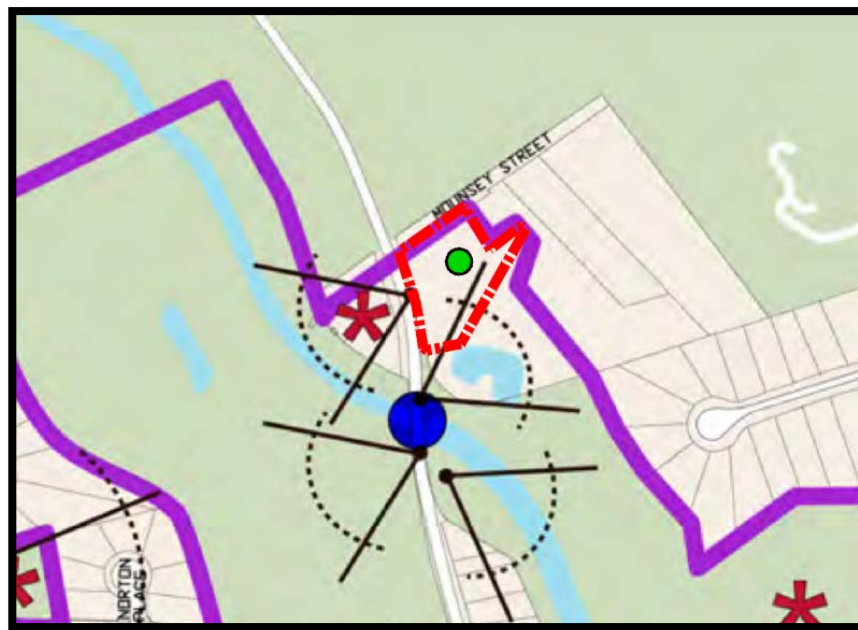
Figure 38: Excerpt of Schedule 19 of the Woodbridge HCD Study and Plan (2009); red dotted line indicates the location of the subject land; Green dot indicates approximate location of heritage house (MHBC, 2019)

Appendix 'A' of this report shows an overlay of Schedule 19 of the HCD Study and Plan (2009) on the subject land exhibited in Figure 38 to identify the subject property in relation to identified views, landmarks and bridges in the HCD. The property adjacent (non-contiguous) to the west of the subject property is identified as special landmark, open space. The Humber River Bridge is also within close proximity of the subject property.

There is an identified view from the Humber River Bridge that included a portion of the subject property, however, the house is exempted from this view. There is also a view identified *from* the front property line of the subject property along Clarence Street and is within close distance of the house on-site, however, the intent is to view the adjacent special landmark open space identified along the south side of Claddamour Place (see Appendix A from a map overlay of views in relation to subject land).

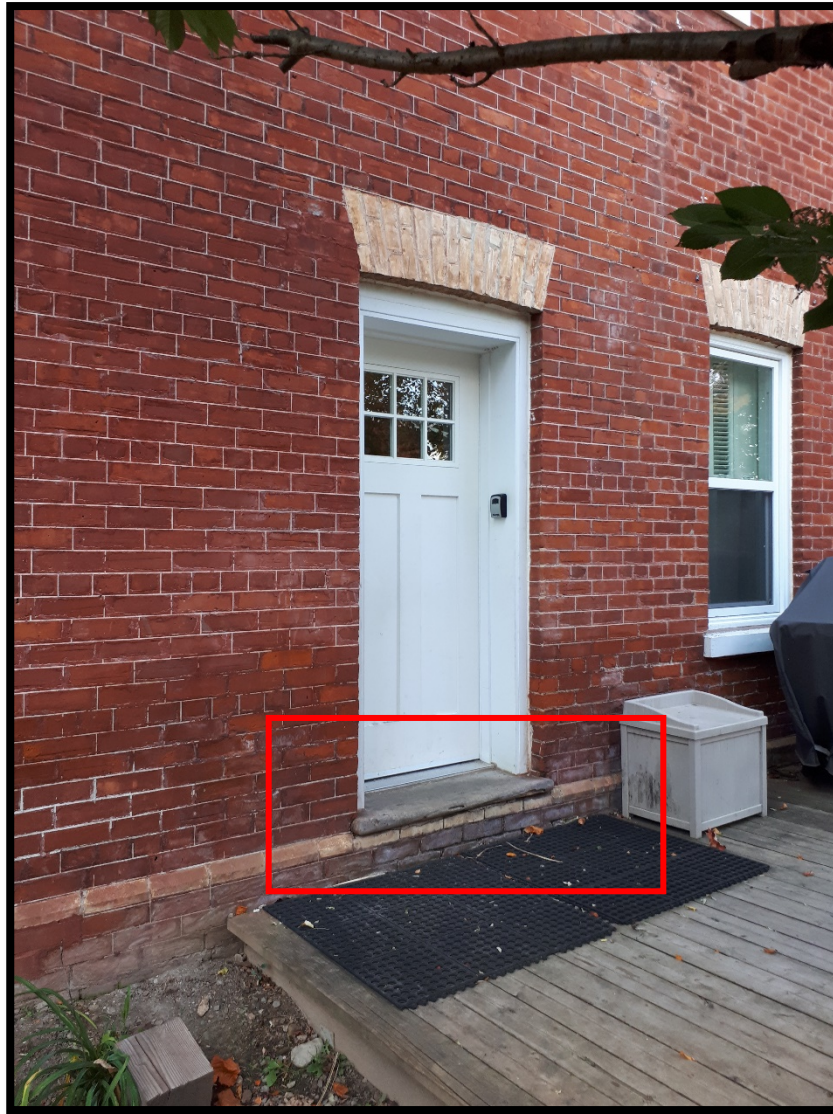
The new construction proposes to retain the original wooden threshold which is above grade. During the new construction, the wooden threshold should be repaired in accordance with Section 4.5.2 Guidelines for Wood and Wood Products (See Appendix G).

Figure 42: View of rear door opening which will provide passage from the vestibule to the heritage house; red box identifies the wooden threshold of the door opening that may require repair doing new construction (MHBC, 2019)

- The addition retains the original wooden threshold which is above grade. As part of the construction of the addition, the existing wooden threshold of the church will be repaired in accordance with *Standards and Guidelines for the Conservation of Historic Places in Canada -Section 4.5.2, Guidelines for Wood and Wood Products*

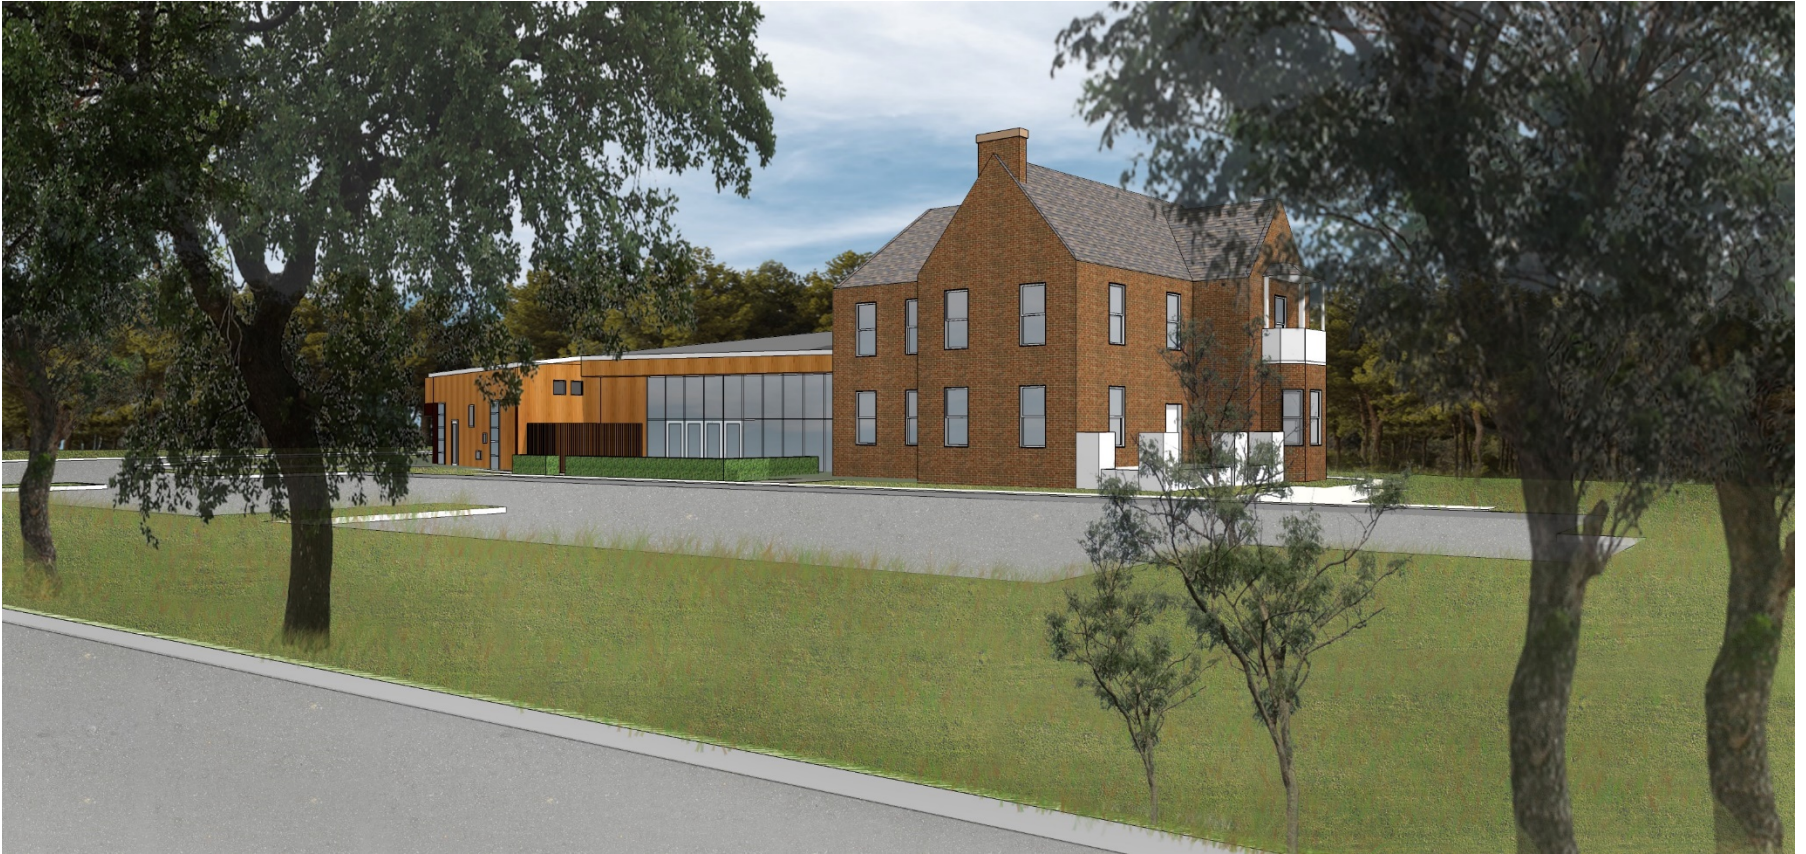
Rendering from Mounsey Street

Views from Mounsey Street are not identified as significant views in the HCD. Nonetheless, a rendering completed by C.Y. Lee Architects Inc. from the Mounsey Street streetscape demonstrates that the addition does not negatively impact the significant view of the house- the front façade (see Appendix B).

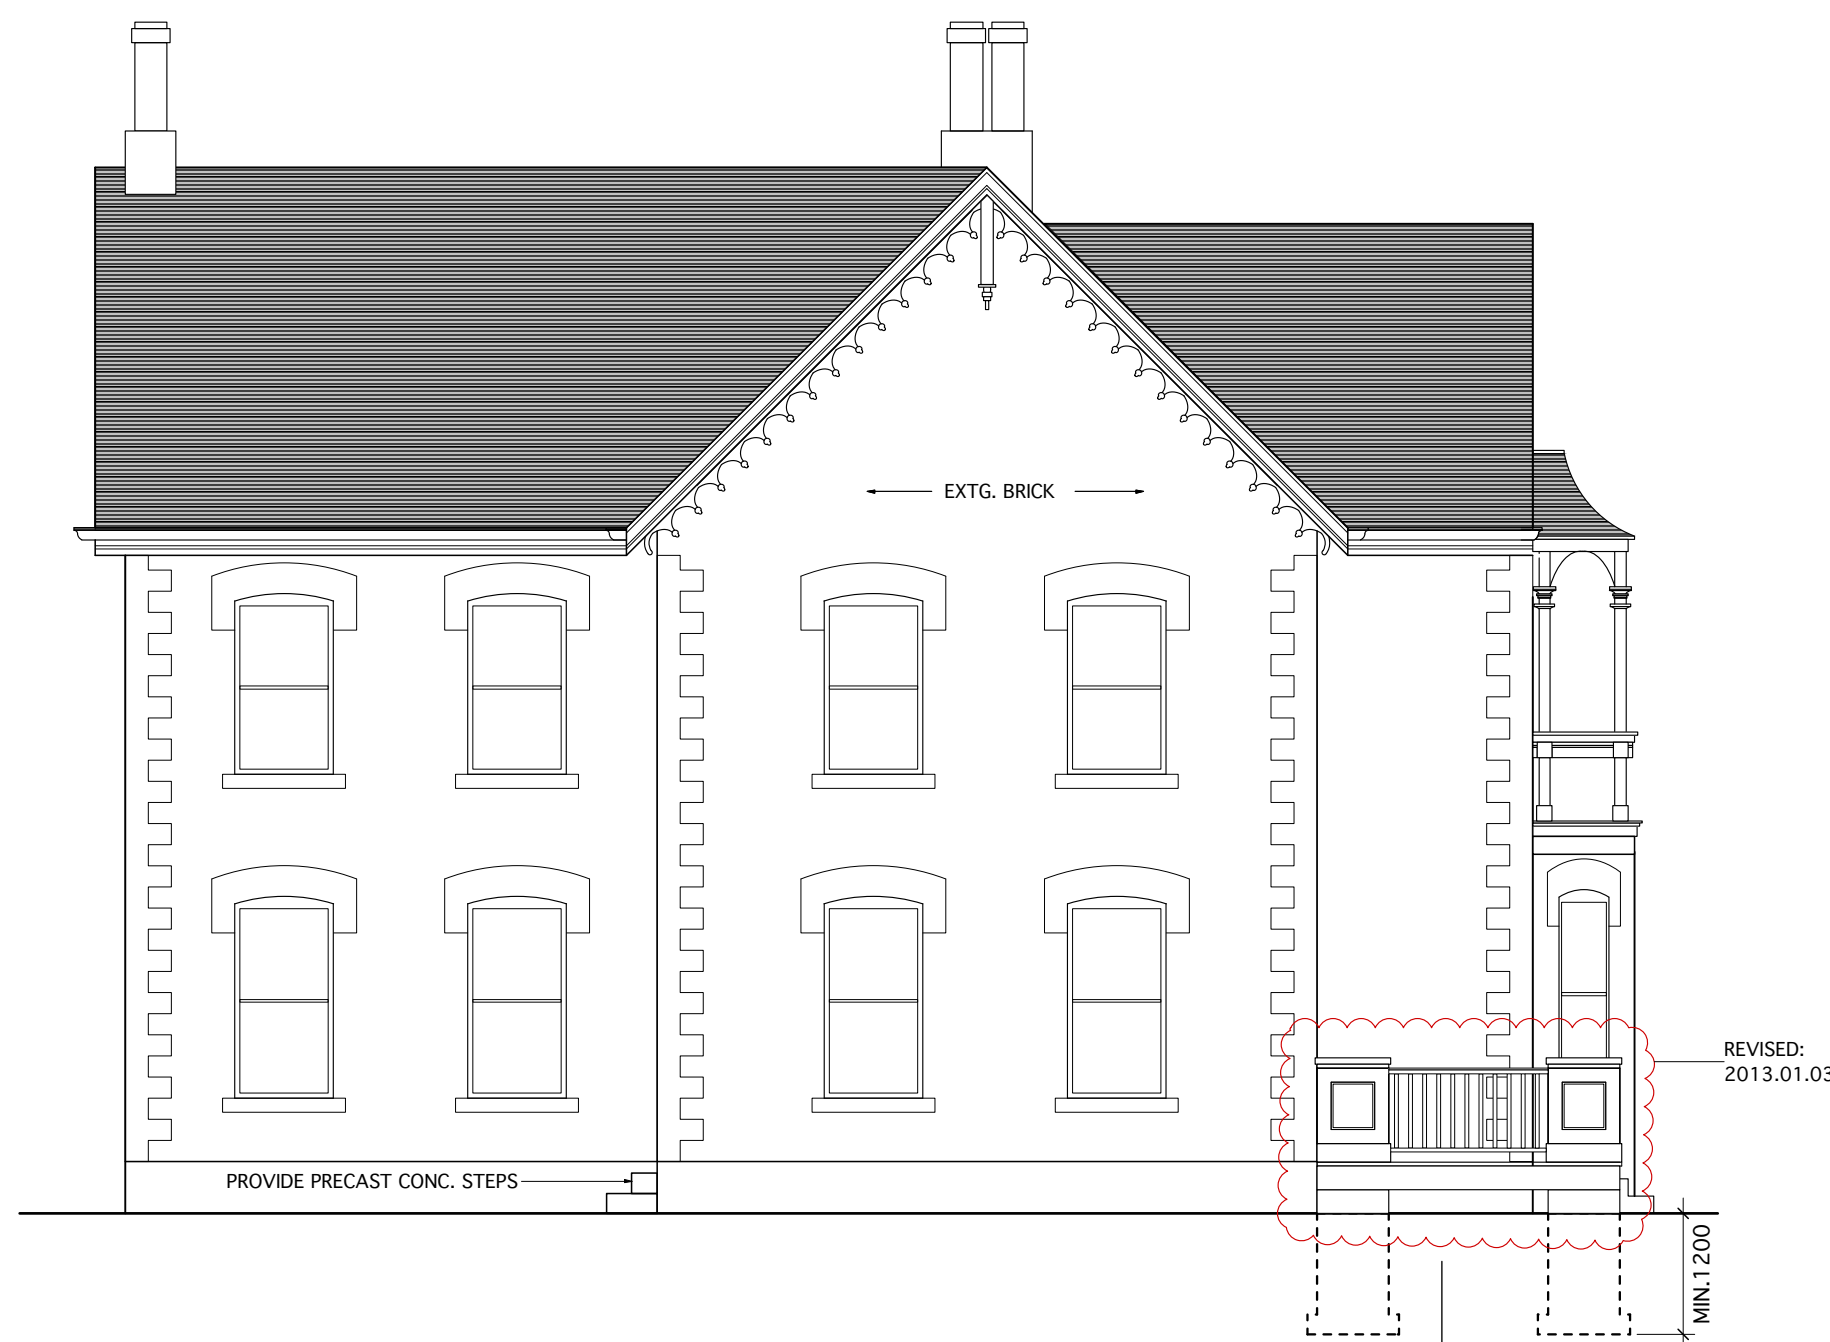
5 NORTH ELEVATION
A4.1 Scale: 1:75

RECONSTRUCT PORCH TO MATCH ORIGINAL DESIGN IN STYLE, MATERIALS AND SIZE BASED ON ARCHIVAL PICTURES.
WEATHER RESISTANT PAINT COLOUR TO MATCH EXISTING. BENJAMIN MOORE; "HISTORICAL COLOURS OR TORONTO HERITAGE COLLECTION"; WHITE COLOUR TO MATCH EXISTING.
REFERENCE: WOODBRIDGE HERITAGE CONSERVATION DISTRICT GUIDELINES SECTION 7.1.10 & SECTION 7.1.12

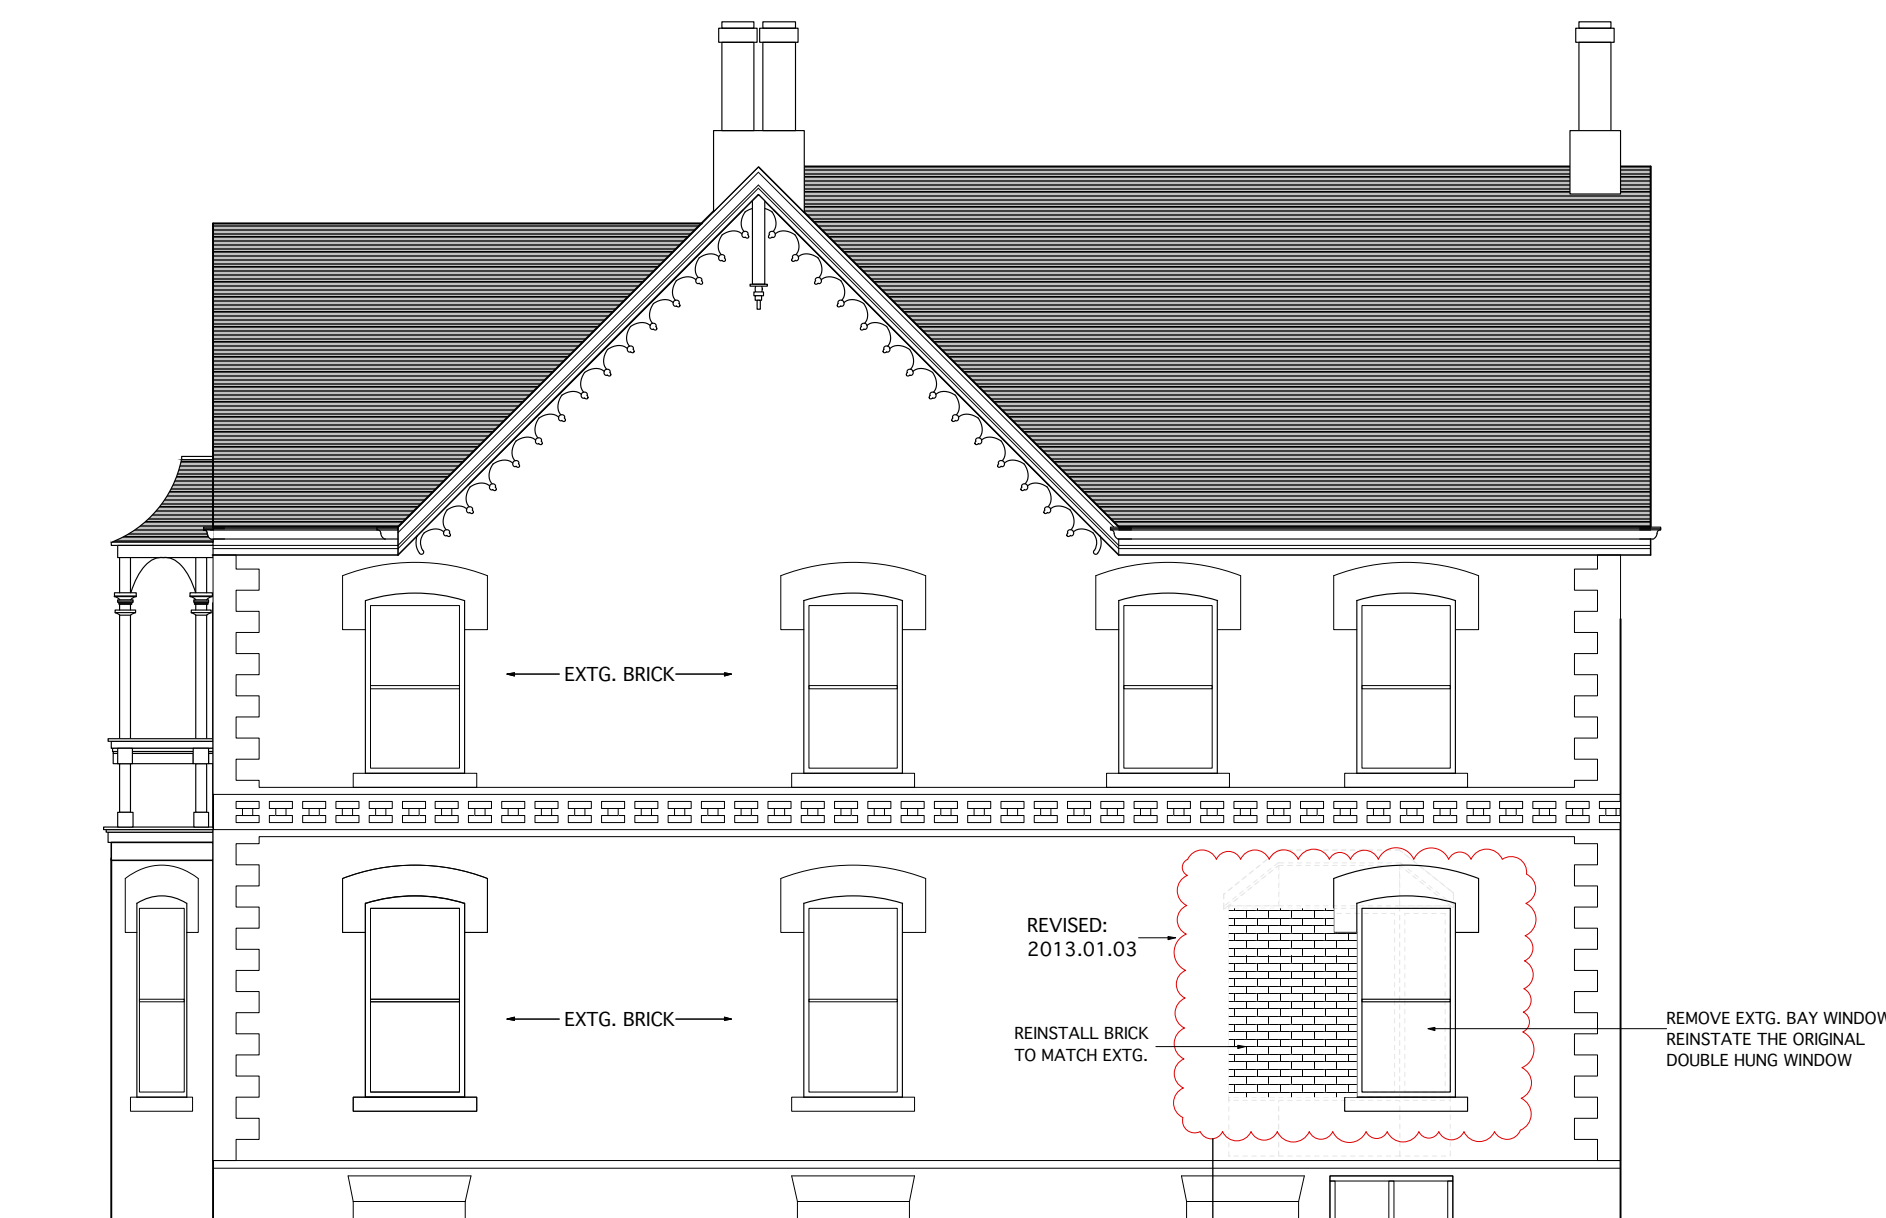
4 SOUTH ELEVATION
A4.1 Scale: 1:75

REPLACE EXTENSIVELY DAMAGED BRICKS AND FILL THE VOID CREATED BY REMOVAL OF BAY WINDOW. REPOINT WITH LINE MORTAR. NEW BRICKS SHALL MATCH IN SIZE AND COLOUR.
IBSTOCK BRICKS - "HERITAGE RED BLEND" & "LEICESTER MULTICREAM STOCK" / "ONTARIO" SIZE MORTAR - NATURAL HYDRAULIC LINE TYPE 3
CLEAN BRICK SURFACE (CARBON REMOVAL) USING LOW PRESSURE CLEANING METHOD WITH AN ENVIRONMENTALLY FRIENDLY CLEANING AGENT. HAND METHOD WITH BRUSH IS PREFERRED BUT WATER WASHING IS ALSO ACCEPTABLE AT 400psi OR LOWER.
REFERENCE: WOODBRIDGE HERITAGE CONSERVATION DISTRICT GUIDELINES SECTION 6.2.8 & SECTION 7.1.1

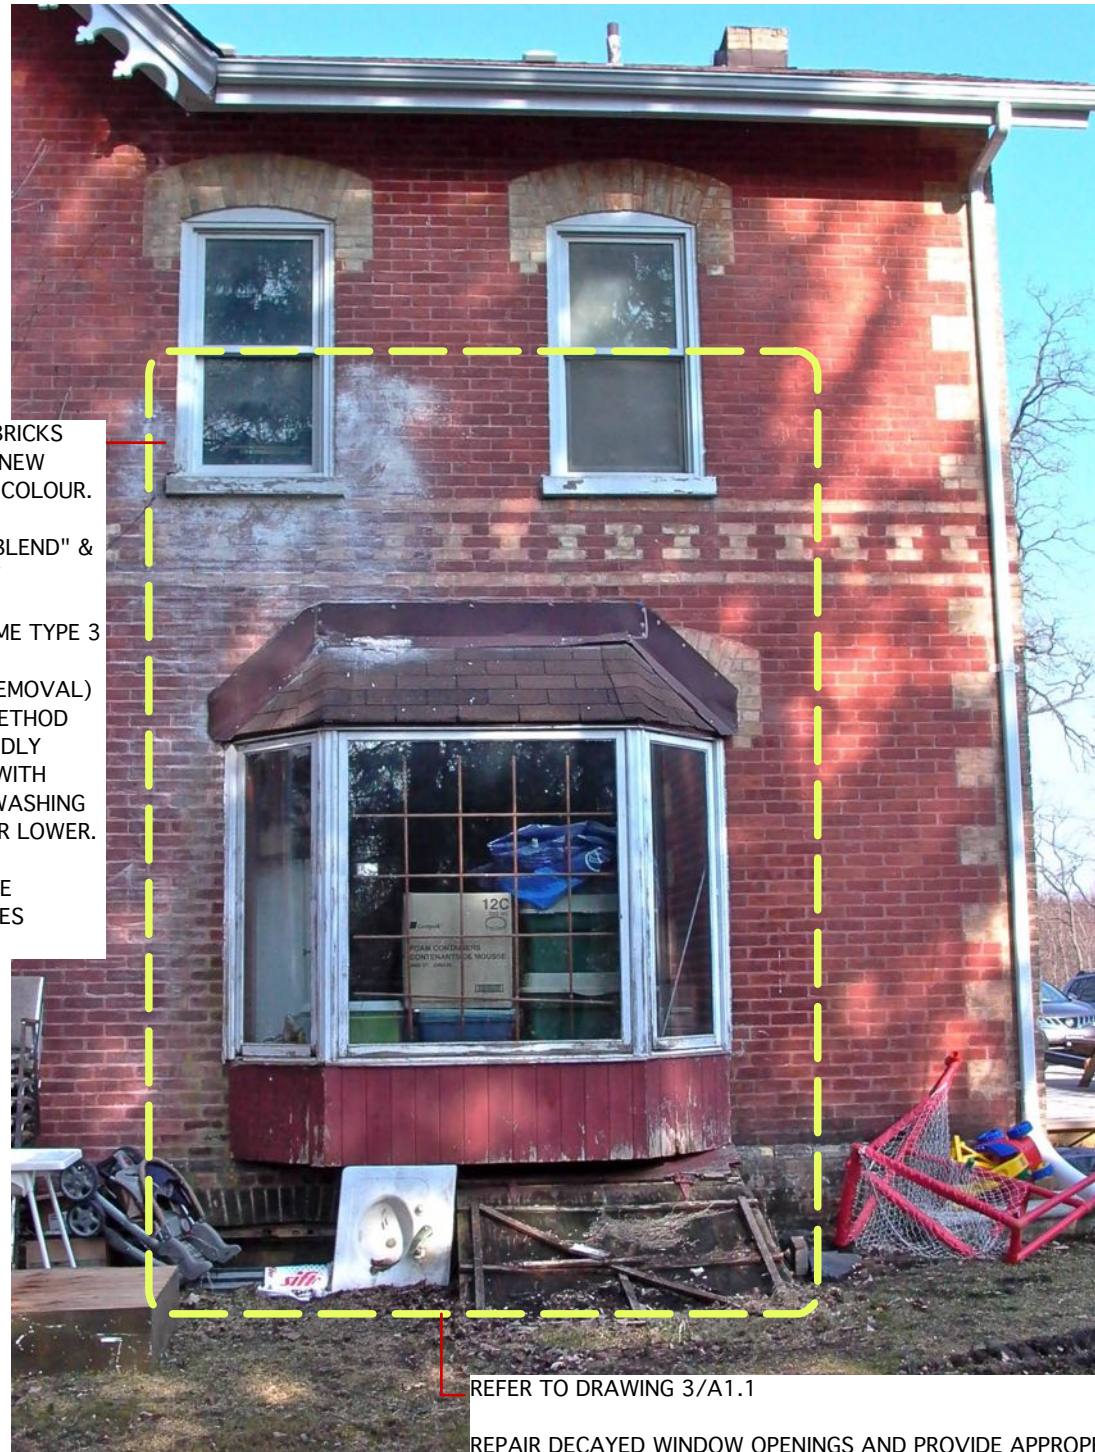
FIGURE 6

REFER TO DRAWING 3/A1.1

REPAIR DECAYED WINDOW OPENINGS AND PROVIDE APPROPRIATE WOOD STORM WINDOWS. WINDOWS FRAME, MULLION, MUNTIN SIZES AND PROFILES SHALL MATCH THE EXISTING WINDOWS. WOOD WINDOW BY "JELD-WEN" OR "LOWEN" OR PVC WINDOW BY "WINDOW CITY"

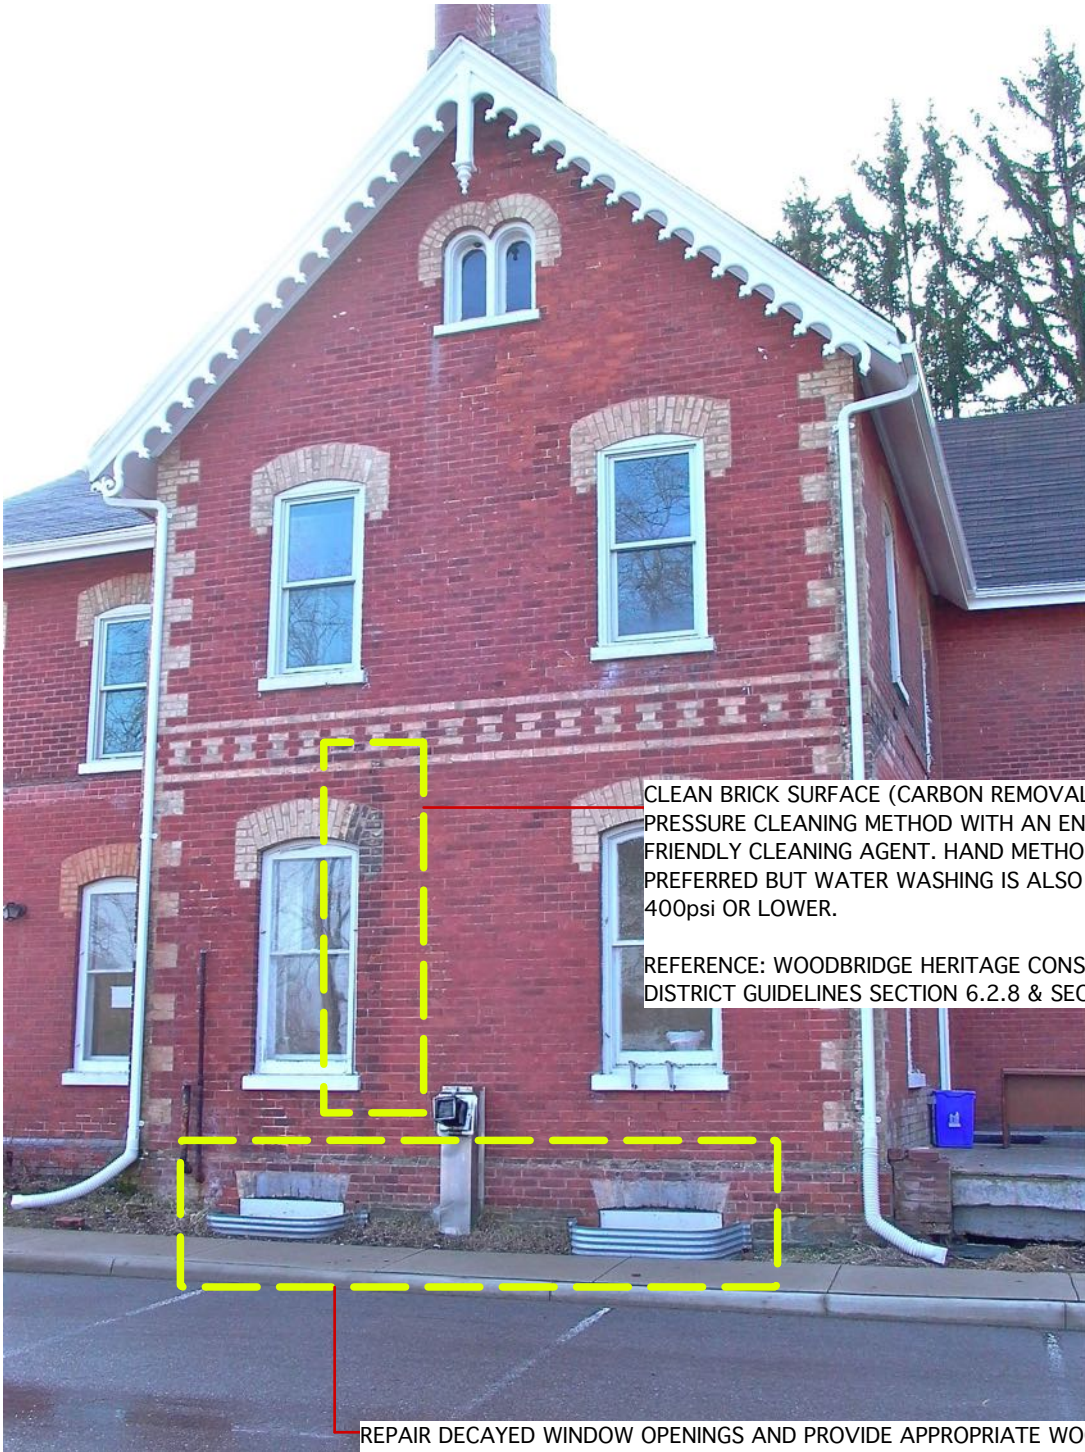
FIGURE 8

CLEAN BRICK SURFACE (CARBON REMOVAL) USING LOW PRESSURE CLEANING METHOD WITH AN ENVIRONMENTALLY FRIENDLY CLEANING AGENT. HAND METHOD WITH BRUSH IS PREFERRED BUT WATER WASHING IS ALSO ACCEPTABLE AT 400psi OR LOWER.

REPAIR DECAYED WINDOW OPENINGS AND PROVIDE APPROPRIATE WOOD STORM WINDOWS. WINDOWS FRAME, MULLION, MUNTIN SIZES AND PROFILES SHALL MATCH THE EXISTING WINDOWS. WOOD WINDOW BY "JELD-WEN" OR "LOWEN" OR PVC WINDOW BY "WINDOW CITY"

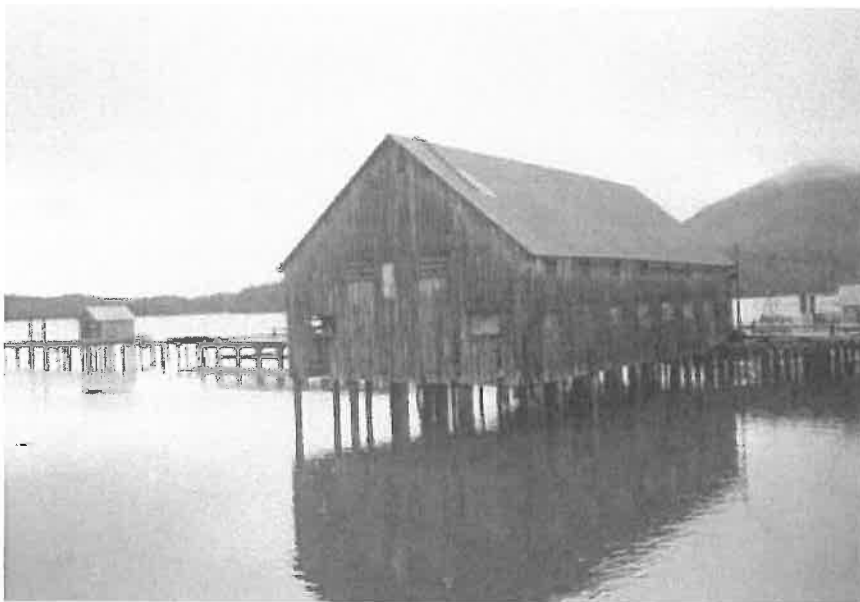
It is important to identify the cause of any damage to a wooden building element before beginning a Preservation treatment. For the former machine shop of the North Pacific Cannery in Port Edward BC, exposure to marine conditions caused the exterior wood cladding to deteriorate.

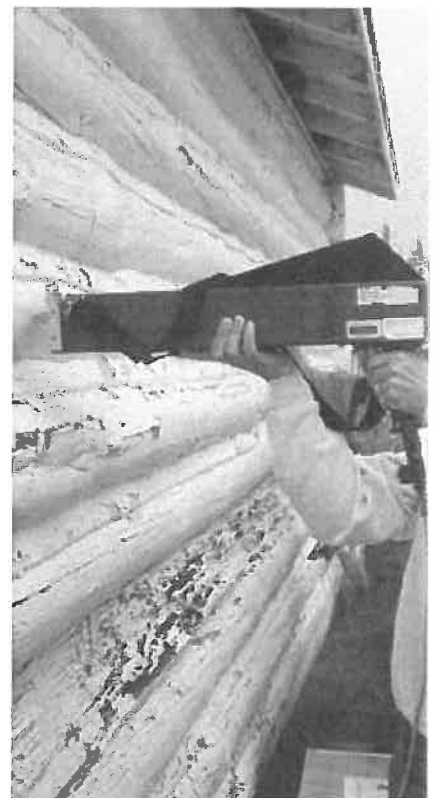
Using minimally destructive testing methods can help evaluate the condition of wood without damaging it. Here a resistance measuring micro drill is being used to evaluate the condition of a log wall at Fort Walsh, NHSC in Saskatchewan. A drilling needle penetrates the wood at a constant speed and measures the resistance encountered to advance the drill bit. The resistance the wood offers indicates its condition: low resistance can indicate decay.

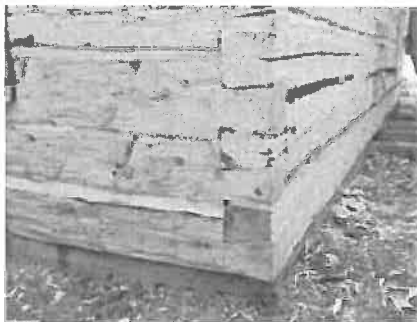
Deteriorated logs at the John Walter Historic Site in Edmonton were replaced in kind with hewn logs that used the originals as templates to reproduce tooling marks on visible surfaces. On close inspection, this distinguishes the new materials if the logs are separated in the future.

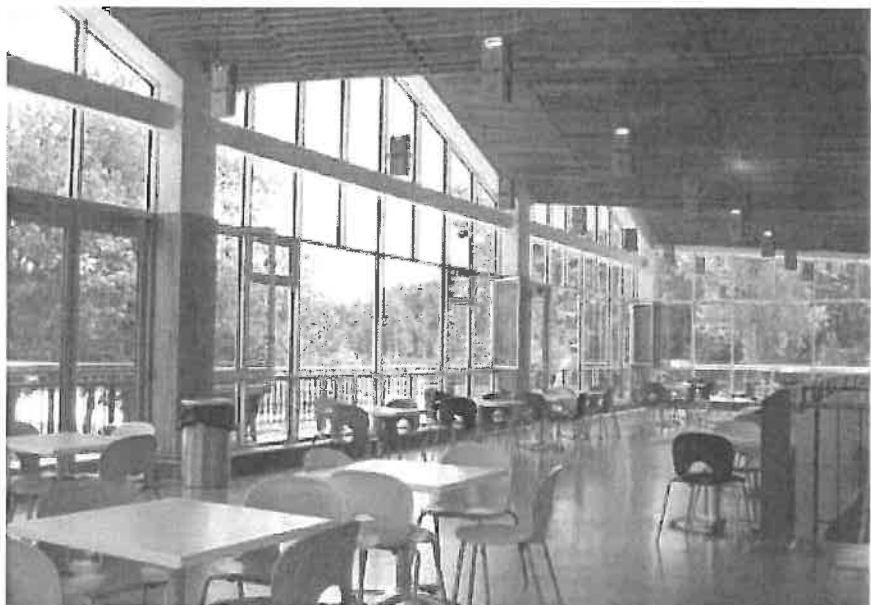
Wood was often used in modern buildings as a finish to contrast with more industrial materials, or as part of an acoustical treatment on ceilings and walls. The wood ceiling and column claddings of the Beaver Lake Pavilion in Montreal were carefully preserved as part of the recent rehabilitation of the pavilion.

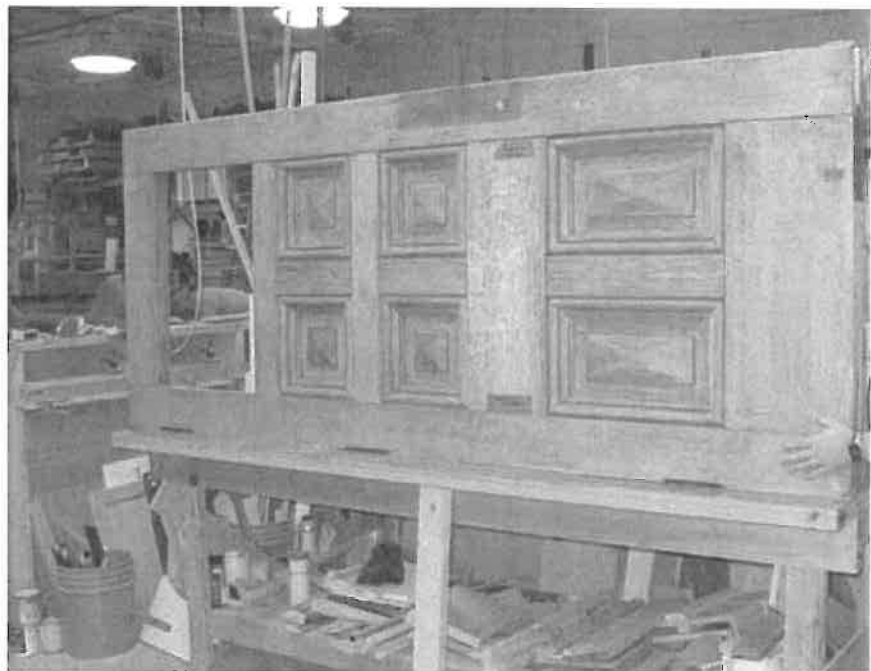
Preserving the wood doors of the Langevin Block in Ottawa included carefully dismantling the doors to permit the damaged and decayed wood to be repaired.

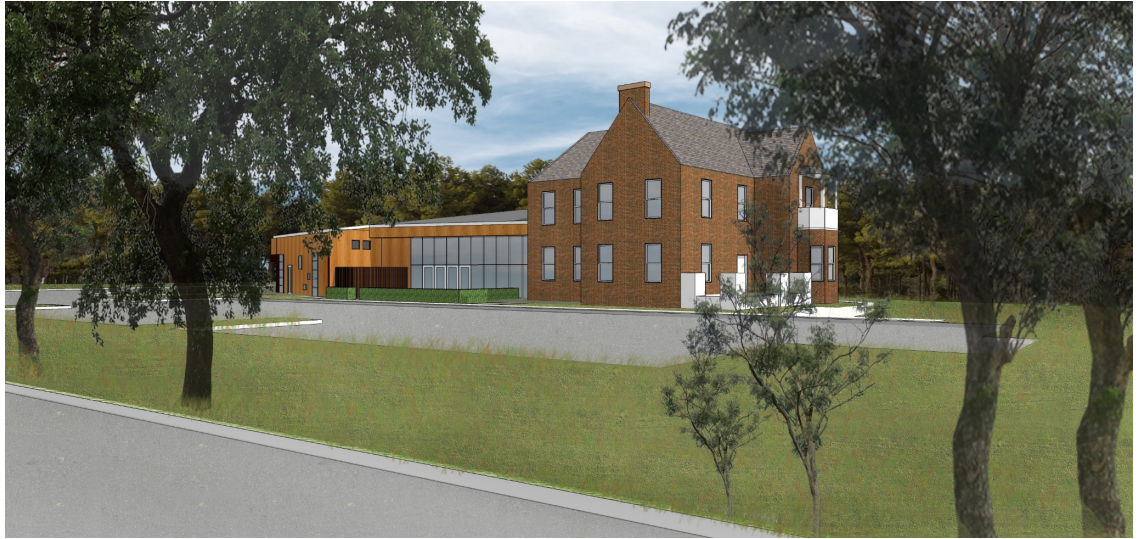
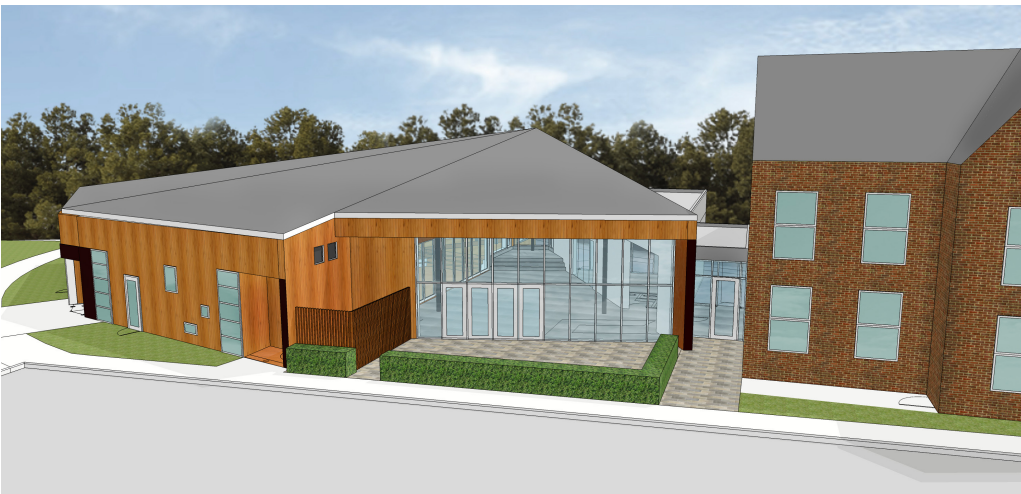
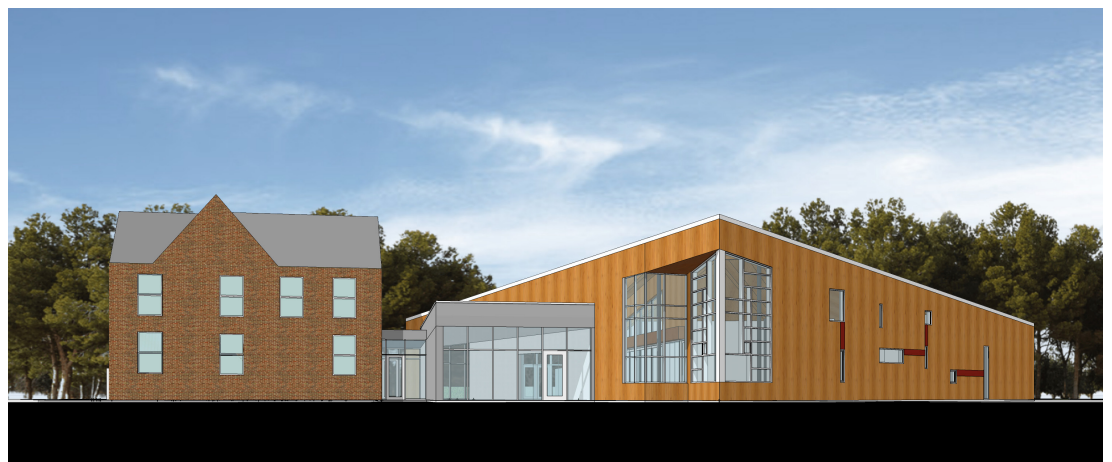
PERSPECTIVE DRAWINGS

- LEGEND
- 1. GALV. STANDING SEAM METAL ROOF
 - 2. PREFIN. METAL EAVESTROUGH
 - 3. CLEAR CEDAR SIDING
 - 4. ALUM. & GLASS WINDOW/CURTAIN WALL
 - 5. PREFIN. WOOD PANEL
 - 6. CEMENT FIBRE BOARD
 - 7. GALV. METAL FLASHING TO MATCH METAL ROOF
 - 8. EXTG. BRICKS

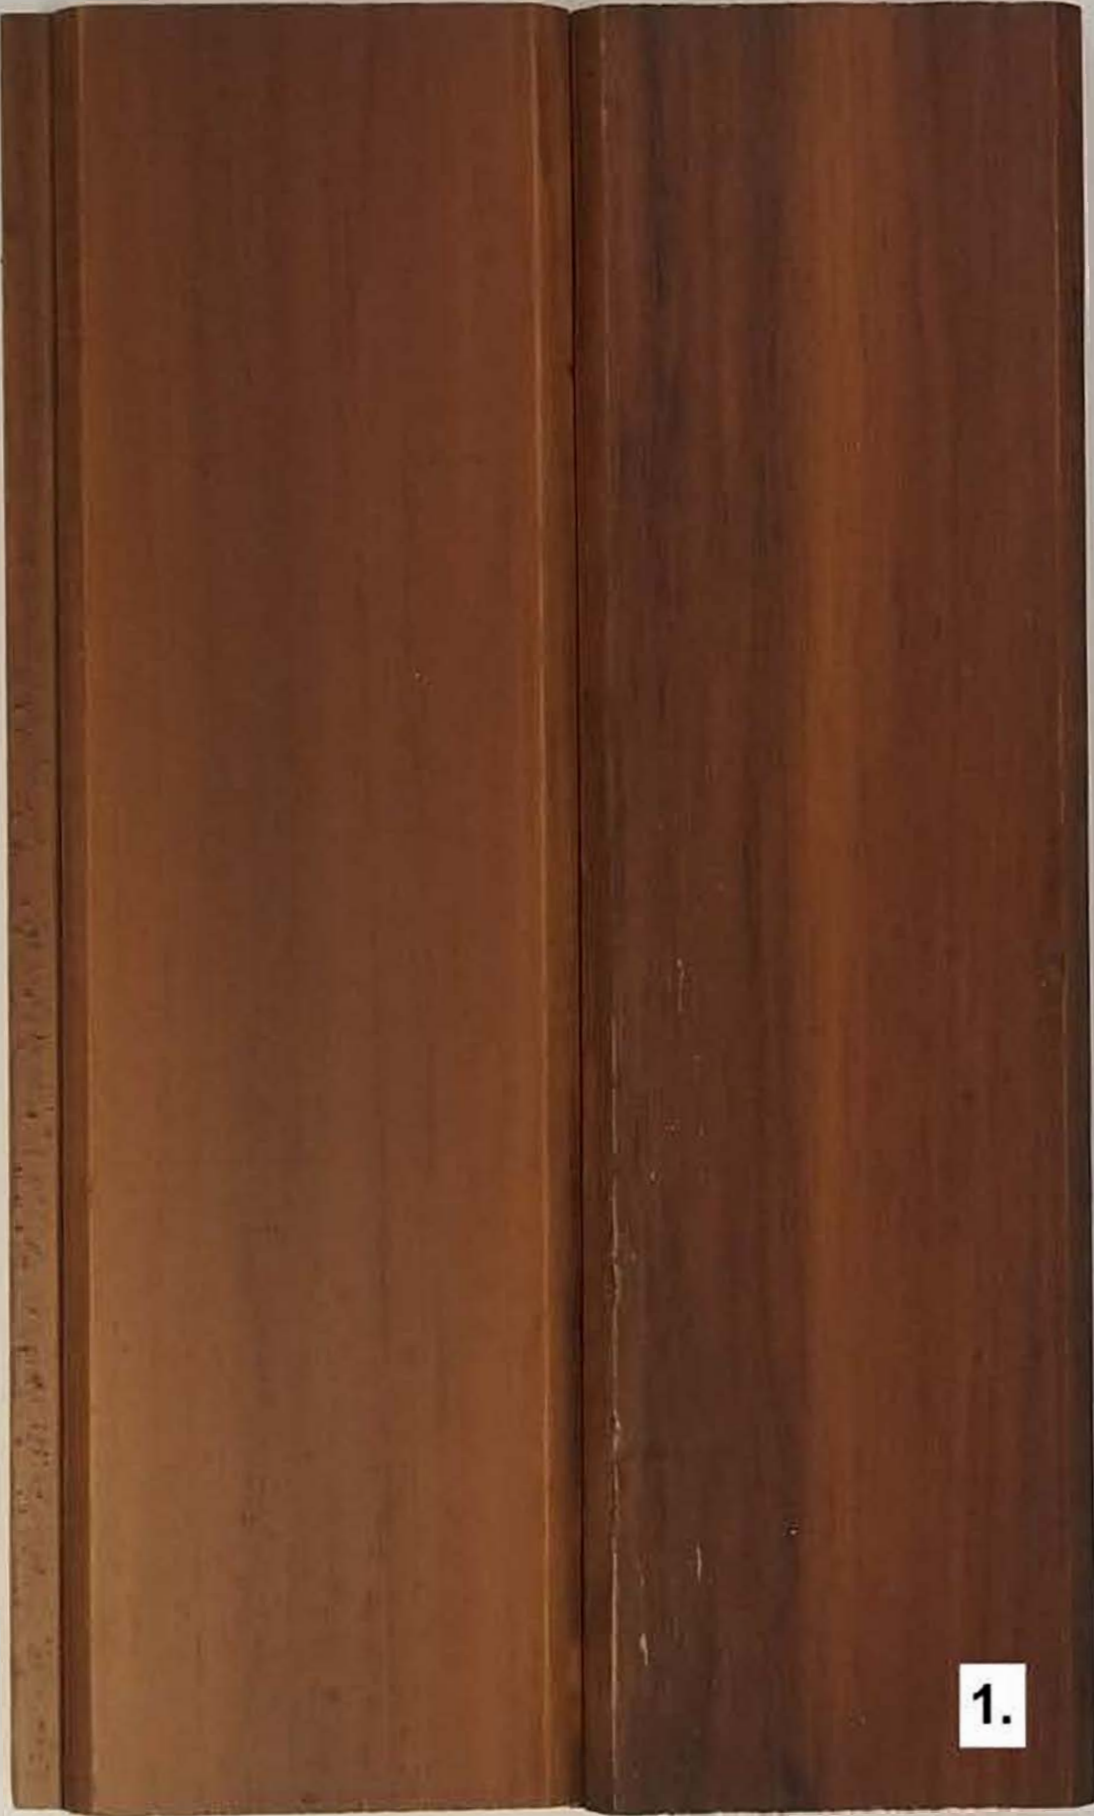
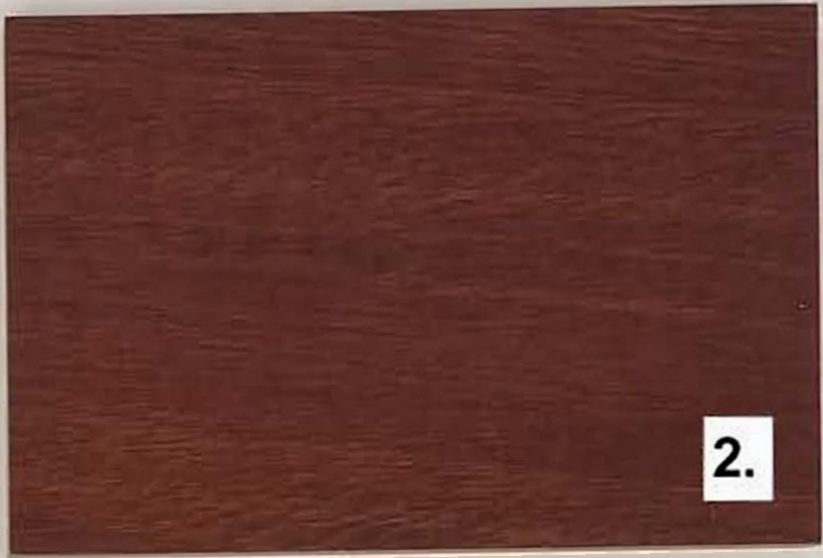
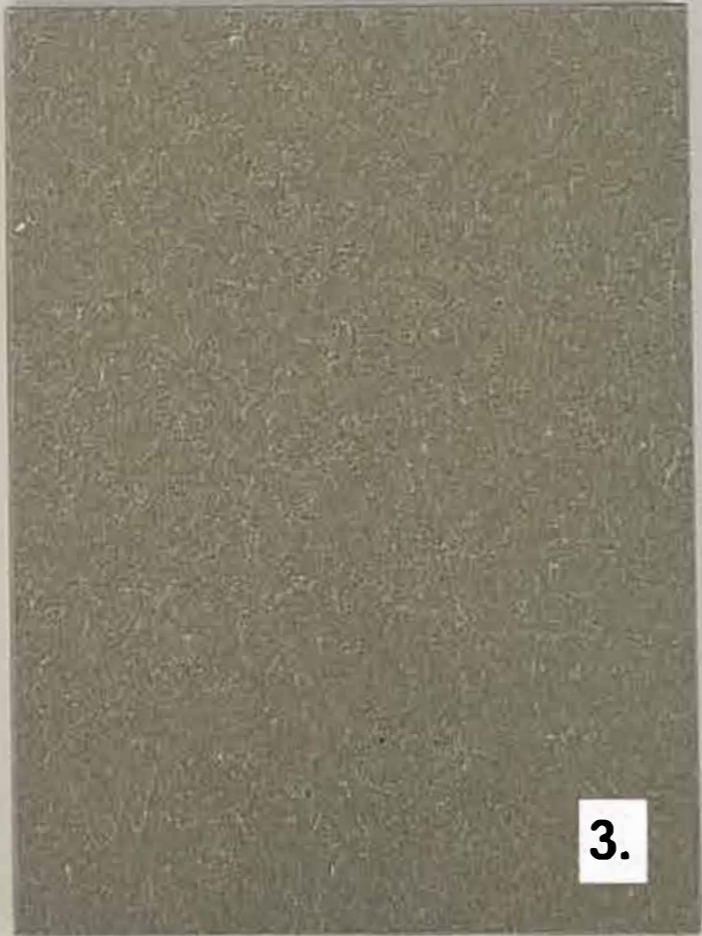
1. CEDAR WOOD SIDING

19x89 “V” JOINT TONGUE AND GROOVE
CEDAR, CETOL FINISH BY CEDARONE,
WEYERHAUESER

2. PREFIN. WOOD PANEL

3. CEMENT FIBRE BOARD
