**CITY OF VAUGHAN
HERITAGE VAUGHAN COMMITTEE
AGENDA**

Wednesday, April 21, 2021

TITLE: RENOVATION OF EXISTING HERITAGE HOUSE, AND REAR
ADDITION AT 7714 YONGE STREET, THORNHILL HERITAGE
CONSERVATION DISTRICT
(REFERRED)

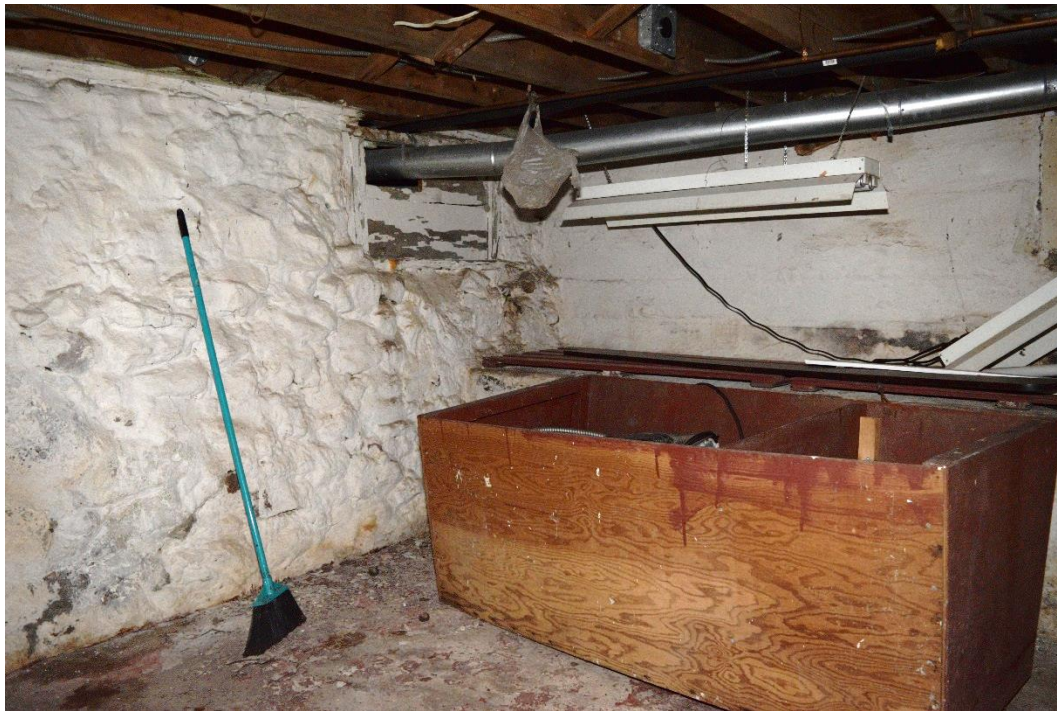
Figure 33: The rounded fieldstone foundation as seen from beneath the West Wing Extension.

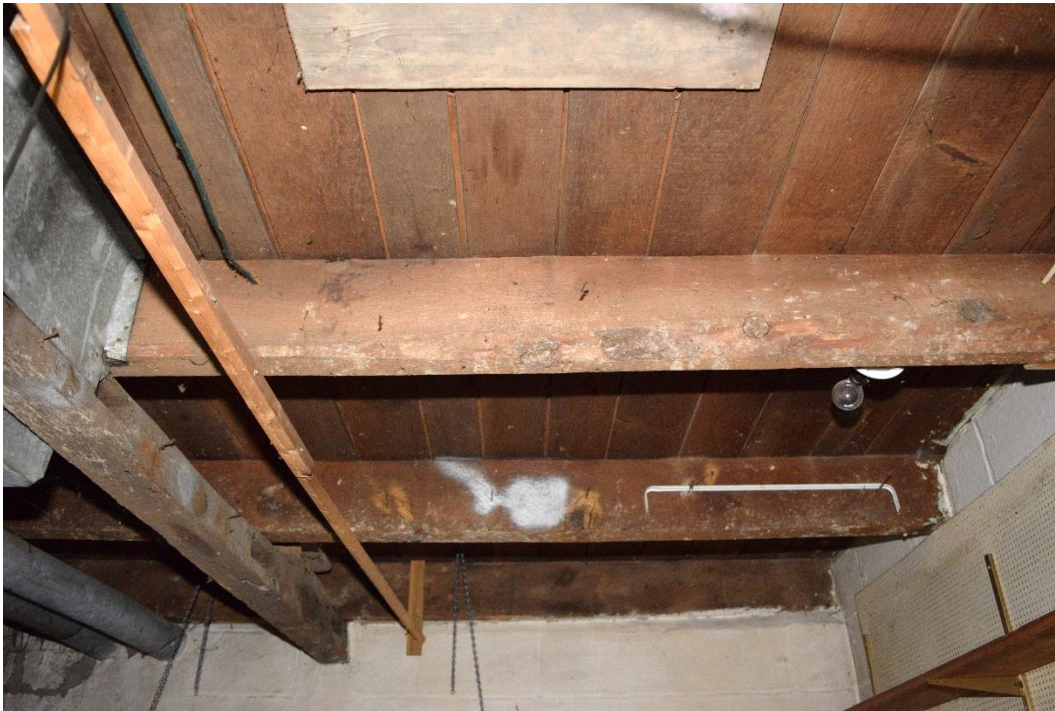
Figure 34: Planed wood joists and floorboards as seen from the Main Block basement.

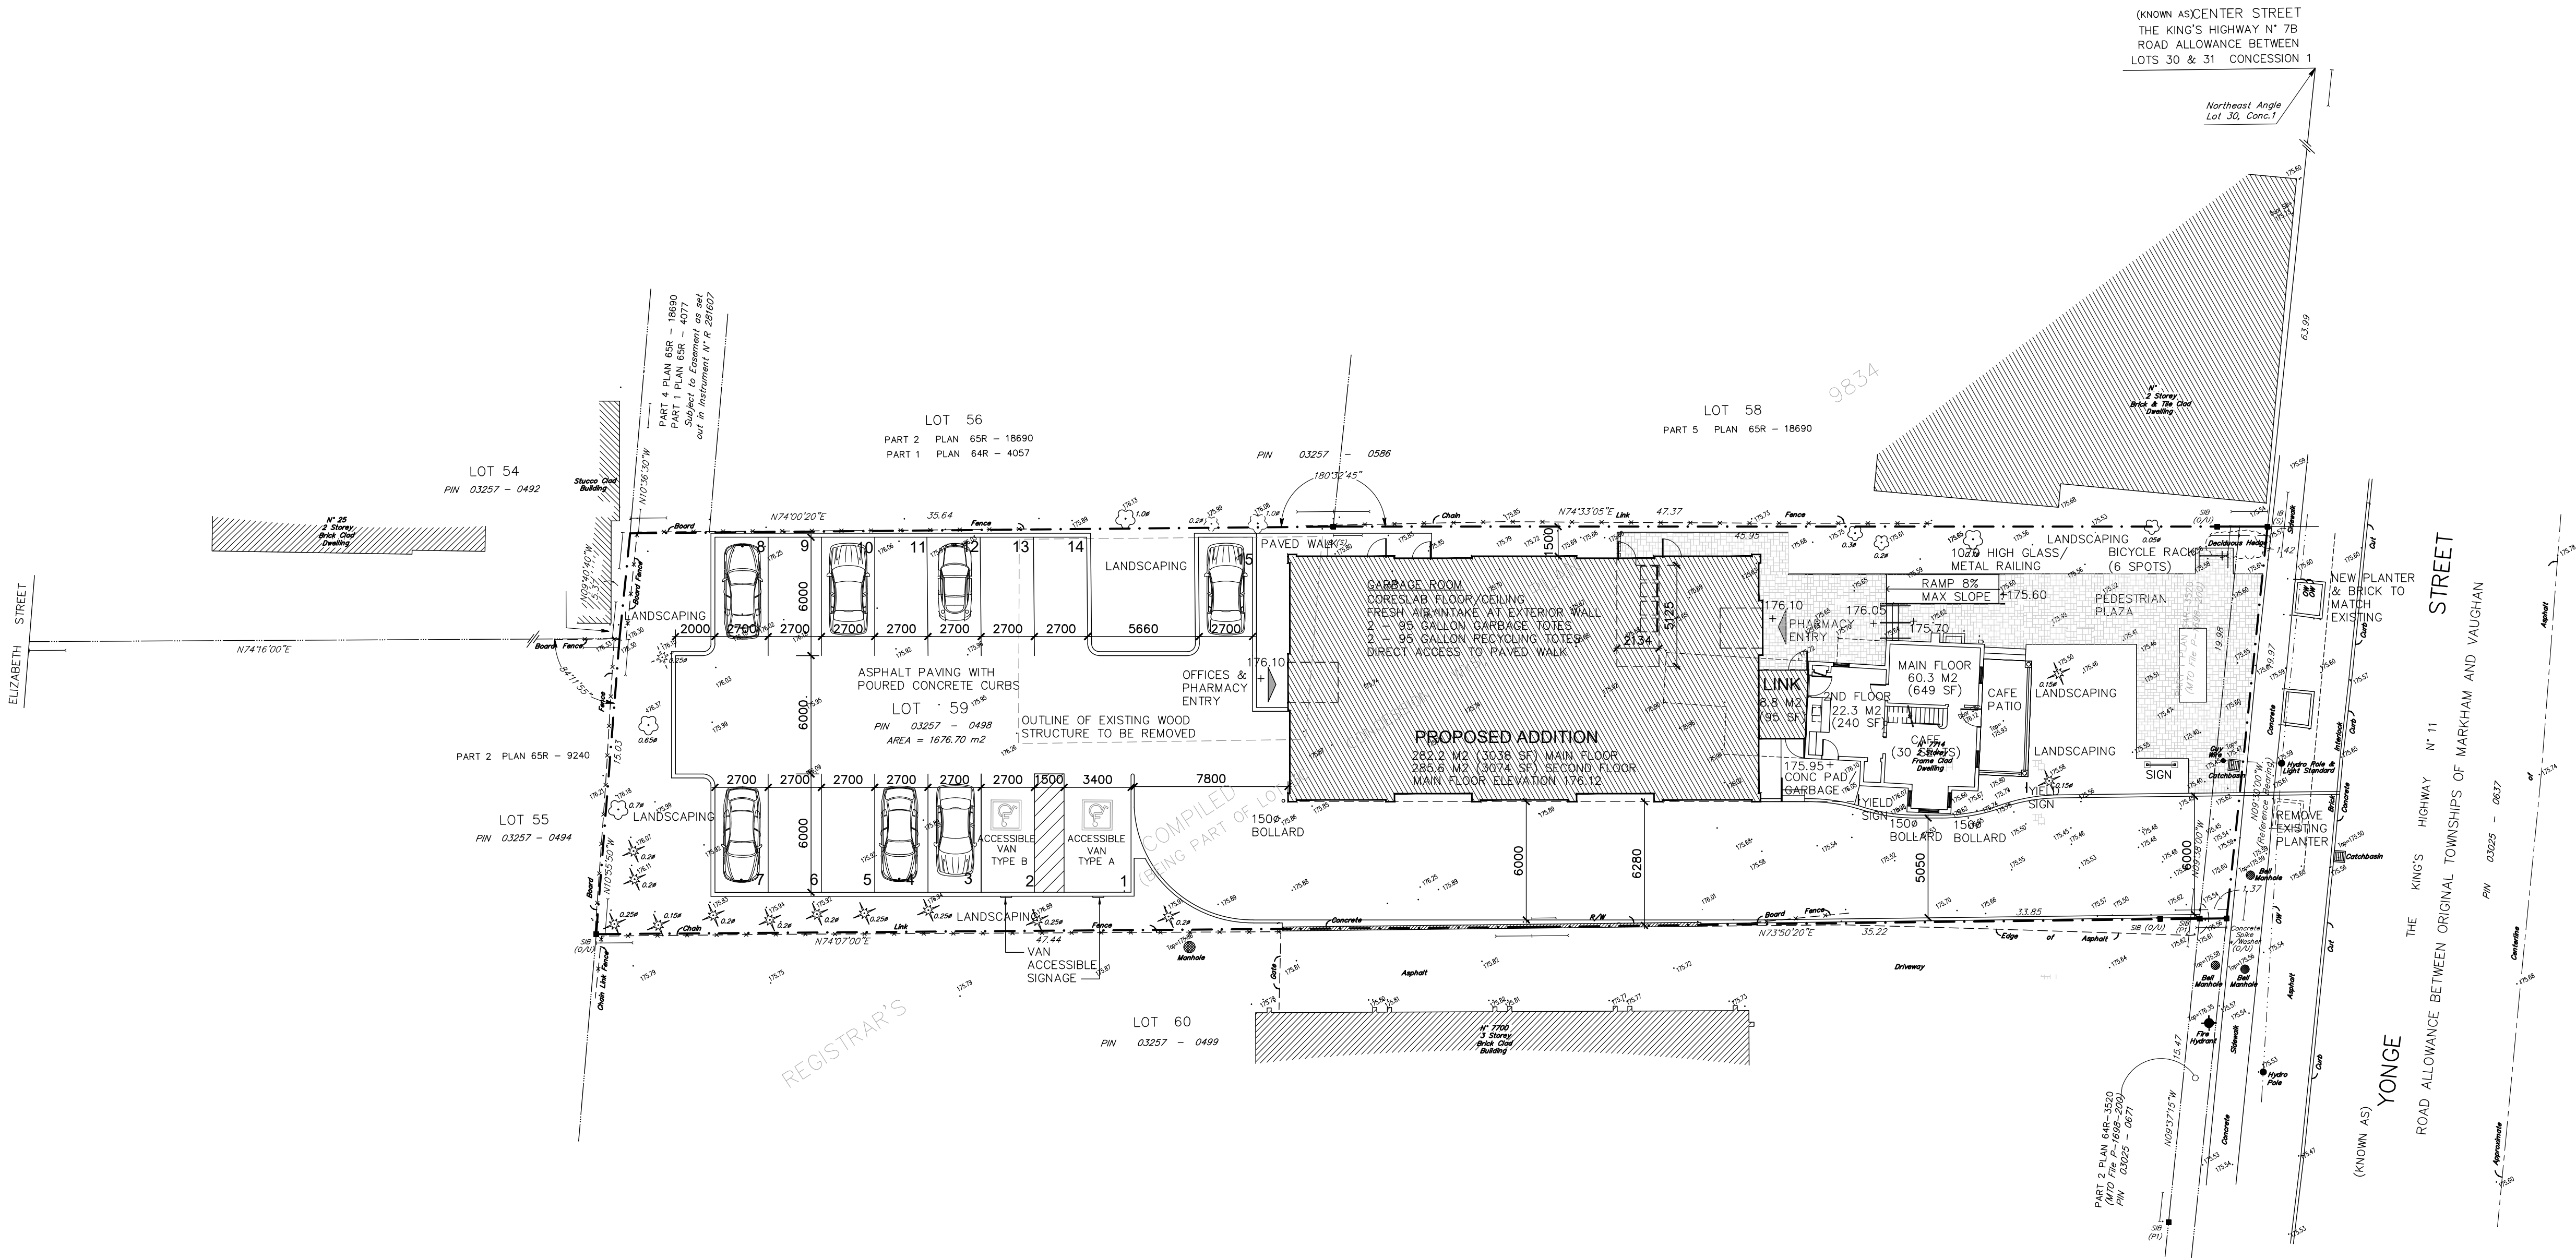
Drawing Name: PRELIMINARY SITE PLAN	
Scale 1:200	Revision No 8
Project No 16.17	Drawing No SK-1

SITE STATISTICS	
LOT AREA	1676.7 M ²
SITE COVERAGE	
EXISTING BUILDING	60.3 M ²
PROPOSED LINK	8.8 M ²
PROPOSED ADDITION	291.8 M ²
TOTAL	360.9 M ²
	21.5%
FLOOR AREAS	
FIRST FLOOR EXISTING	60.3 M ²
SECOND FLOOR RENOVATED	22.3 M ²
LINK NEW	8.8 M ²
FIRST FLOOR NEW	282.2 M ²
SECOND FLOOR NEW	285.6 M ²
TOTAL	659.2 M ²
FLOOR SPACE INDEX	0.39
NEW BASEMENT	282.2 M ²
BUILDING HEIGHT	8.1 M

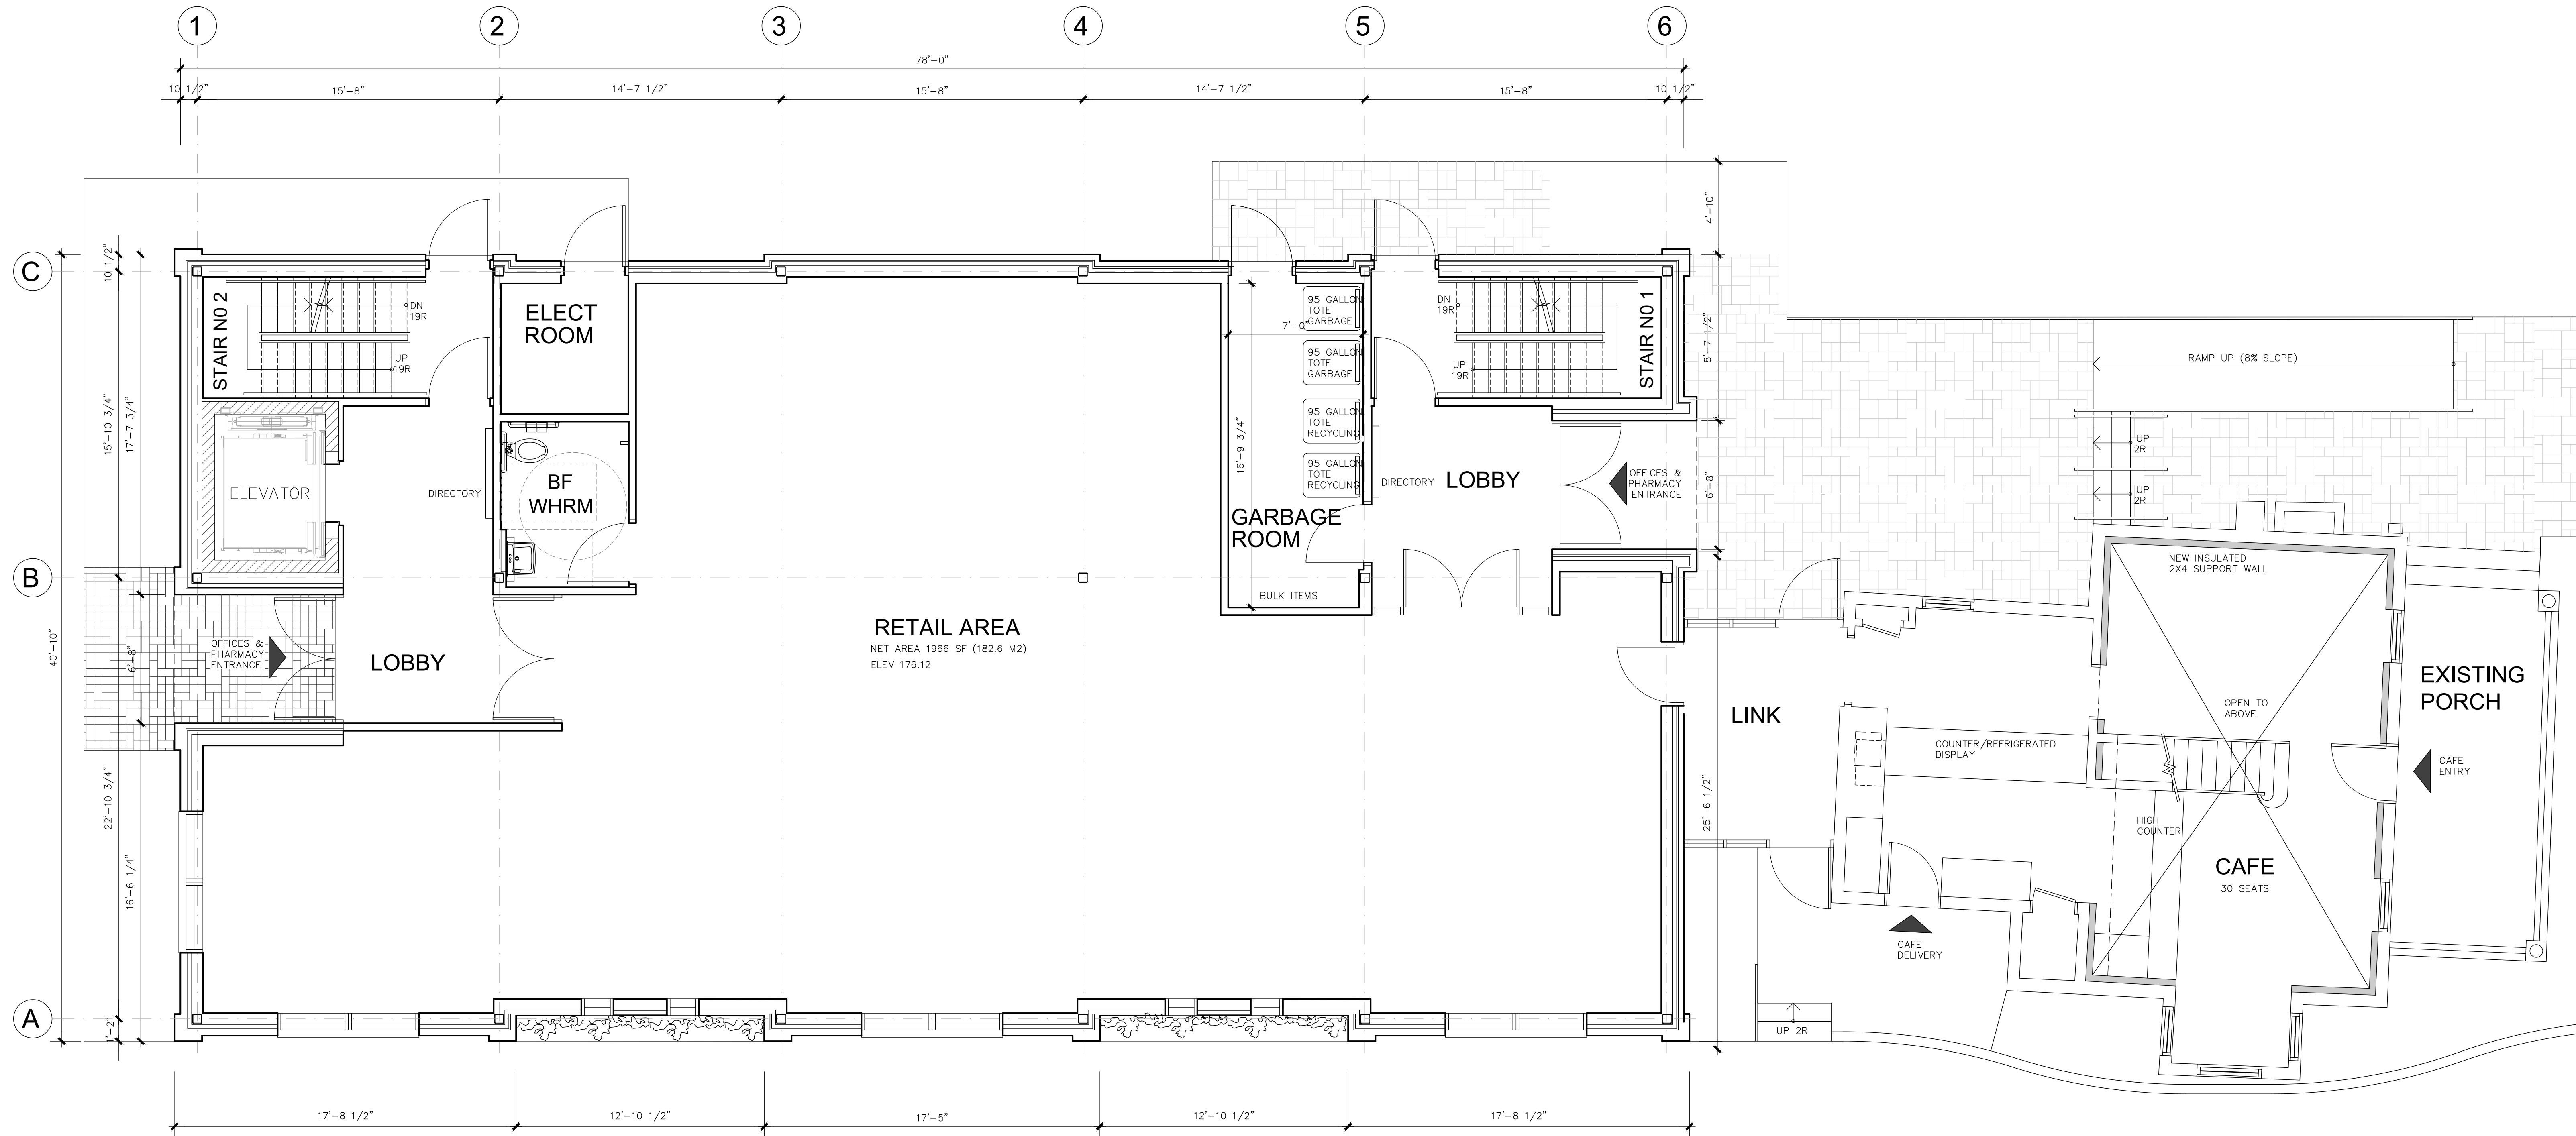
Scale 1/4" = 1'-0"	Revision No 7
Project No 16.17	Drawing No SK-2

FIRST FLOOR PLAN
282.2 M2 (3038 SF) ADDITION
8.8 M2 (95 SF) LINK
60.3 M2 (649 SF) HERITAGE HOUSE

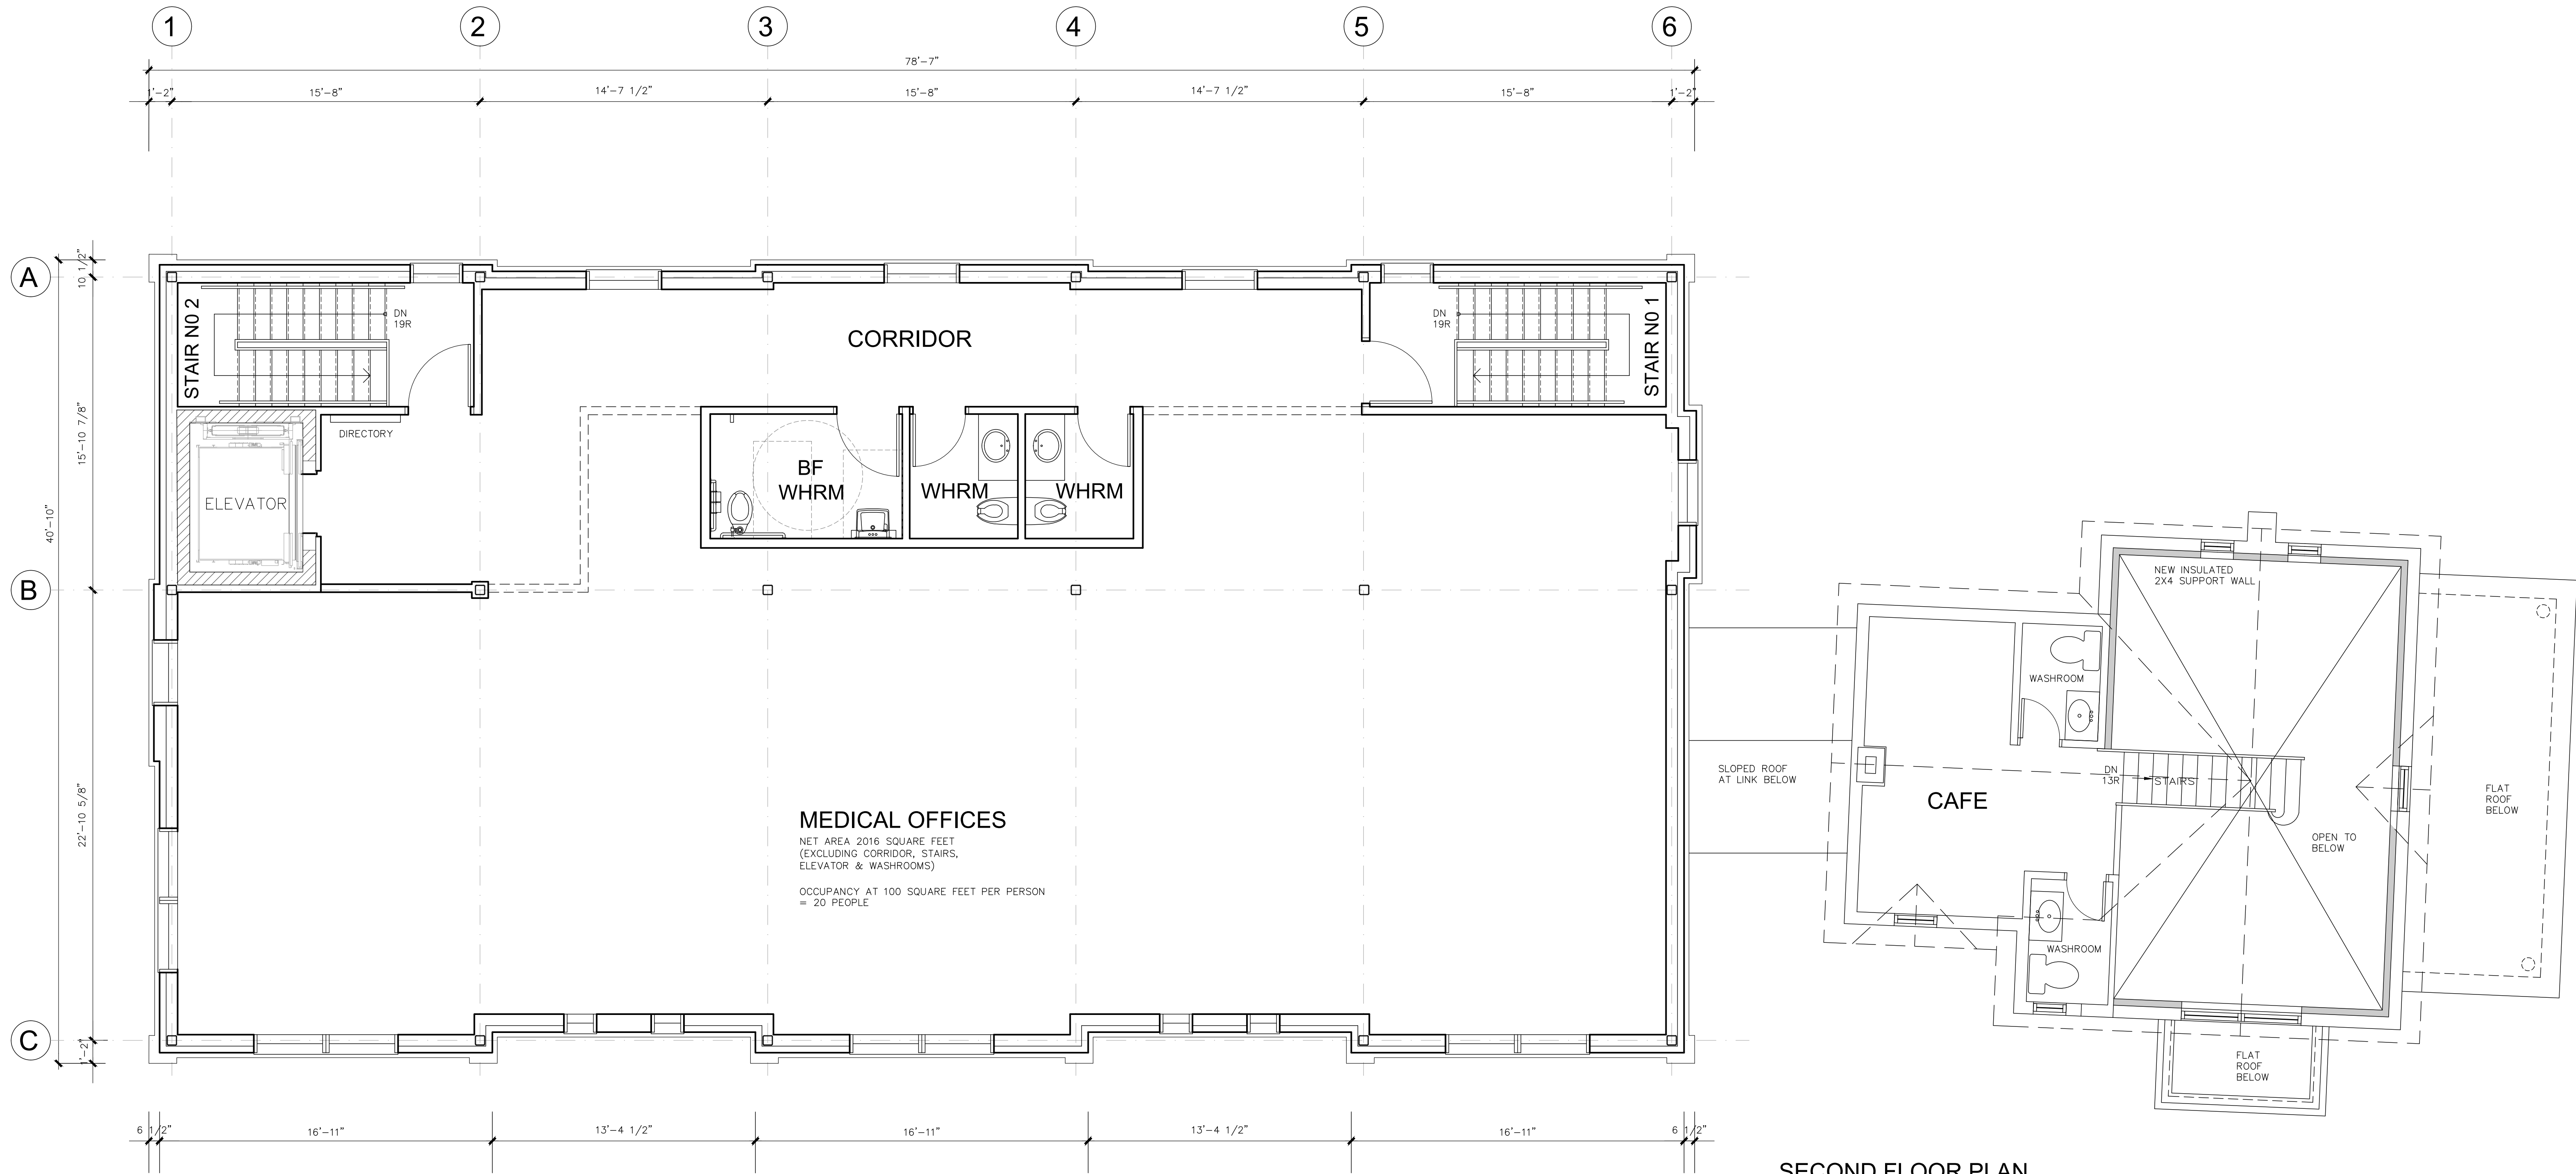
Drawing No
SK-3

SECOND FLOOR PLAN
285.6 M2 (3074 SF) ADDITION
22.3 M2 (240 SF) HERITAGE HOUSE

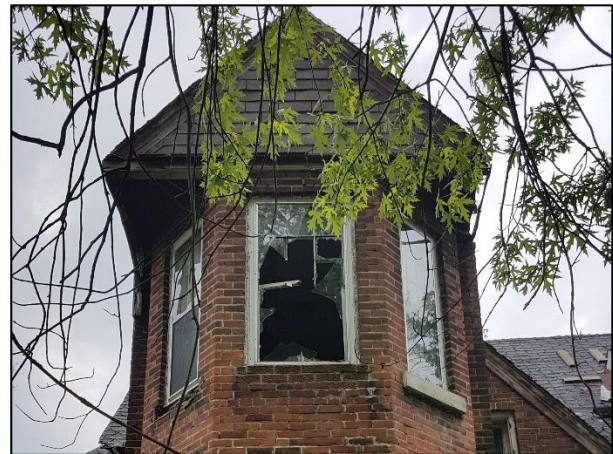
Figure 33: East elevation detail showing window openings and broken windows at the second storey
(ASI 2019)

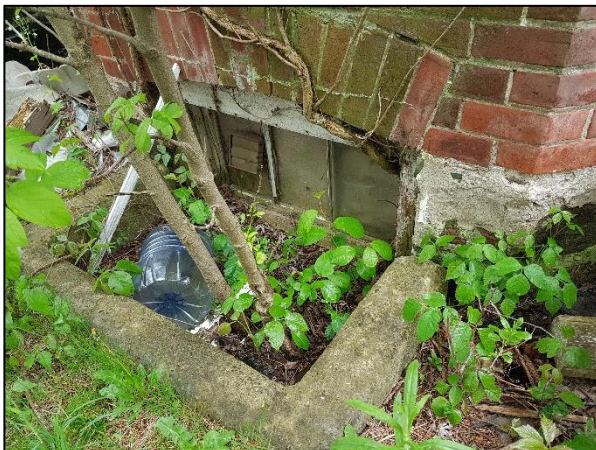
Figure 34: East elevation detail showing segmentally arched basement window openings and parged foundation
(ASI 2019)

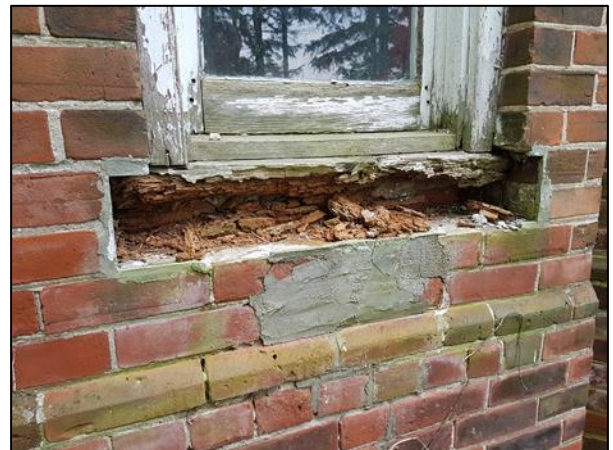
Figure 35: East elevation detail showing missing sill and deteriorated window
(ASI 2019)

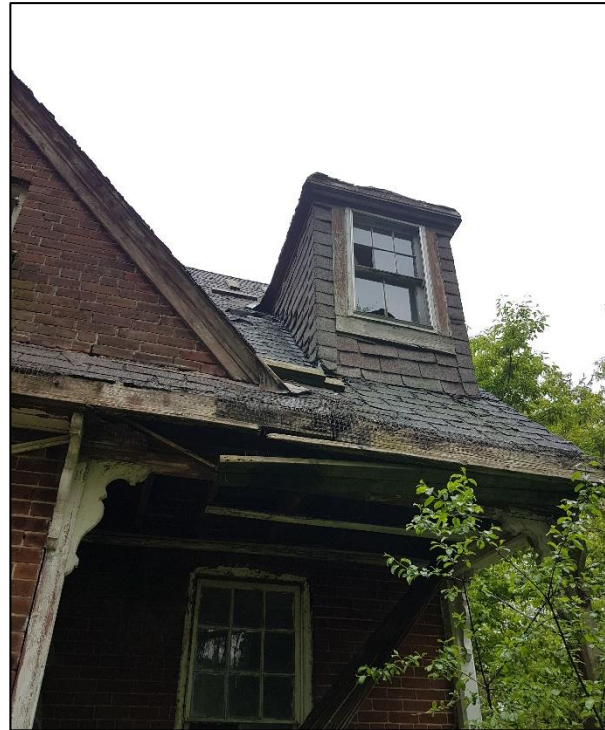
Figure 41: East elevation detail showing the deteriorated porch roof and dormer above the porch

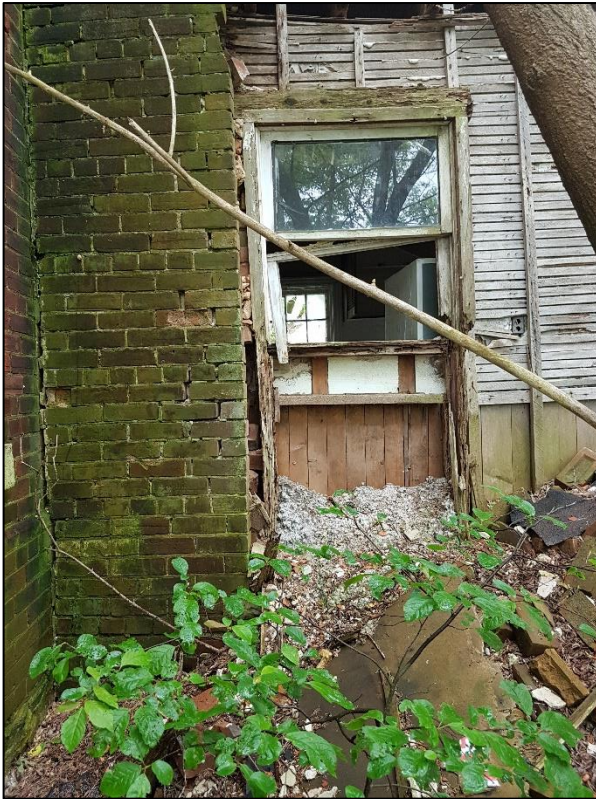
Figure 46: North elevation detail showing deteriorated exterior wall and first-floor window opening
(ASI 2019)

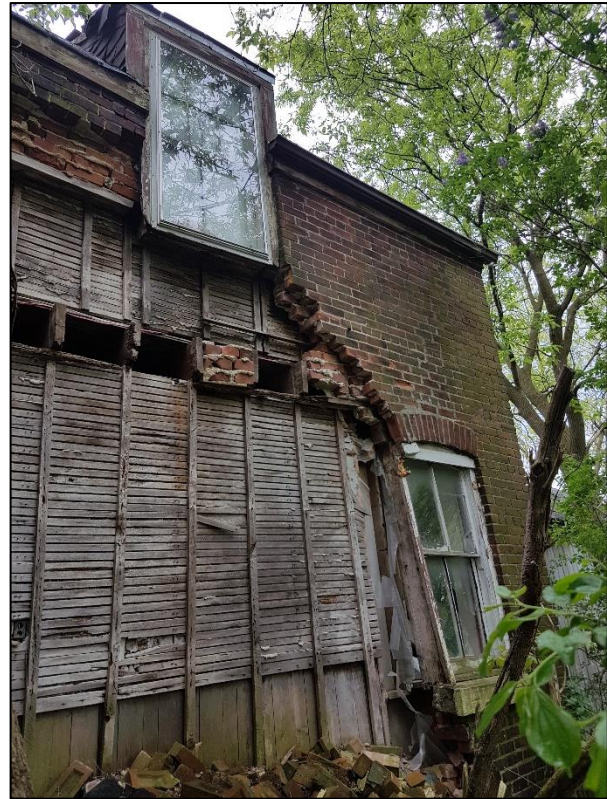
Figure 47: North elevation detail showing deteriorated and missing exterior wall, dormer window and first-floor window opening
(ASI 2019)
