**CITY OF VAUGHAN  
HERITAGE VAUGHAN COMMITTEE  
AGENDA**

**TITLE: PROPOSED RELOCATION OF 2-STOREY HERITAGE BRICK  
DWELLING AT 10436 HUNTINGTON ROAD ON THE SAME  
PROPERTY**

357, 365, & 375 Stegman's Mill Road  
City of Vaughan, Ontario

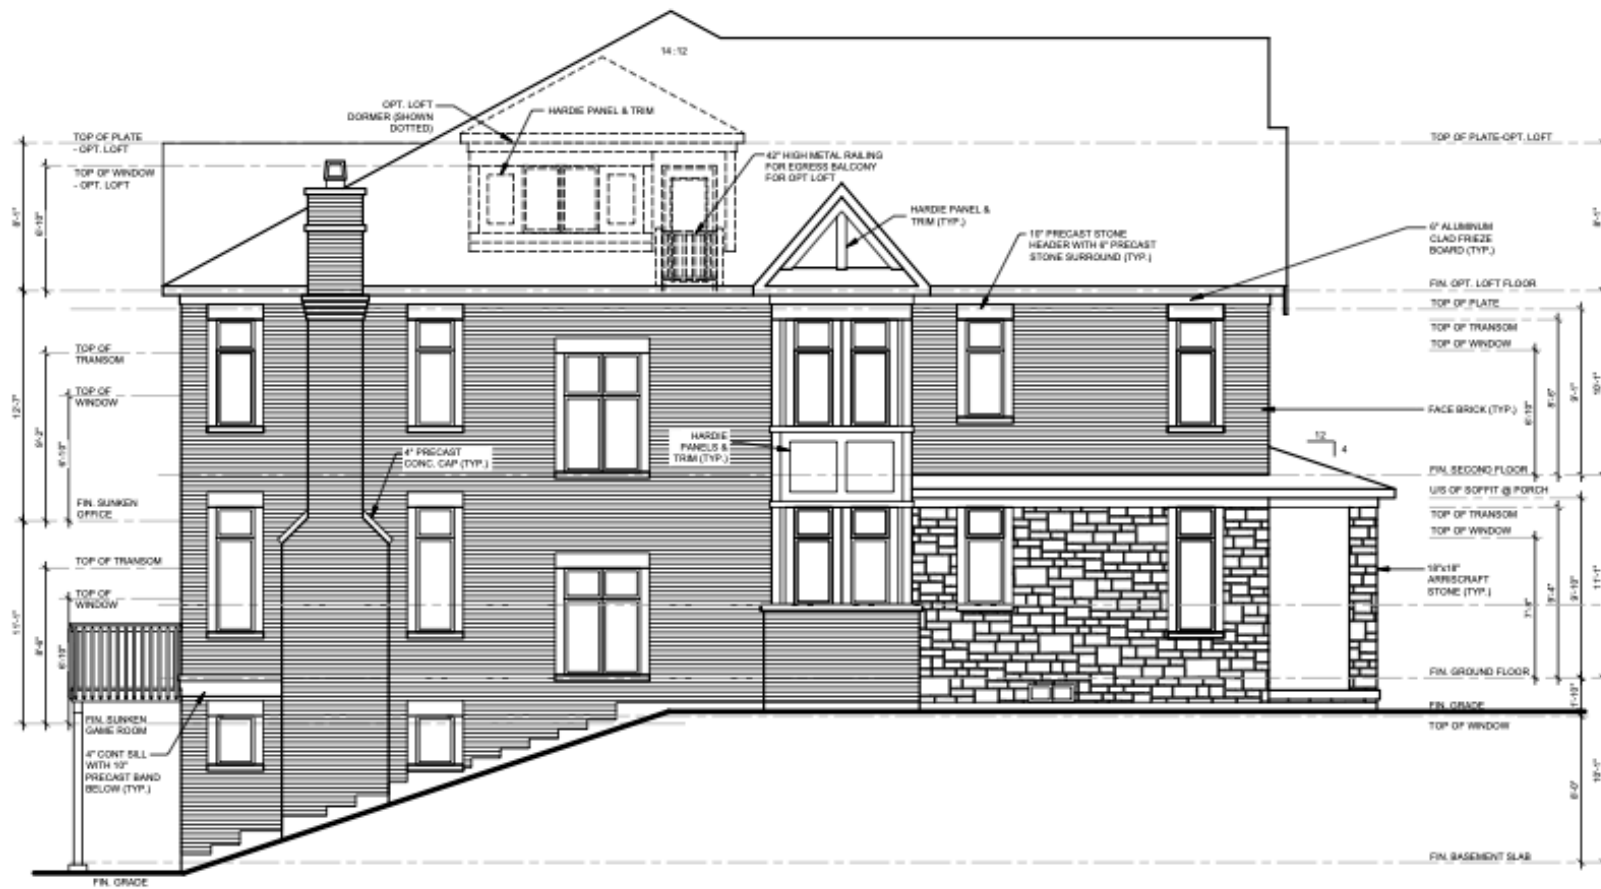
50-3 UNITS 1 AND 13  
LEFT SIDE UPGRADE ELEVATION 'A' FOR WALK OUT BASEMENT - OPT.1  
WITH REAR ELEVATION UPGRADE FOR OPT. 1

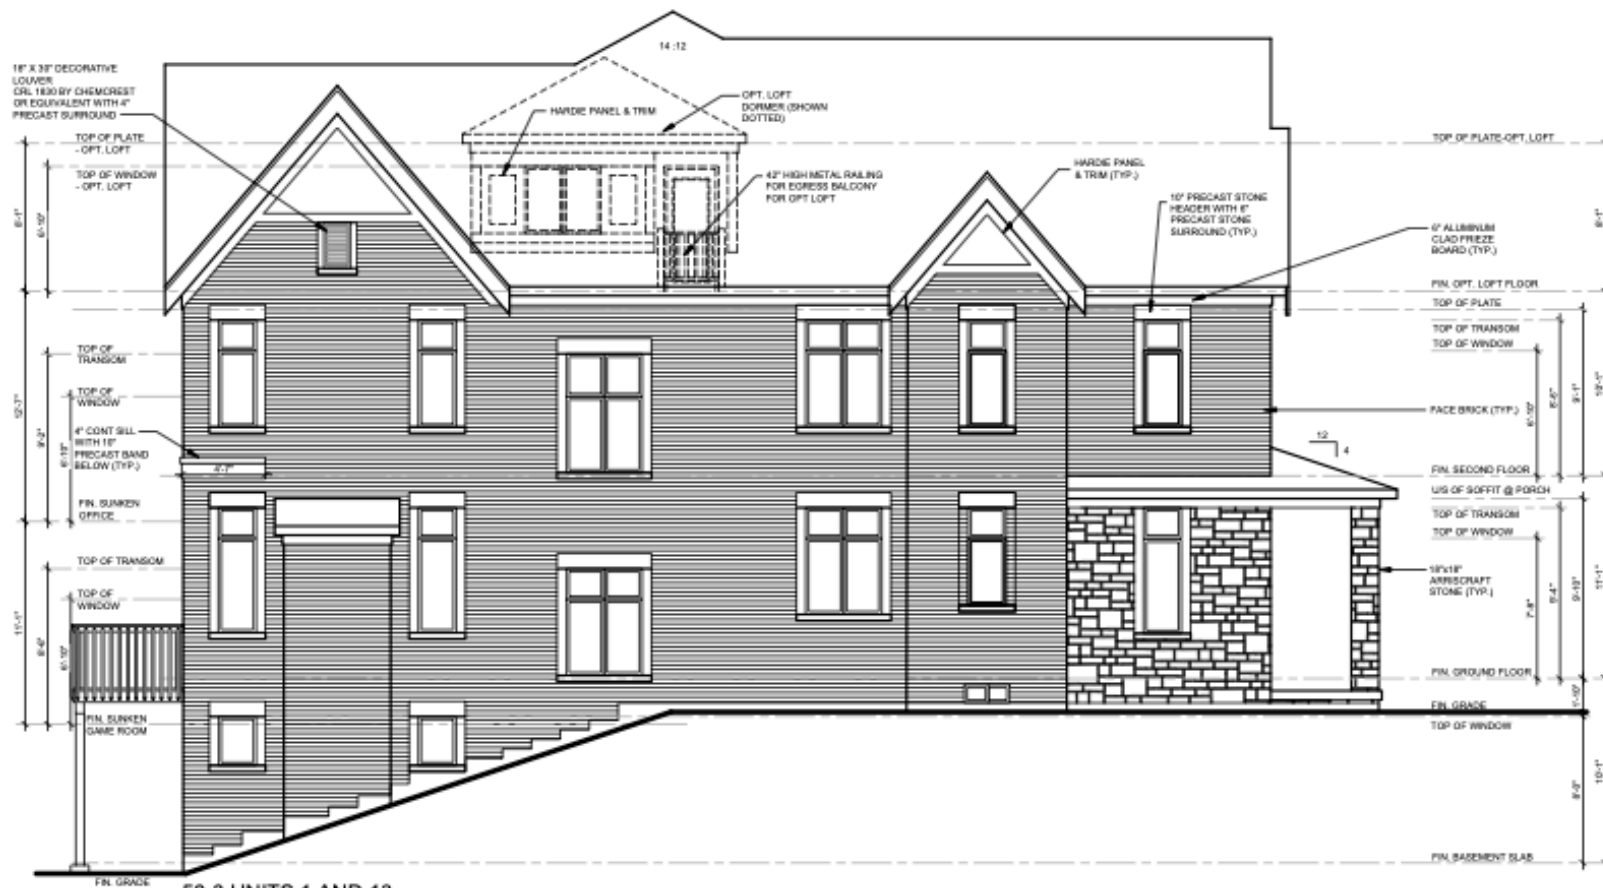
50-3 UNITS 1 AND 13  
LEFT SIDE UPGRADE ELEVATION 'A' FOR WALK OUT BASEMENT - OPT.2  
WITH REAR ELEVATION UPGRADE FOR OPT. 2

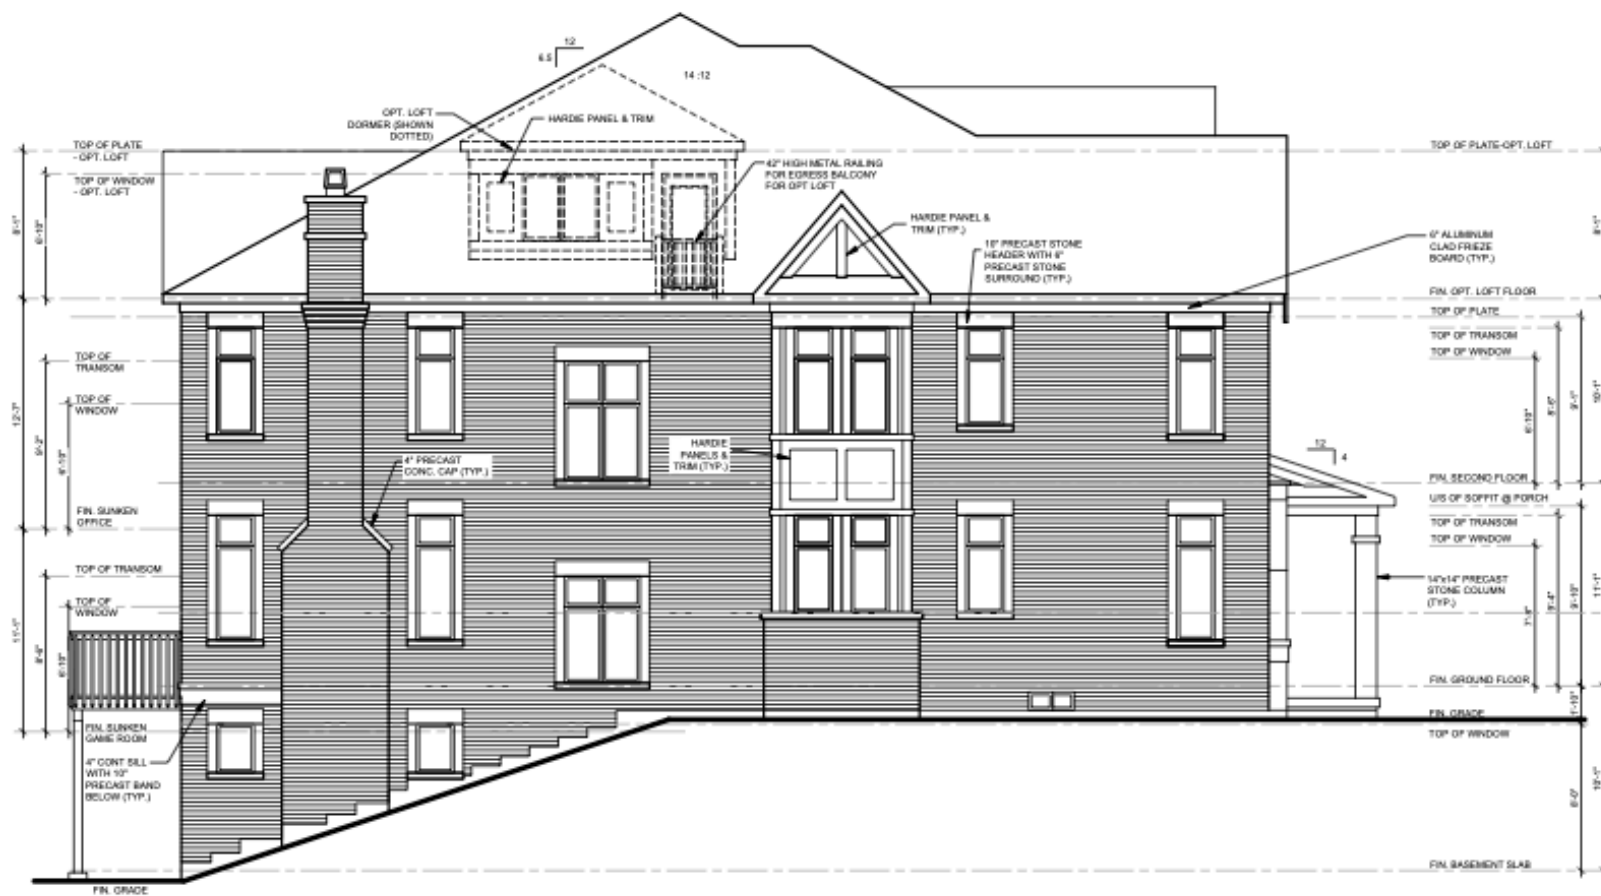
50-3 UNITS 1 AND 13  
LEFT SIDE UPGRADE ELEVATION 'B' FOR WALK OUT BASEMENT - OPT.1  
WITH REAR ELEVATION UPGRADE FOR OPT. 1

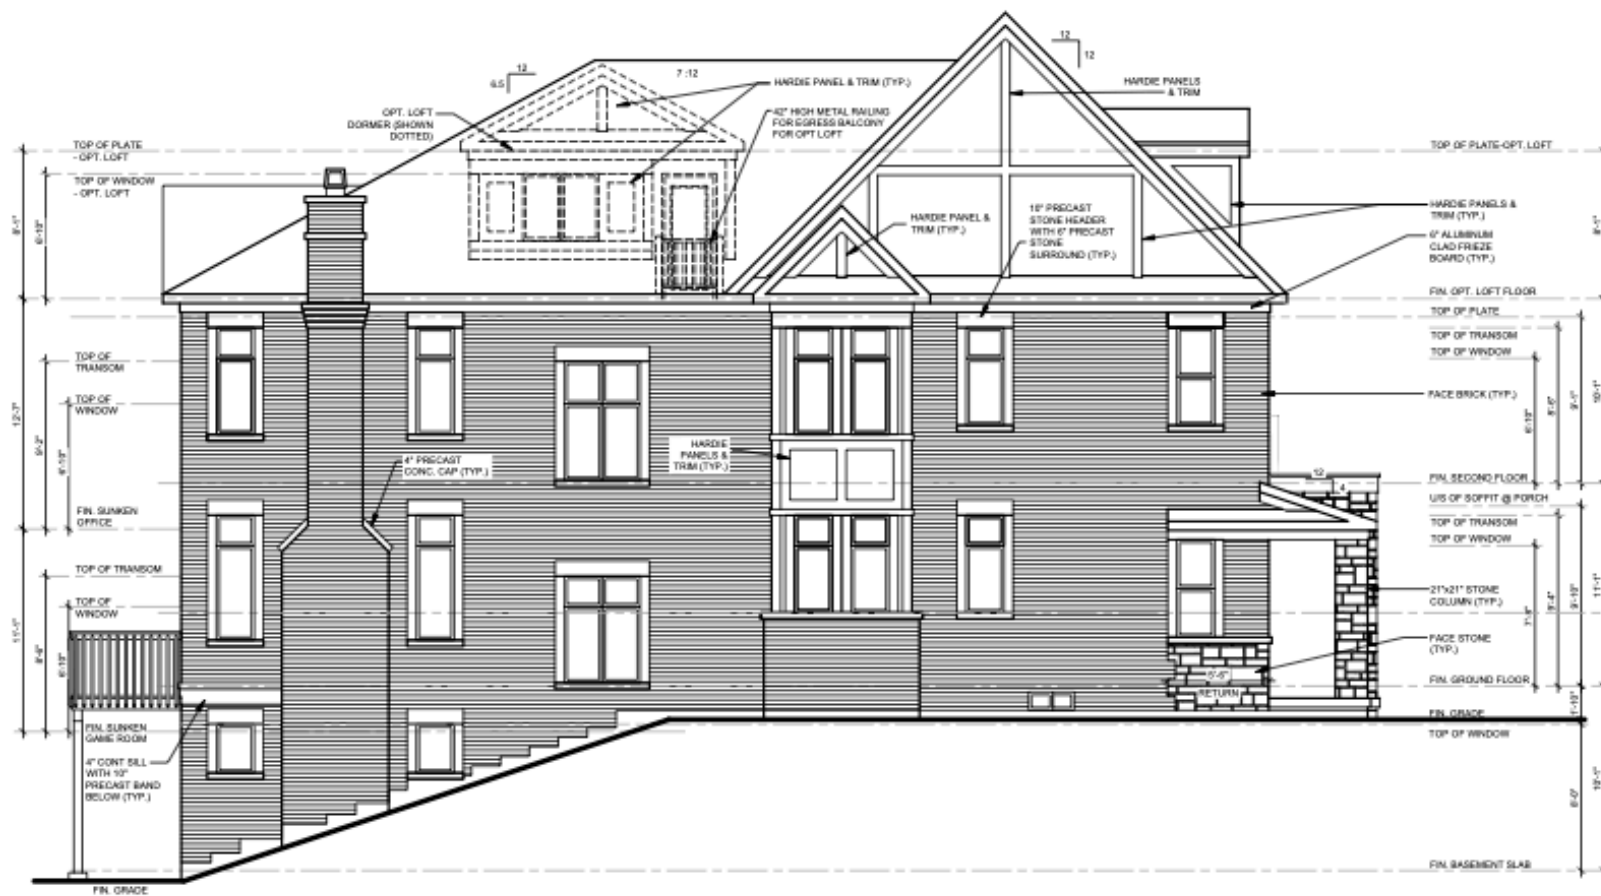
50-3 UNITS 1 AND 13  
LEFT SIDE UPGRADE ELEVATION 'C' FOR WALK OUT BASEMENT - OPT.1  
WITH REAR ELEVATION UPGRADE FOR OPT. 1

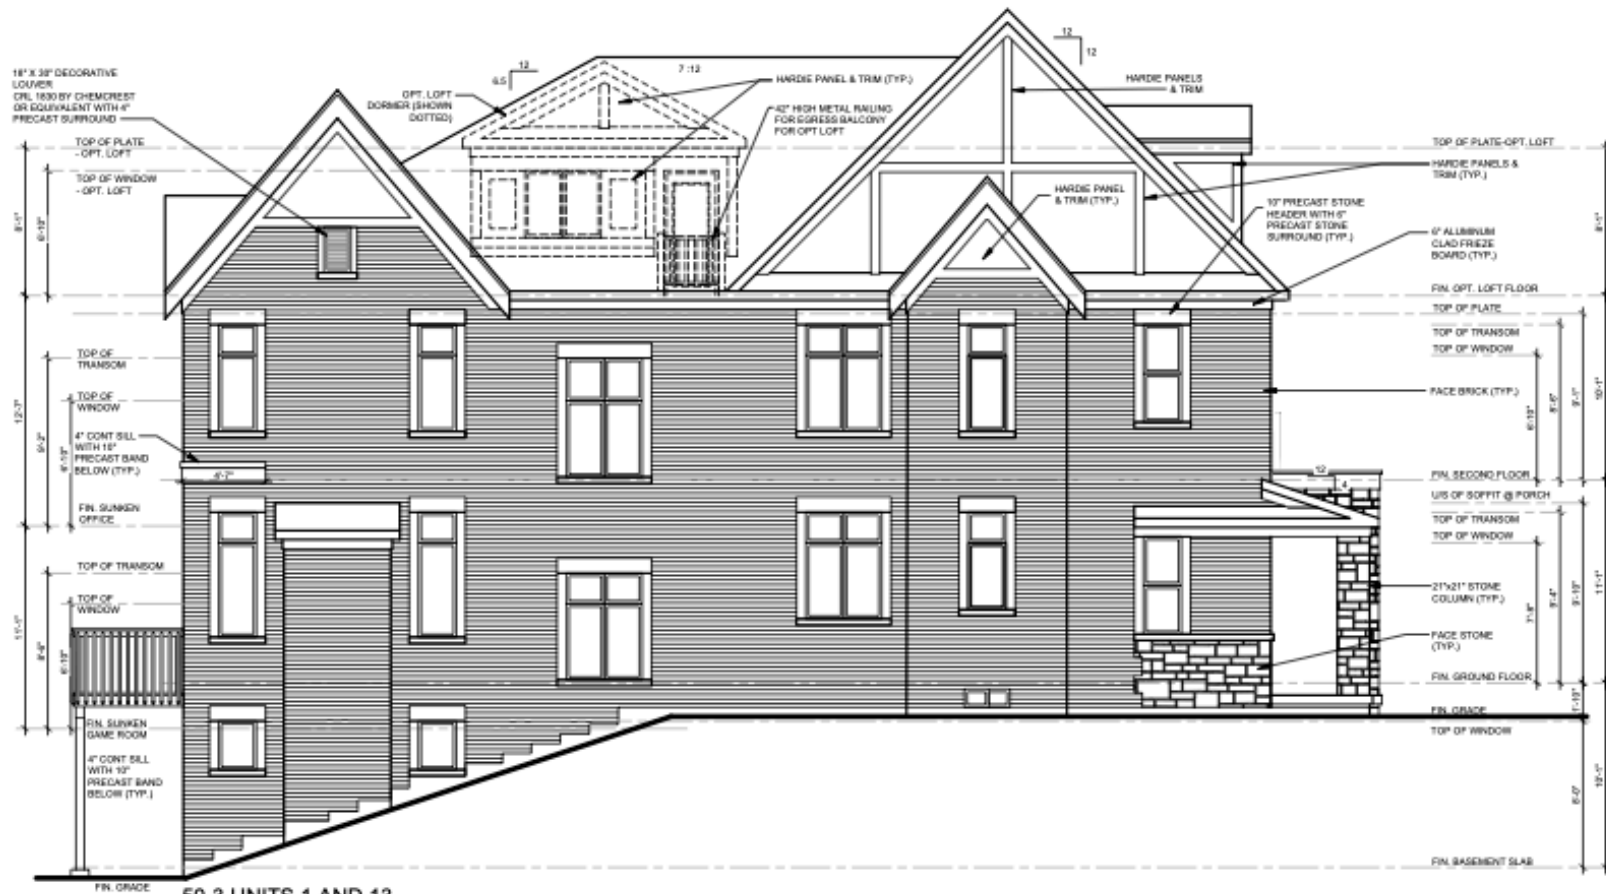
50-3 UNITS 1 AND 13  
LEFT SIDE UPGRADE ELEVATION 'C' FOR WALK OUT BASEMENT - OPT.2  
WITH REAR ELEVATION UPGRADE FOR OPT. 2

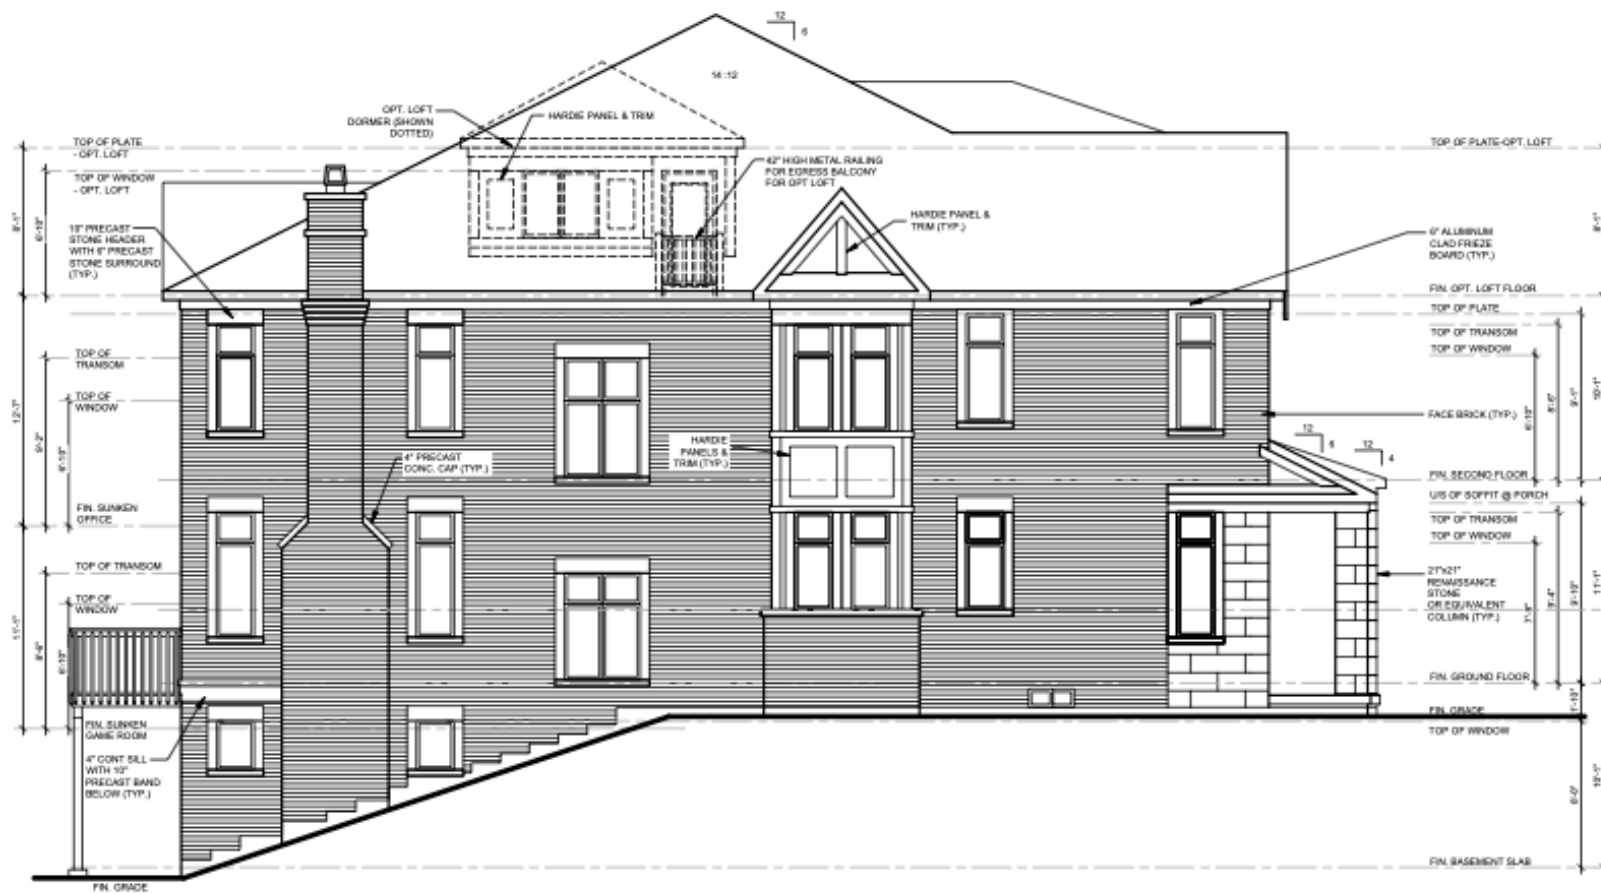
50-3 UNITS 1 AND 13  
LEFT SIDE UPGRADE ELEVATION 'D' FOR WALK OUT BASEMENT - OPT.1  
WITH REAR ELEVATION UPGRADE FOR OPT. 1
