### A086/22

Dear City of Vaughan Staff and members of the Committee of Adjustment:

In response to Minor Variance Application A086/22 for 19 Granary Road, I am the immediate, adjacent neighbor at 25 Granary Road and submit the following comments along with two attachments. My family has been negatively impacted by the ongoing construction and other commercial business activity at 19 Granary Road for more than a year now. I am opposed to the variances being requested by the Applicants for the following reasons:

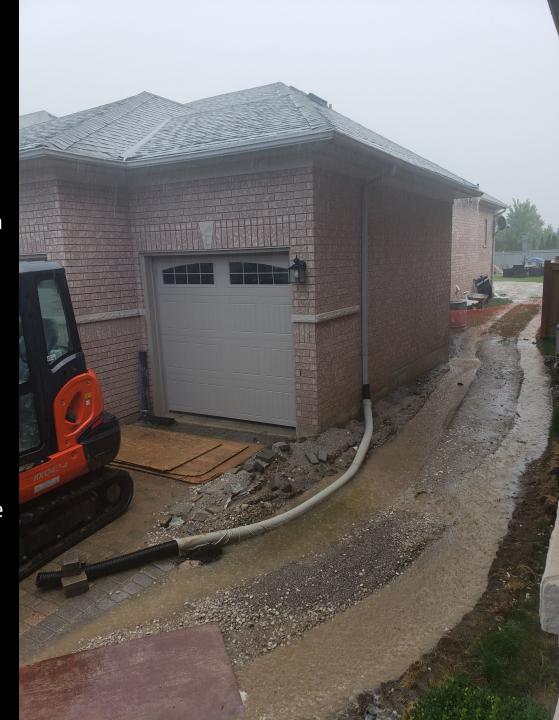
Picture A - taken August 29, 2021.

- View between 19 Granary (left) and
   25 Granary (right)
- 1. Applicant has altered grades on both 19 Granary and 25 Granary Road properties, the swale is gone, two downspouts are blocked at 25 Granary Road by construction soils and water is ponding.
- 2. Original grades and swale must be restored between properties.
- 3. As per Applicants drawing: No grade changes or hardscaping within 0.6m of the property line will be made. Therefore, any walkway along the Applicants' property cannot extend into the 0.6m along the property line.

- d. Original grades and swale **must** be restored between properties.
- e. The stone waterfall wall recently constructed along the pool is not shown on the Applicants Pool Permit Plan drawing and not clear if this is part of the pool permit.

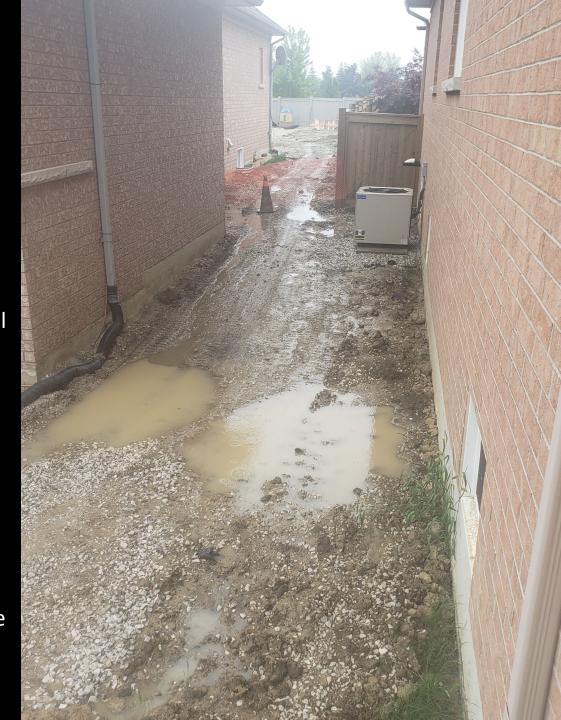
Picture B - taken June 7, 2022.

- View between 19 Granary (left) and
   25 Granary (right)
- 1. Current condition between homes.
- Applicant has refused to reinstate original condition at 25 Granary Road, including swale. Ongoing legal dispute.
- 3. Stormwater is not flowing from backyard at 25 Granary Road, two downspouts are blocked by construction soils and water is ponding.
- 4. Original grades and swale must be restored between properties.
- 5. As per Applicants drawing: No grade changes or hardscaping within 0.6m of the property line will be made.

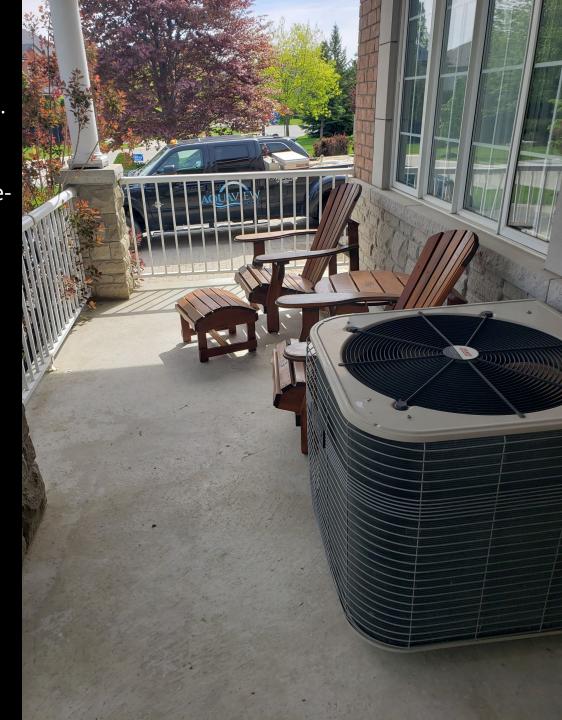
Picture C - taken Monday May 23, 2022.

- Victoria Day Monday
- View of my AC on my porch that Applicant removed and refusing to reinstate.
- Applicant removed my AC at 25 Granary for construction access and refused to reinstate in April/early May 2022 before warm temperatures commenced.
- 2. I had to commence legal action against the Applicants at great expense to reinstate the AC and pursue repairs for damage to my foundation wall.
- 3. AC was finally reinstated on May 24, 2022. Legal action & claim for foundation wall damage etc. is pending.

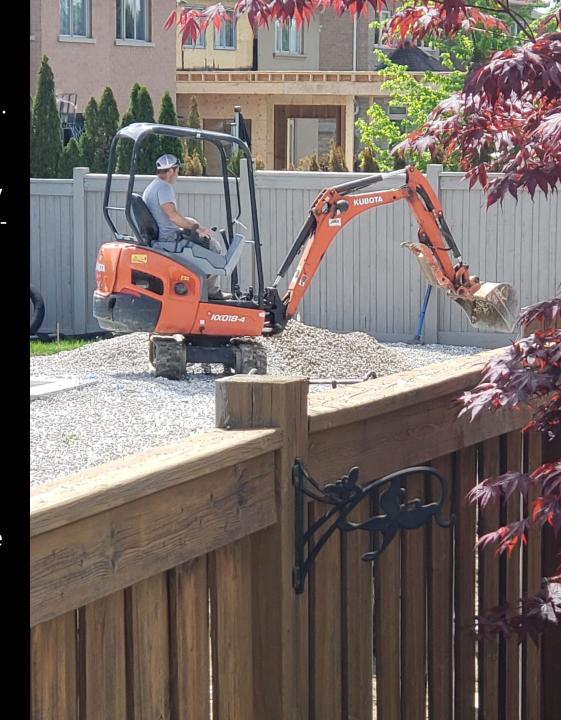
Picture D - taken Monday May 23, 2022.

- Victoria Day Monday
- View of Applicant operating construction equipment on Statutory Holiday contrary to Noise By-law 121-2021.
- 1. Construction work is not permitted on Sunday or statutory holidays.
- 2. Our guest that day decided to go home rather than listen to the construction noise.
- 3. We have experienced many intrusions into our family home time with the Applicant running his Bobcat back and forth on Sundays and other days causing excessive noise and vibration to our home.

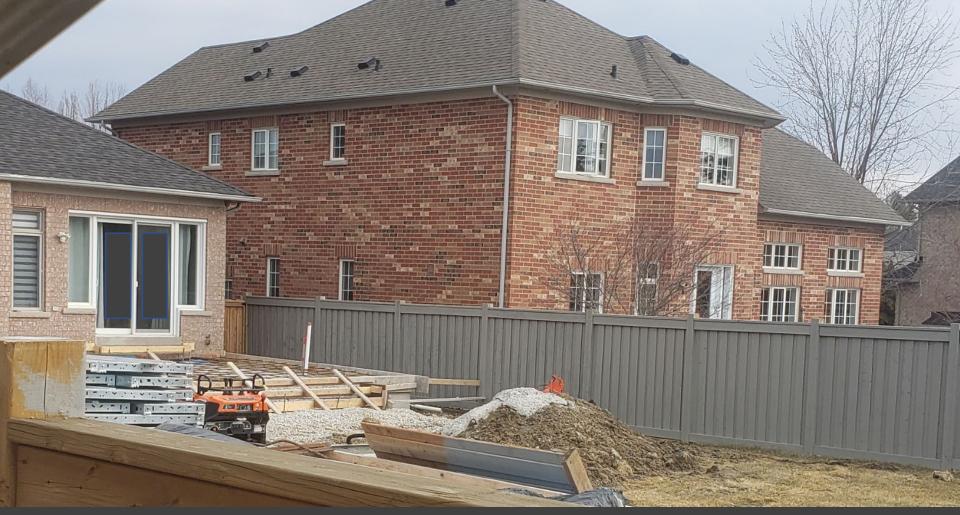
Picture E - taken Tuesday May 24, 2022 at 7:00am.

View of Applicant's own construction company Core Precision Interlock Inc. picking up construction equipment to bring to other job sites which is a typical weekly occurrence.

1. Truck and trailer arrived before 7:00 am.

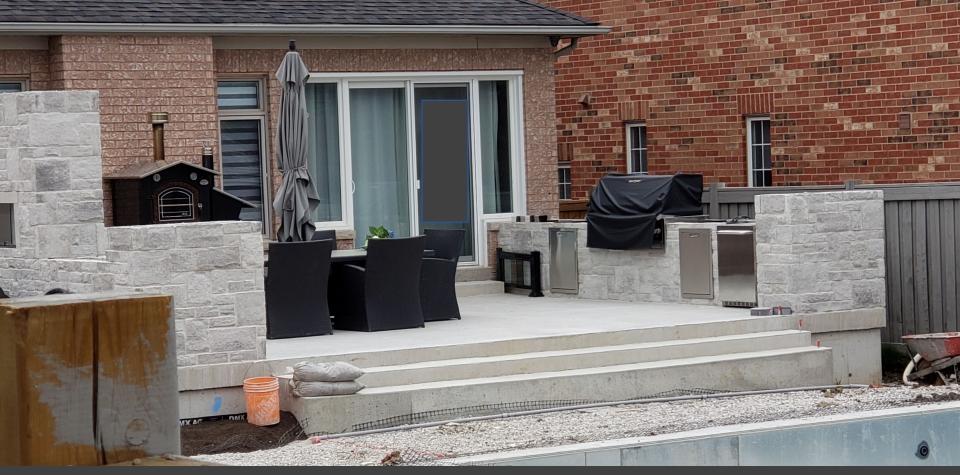
Picture F - taken March 18, 2022.

• View of Applicant's concrete structure with full foundations built after they said it was.

- 1. Applicants Pool Permit Plan drawing dated March 6, 2022 indicates "existing concrete patio" but picture clearly shows that the concrete structure was not existing on March 18, 2022.
- City of Vaughan to confirm building permit requirements.

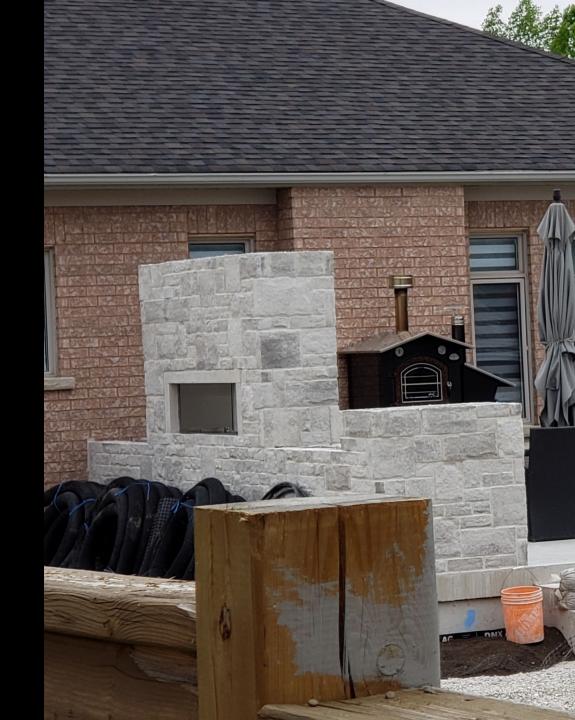
Picture G - taken June 5, 2022.

View of Applicant's concrete structure with full foundations.

- 1. Applicants Pool Permit Plan drawing dated March 6, 2022 indicates "existing concrete patio" but it did not exist on that date. Started Nov 2021.
- City of Vaughan to confirm if this structure is a basement extension with building permit. DMX AG Foundation Wrap Water Proofing is clearly visible.
- 3. Includes natural gas and electrical services.

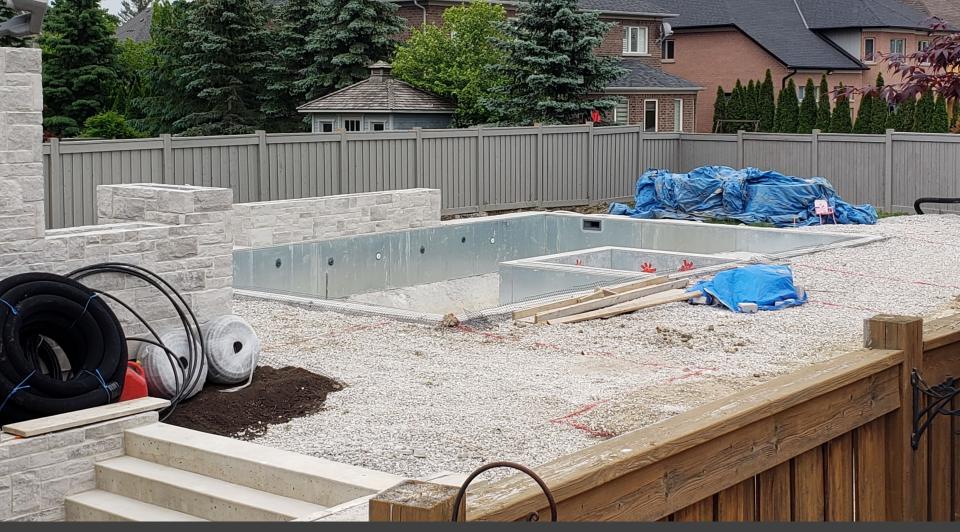
- Picture H taken June 5, 2022.
- View of Applicant's concrete structure with fireplace and full foundations.
- City of Vaughan to confirm if this a basement structure with permit.
   DMX AG Foundation Wrap Water Proofing is clearly visible.
- 2. Includes new natural gas and electrical services.

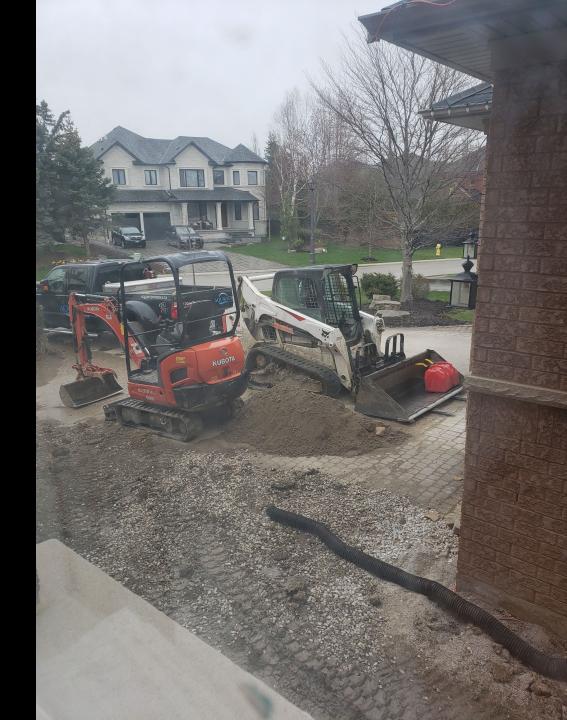
Picture K - taken Sunday May 1, 2022.

- View of Applicant's construction equipment stored on driveway.
- 1. Open fuel containers.
- 2. A disaster to look at from my porch.

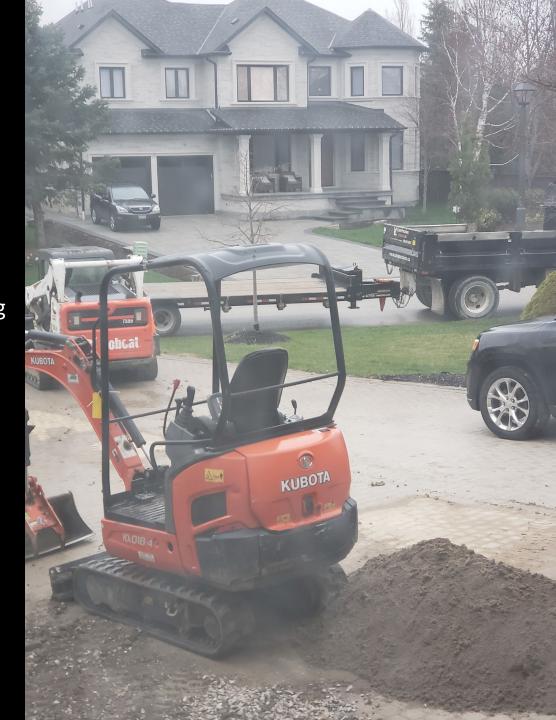
Picture L - taken Monday May 2, 2022.

- View of Applicant's construction equipment being picked up by their construction company Core Precision Interlock Inc to transport to another of their job sites.
- 1. Truck usually shows up early morning before 7 am and the thud of the ramps being let down can be heard plus the back-up beeping of machines.

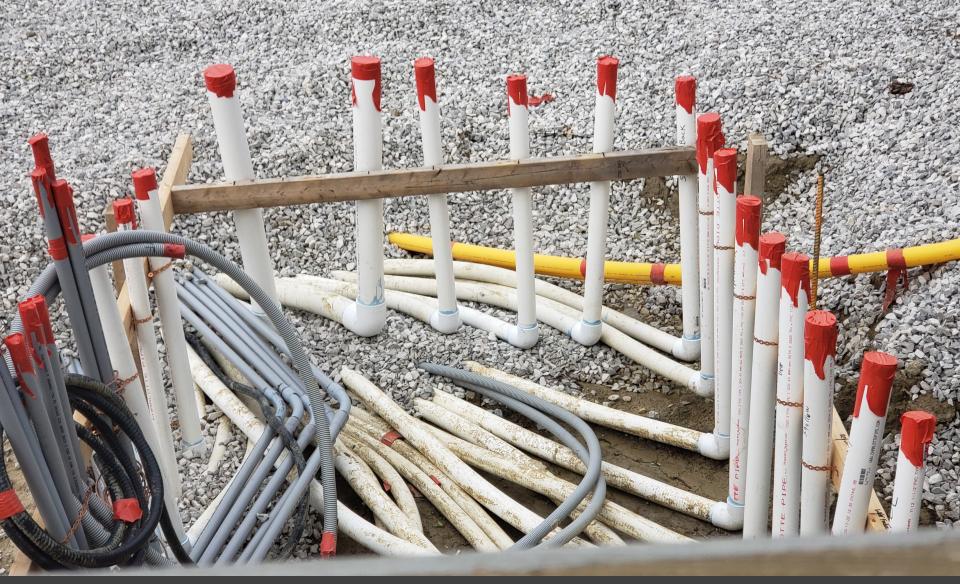
Picture M - taken June 1, 2022.

View of Applicant's pool equipment rough-in.

.. Rough-in area with numerous hoses and conduits appears far larger than on the Applicants drawing. What is the size of the pool equipment room?
