46 CENTRE STREET, THORNHILL

CULTURAL HERITAGE IMPACT ASSESSMENT (CHIA) REV.III

FINAL
SEPTEMBER 17, 2021

PREPARED FOR
PHAEDRUS STUDIO

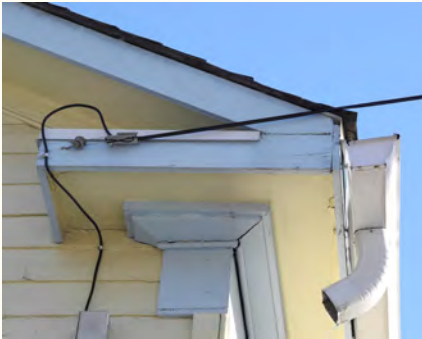
Drainage	
<p><i>Description:</i> Externally mounted aluminum eaves and downspouts used on both main house and tail addition. Eaves are mounted onto fascia boards. Aluminum flashings are used between shingles and eaves, as well as fascia returns and at chimney.</p> <p><i>Condition:</i> Eaves and downspouts are in fair condition where present. Front eaves connection is slowly failing, likely related to poor condition of anchoring fascia boards. Downspout disconnected and missing at southwest corner of main house, discharging water directly onto wooden siding.</p>

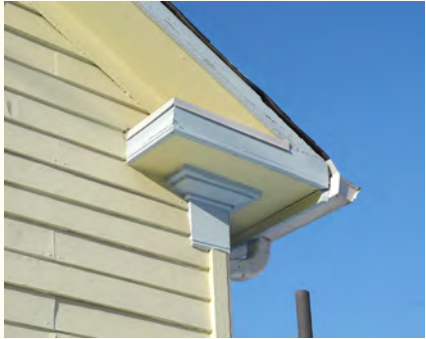
Fascia & Soffit	
<p><i>Description:</i> Wooden fascia and soffit boards used throughout both main house and tail addition. Fascia boards are painted baby blue, with minor variations in dimensions throughout. Generally unadorned dimensioned lumber, some (presumably historic) fascia boards are embellished with a bead profile. Certain boards appear to have been replaced with eavestrough installation, being unadorned and taller than others. Soffit boards are dimensioned lumber painted yellow, and slightly recessed from the fascia bottoms.</p> <p><i>Condition:</i> Fascia boards are in fair to poor condition. Paint failure observed throughout, with rotting and warped wood apparent in many cases as well. Boards displaying historic detailing are in particularly poor condition.</p> <p>Soffits are in fair condition, displaying a moderate amount of paint failure throughout. Wood beneath is weathered, but not compromised to the degree of the fascia boards.</p>

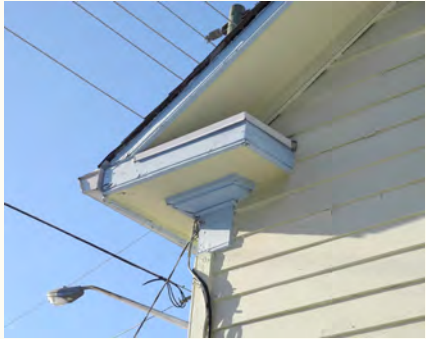
Flashings	
<p><i>Description:</i> Metal flashings are primarily used at the fascia returns, and between the roof deck and eaves. Flashings above front door and at chimney are dealt with separately.</p> <p><i>Condition:</i> Flashing at fascia returns appear to be in good condition, displaying no obvious defects.</p> <p>Flashings at eaves are in fair condition, but could be compromised by the ongoing failure of fascia boards.</p>

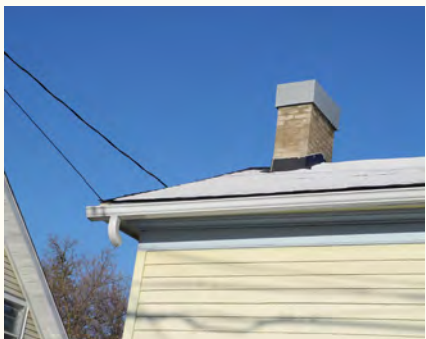
Chimney	
<p><i>Description:</i> Exterior chimney is comprised of non-historic grey (concrete) bricks, surmounted by a galvanized metal cap.</p> <p><i>Condition:</i> Chimney appears to be in good condition. No obvious defects observed on brickwork, mortar, flashings and metal cap. Condition of materials beneath metal cap undetermined.</p>

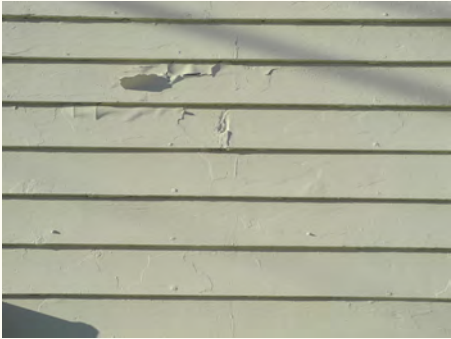
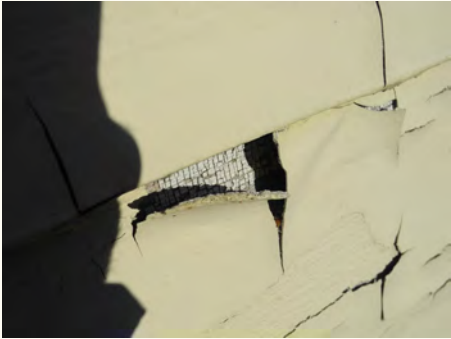
Siding	
<p><i>Description:</i> Primary cladding material is painted wooden siding, consistently sized and running continuously between the main house and tail addition. The use of machine cut wrought iron nails suggests the cladding is not original but still historic. The lower three courses have been replaced with a non-wood cladding presenting as siding of similar dimensions and finish. Siding butts into the vertical board framing the corners, which feature a bead at the corner itself. Replacement material appears to have been used at the exposed portion of the main house's north elevation (metal or vinyl) and at the gable end of the tail addition (material undetermined).</p> <p><i>Condition:</i> The wood siding appears to be in worn but fair condition overall. Paint failure is found throughout, but is worst on the elevation. Manifests in bubbling or delamination revealing older finishes below. Wood appears weathered, but sounds where exposed with relatively little cracking or rot observed. A large area of unrepaired nail holes with associated paint failure are found above the front door of the main house, likely related to previous signage. Instances of splitting and cracked boards observed at east side of south elevation, potentially indicative of movement in house frame. Numerous services penetrate or are mounted on siding. In some cases penetrations are unprotected holes, which likely make the cladding system pervious to moisture. Damage related to other mountings / openings not confirmed.</p>

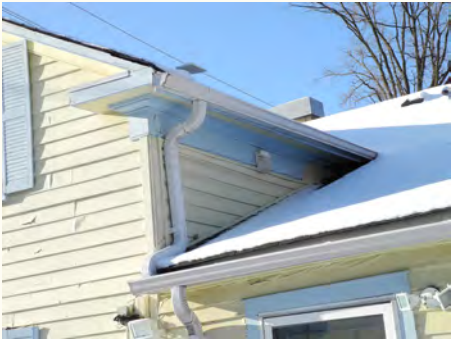
Mouldings	
<p><i>Description:</i> Mouldings form cornices beneath soffits on both the main house and tail addition. There are two types: Mouldings beneath the flat eaves are bolder and more complex, built of an ogee and beaded frieze board. These are painted baby blue. Mouldings within the gables by contrast are simpler and subtle, comprised of a beaded board and painted yellow to match the siding.</p> <p><i>Condition:</i> Wooden mouldings are in fair condition overall. Light to moderate paint failure observed throughout, while wood generally appears sound. Failure is darker and more several in several locations, and further investigation is required to determine integrity of nearby wood. Some separation of assembly noted at southwest corner of main house, along with damage to frieze board at northeast corner.</p>

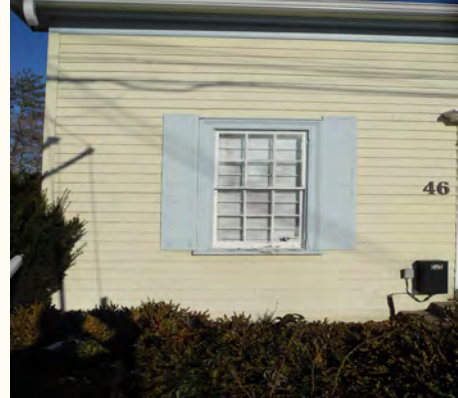
Window sashes are in fair condition overall. Paint failure is common throughout, with cracking exposing areas of bare wood in certain cases. Integrity of wood frames undetermined, but no major areas of rot observed. Putty failure common throughout, with several instances of cracked glass at second floor windows.

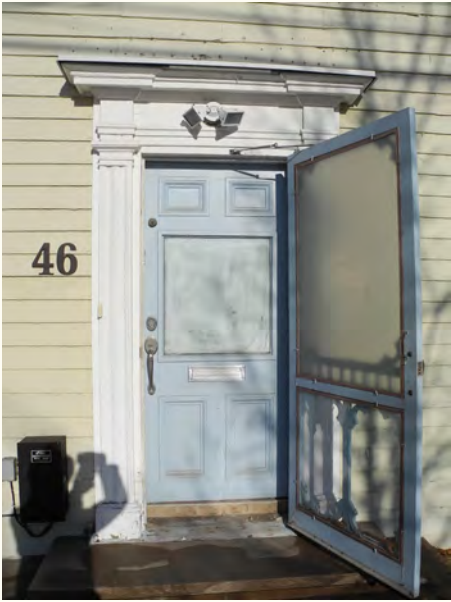
Doors	
<p><i>Description:</i> Front door is a modified panel door, with the middle panels replaced by a single glazed opening. Hardware not historic. Panels are surrounded by bolelection mouldings. A front storm door is frame style with decorative braces and spindles. Norfolk-style brass handle on storm door with latch removed.</p> <p><i>Condition:</i> Door is in good condition, displaying minor paint failure / cracking at horizontal surfaces and joints. Screen door is in fair to poor condition, with paint failure through, rotting wood, and damaged decorative braces.</p>

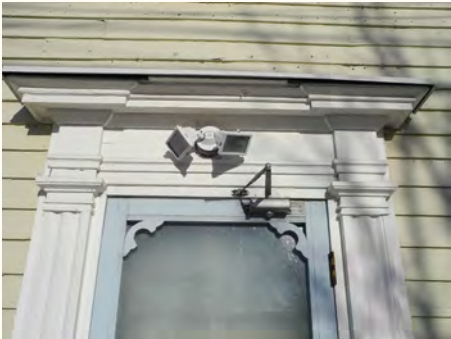
Surrounds	
<p><i>Description:</i> Front door surround is an elegant wooden entablature, with a pair of pilasters rising to a frieze above. The built-up assembly is painted white and topped by a large flashing. A wood sill sits at the bottom, several inches below the main door.</p> <p><i>Condition:</i> Door surround is in fair to good condition. Integrity of the assembly is very high, with only a small band missing material atop the west pilaster. Minor paint failure throughout, with two bases displaying more severe paint failure and a degree of rot. In appropriate lighting penetrates the centre of the frieze, and the flashing does not respond to the undulations of the profile, harming the overall effect. Sill is in poor condition, being highly worn from total finish failure and environmental exposure.</p>

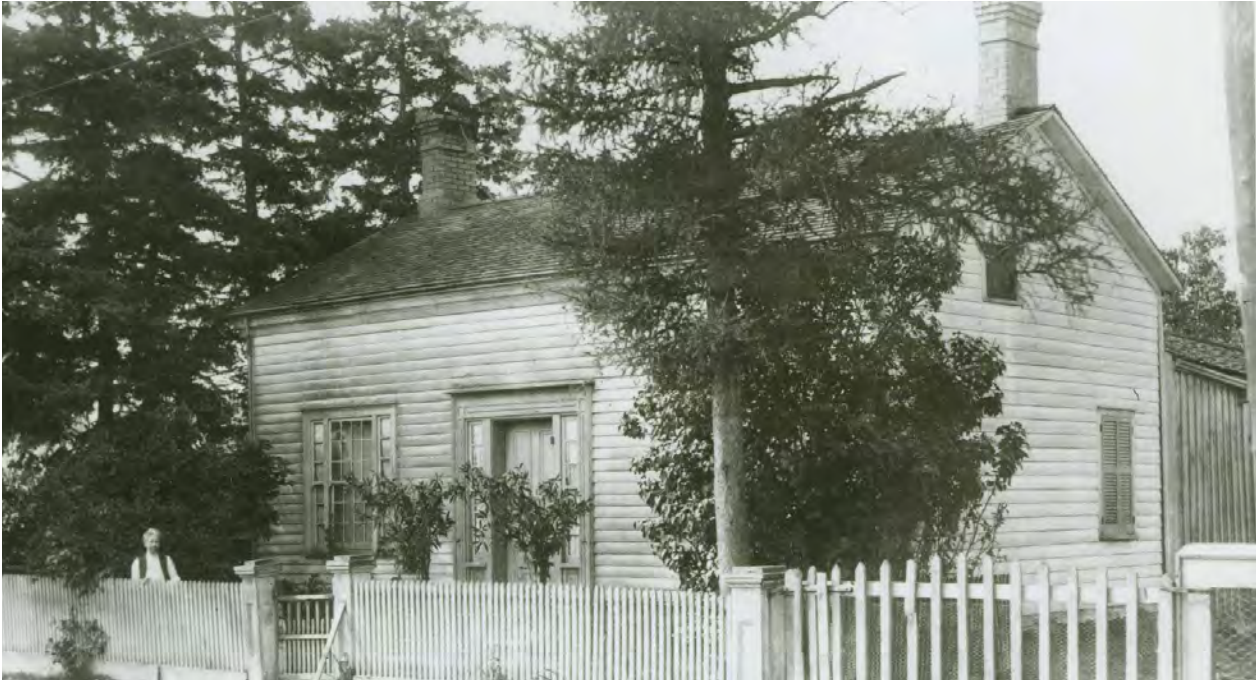
Figure 3: William Watson house, c1900. The vertical board and batten siding of the addition differentiates it from the main house which is clad in horizontal wood siding. Source: Thornhill Archives, Weaver Collection, Thornhill Houses and Buildings.

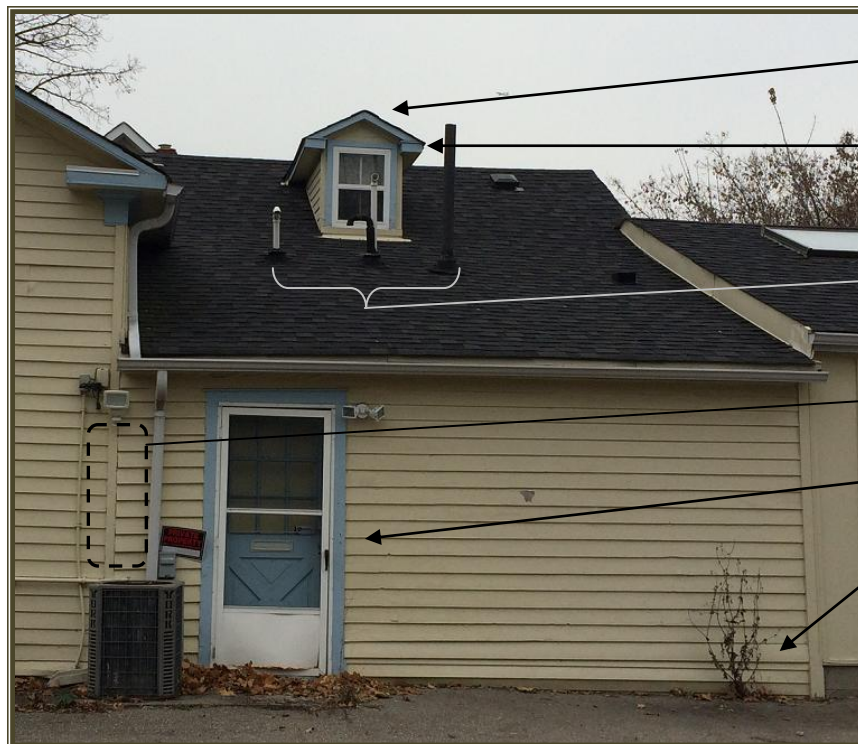
- Small gabled dormer with double hung window
- Note eaves returns
- Dormer obscured by building services
- Painted beveled wood siding to match existing in width if not in coursing
- Aluminum screen door
- Irregular coursing - on walls of both masses siding is not terminated or differentiated from the foundation

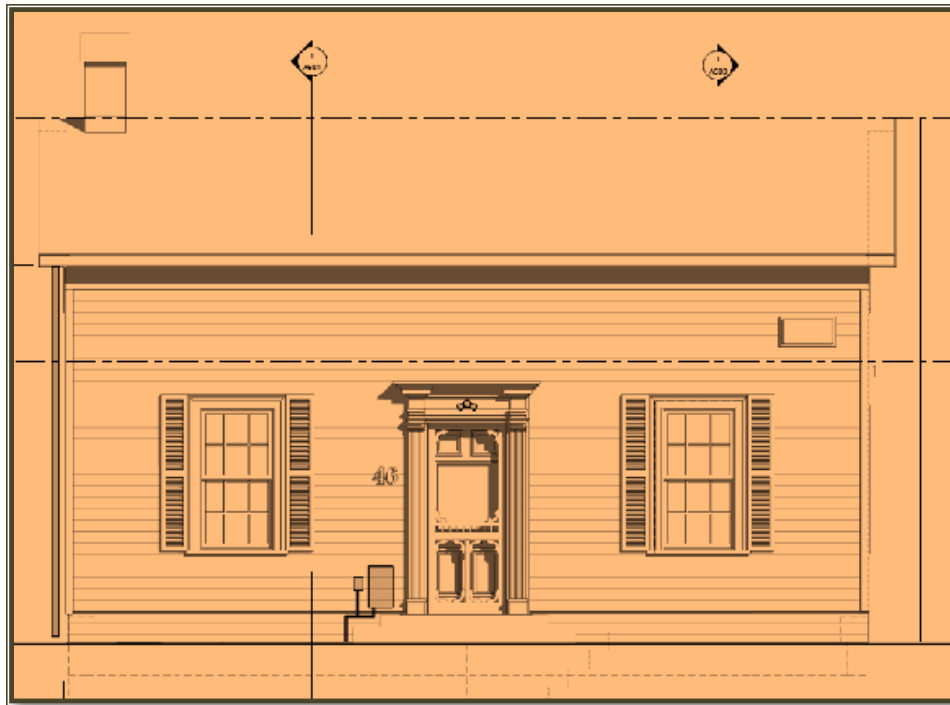
5.3.2 Measured drawing of front elevation showing the symmetrical facade with well-detailed classical door surround, courtesy Phaedrus Studio, 1 August 2017.

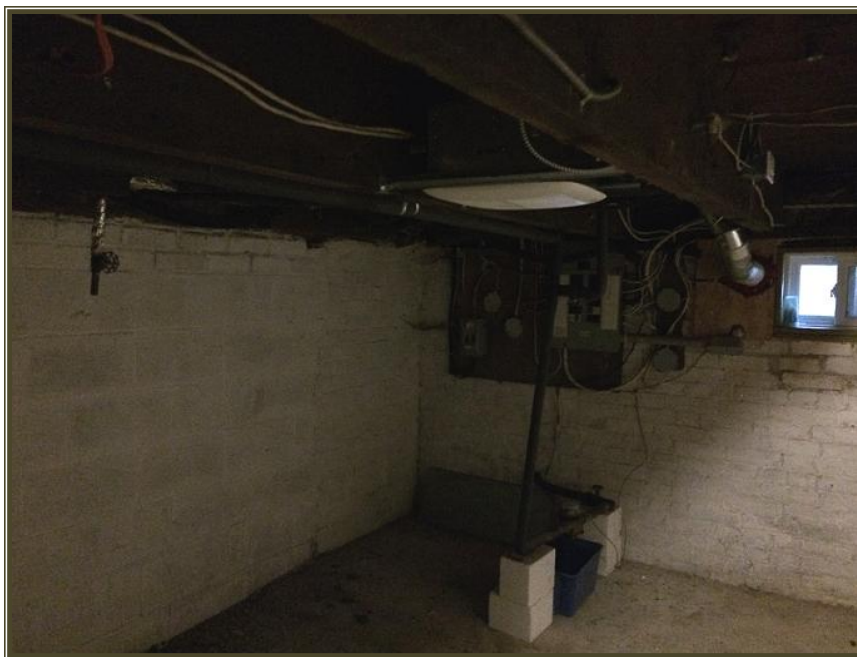
5.4.2 Southwest corner of painted brick foundation beneath tail addition, 15 November 2017.

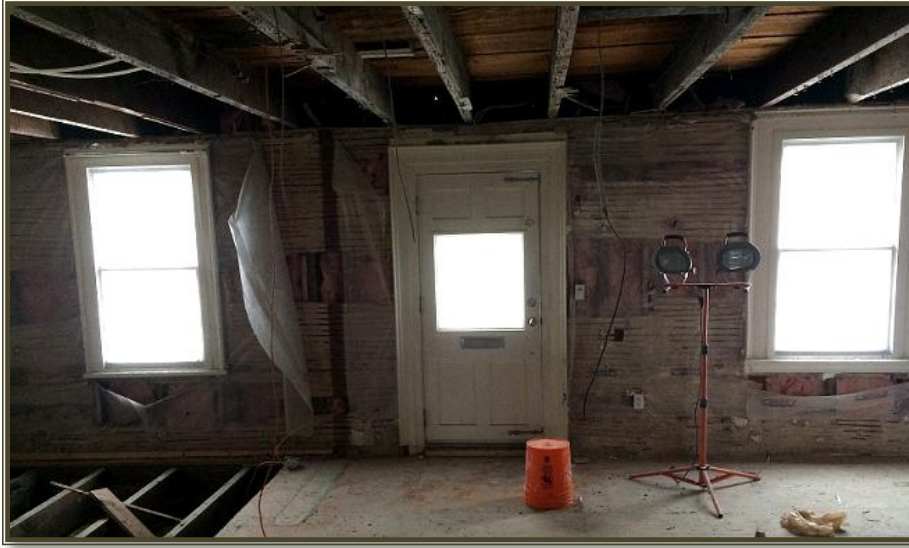
5.4.3 View of interior of front (south-facing) wall of probable original mass, 15 November 2017. Note compressed space between top of windows & door and upper floor joists.
