**CULTURAL HERITAGE IMPACT
ASSESSMENT**

**NO. 8682 HIGHWAY 27 (REGIONAL ROAD 27)
(LOT 12, CONCESSION 9)
CITY OF VAUGHAN, ONTARIO**

**CULTURAL HERITAGE IMPACT
ASSESSMENT REPORT**

**NO. 8682 HIGHWAY 27
LOT 12, CONCESSION 9
CITY OF VAUGHAN, ONTARIO**

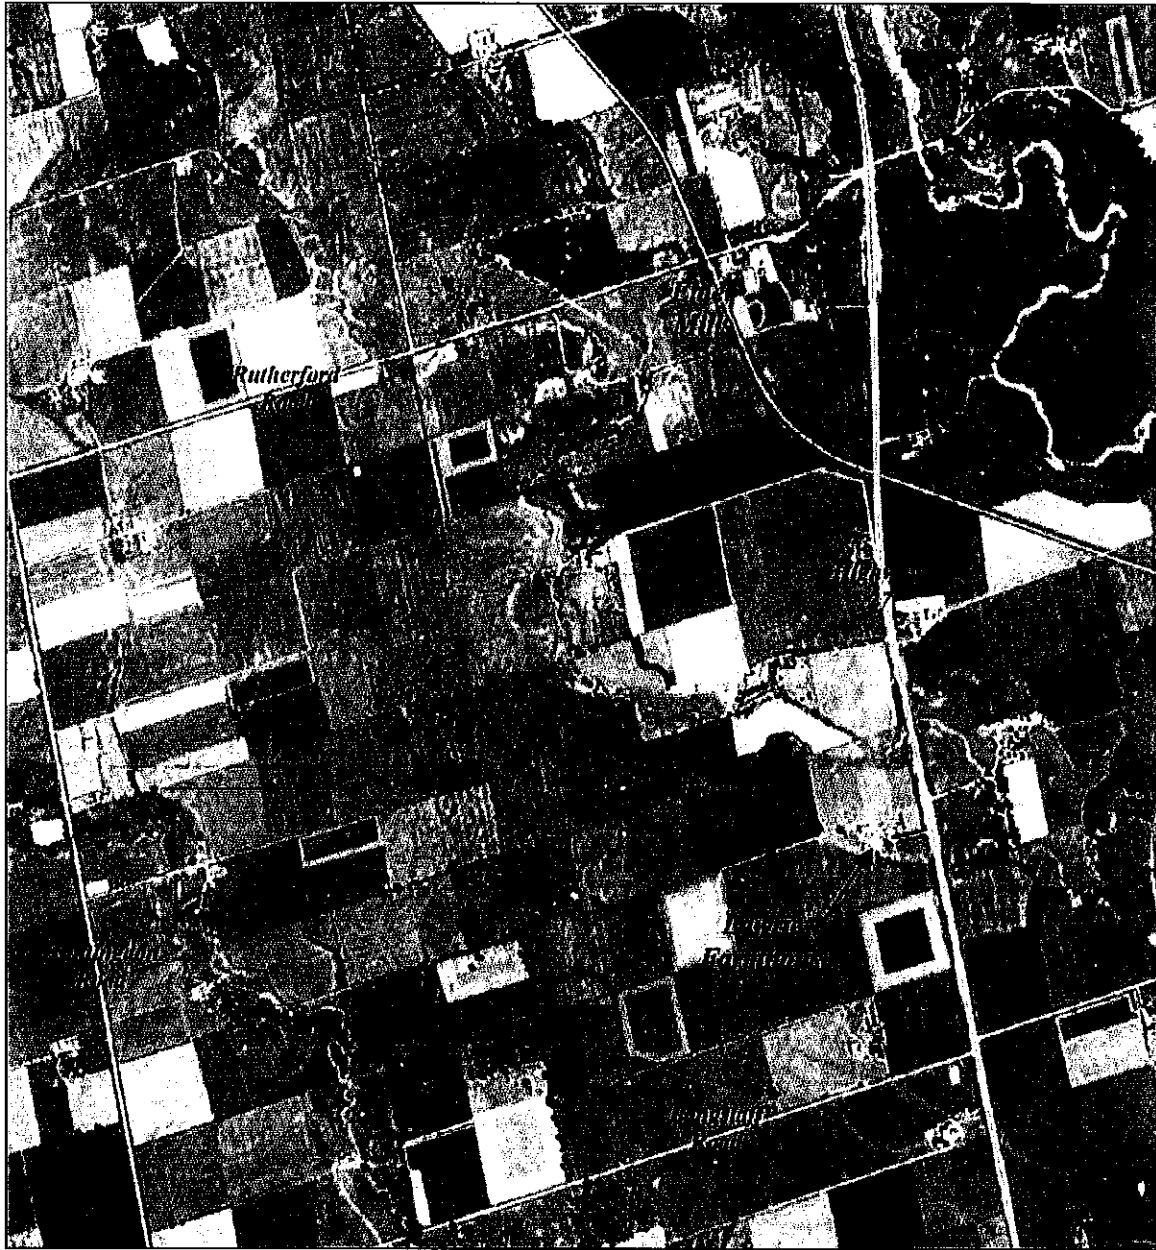
Figure 2.4
1946 (July 2) Aerial Photograph
[Source: National Air Photo Library, Roll A10118, Photo 62].

Except for the transmission corridor, all of the landscape and built heritage resources evident in the topographic map (**Figure 2.3**) appear on the 1946 aerial photograph (**Figure 2.4**). Appendix A contains aerial photographs of the study from 1946, 1960 and 2007.

In 1946, the area was rural (*Figure 2.4*) except for the hamlet of Elder Mills. Since then most of the area east of Highway 27 has been developed for urban purposes (*Figures 2.2 and 2.5*) while the area to the west remains rural.

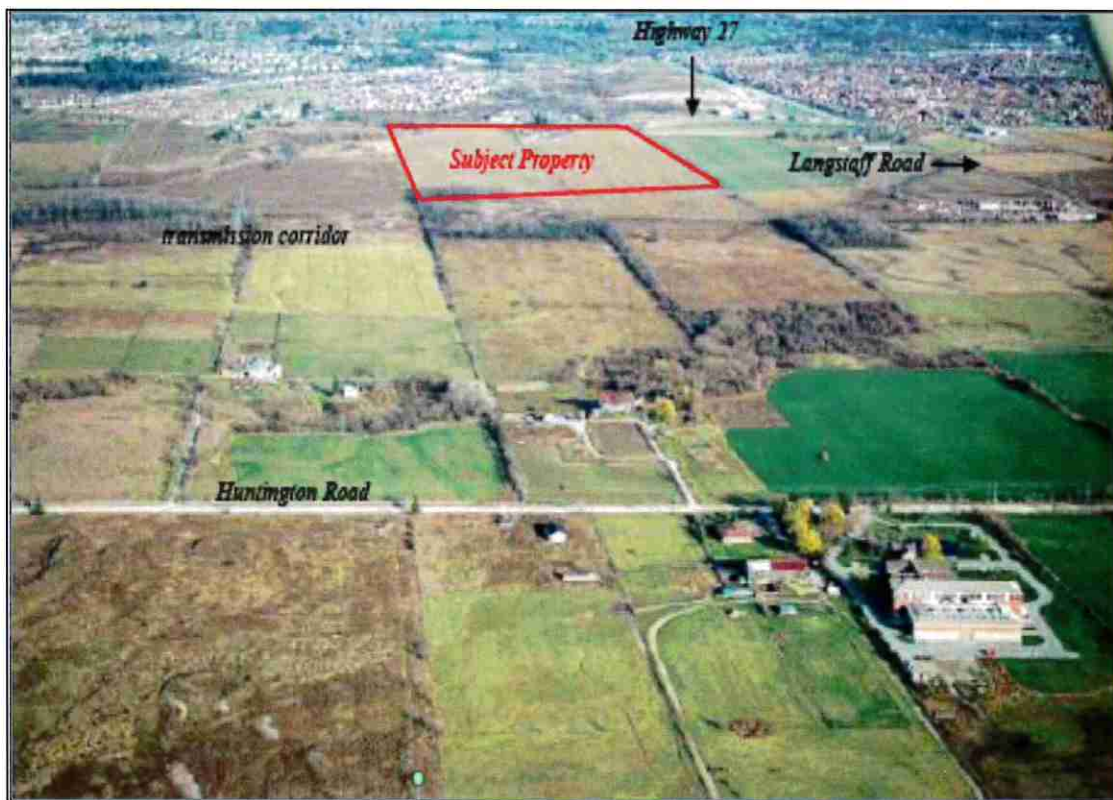
Figure 2.6
Context – View From West of the Subject Property 1999 - 2000
[Source: York Region Geomatics, Oblique Aerial Photographs].

To the west, north and south of the Lawrie Farm, the lands are rural, with a high voltage transmission corridor cutting across the centre of the block (*Figure 2.6*).

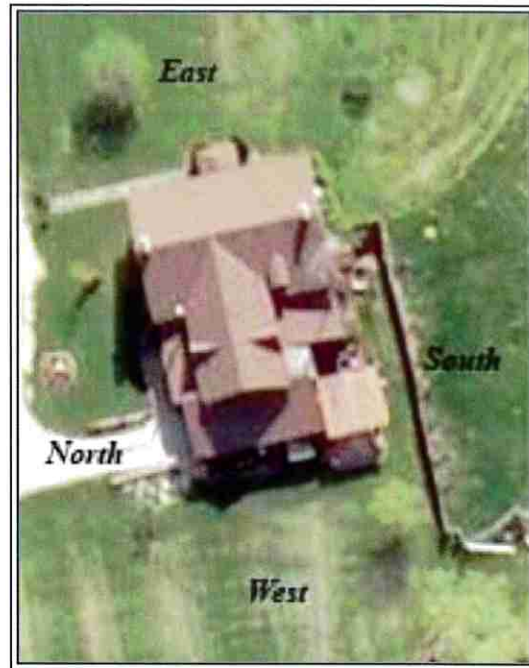
Figure 4.1
2008 Aerial View of the John Lawrie Farmhouse
[Source: Microsoft Virtual Earth].

This stone farmhouse is 'T'-shaped in plan (*Figure 4.1*) with the principal or front elevation facing east to Highway 27. The tail wing is off centre, located slightly to the north. The gable roof of the main block has two chimneys on the peak at the north and south ends. There is a small dormer window on the west slope of the roof, south of the tail wing. The gable roof of the tail wing has two gable dormers across from each other. There are additions to the tail wing, one to the rear with a shed roof, and two on either side.

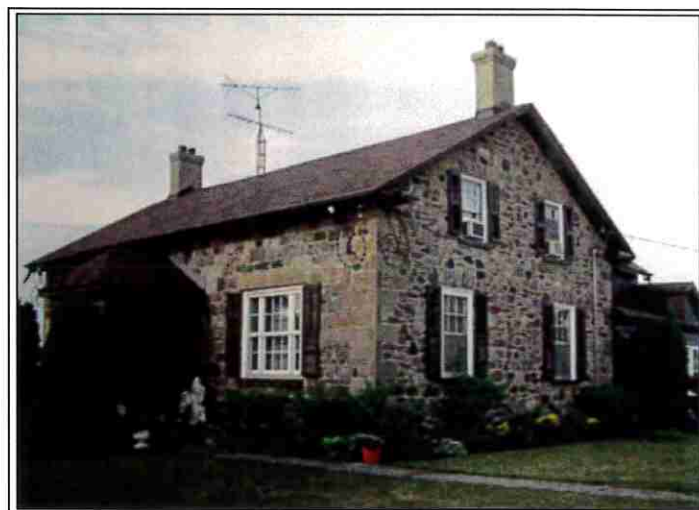
Figure 4.2
*John Lawrie Farmhouse – 2005 –
East and North Elevations*
[Source: City of Vaughan, Recreation
and Culture Department].

The one and-a-half storey building is constructed of stone rubble that has been dressed and coursed on the main (east) elevation and laid in a random fashion on the other elevations creating a patchwork quilt of colours. The structure rests on a stone rubble foundation. The gable roof is covered with brown asphalt shingles. The brick tail wing is one and-a-half storey high, while the brick shed attached to the rear of the tail wing is one storey. The stucco clad brick chimneys are single stacks with corbelled tops and exposed clay liners. The chimney at the end of the tail wing is no longer extant, although evidence of it appears in the west wall of the tail wing (*Appendix C: Photo 4*).

The east or principal elevation of the main section contains three bays consisting of a centre door, now within a vestibule, and two large window openings on either side. The window openings contain a central double hung sash flanked by narrower double hung sashes. The central sashes have six over six lights, while the narrower windows are two over two lights (*Figure 4.2*). Each window opening on the principal elevation is surmounted by a flat, finely tooled stone lintel (*Appendix C: Photo 7*), while the window openings have wooden lug sills. The door opening once contained a wooden door with sidelights and a flat transom (*Figure 4.2*). The existing door opening is enclosed within a hip roof, frame vestibule that is clad in clapboard. The corners of the principal elevation have finely tooled and dressed stone quoins. The projecting eaves are boxed with plain soffits, a plain fascia and have metal eavestroughs. A survey bench marker noted “Department of Highways No. 46-70 Ontario” is located on the northeast corner of the residence.

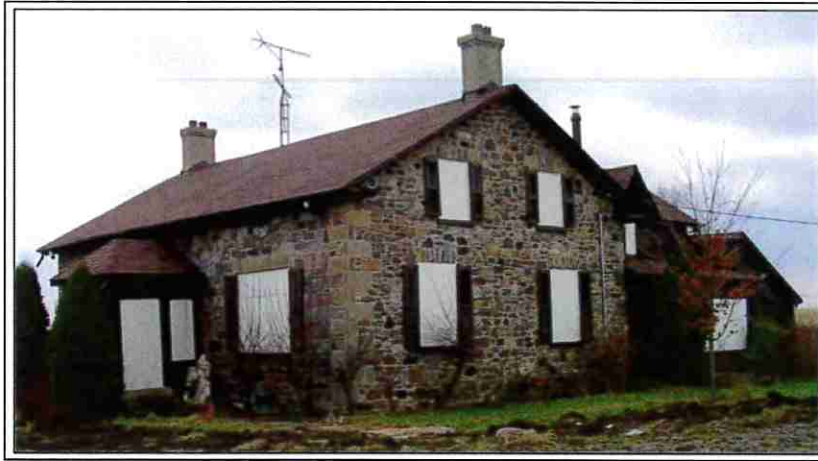
*John Lawrie Farmhouse
– 2005 –East and North
Elevations [Source: City
of Vaughan, Recreation
and Culture
Department].*

The north and south elevations of the main house contain two window openings on the ground floor and smaller window openings on the upper floor. The upper floor window openings are inset equally from the ends of the wall on both sides of the building. All window openings have stone voussoirs and wooden lug sills (*Appendix C: Photo 10*). The side elevations have roof trim that includes projecting boxed verges, returned eaves, plain soffits and moulded fascias (*Appendix C: Photo 11*). On the south elevation, there is a stone vestibule with a gable roof that protects a basement entrance (*Appendix C: Photo 12*).

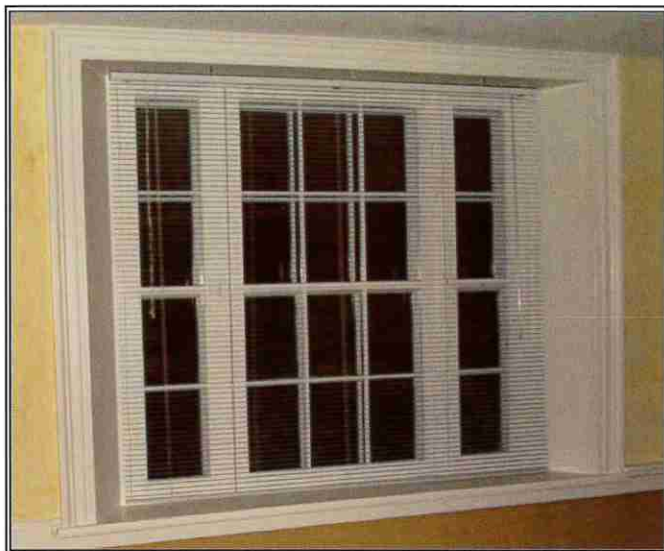
Figure 4.4
John Lawrie Farmhouse —
Ground Floor—South Room—
East Window.

A simple baseboard profile is found throughout the ground floor rooms of the main section of the house (*Appendix C: Photo 19*). The top element of the baseboard in the Lawrie House may have been replaced in the side rooms during the recent replastering. In both rooms north and south of the centre hall, the east window is a distinguishing feature (*Figure 4.4*).

This window has three sections – two narrow glazed areas, filled with casement sashes containing four vertical lights, flanking a larger glazed area originally containing two double hung sashes with six over six lights. The interior view of these windows appears to be of storm windows constructed in the style of the original sashes. The original sash appears to be on the exterior. The interior window openings have splayed jambs indicative of the thick stone walls and to increase the flow of light into the rooms.

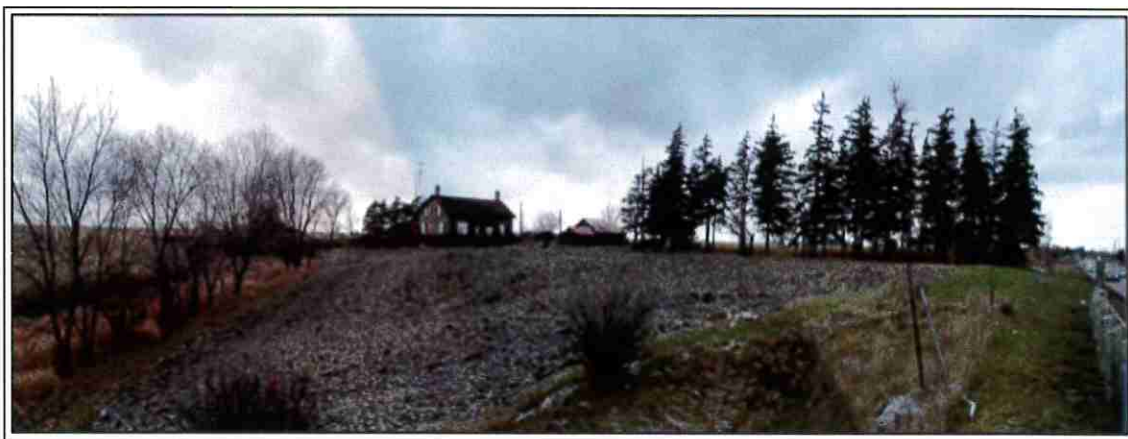
Figure 4.6
John Lawrie Farmhouse from the southeast at Highway 27.

The contextual value of the property arises from its visibility as a landmark from Highway 27 (*Figure 4.6*), set in an agricultural landscape. The contextual value of the

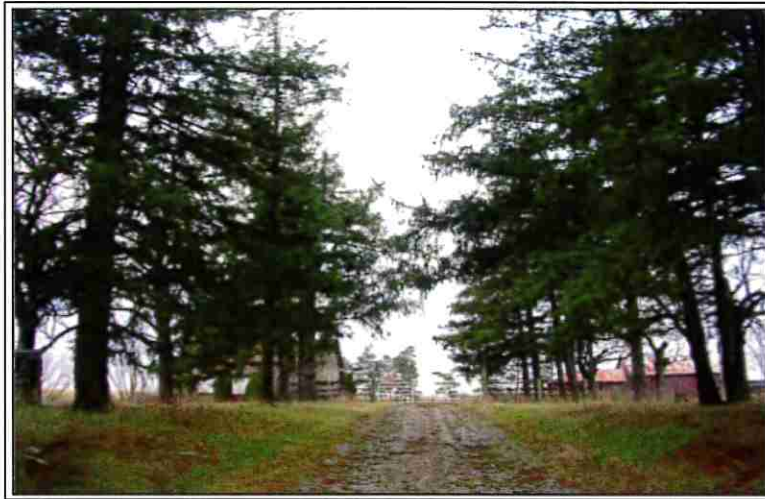
*Figure 4.7
View of Farm Lane from the
John Lawrie Farmhouse
west to Highway 27.*

house is reinforced by its long association with a tree-lined laneway that enters the property directly from Highway 27 (**Figures 4.7 and 4.8**). Although the barn has been demolished, the farmstead and the surrounding field patterns remain in the landscape as a visible reminder of the 19th century agricultural development of the area.

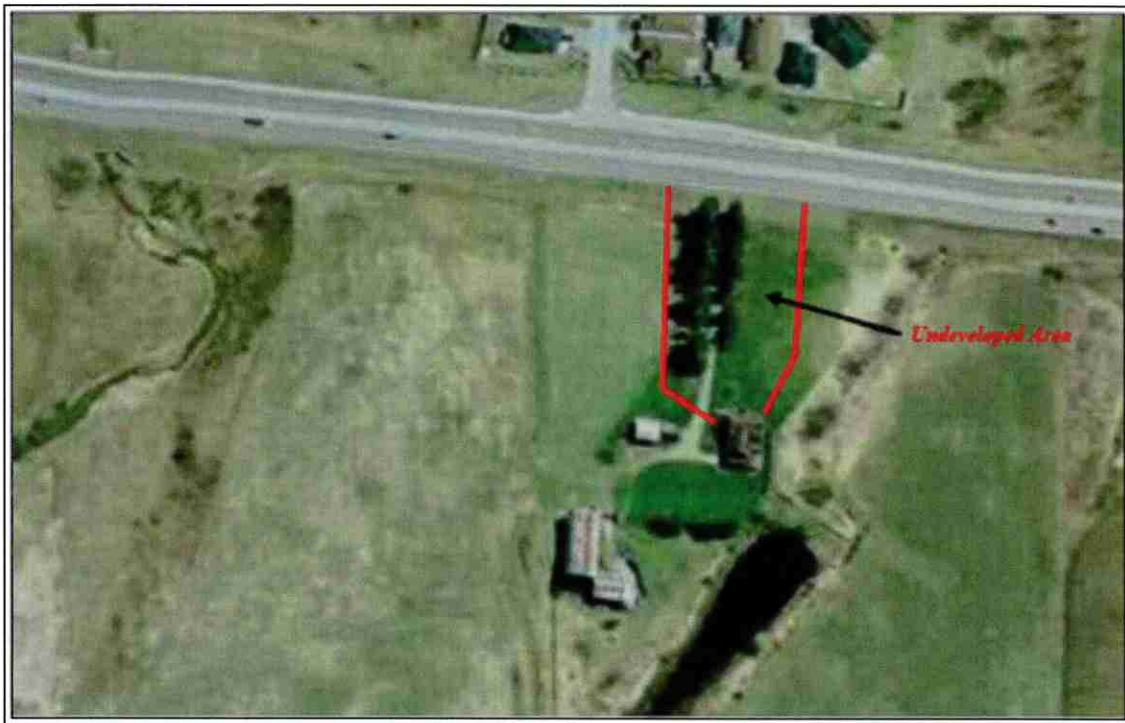
Figure 7.1: Option for the Conservation of Landscape Features.
[Google Earth 2007].

There are no heritage landscape features that merit conservation. However, two attributes have been identified that have merit in relation to the Lawrie Farm House. The tree-lined laneway, which leads directly to the House from Highway 27, is an important and long standing visual feature (***Figures 4.7 and 4.8***). The other landscape feature is the unobstructed view of the House from various points along Highway 27 (***Figure 4.7***) resulting in the farmhouse being considered to be landmark for those travelling on Highway 27. Removal of these features will diminish the cultural heritage landscape value.

Therefore, it is recommended as part of the mitigation for the retained or relocated House that an unobstructed view of the John Lawrie Farmhouse be maintained from at least one

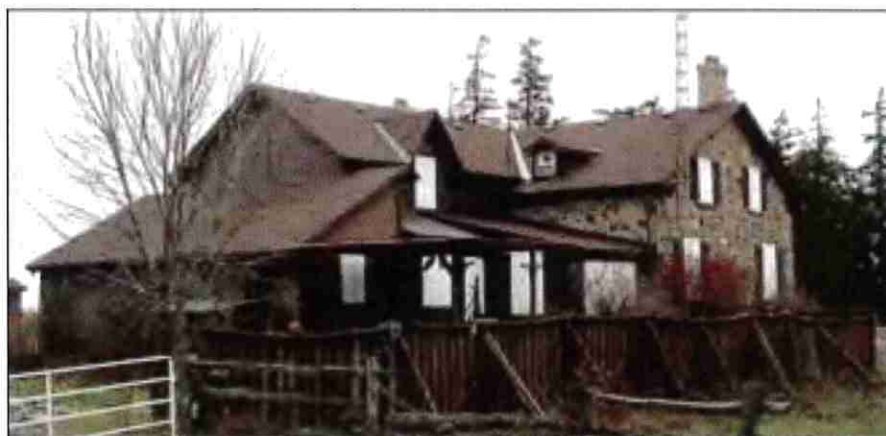
*Photograph No. 5
South & West
Elevations*

modern 'picture' window. The south elevation of the tail wing has a similar addition (*Appendix C: Photo 5*) with the same cladding and three openings, now boarded up. Attached to the rear of the tail wing is a brick shed. It appears to be covered with red brick with yellow brick trim (quoins and voussoirs). The brick has been painted brown and it has been altered on the north elevation with the insertion of a garage door.

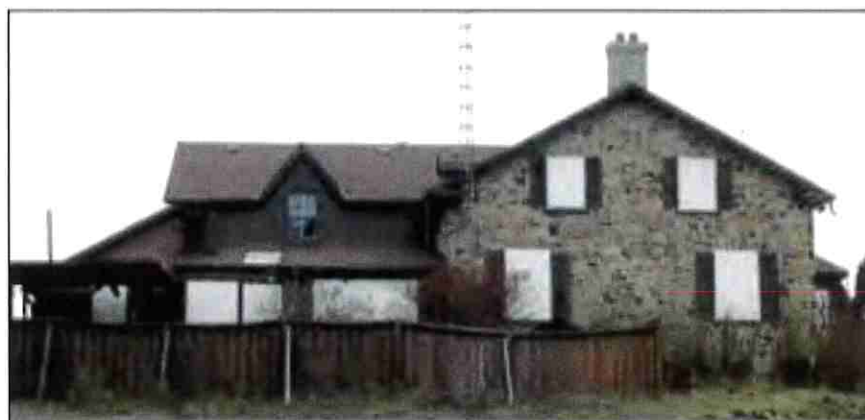
*Photograph No. 6
South Elevation.*

The exterior brick of the tail wing is painted. The upper floor of the brick tail wing has segmental window openings in the dormers, which have radiating brick arch voussoirs. The windows have double hung sashes with 2 x 2 lights (*Appendix C: Photo 6*), suggesting the tail wing may be a later addition c1870 to c1890), which may have replaced an earlier wing. On the north elevation of the tail wing, there is an additional window opening in the upper floor under the projecting eaves. On the north elevation, the earlier open veranda (*Appendix C: Photo 4*). It has been removed and replaced by a similar enclosed addition clad in clapboard. It has an entrance opening and a large,

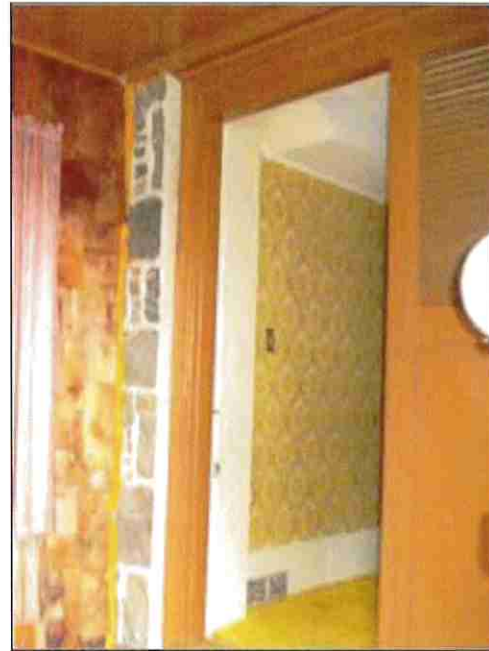
*Photograph No. 13
Front Entrance, within Vestibule.*

The main stone section of the farmhouse has a central hallway (*Appendix C: Photos 14 & 16*) with a staircase and flanking rooms. The front door, side lights and transom, have been replaced by a relatively modern door and louvered screen placed within the original opening that has its interior and exterior wood trim (*Appendix C: Photo 13*). The vestibule prevents a photograph of the full entrance in a single view.

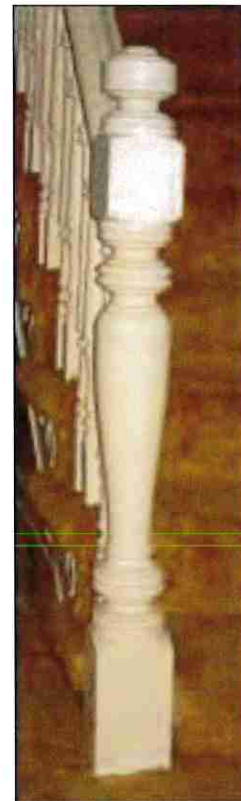
*Photograph No. 15
Newell Post.*

The ground floor front hall contains a staircase with newel post and spindles, possibly from a later period, c1880 – 1890 (*Appendix C: Photo 15*). The carving on the side of the staircase may date from the construction of the house (*Appendix C: Photo 17*). All doors from the hall to the side rooms have been removed except to the tail wing (*Appendix C: Photo 18*). This six-paneled door, often referred to as a 'cross and bible' door, is typical of the 1850s or earlier. The door closing mechanism is a thumb latch, rather than a box lock typically found in buildings constructed in the later half of the nineteenth century.

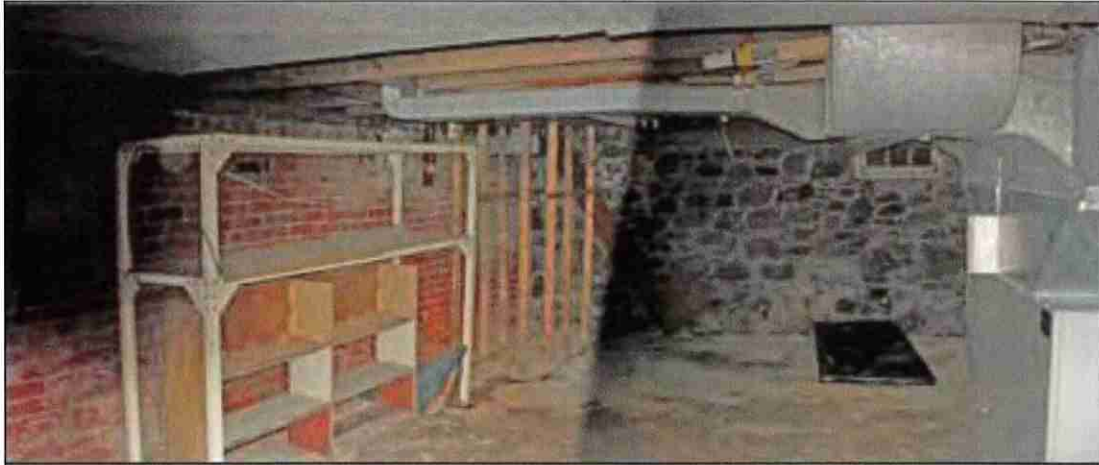
*Photograph No. 23
Basement – South Room
looking east*

There is a basement under the stone section of the house. It is accessed from the centre hall under the staircase (*Appendix C: Photo 16*), or by the exterior entrance on the south side (*Appendix 7, photograph 12*). From the plain door trim of the interior basement access, it would appear this entrance may be a later alteration, with access originally just from the exterior. The stone foundation of the building is visible in the basement (*Appendix C: Photo 24*). The basement floor is concrete (a later addition) and has been partitioned into two spaces by a brick dividing wall that supports a main beam measuring 13-in. x 13-in. The floor joists measure 10-in x 3-in. The north section has parged walls and a drywall ceiling (*Appendix C: Photo 25*), while the south section, which contains the forced air furnace, has exposed stone walls and an exposed ceiling. Stone piers have been constructed against the north and south walls to support the chimneys above (*Appendix C: Photo 23*).

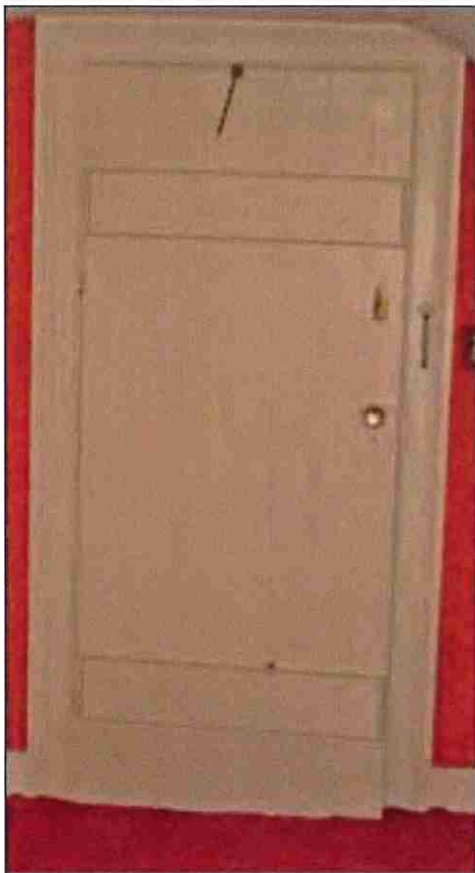
Photograph No. 28
2nd Floor – typical board door.

The second floor of the main house contains a centre hall with four flanking bedrooms (*Appendix C: Photos 24 & 27*). The ends of the hall have been partitioned for closets. Three of the four bedrooms have plank doors (*Appendix C: Photo 28*), while one has a six paneled door. All doors have simpler casings than those on the ground floor (*Appendix C: Photo 27*). The baseboards are shorter than those found on the ground floor. Each bedroom has a knee wall and a window with a double hung sash with six over six lights and splayed jambs (*Appendix C: Photos 30 & 31*).

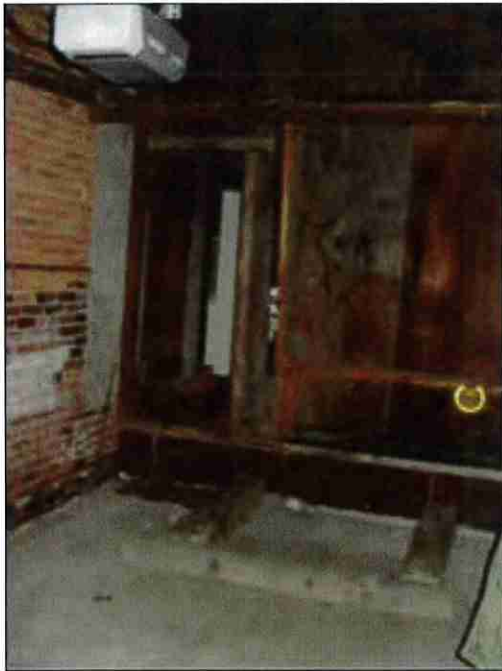
*Photograph No. 37
Shed facing south with
tail wing wall on left.*

The brick shed attached to the rear of the tail wing is now a garage (*Appendix C: Photo 37*). A large section of the original floor was removed and replaced by a lower concrete floor and an earlier entrance closed in (*Appendix C: Photo 38*), although these alterations have occurred within the original structure. The original chimney of the tail wing is visible in the shed (*Appendix C: Photo 39*).
