Cultural Heritage Impact
Assessment – Revised

7808 Yonge Street,
City of Vaughan, Ontario

27 March 2023

Project # LHC0214

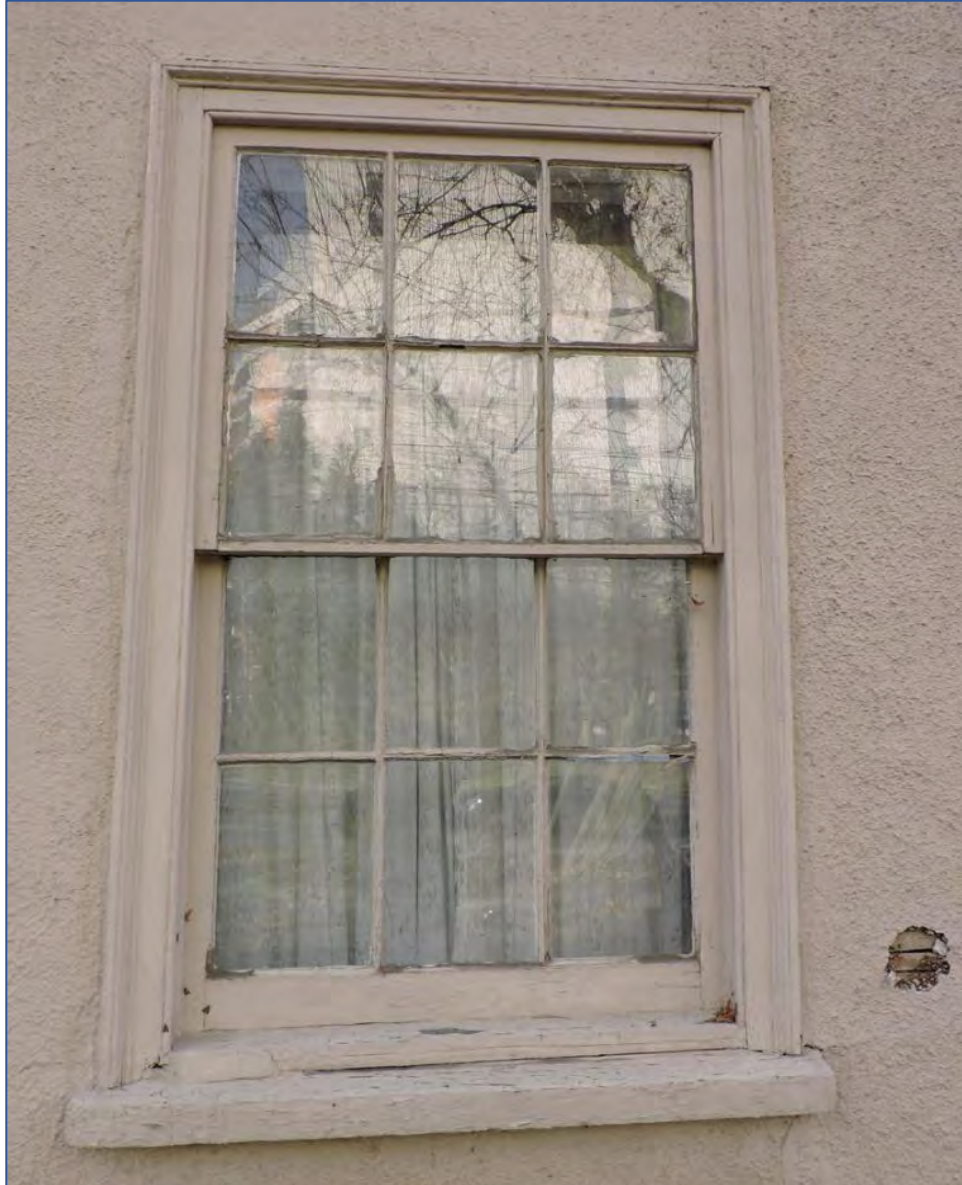
Figure 28: Detail view of a 6 over 6 double hung sash window, stucco finish on the wall and exposed circle showing lath and plaster cladding

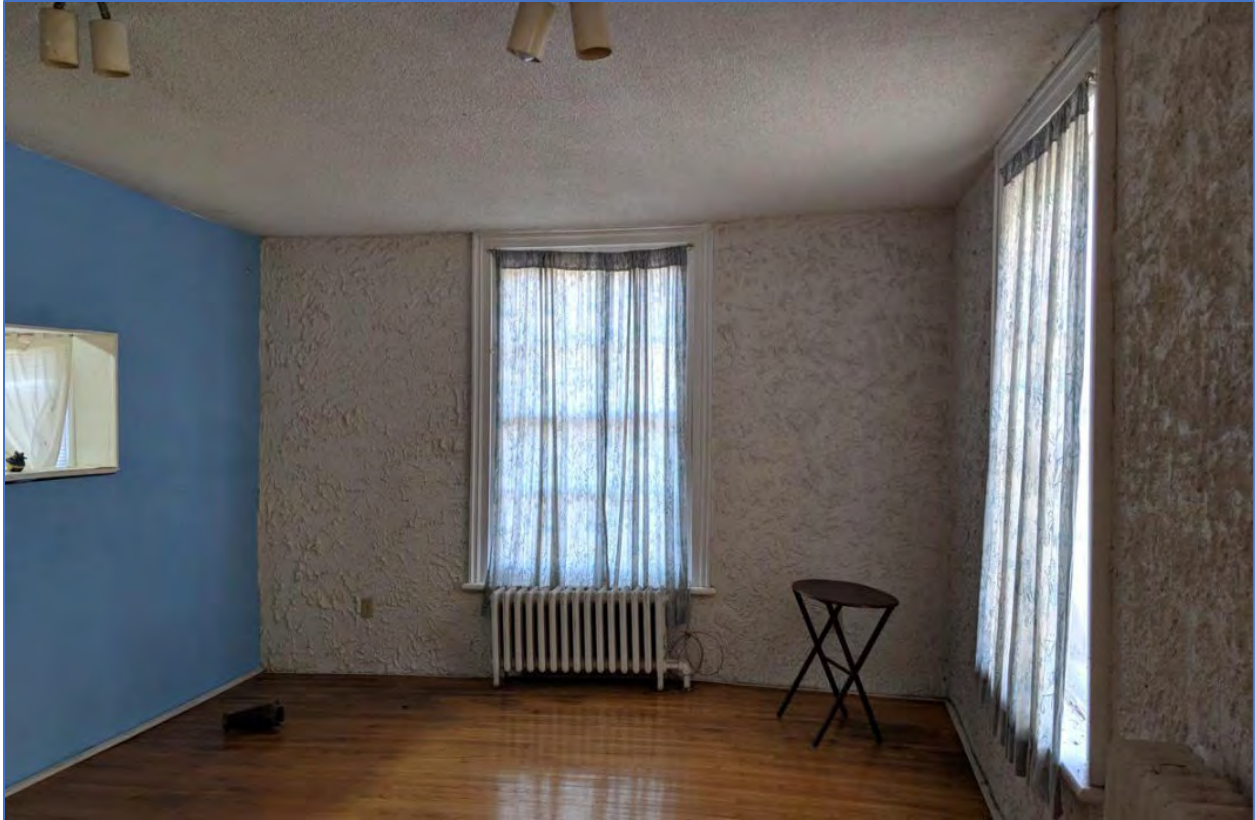
Figure 39: Dining area. Note the significant bow in the floor.

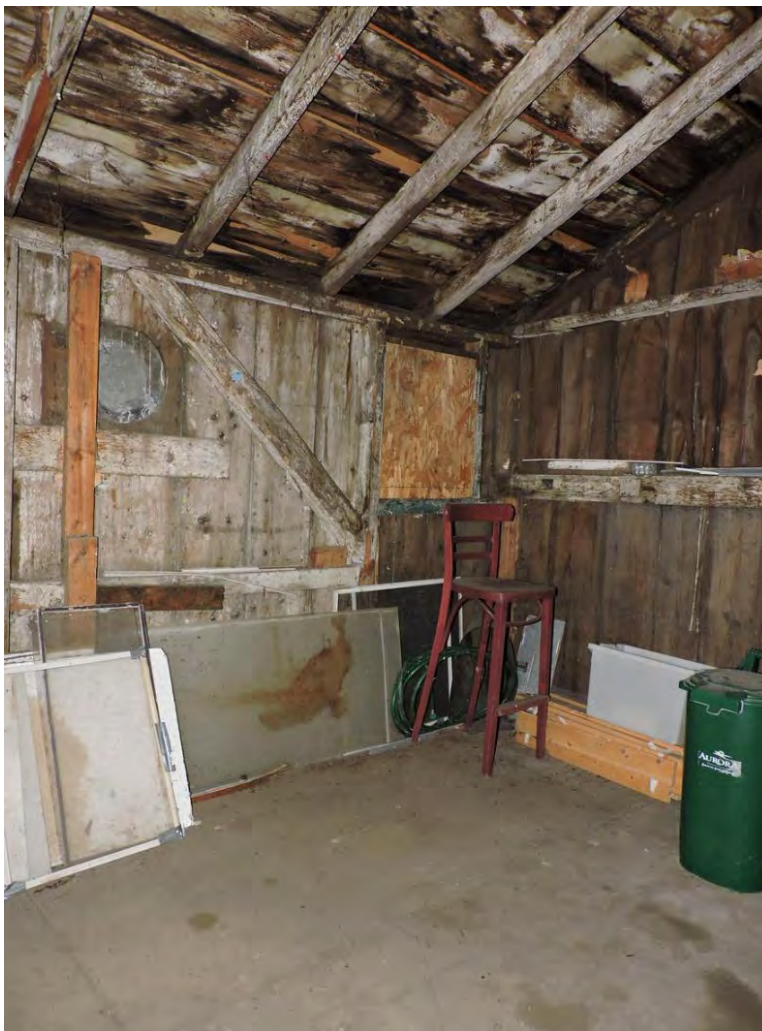
The interior of the lean-to shed is a simple open area used for storage. The flooring is covered with particle board of various sizes (Figure 44). The exposed wood joists appear to have been whitewashed at one point and show watermarks throughout. The walls have a variety of patched work in various materials.

Figure 44: Interior of lean-to

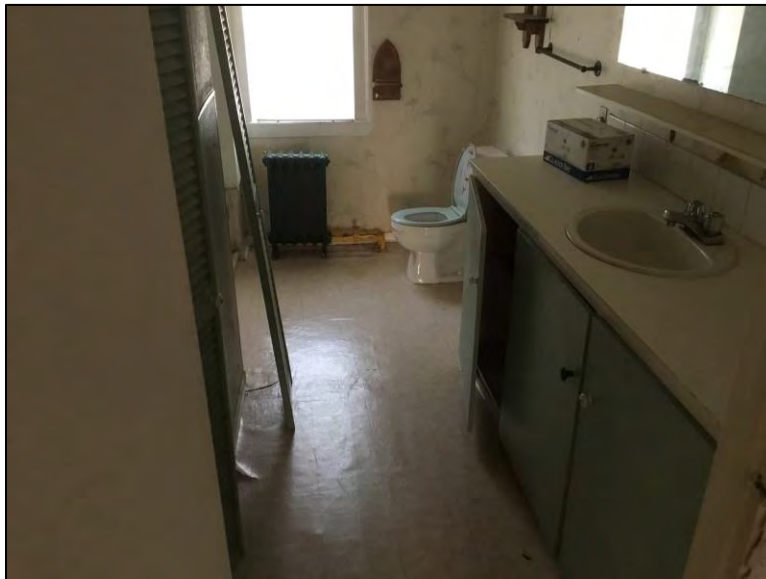
Floors on the second storey (and the associated main floor ceilings) are also deflected significantly, especially in the bathroom and north bedroom.

Photograph 2: Bathroom floor deflection

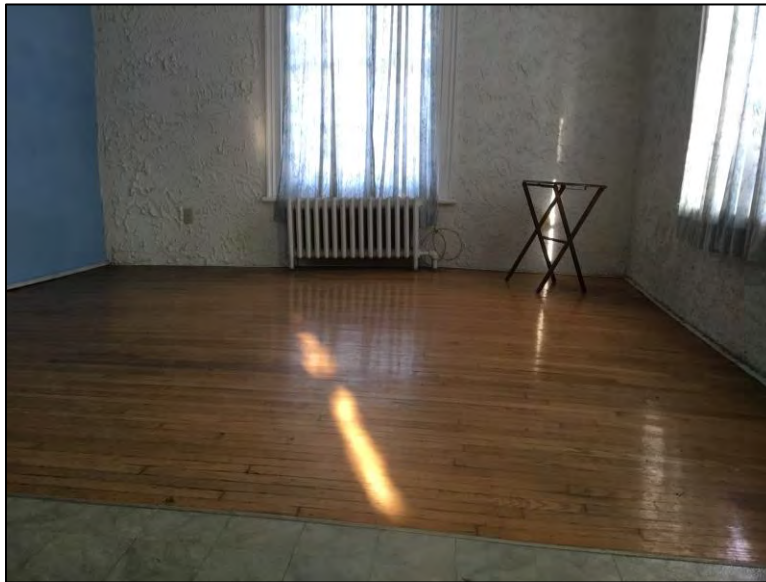
Similar to conditions on the second floor, deflections of the floor framing were found to be significant.

Photograph 3: Northeast living room floor deflection

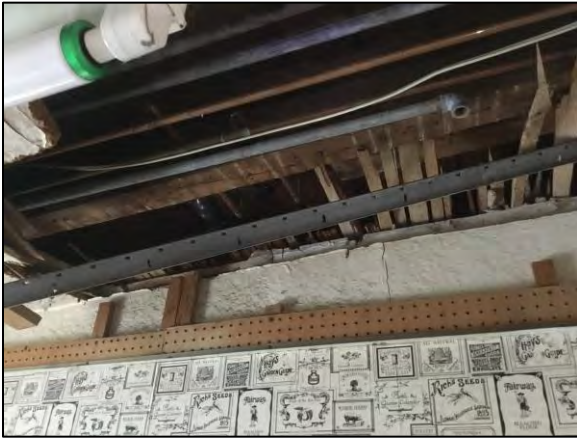
The kitchen ceiling, immediately below the washroom, was partially opened at the time of the review. The wall separating the front living room from the kitchen appears to have been built to match the slope of the upper floor, and the exposed wood lathe appears to have been cut or altered to suit. Localized areas of the kitchen ceiling framing (bathroom floor framing) have been altered to accommodate the installation of the drains for the bathroom above.

Photograph 4a, 4b: Exposed kitchen ceiling; sloping partition wall

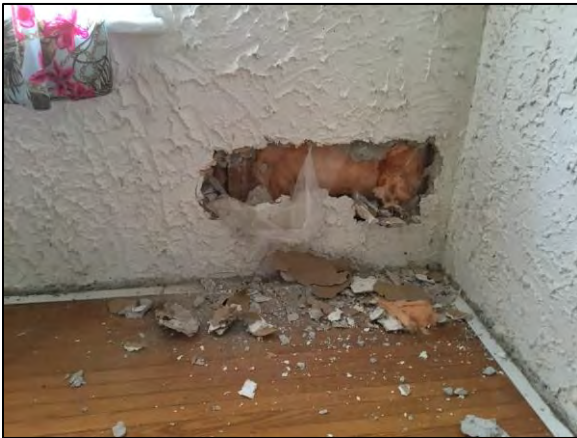
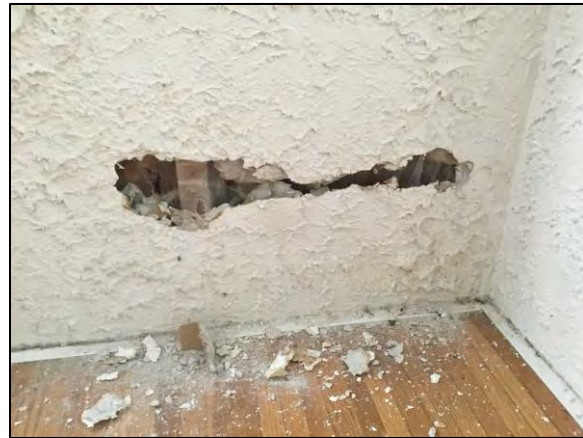
Exterior walls were found to have been provided with relatively modern insulation and vapour barrier.

Photograph 5a, 5b: Opening in east exterior wall; opening in south exterior wall

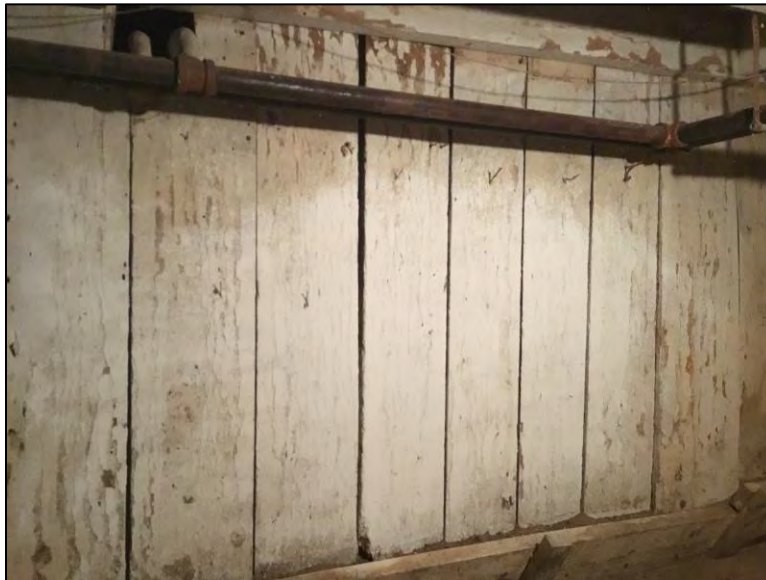
The basement of the house is partially excavated, with the majority of the main floor structure supported above a low crawlspace. Much of the perimeter of the excavated space is shored up using relatively thin vertical boards to hold back the retained soils.

Photograph 6: Wood slat shoring

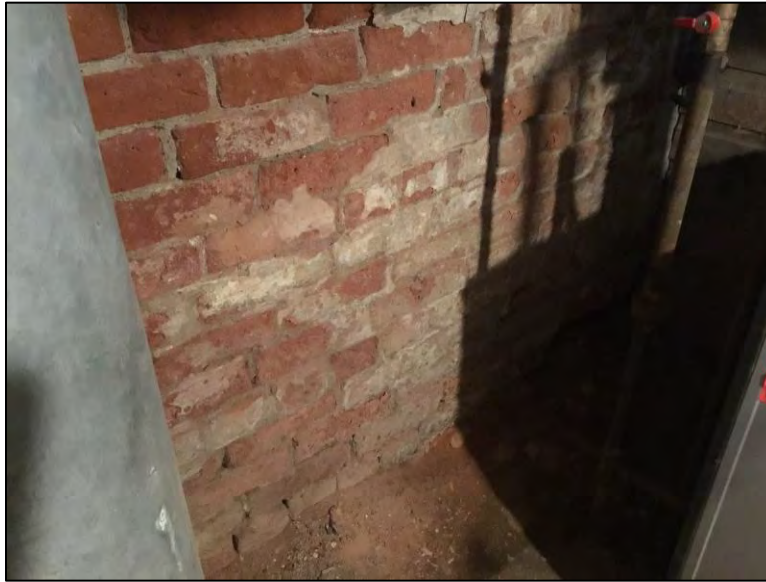
Other exposed areas of the foundation were found to be constructed with red clay brick, much of which is in poor condition.

Photograph 7: Exposed brick foundation

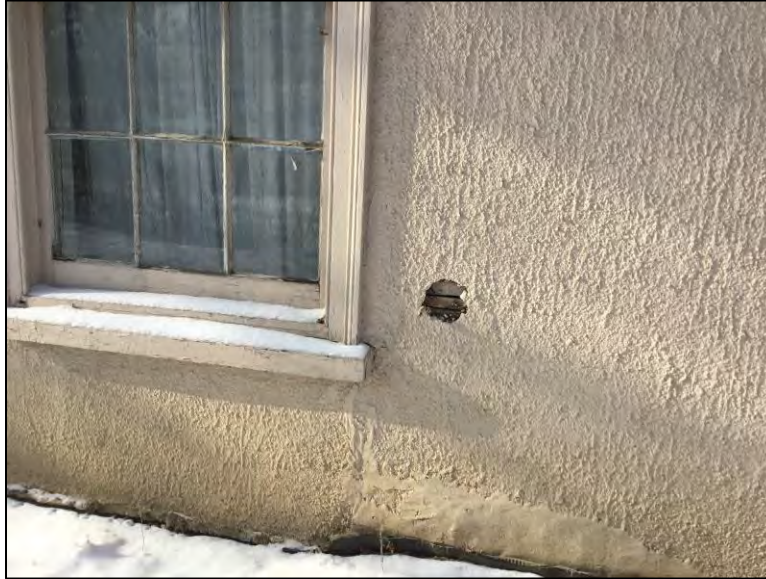
The exterior of the building is clad with a stucco parge coat supported on wood lathe.

Photograph 8: Exposed exterior lathe on east elevation

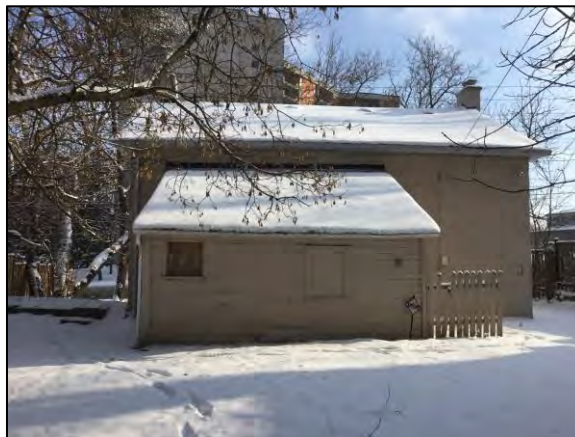
A wood-framed lean-to was added to the west elevation of the building at some time in the past.

Photograph 9: Lean-to on west elevation

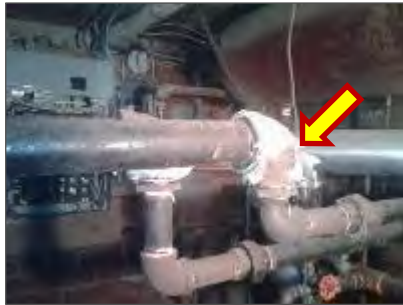
Pipes insulated with asbestos-containing insulations may be present in inaccessible spaces such as above solid ceilings, in chases, in column enclosures and within shafts, which are not identified in the above table.

Photo 3: Asbestos containing paring cement on an elbow fitting in the Basement (Loc. 7).

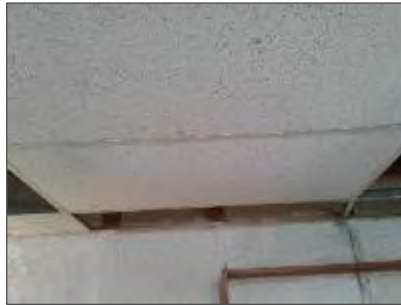
Ceiling tiles are presumed to be non-asbestos based on the date of manufacture determined from the date stamp applied to the top of the tiles. The tiles were manufactured after asbestos was stopped being used in acoustic ceiling tiles.

Photo 7: Non-asbestos 24" x 48" lay-in, fissure and pinhole ceiling tile in the Kitchen (Loc. 3).

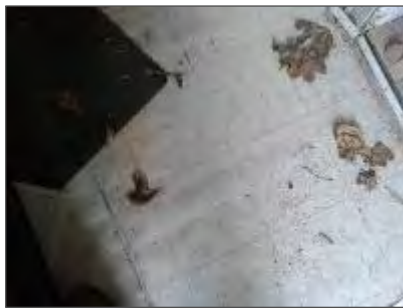
The vinyl sheet flooring is non-friable but can become friable upon removal due to the separation of the vinyl face and paper backing. Vinyl sheet flooring is in good condition.

Photo 10: Non-asbestos pink vinyl sheet flooring on the floor of the Back Entrance (Loc. 2).

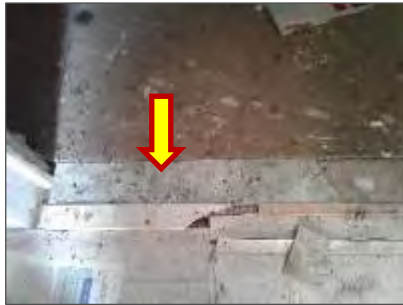
The vinyl floor tiles and mastic are non-friable and are in good condition. Mastic was analysed for asbestos content where it was present on the tiles.

Photo 12: Non-asbestos 12" x 12" green vinyl floor tiles in the Back Entrance (Loc. 2).
