## ***VALENTIN ENGINEERING LTD***

Re: 40 Nashville Road, Vaughan – Existing Wood Members

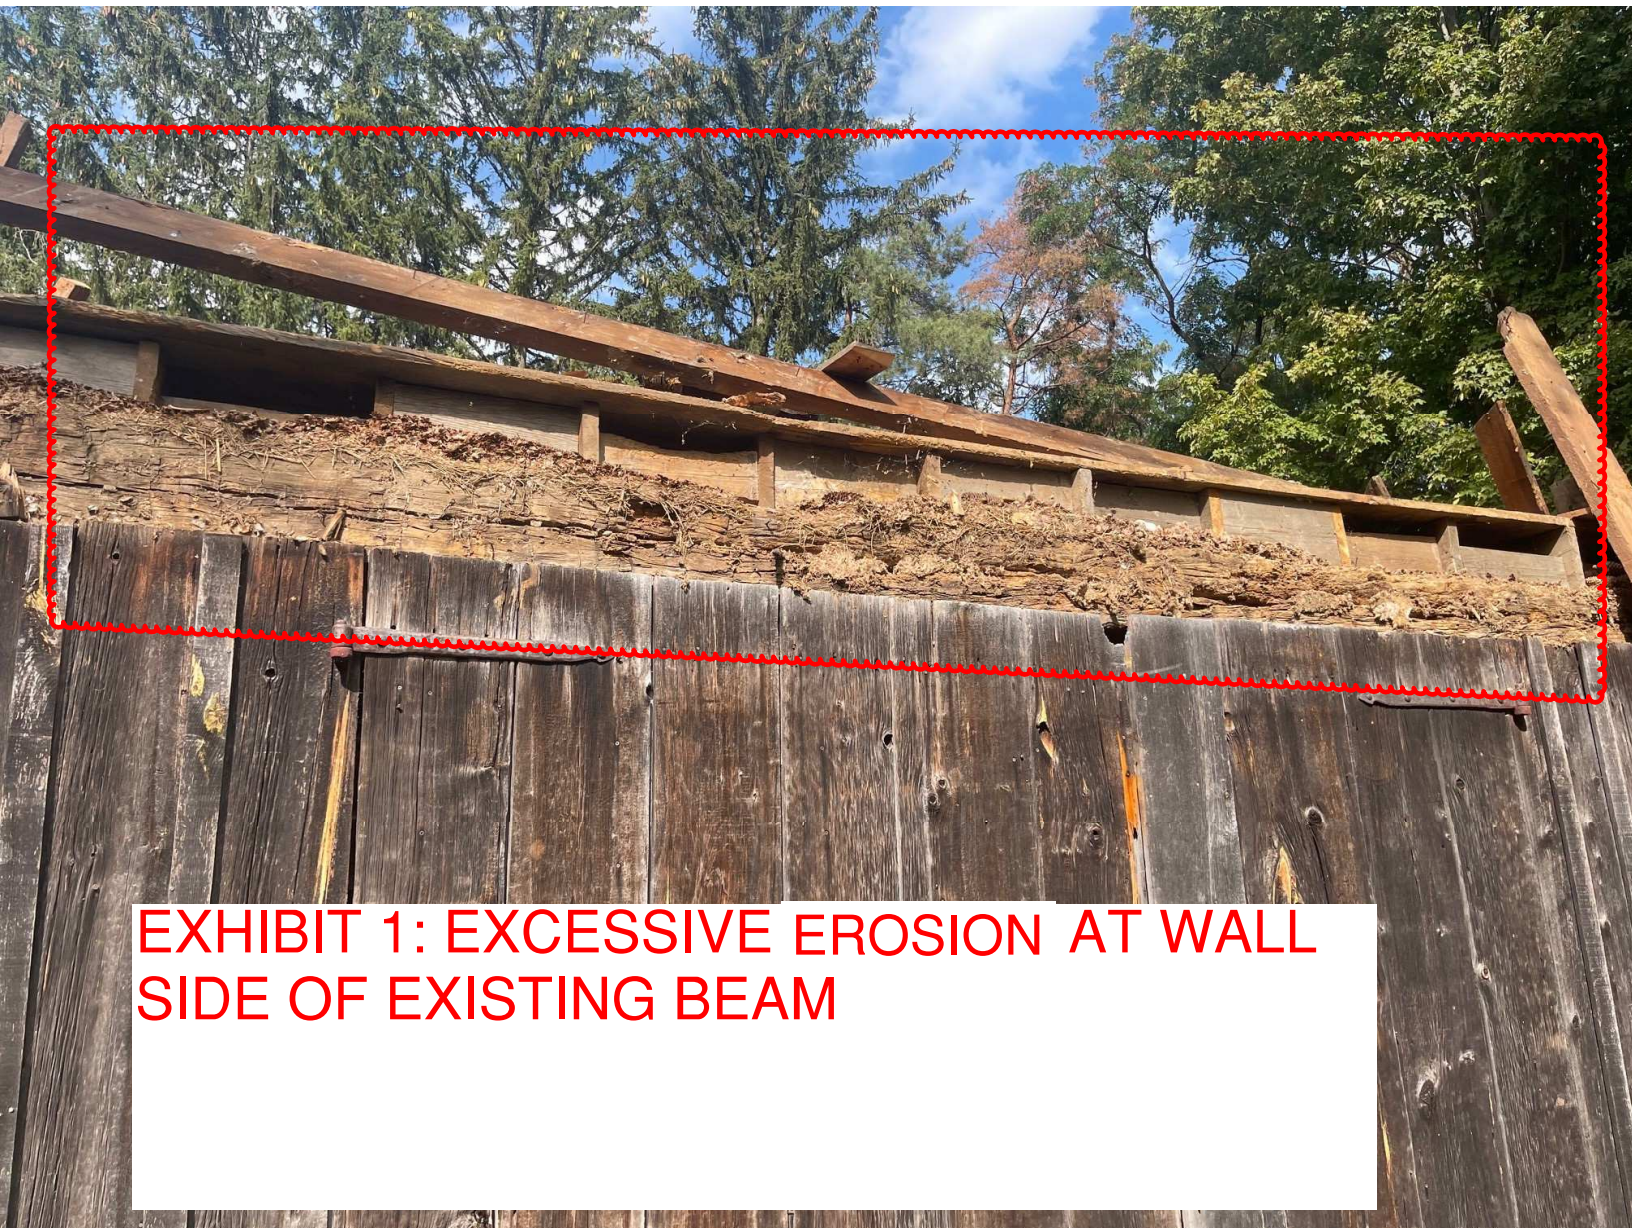
Once the existing wood members were disassembled, they were found to be not structurally adequate to be utilized as beams and columns in the rebuilt structure. New structurally sound columns and beams were required in the reassembly. Please call if you have any questions.

EXHIBIT 1: EXCESSIVE EROSION AT WALL  
SIDE OF EXISTING BEAM

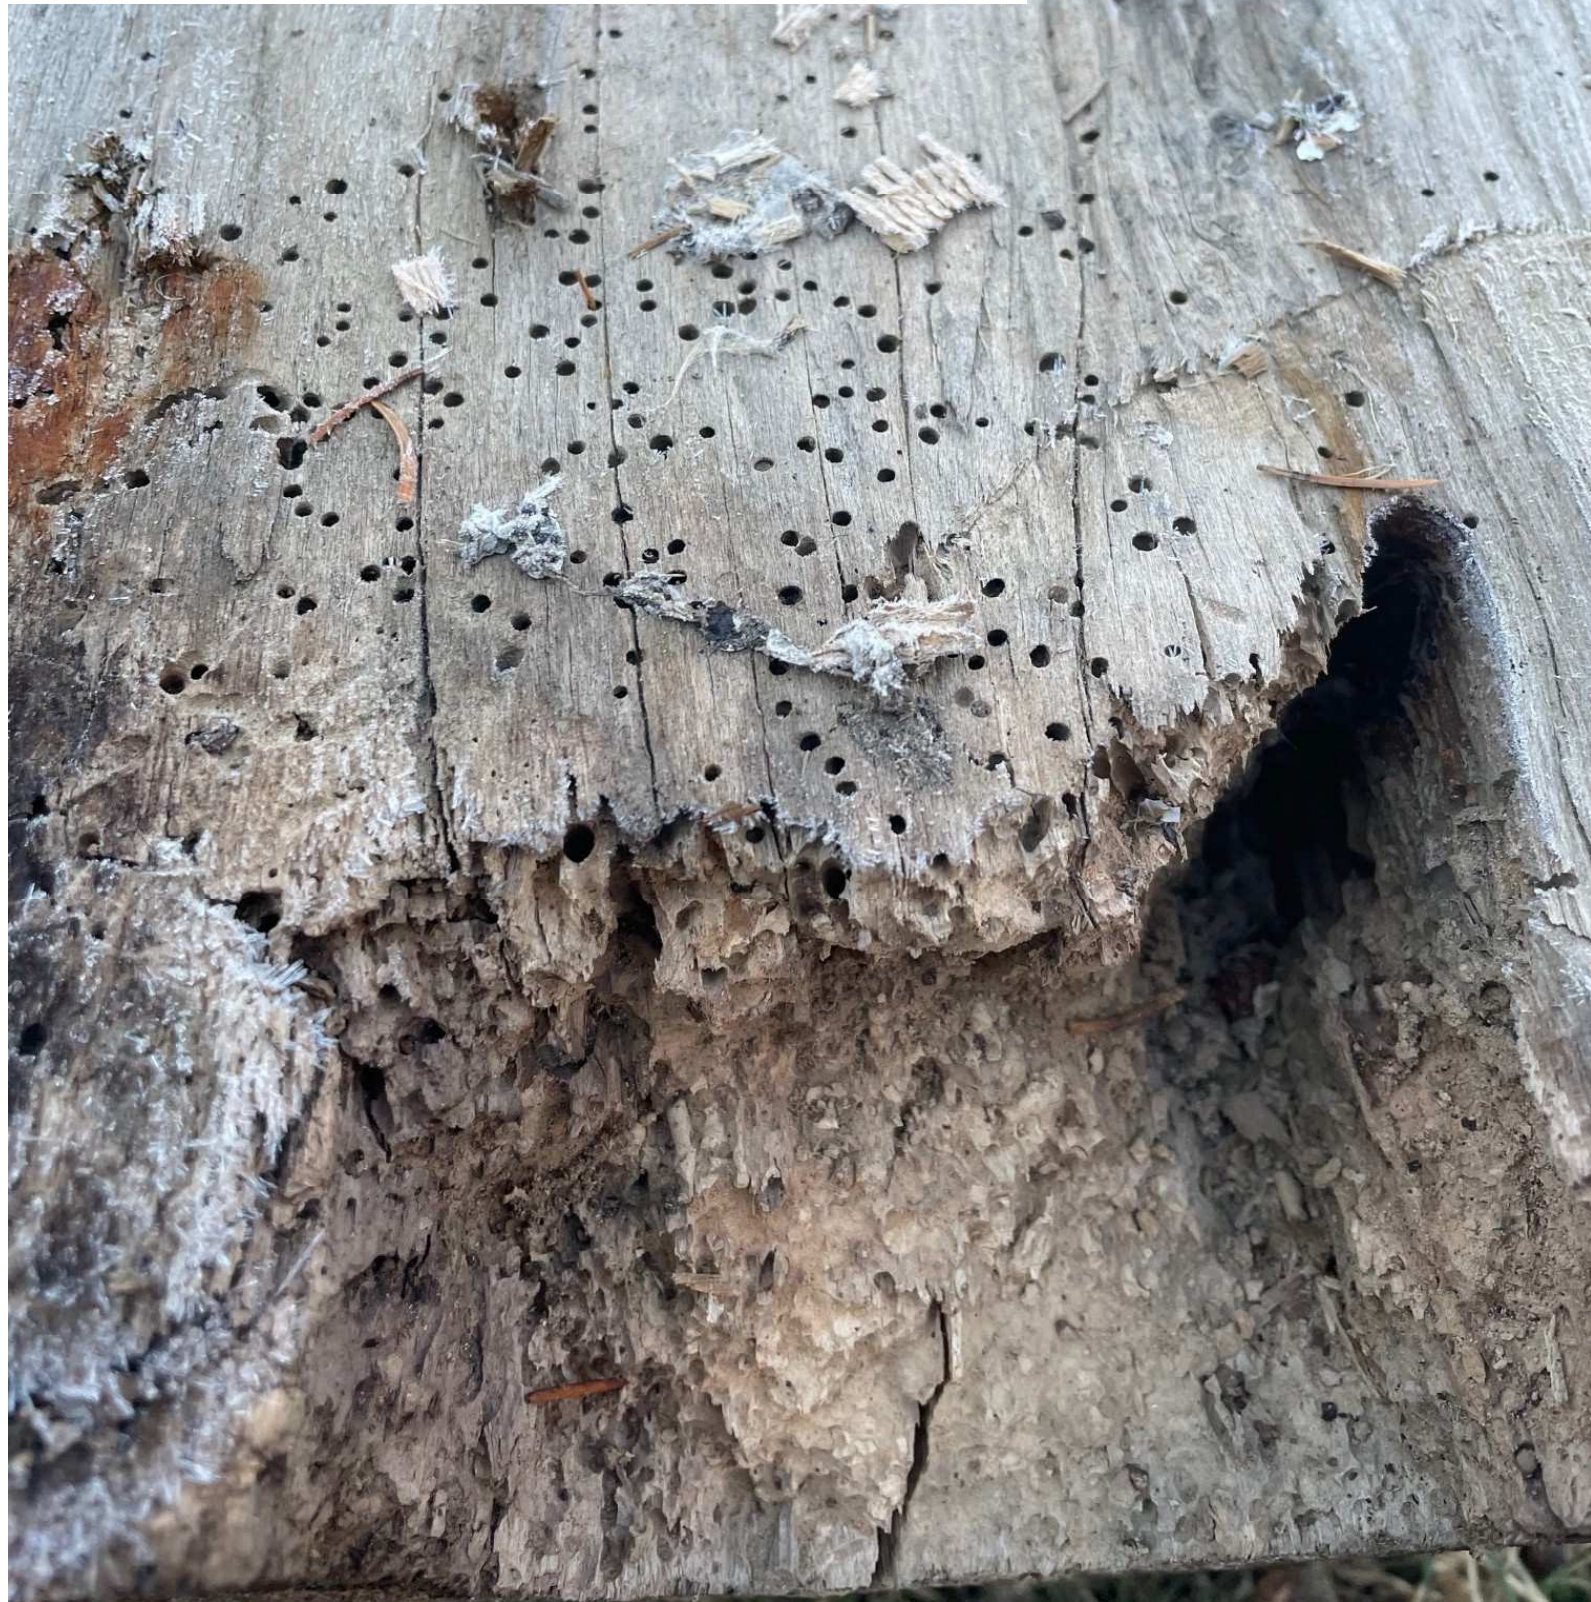
EXHIBIT #2 - 40 Nashville  
Existing Beams and Columns  
:Post Powder Beetle Boring  
and Wood erosion at base of  
column

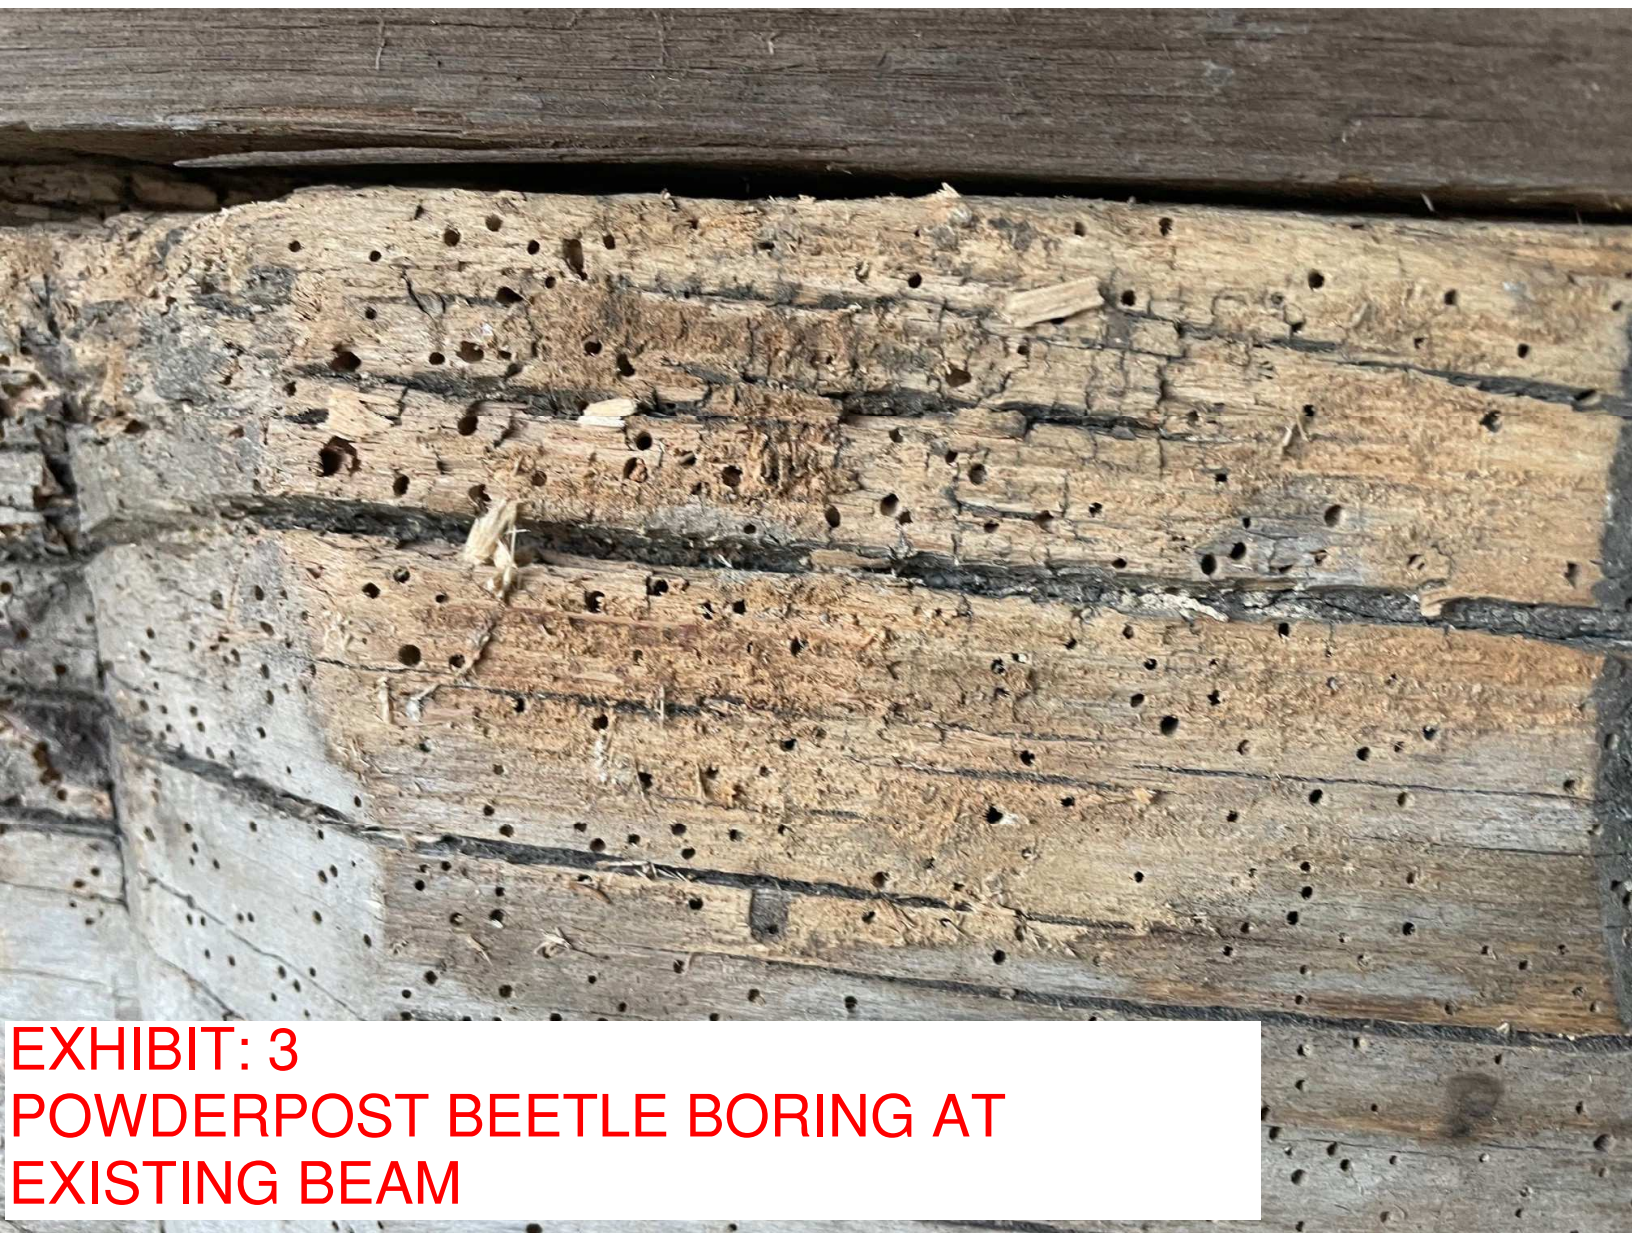
**EXHIBIT: 3**  
**POWDERPOST BEETLE BORING AT**  
**EXISTING BEAM**
