CULTURAL HERITAGE IMPACT ASSESSMENT

2057 Major Mackenzie Drive West
Part of Lot 20, Concession 3 in former Township
of Vaughan
City of Vaughan, Ontario

Report Number: 1539132-R01

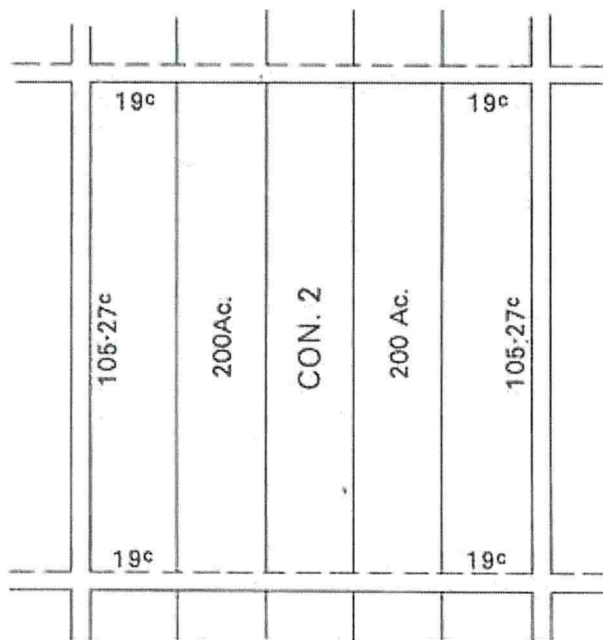
Figure 3: The single front survey system, used from 1783 to 1818. As depicted here, each lot is 200 acres (Ac.), created from surveying 19 chains by 105.27 chains (1 chain = 66 feet/ 20.12 metres).⁴

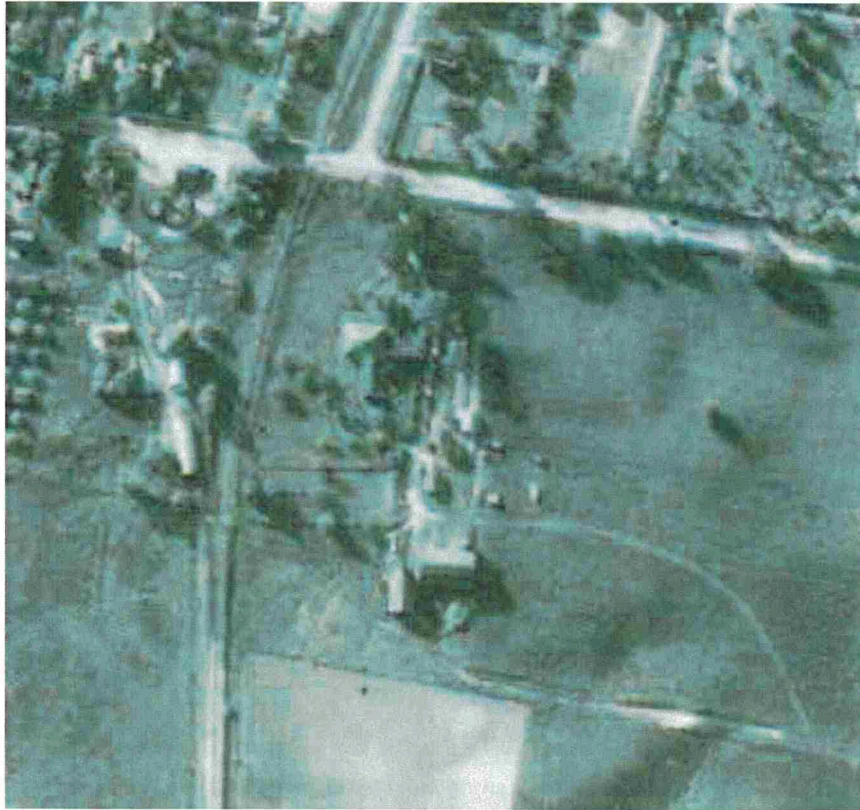
Figure 5: 1942 aerial photograph showing Joshua Oliver House, outbuildings, and barn (Vaughan Archives).

- Although the resolution is poor, this building does not appear to be present on the 1942 aerial photograph. However, it is clearly visible on the 1970 aerial image. The concrete block foundation suggests a mid-20th century date of construction, although it may have been built just prior to 1970.

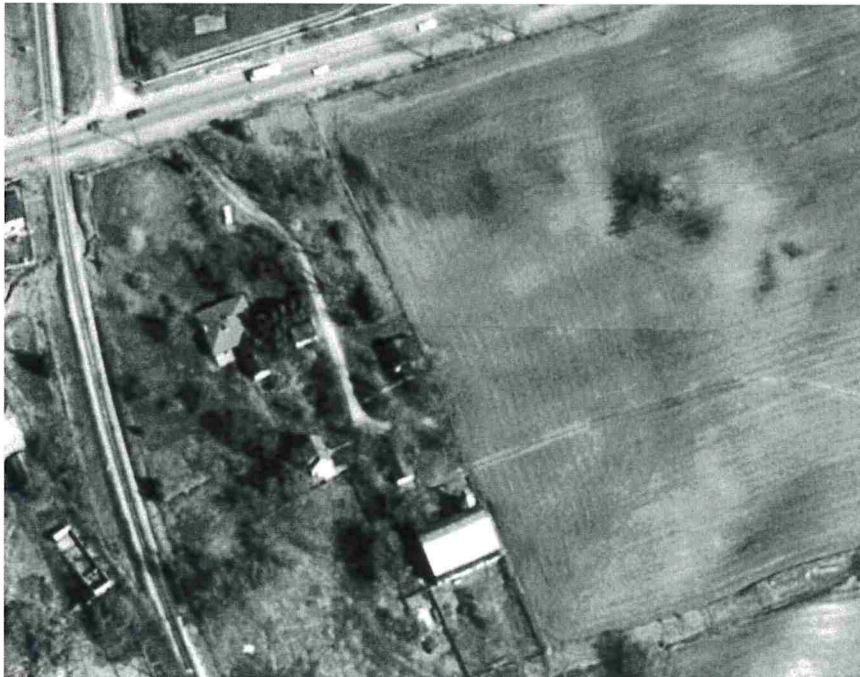
Figure 6: 1970 aerial photograph showing Joshua Oliver House at left, driveway off of Major Mackenzie West, and barn south of the house (Vaughan Archives).

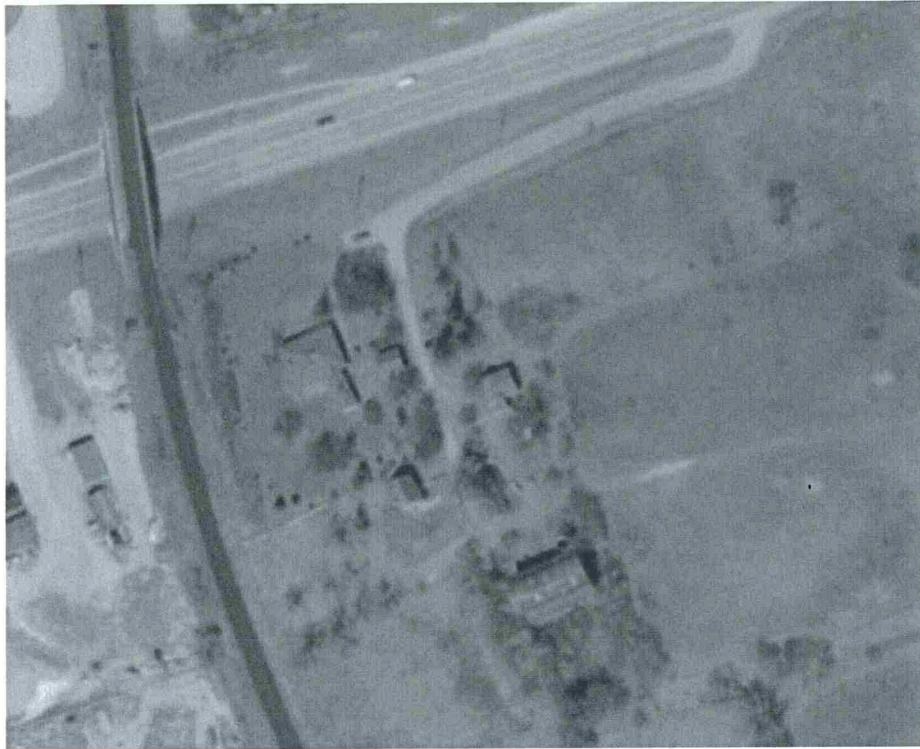
Figure 7: 1988 aerial photograph showing the altered driveway (Vaughan Archives).

- Despite its historic design, this structure must have been erected after 1988 since it does not appear on the aerial photography from that year, but is found on the 2002 aerial photograph. An assessment of its interior reveals it was built in new lumber, so is unlikely to have been moved from another property.

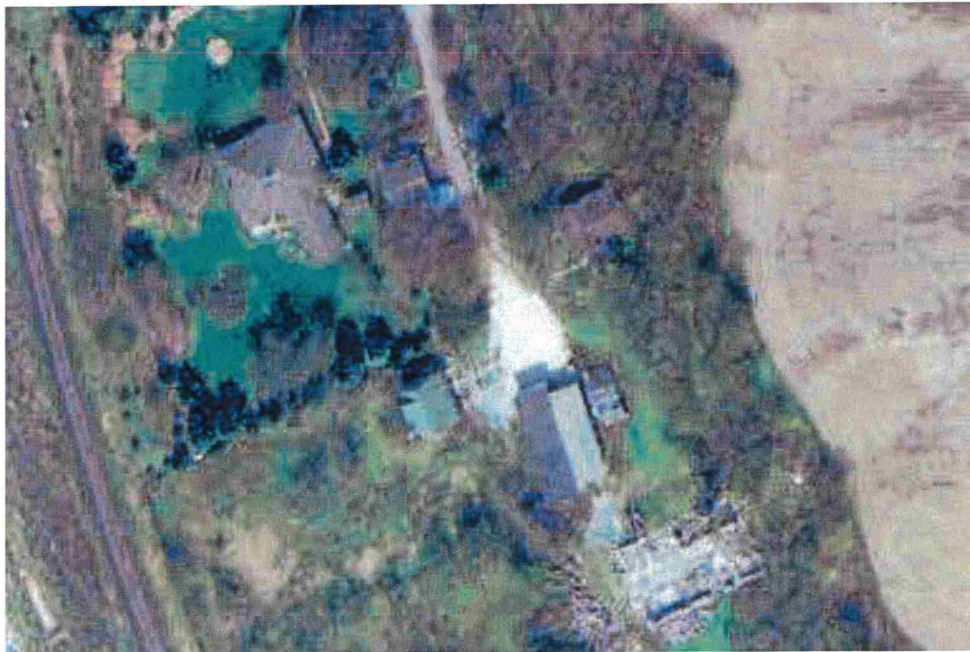
Figure 8: 2002 aerial photograph showing demolition of barn at the rear of the property. Additional outbuildings are visible between Joshua Oliver House and the barn foundation (Vaughan Archives).

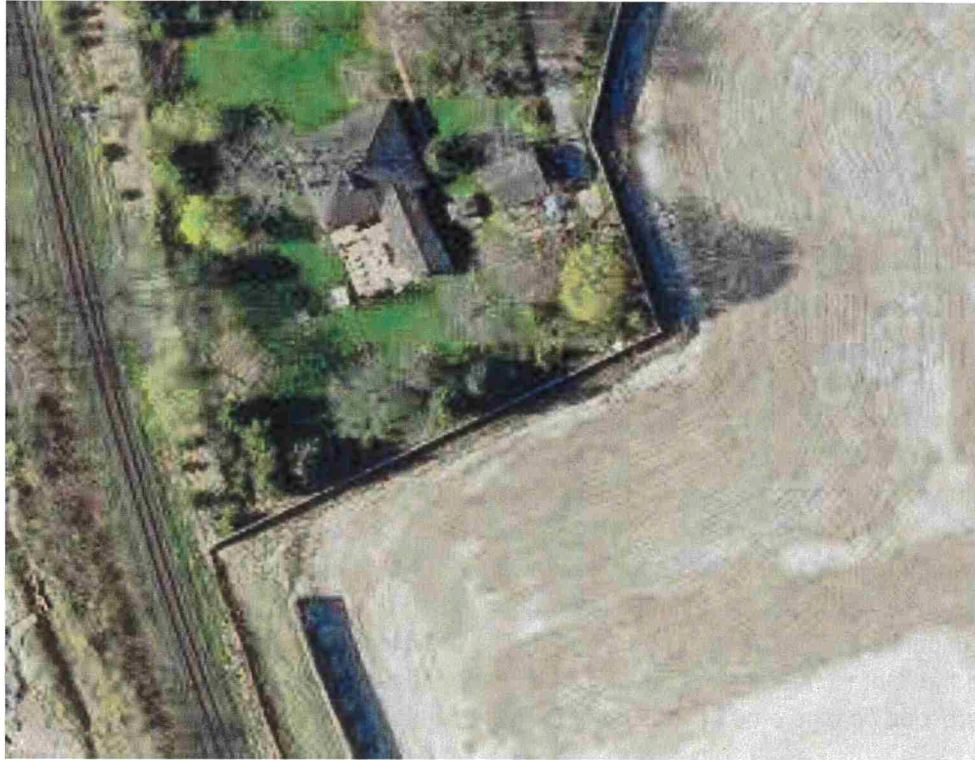
Figure 9: 2007 aerial photograph showing the subdivided property and the extensive grading to accommodate new development (Vaughan Archives).

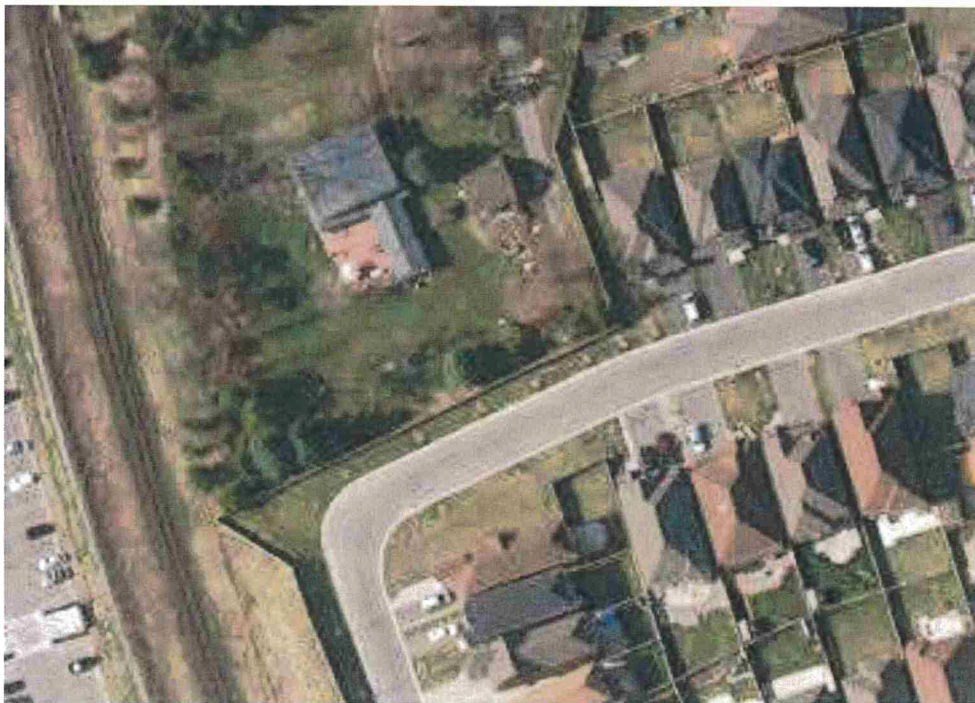
Figure 10: 2013 aerial photograph showing the completed residential subdivision and separate lot for Joshua Oliver House (Vaughan Archives).

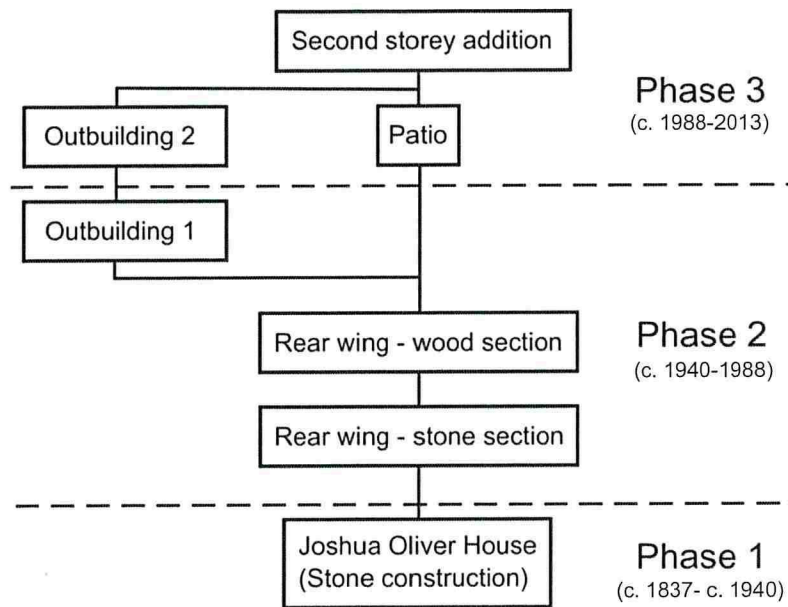
Figure 11: 'Harris Matrix' illustrating the structural sequence for built elements within the Study Area.

This sequence and phases are visually illustrated in Figures 11 and 12.

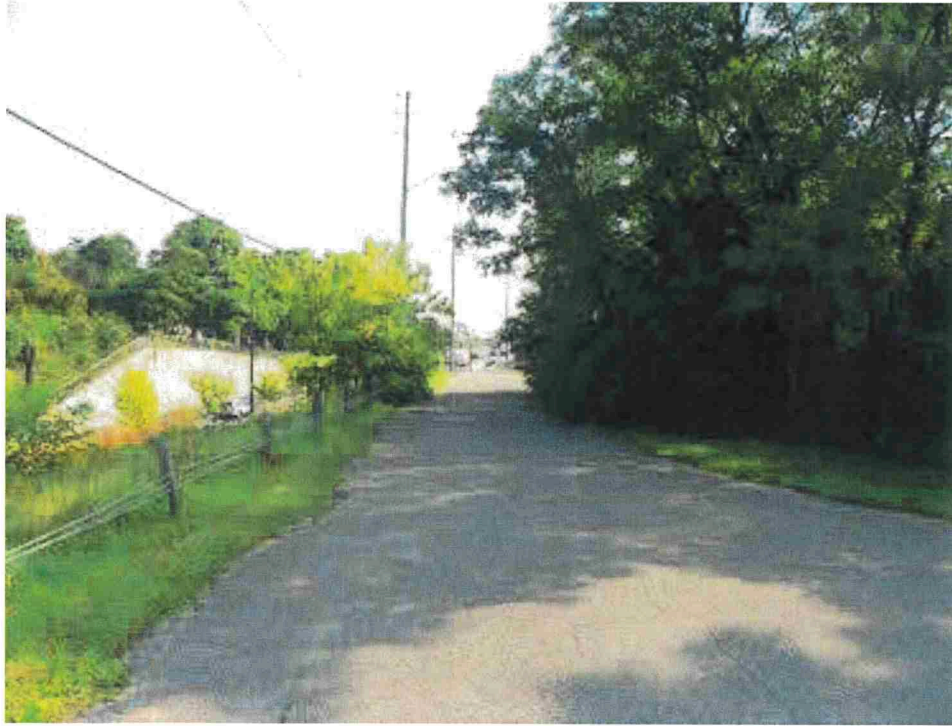
Figure 13: View facing east from end of the driveway towards Major Mackenzie Drive West showing the grade separation at left.

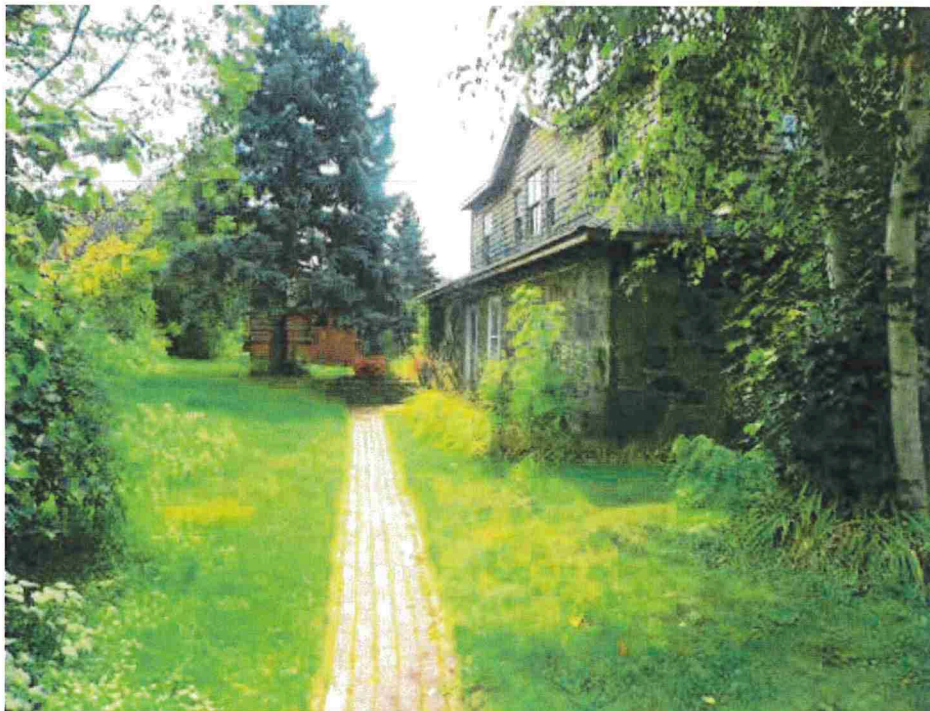
Figure 14: View facing south of the brick path that runs from the western edge of the driveway to the east façade door.

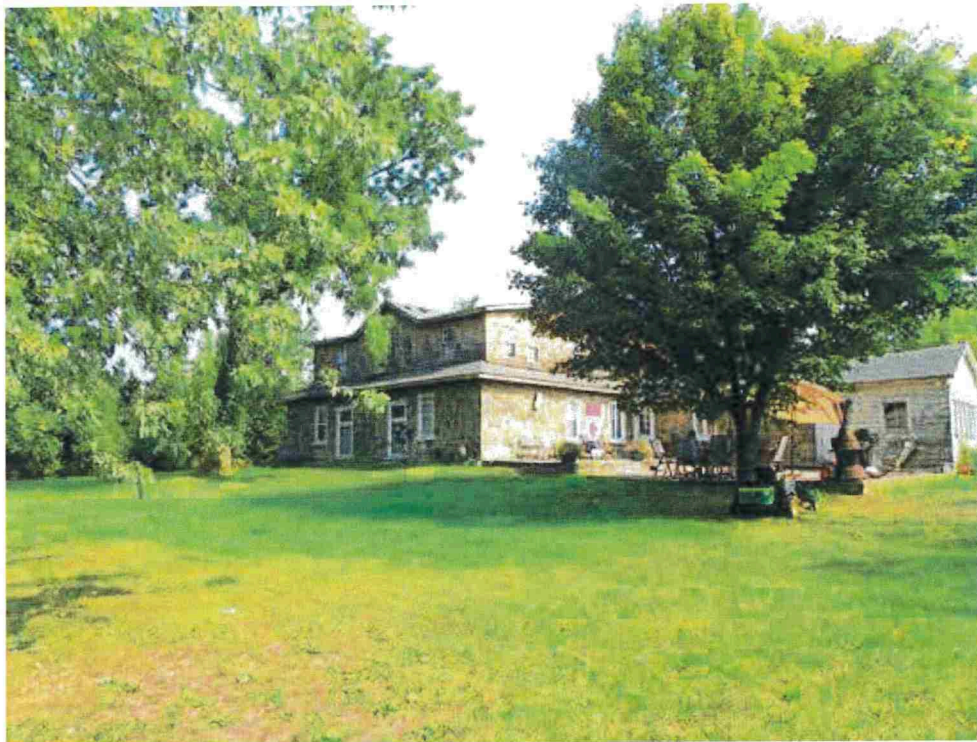
Figure 15: View facing northeast of the west side of the property showing the smooth terrain and gentle slope to the south west.

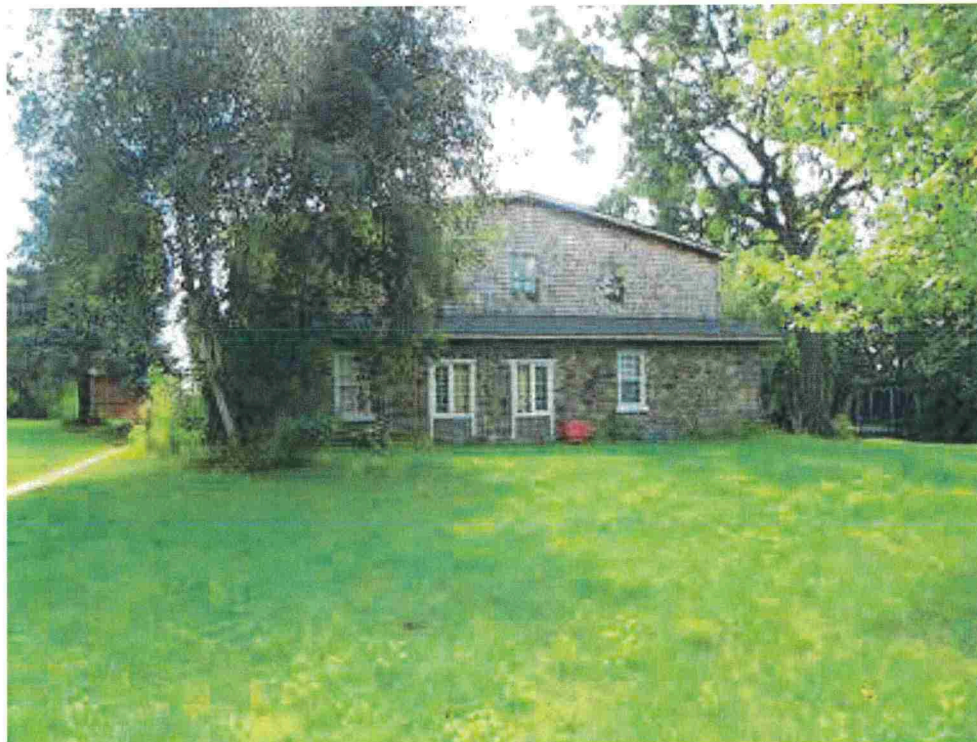
Figure 16: The north façade of Joshua Oliver House.

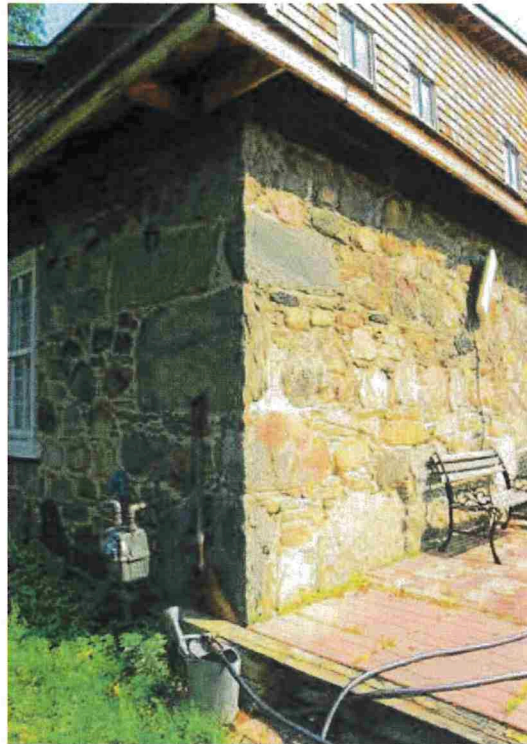
Figure 17: The southwest corner of Joshua Oliver House showing the large stone quoins and coursed rubble masonry.

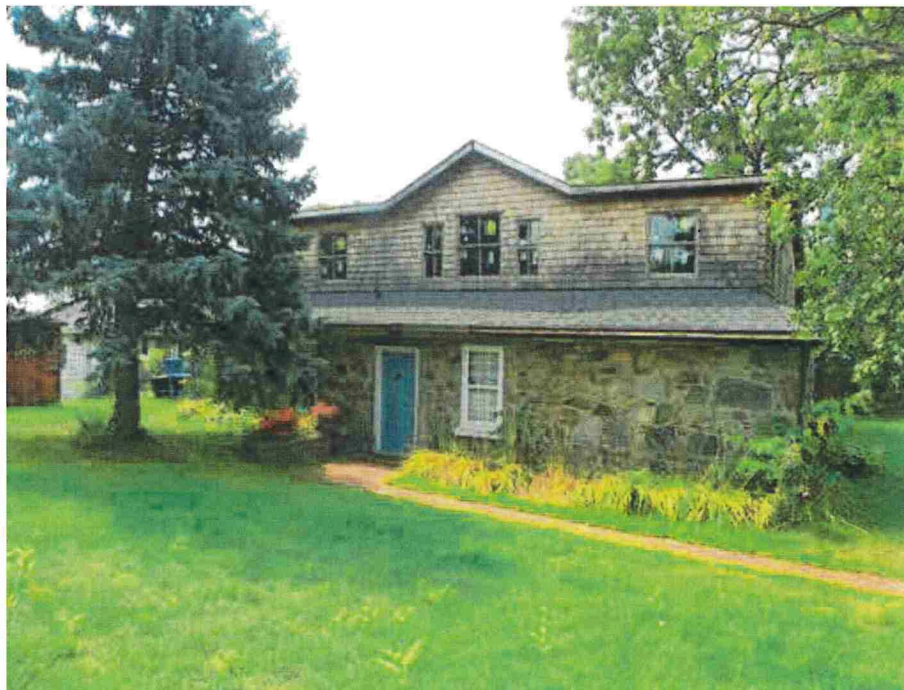
Figure 18: The east façade of Joshua Oliver House.

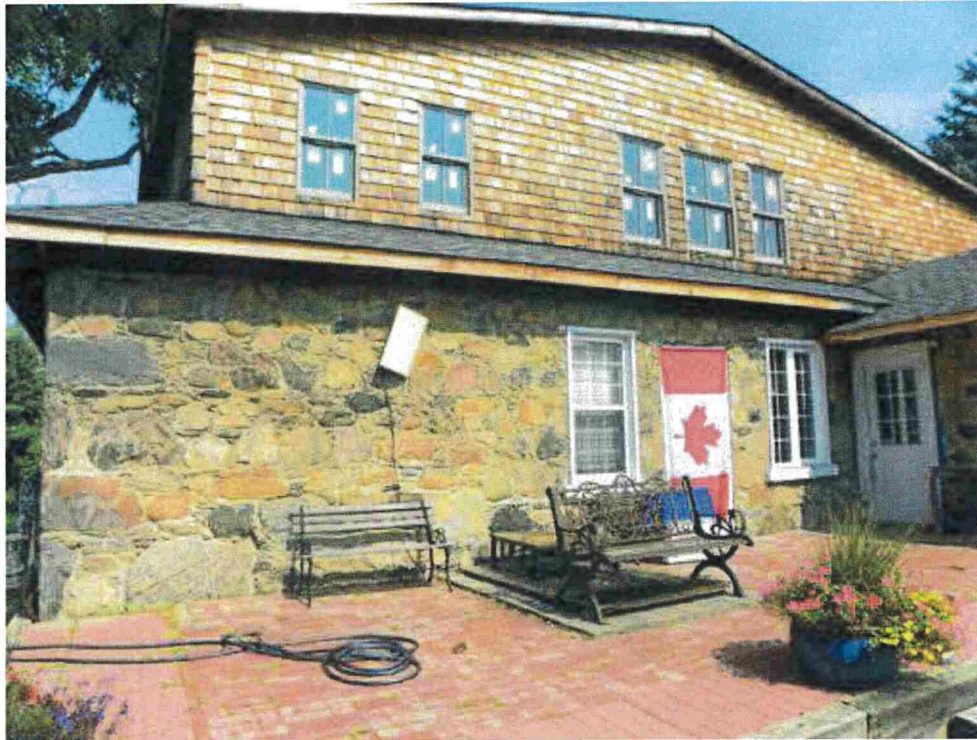
Figure 19: The south façade of Joshua Oliver House.

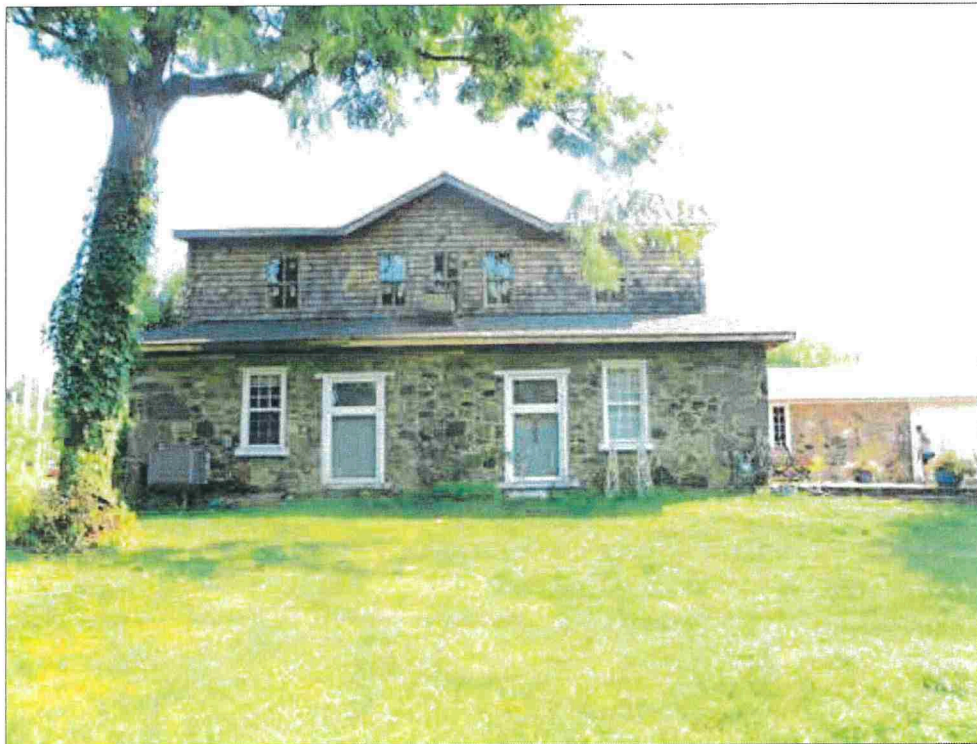
The windows have been replaced with vinyl inserts and removable muntins throughout yet retain the plain wood lintels and lug sills. There are two double-hung windows flanking an eight-panelled wood door with moulded trim on the east façade, and a double hung and casement window flanking a five-panelled wood door with original hardware on the south façade (Figures 18 and 19). Two double-hung windows are either side of two large hinged and fixed sash windows on the west façade, and an infill in the masonry suggests the location of a third window in the centre of the wall between the two hinged and fixed sash windows, although this is where the fireplace is now situated inside the west wall. Like the north façade, the two hinged and fixed sash windows on the west façade may have originally been doorways (Figure 20).

Figure 20: The west façade of Joshua Oliver House. Note the in-filled section in the centre of the stone wall between the two large hinged and fixed-sash windows.

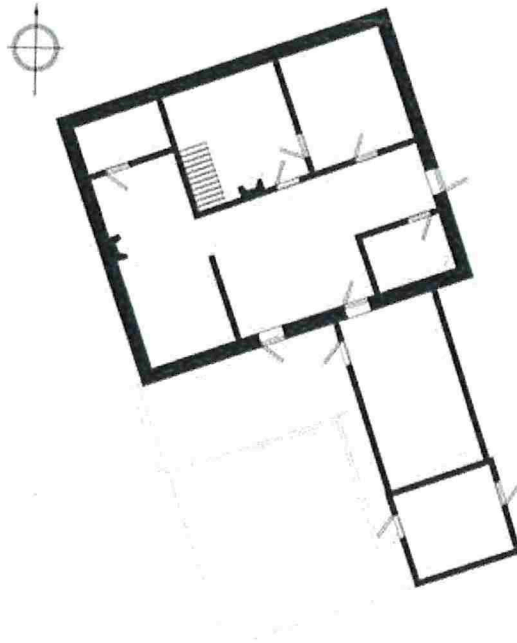
JOSHUA OLIVER HOUSE
Schematic Floor Plan
NOT TO SCALE

Figure 21: Schematic ground level floor plan of Joshua Oliver House.

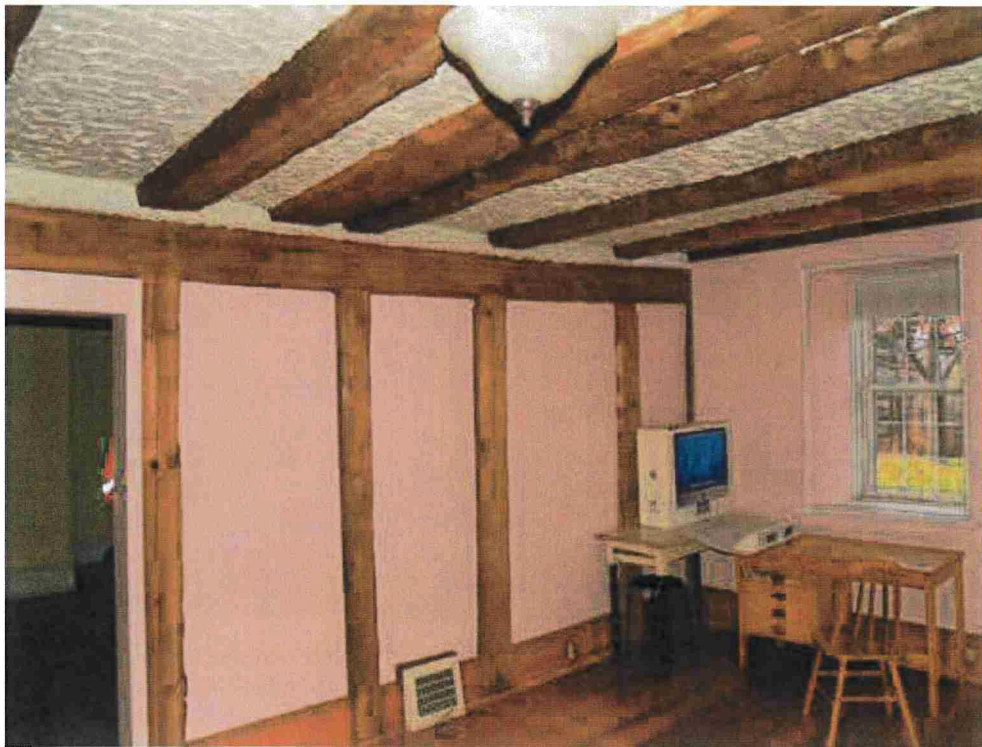
Figure 22: View facing west of the northeast room in Joshua Oliver House. Note the hewn ceiling joists and studs, and tall, beaded wood baseboard.

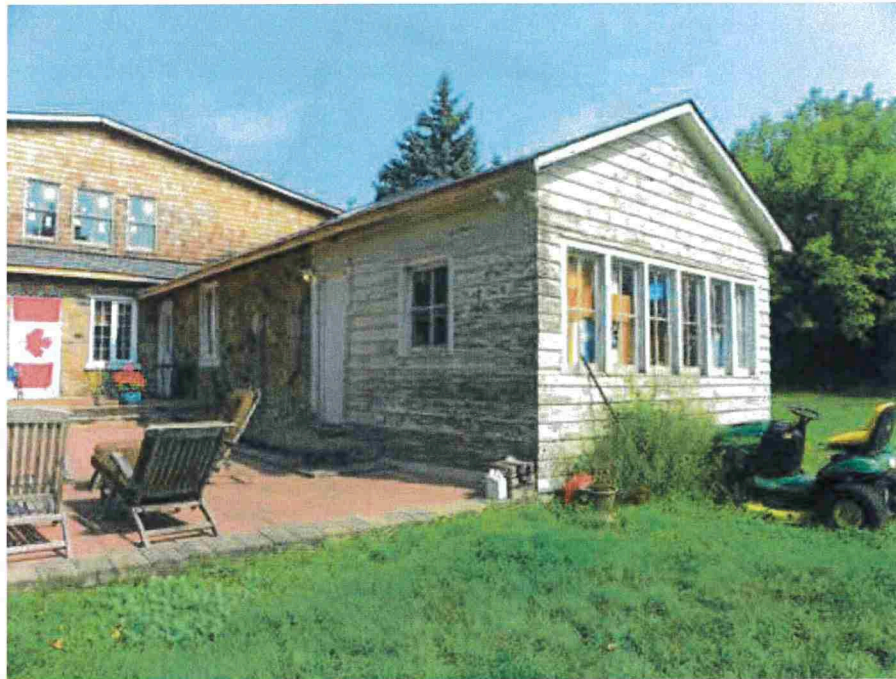
Figure 23: View facing northeast of the rear stone and wood frame wing.

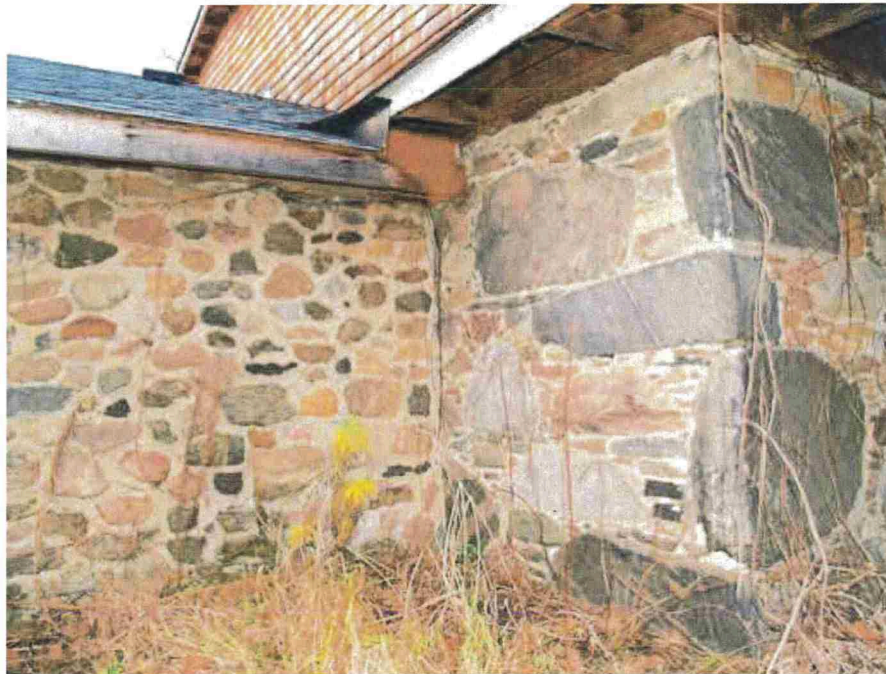
Figure 24: View facing northwest of the junction of the wing and original masonry near at the southeast corner of Joshua Oliver House. Note the contrast in stonework between the original construction on the right and the more recent wing construction on the left.

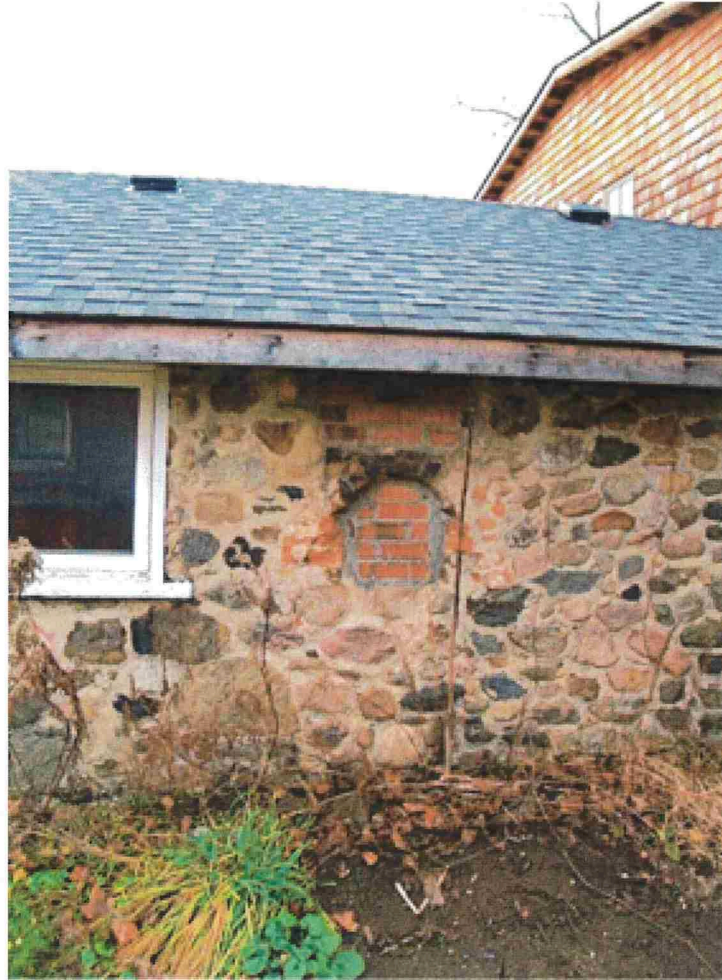
Figure 25: View facing west of the keyhole-shaped brick in-fill on the east wall of the wing.

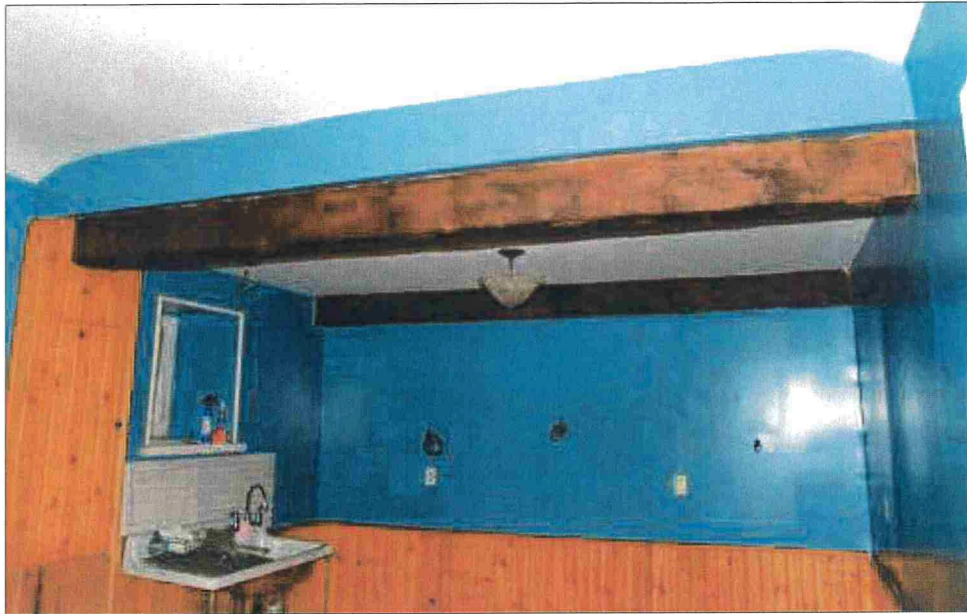
Figure 26: Interior of the stone portion of the rear wing showing the widely spaced and hewn ceiling joists.

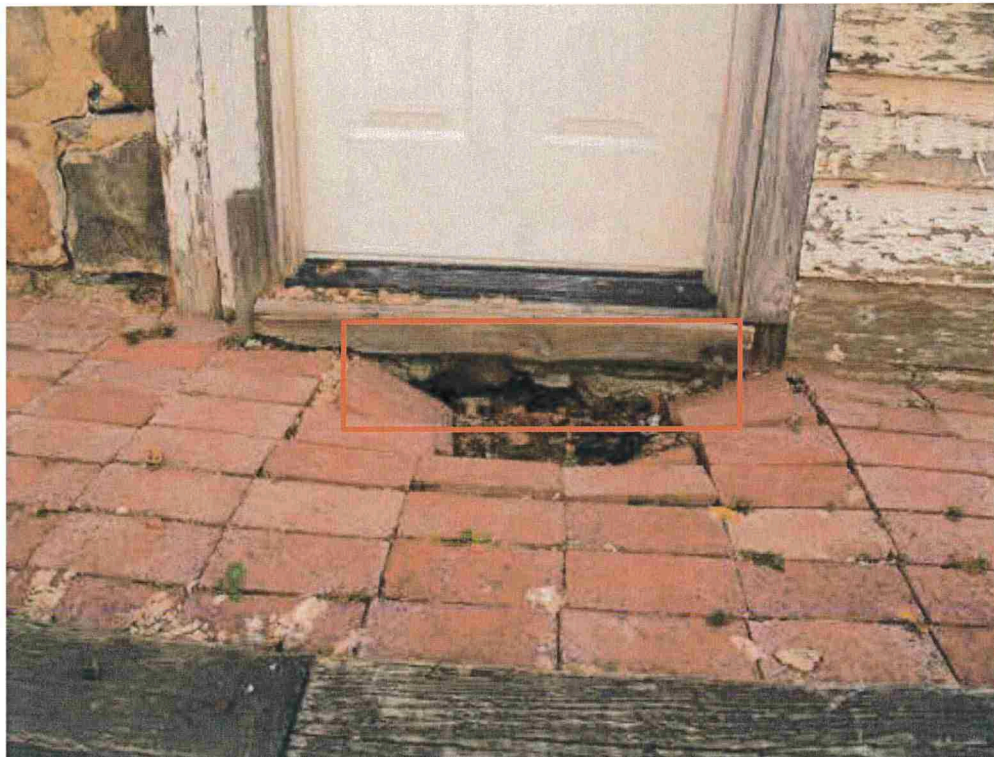
As mentioned above, the stone section appears to have been set in a coarse aggregate concrete foundation, while the wood frame section sits on a poured concrete foundation (Figures 27 and 28). Overall, both sections are in good condition.

Figure 27: Coarse aggregate concrete evident beneath the threshold of the east door of the wing's stone section.

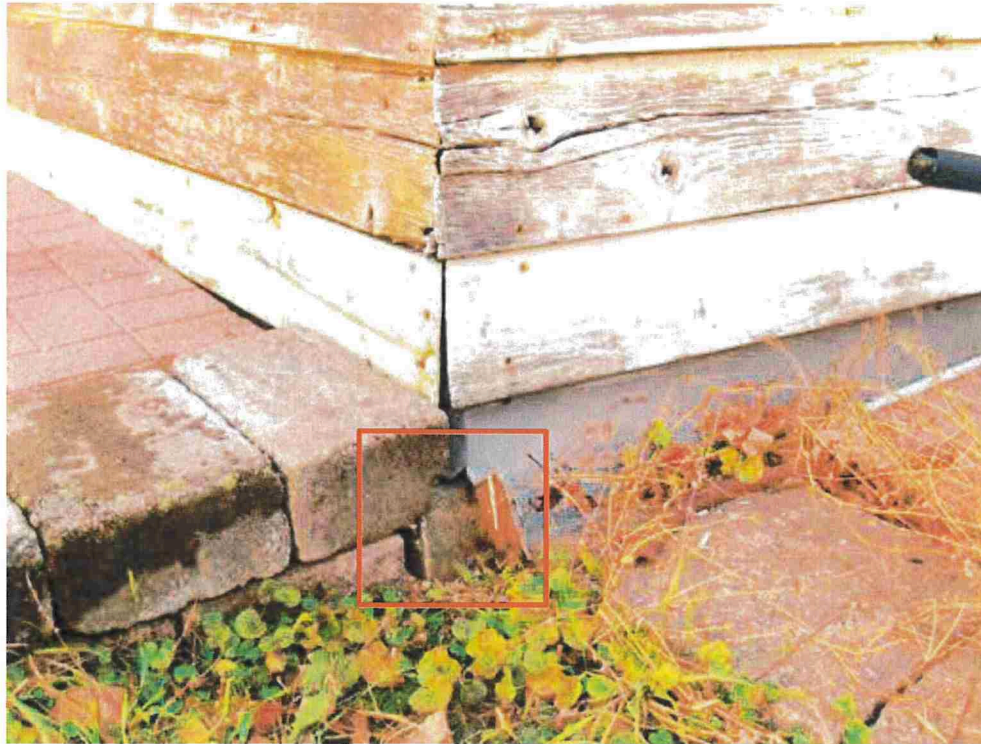
Figure 28: Poured concrete foundation evident at the southwest corner of the wing's wood section.

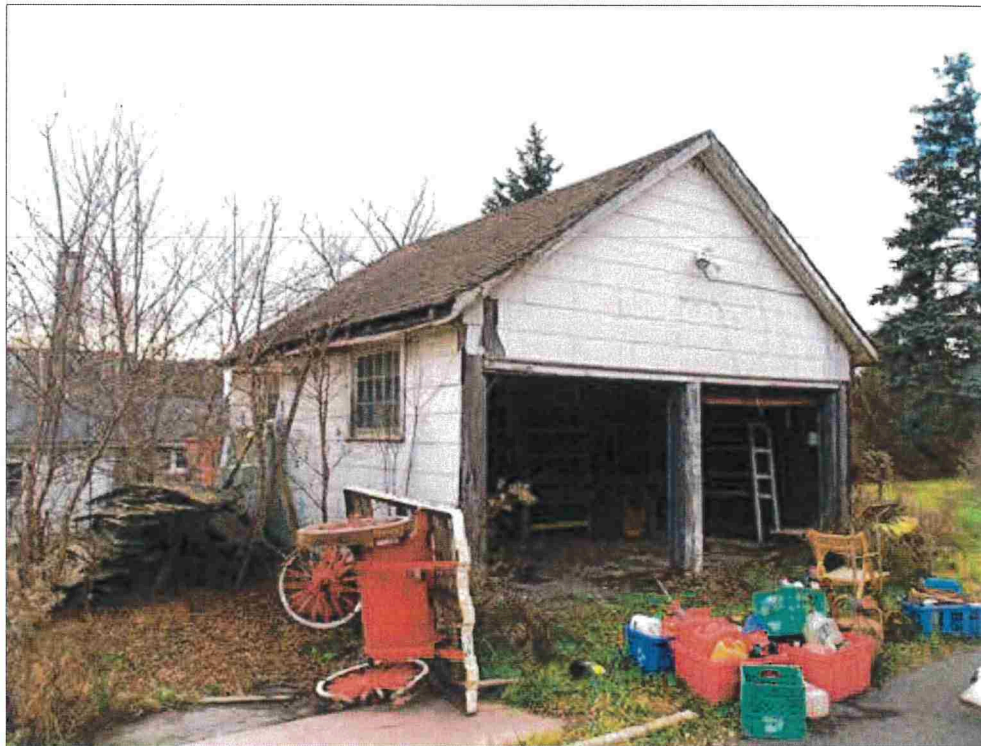
The building sits on a cinder block foundation that is slightly higher in the west as the ground slopes toward the rear wing of Joshua Oliver House. In general, the structure is in good to moderate condition and it does not appear to have been moved from another location.

Figure 29: View facing northwest of Outbuilding 1.

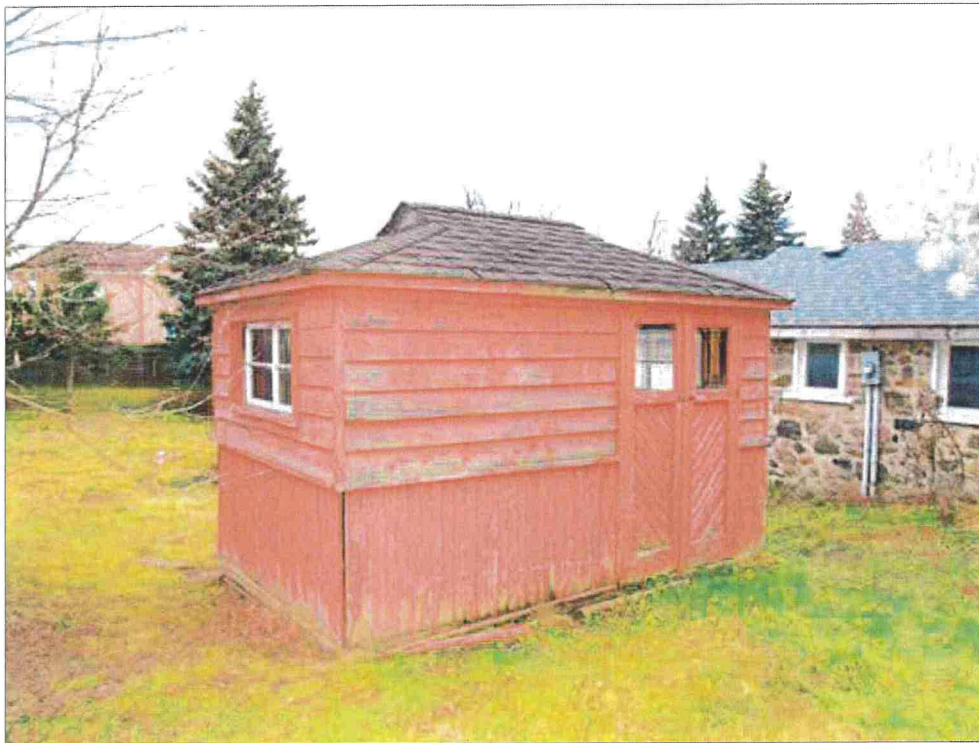
Figure 30: View facing southwest of Outbuilding 2.

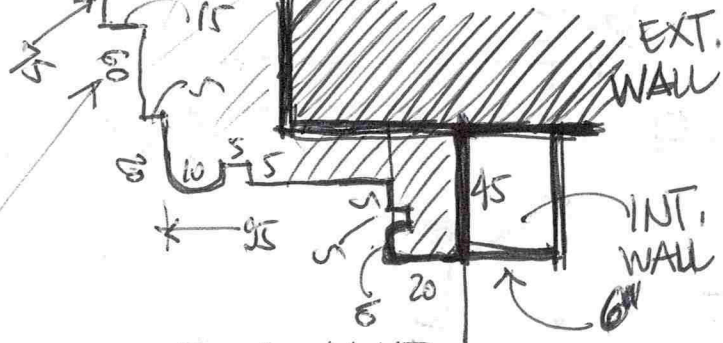
DOOR JAMB
DETAIL
@ EXTERIOR

45 @
INTERIOR
JAMB
