ATTACHMENT 2 4660 KIRBY

HERITAGE REPORT

Inspection done on January 29, 2024 @2:00 pm

The property on 4660 Kirby Road, Kleinburg, Ontario is Listed to the Municipal Heritage Inventory in 2005
Construction date circa 1875.

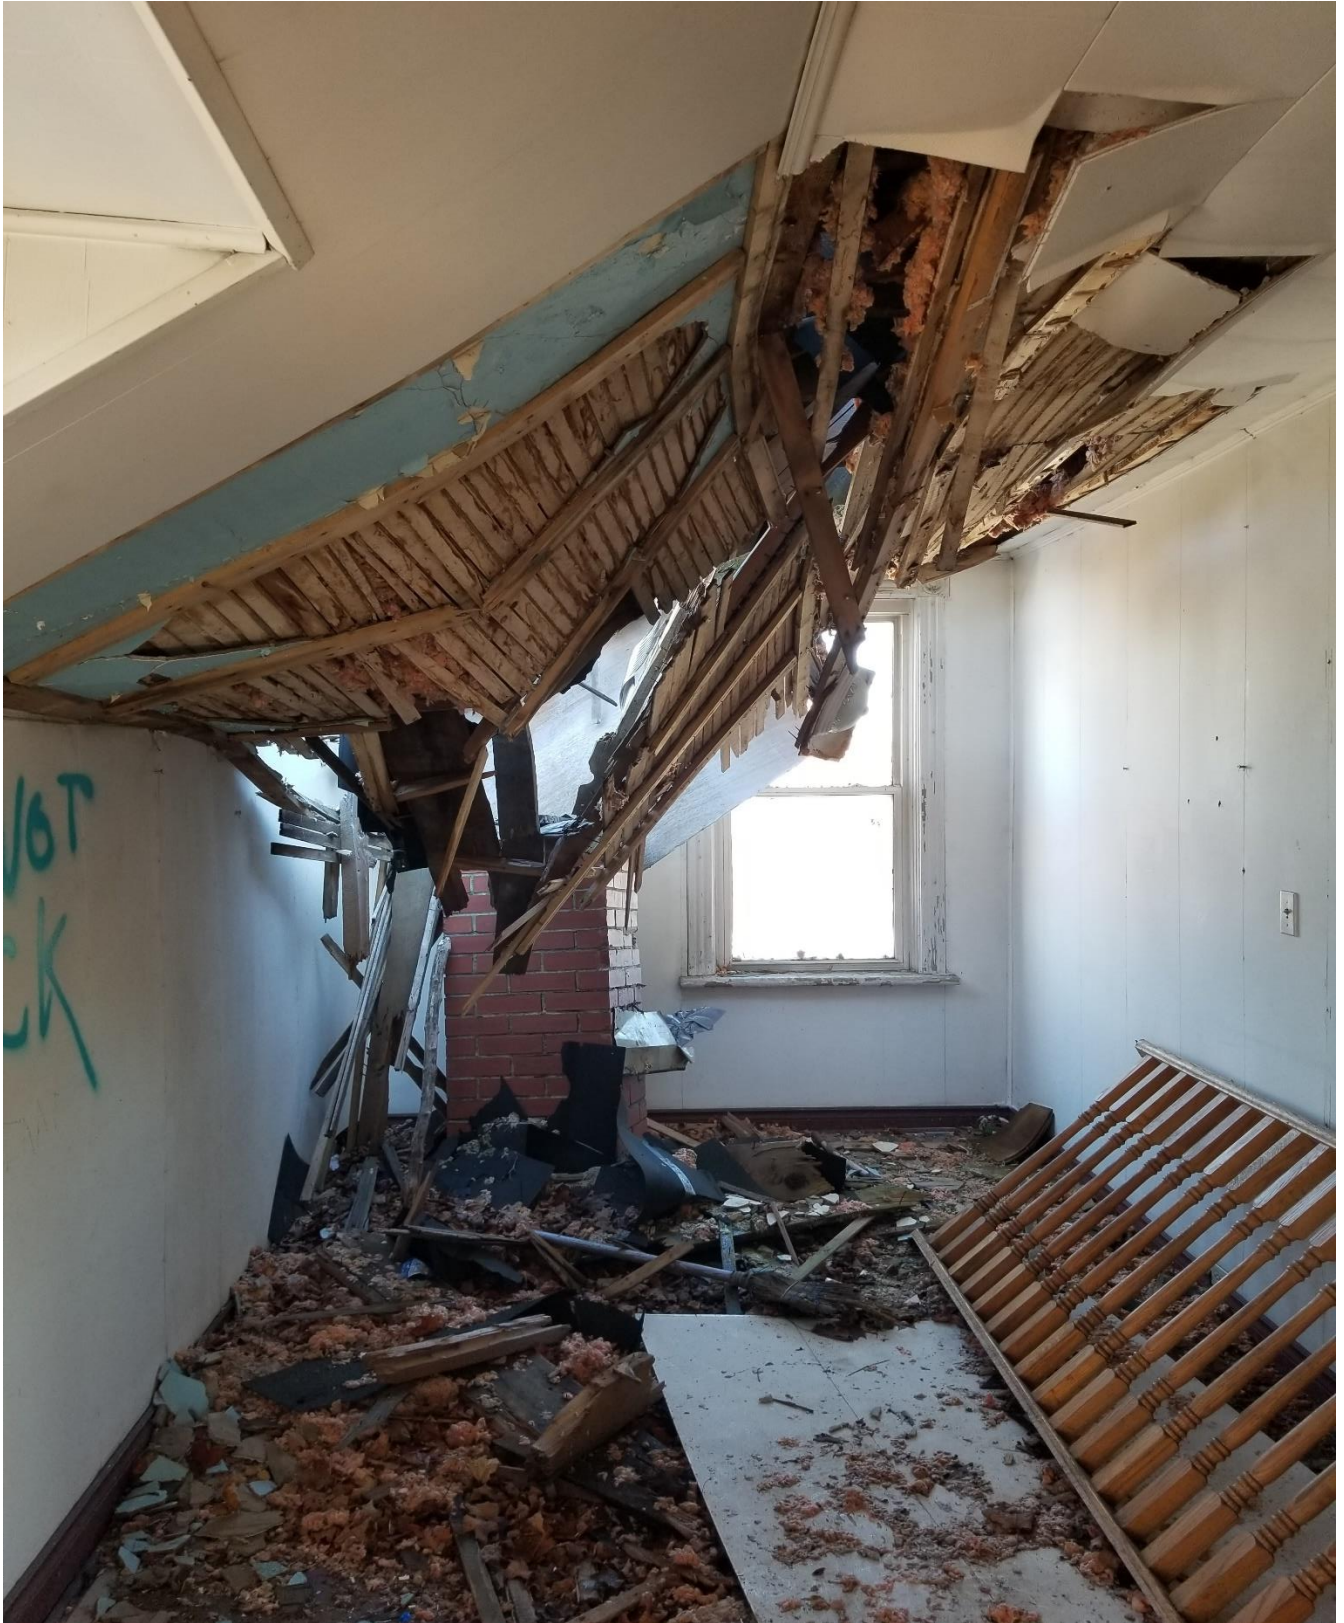
- The interior of the house has suffered major water damage from the second floor and throughout the house. Due to a Chimney falling into the house, creating broken rafters and a hole measuring 10'x10' and a similar hole is seen at the back slope. Repair/Replacement of the roof should be addressed immediately.
- Most of the windows and doors that are missing will also require restoration and replacement.

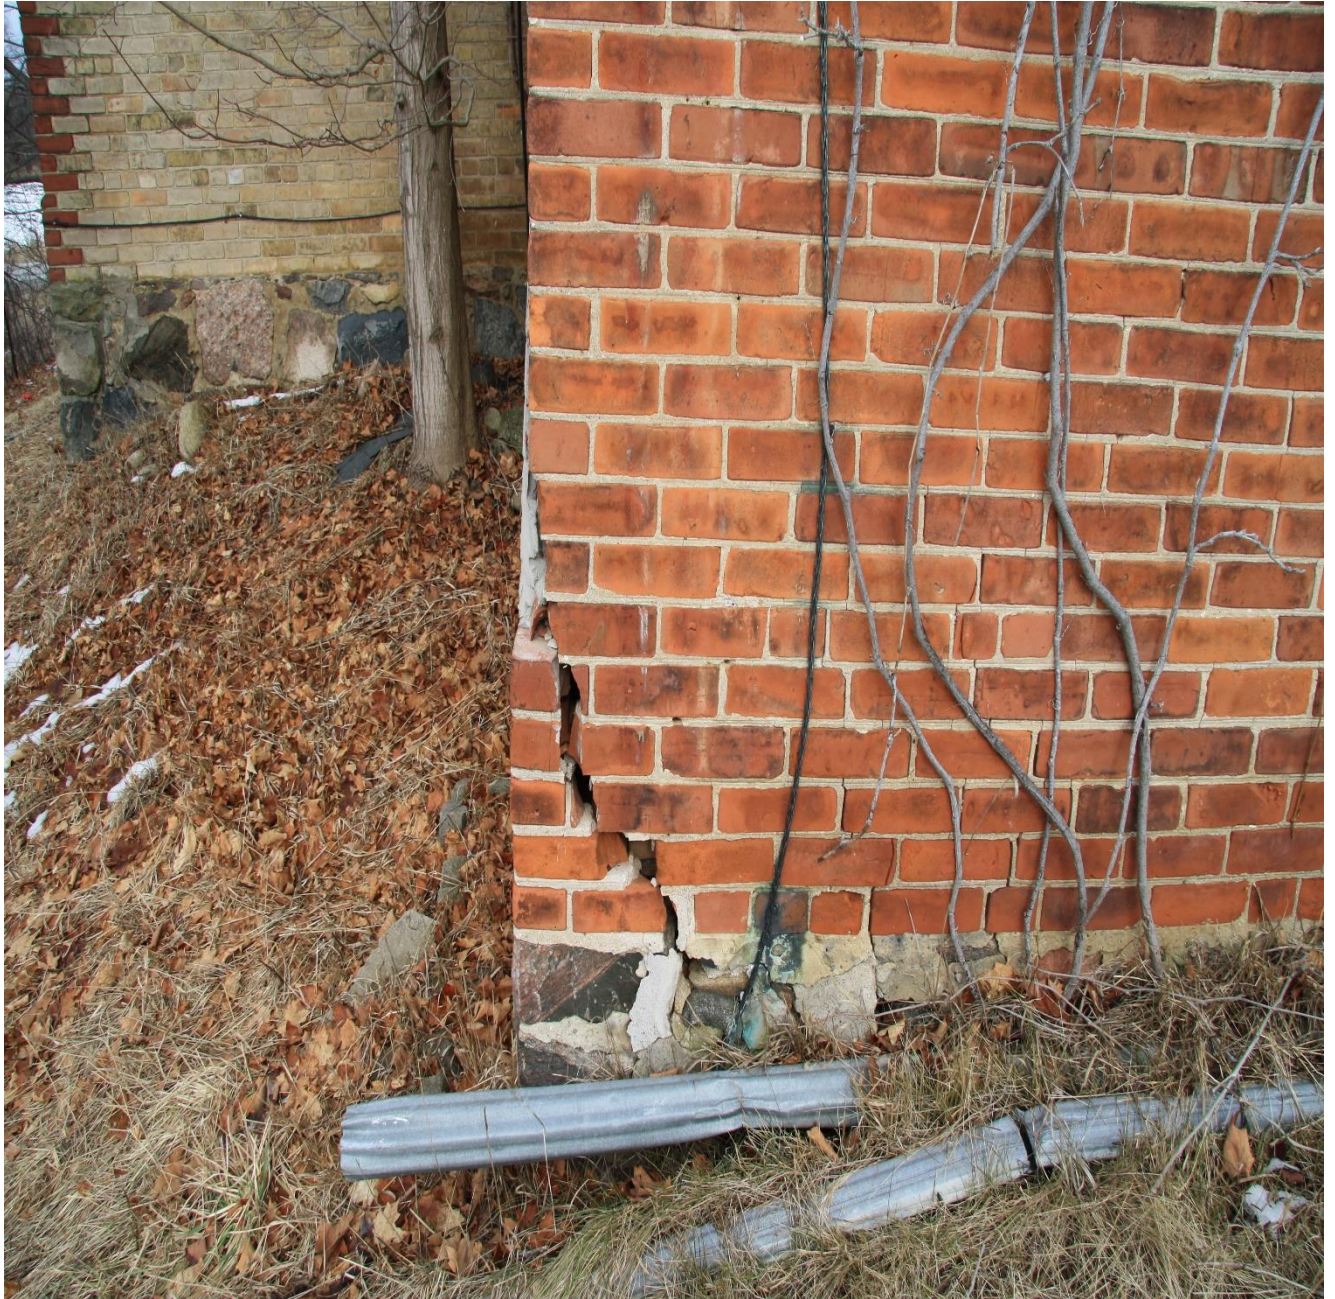
- In the Fieldstone Foundation walls noted major crevices also seen in the brick façade
