ATTACHMENT 4 11151 WESTON ROAD

RE: Response to Evaluation, Proposed Designation, and Recommendations on Same 11151 Weston Road, Vaughan, Ontario (PIN 033450136)

Field Notes on Condition of Residence

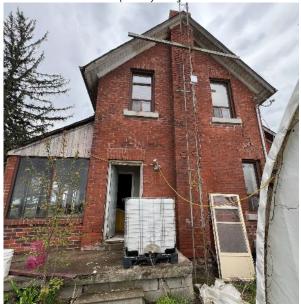
East (Rear) Façade

- According to the current owner, the residence has been vacant for more than 20 years.
- The outside of the residence shows signs of both mild and moderate damage, including:

- Eavestrough sag and detachment;
 - Shingle damage and lack of shingles;
 - Evidence of brick replacement non-matching to original in both colour and bonding;

- Brick and mortar damage both around brick in mortar and through brick, resulting in brick cracks, deterioration, and spalling;
 - Weathering; and
 - Animal entry.

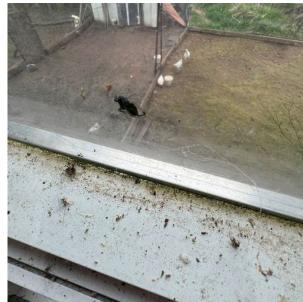
View to North Chicken Run

- The residence has been converted into a coop and run for chickens, turkeys, and quails, and these animals have access inside of the house and outside within a fenced in run.

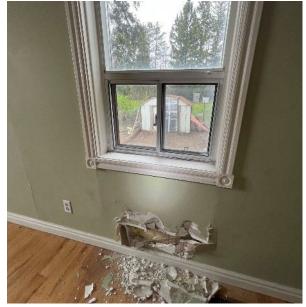
- The interior of the residence is, in our opinion, in very poor condition, and includes severe damage, including:
 - Animal entry and feces;
 - o Collapsing ceilings and drywall damage;

Drywall Damage

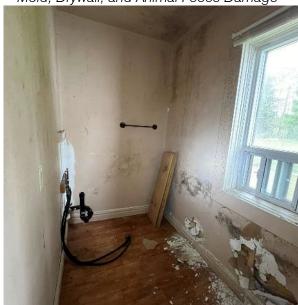
- Mold and mildew damage and smell;
 - Sagging and bouncy floors;

Mold, Drywall, and Animal Feces Damage

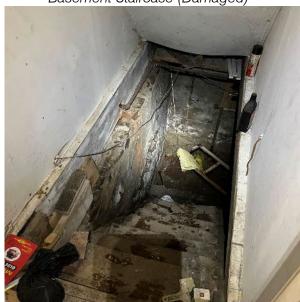
Basement Staircase (Damaged)

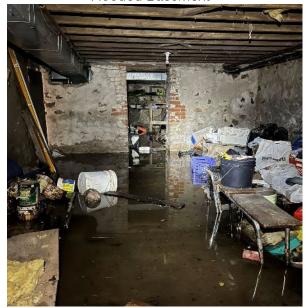
- o Water damage;
- Some evidence of fire damage;
- Flooded basement;
- Retro-fit HVAC system which cuts ductwork through a load bearing brick wall in the basement; and
- o Bowing walls in the basement.

Flooded Basement

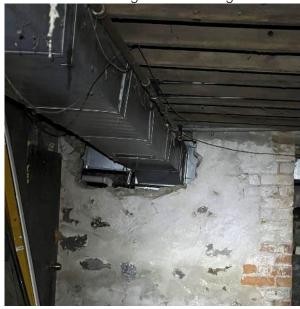
HVAC Cut through Load Bearing Wall

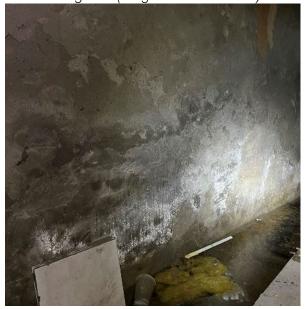
Bowing Wall (Parged with Concrete)
