FINAL REPORT

Cultural Heritage Impact Assessment

John Fleming House, 9151 Huntington Road, Lot 15, Concession 9, City of Vaughan, Regional Municipality of York, Ontario

18107463-R02-Rev1

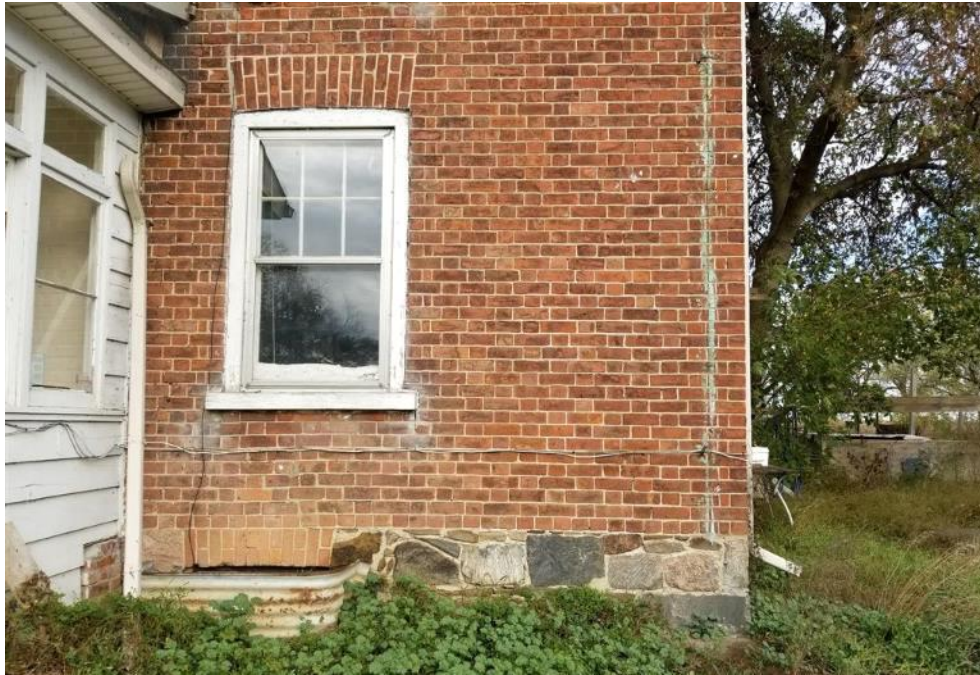
The Main Block is rectangular, measuring 11.3 m north-south and 7.3 m east-west. It is a single-detached, two-storey, three-bay brick farmhouse with a rectangular plan. It sits above a fieldstone foundation and full basement. Constructed from red brick, the main façade is built with Flemish Bond (Figure 22), while the other three sides of the building are 1:5 Common Bond (Figure 23).

Figure 22: Detail of Flemish Bond and coursed rubble foundation on the west façade of the Main Block.

The main front wall (west wall) is constructed of red pressed brick laid up in the Flemish bond fashion. This is a high-strength method of construction which, when used in Ontario, created a solid front to the public face of the building (Goldsmith Borgal & Company Ltd. Architect 2017). It is important to note, the original driveway to the property ran east-west from present-day Huntington Road to the west wall of the Main Block, thus, providing direct visual relationship of the main wall to the roadway. The remainder of the walls of the Main Block as well as the East Wing are construct of red pressed brick laid up in the Common Bond, which is common form in Ontario.

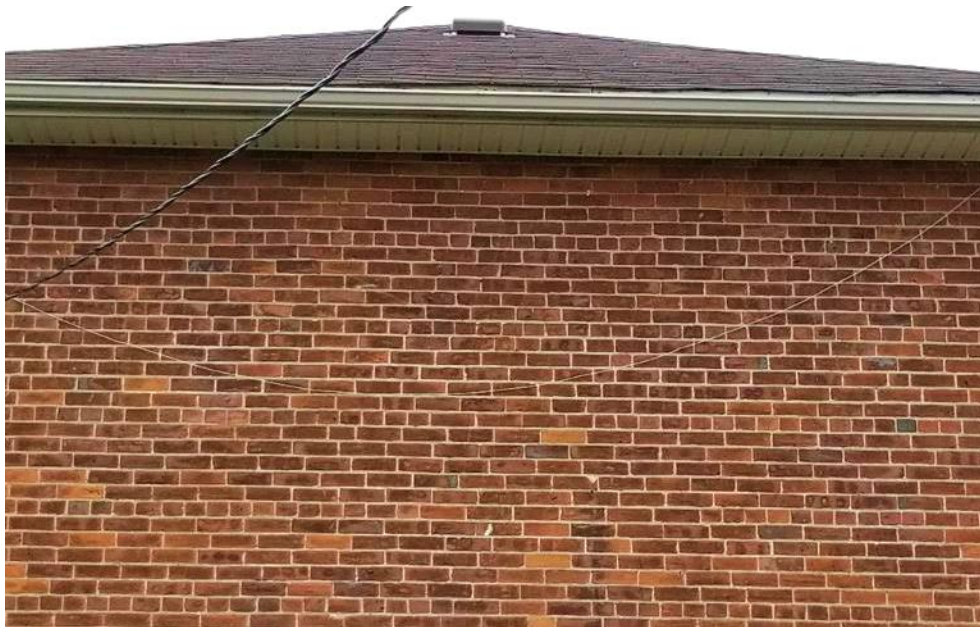
Figure 23: Detail of Common Bond on the north façade.

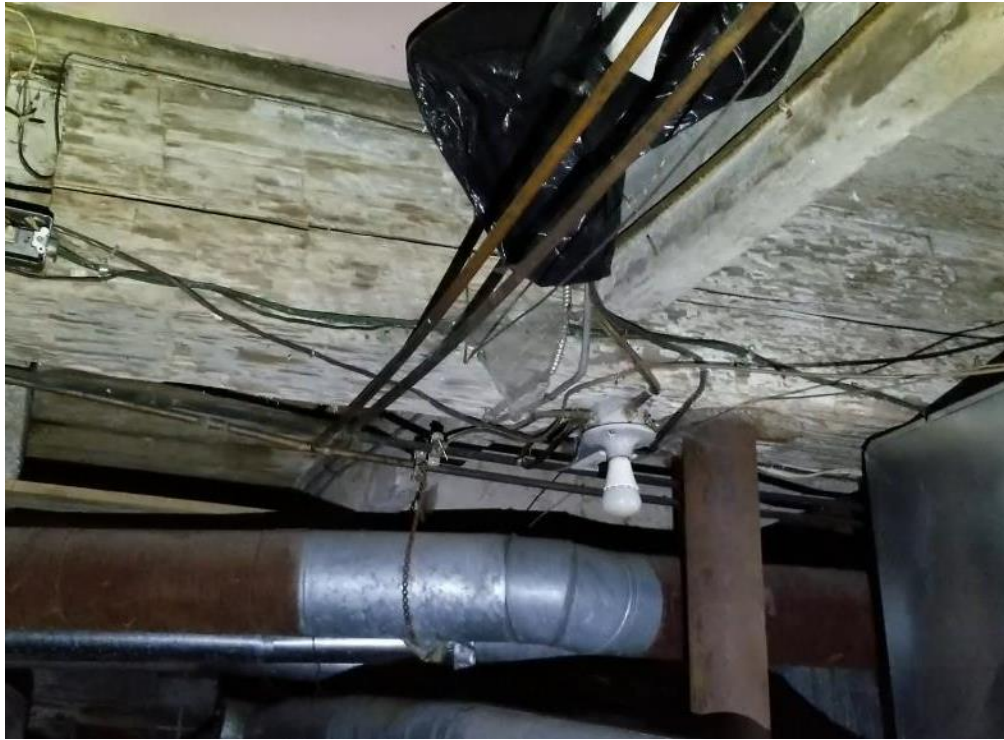
There are two windows on the west wall and one window on the east and south walls (Figure 46). All the basement windows were small and rectangular, likely one or two panes, although no frames have survived. Running east-west through the centre of the basement's ceiling is a large summer beam, as a central support for the floor above (Figure 47).

Figure 47: Close up of the summer beam running east-west across the basement ceiling.

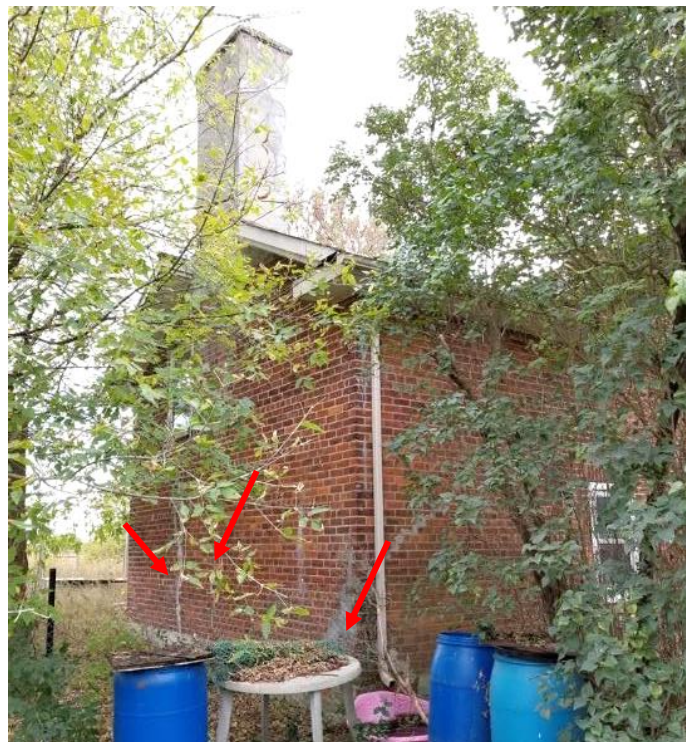
The north, east and west walls of the East Wing have experienced significant structural damage, as evidenced by the presence of tie rods, repaired cracking and patchy color of large brick areas (Figure 50). Thus, relocation of the East Wing may be difficult.

Figure 49: North and east façades of the East Wing. Note, extensive damage and repair to the east wall (red)

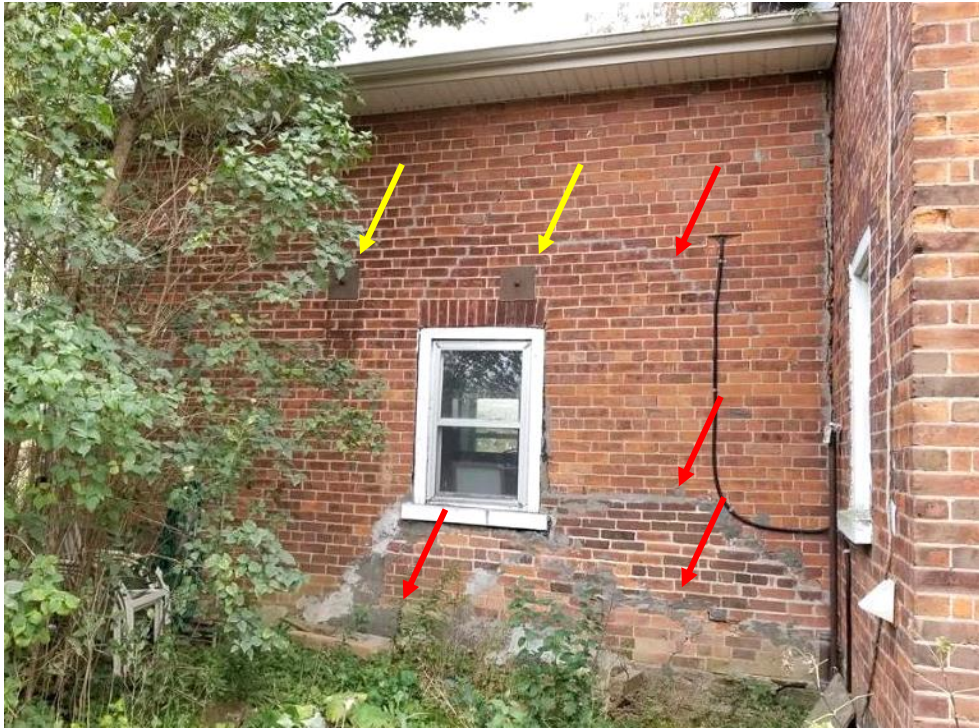
Figure 50: Extensive damage and repair to the north wall (red). Note the metal rods to secure the wall (yellow).

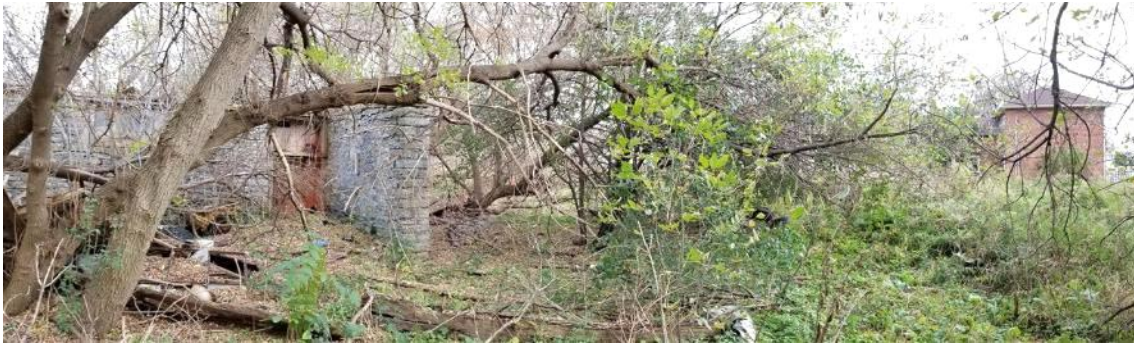
All that remains of the barn is a portion of the stone foundation. The coursed stone foundation presents asymmetrical fenestration with 10-pane fixed wood windows with flat head openings and no exterior decoration (Figure 60 and Figure 61). Exterior doors on the surviving west wall are plain wood. Interior beams which would have supported the floor above have decayed and cracked, and there is not much left inside the barn (Figure 62 to Figure 64).

Figure 64: Panorama of the collapsed barn in relation to the farmhouse visible to the southwest.

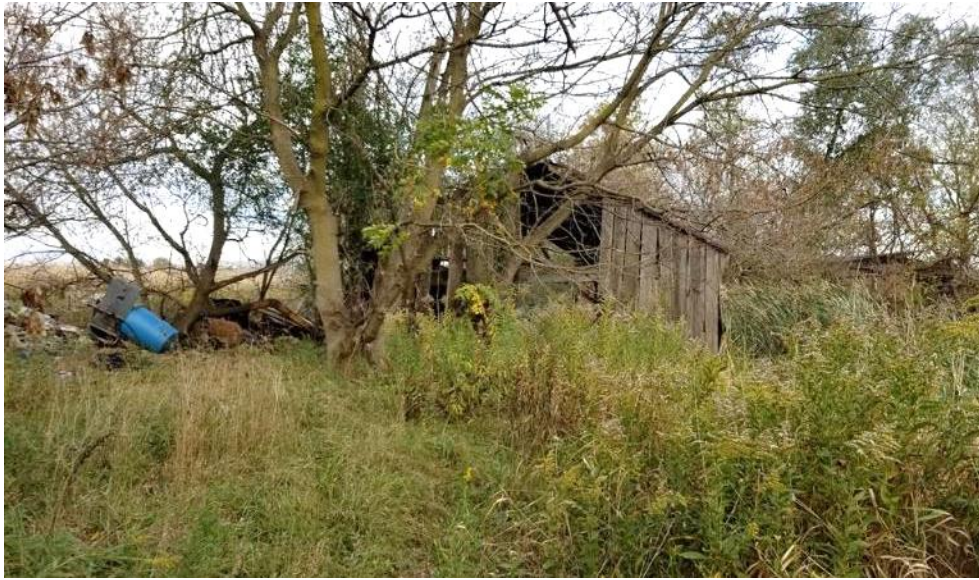
This 20th-century structure has a medium gable roof with a wood frame, currently in a state of collapse. Much of the wall material has rotted away, leaving the support posts in place (Figure 65). It was sided with vertical wood planks and is currently leaning to the east (Figure 66).

Figure 66: The west façade of the northeast outbuilding.

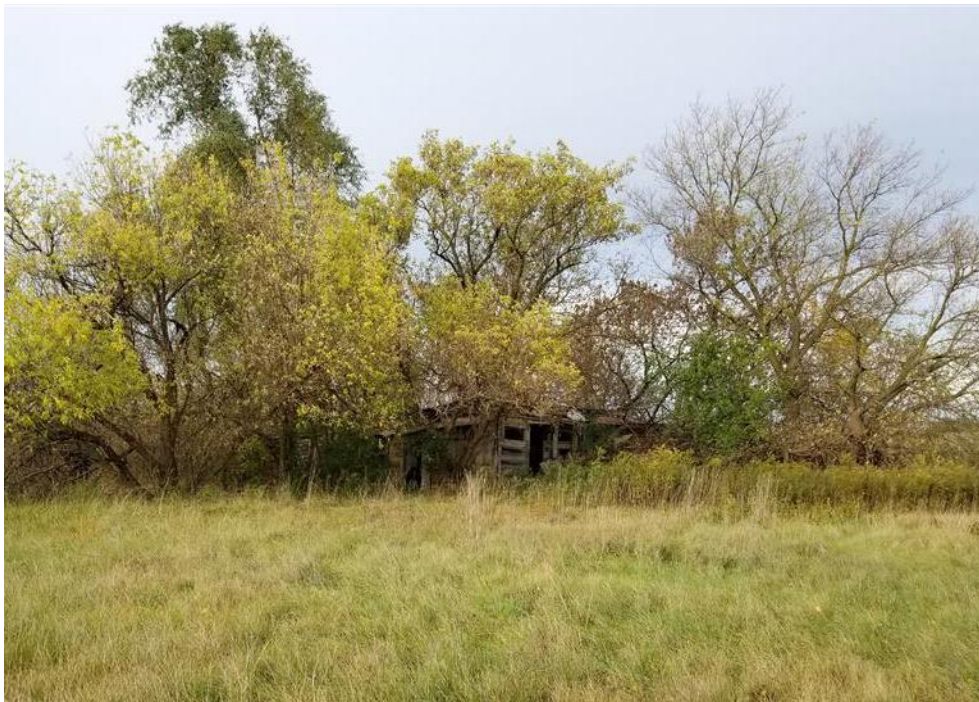
The mid-20th century East Outbuilding is a one-storey, wood frame structure with a low gable roof (Figure 67). It is currently surrounded by trees on the east side of the residential area and is barely visible within the trees and bushes that are growing through the structure.

Figure 67: East outbuilding.

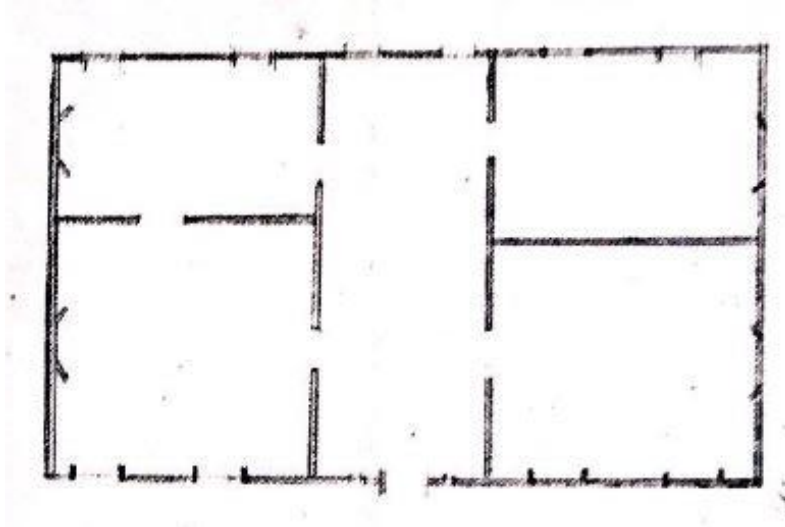
East Wing, with rooms to the north and south. The typical Georgian floorplan is fairly symmetrical, such as this example from Blumenson (1990:6) of the William Dickson House, built in 1794. John Fleming house is nearly symmetrical, with one large room on either side of the central hallway, but a smaller room behind the staircase on the north side of the house which is currently used as a small bathroom.

Figure 68: Georgian floorplan, William Dickson house (Blumenson 1990:6).
