## **CULTURAL HERITAGE IMPACT ASSESSMENT**

**10489 Islington Avenue  
Lot 6, Plan 11, Nashville-Kleinburg Heritage  
Conservation District  
City of Vaughan, Ontario**

**Report Number: 1668503-R01**

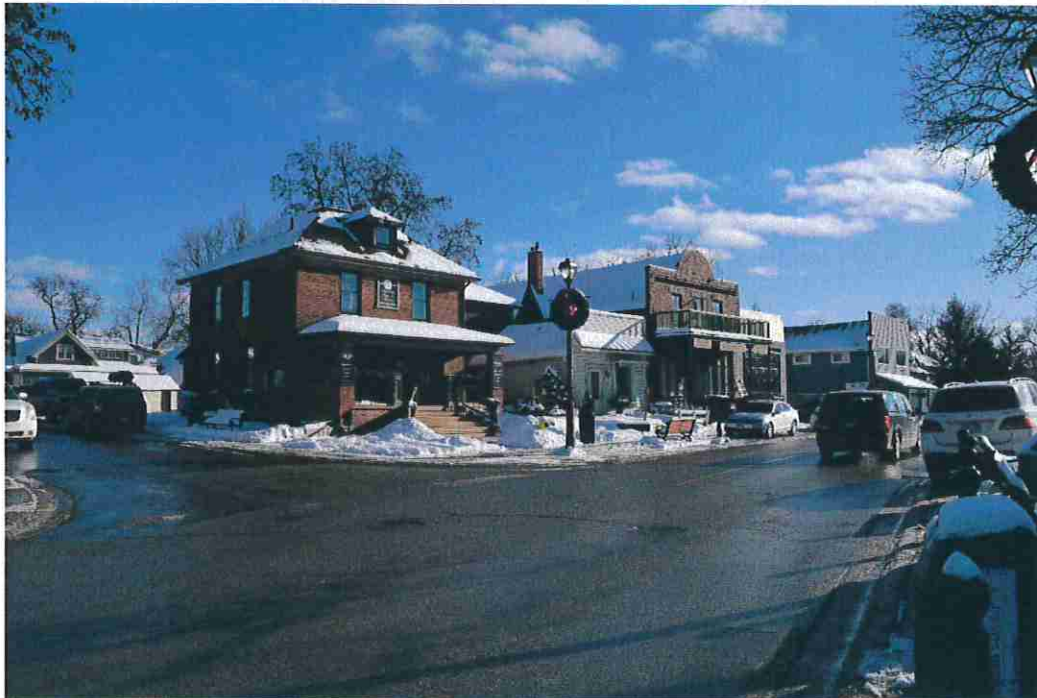
Figure 7: View of the Study Area facing east.

Both the house and store are situated in the west portion of the property, with the main block of the house on the northwest corner, and its wing extending to the southeast (Figure 7). The small store is on the southwest corner of the lot, and although the house and store are relatively far apart, the space between them is enclosed on the east by the southeast wing. Both the small store and the main block have minimal setbacks from the surrounding roads and the building immediately to the south on Islington Street. This short setback distance follows the pattern either side of Islington Avenue and Kellam Street (Figure 8, Figure 9, and Figure 10).

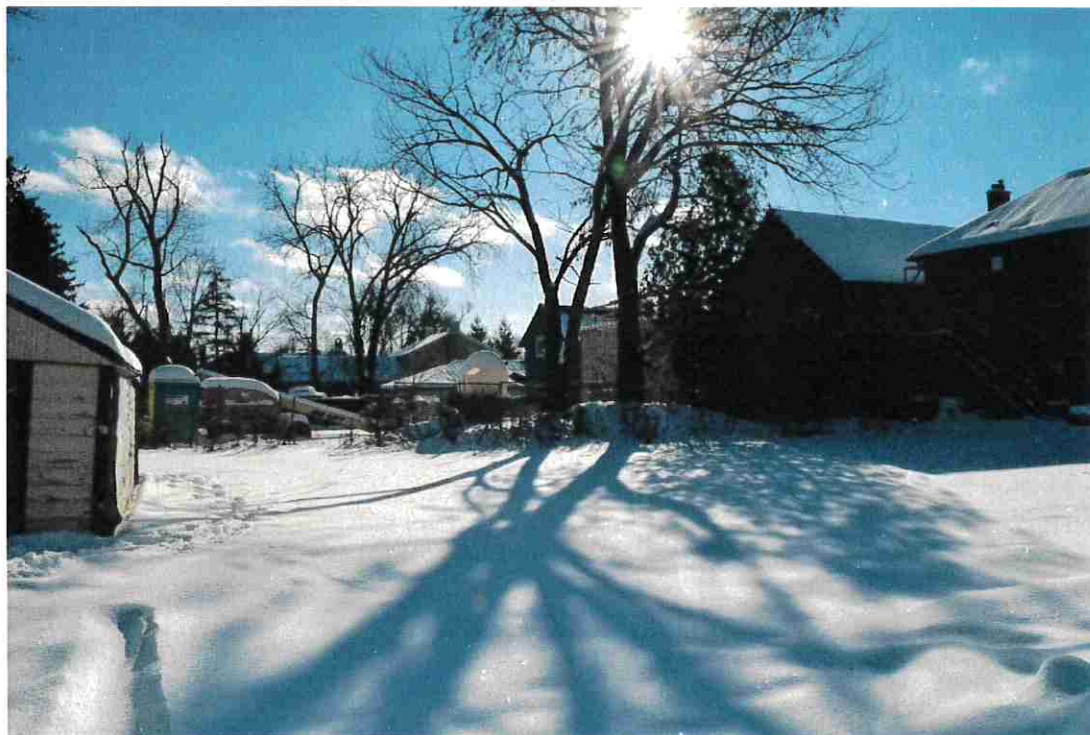
Figure 11: View facing south of the parking lot in the centre of the Study Area.

At the east extent of the property, parallel and near the east fence line, is the shed, and is separated from the house and wing by a flat and open gravel parking area, accessed from Kellam Street (Figure 11). The only boundary demarcation is a chain link fence that runs from the rear wing to the southeast corner, and then north to Kellam Street.

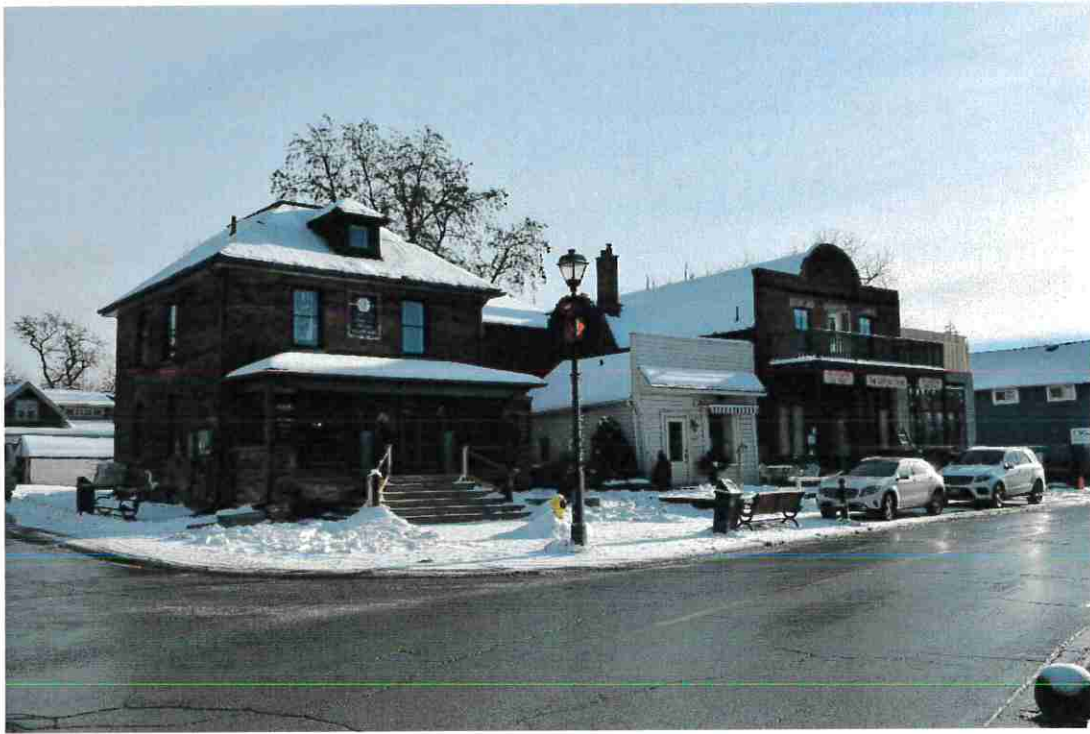
Figure 15: North and west façades of the house and shop.

The Study Area's built environment includes: a house with front verandah, rear wood frame addition, and brick wing; a small shop; and a detached garage. Each are described in detail below. Overall the house and rear wing form a single-detached residence (now commercial use) that is two storeys in height (Figure 13, Figure 14, Figure 15, Figure 16, Figure 17, and Figure 18).

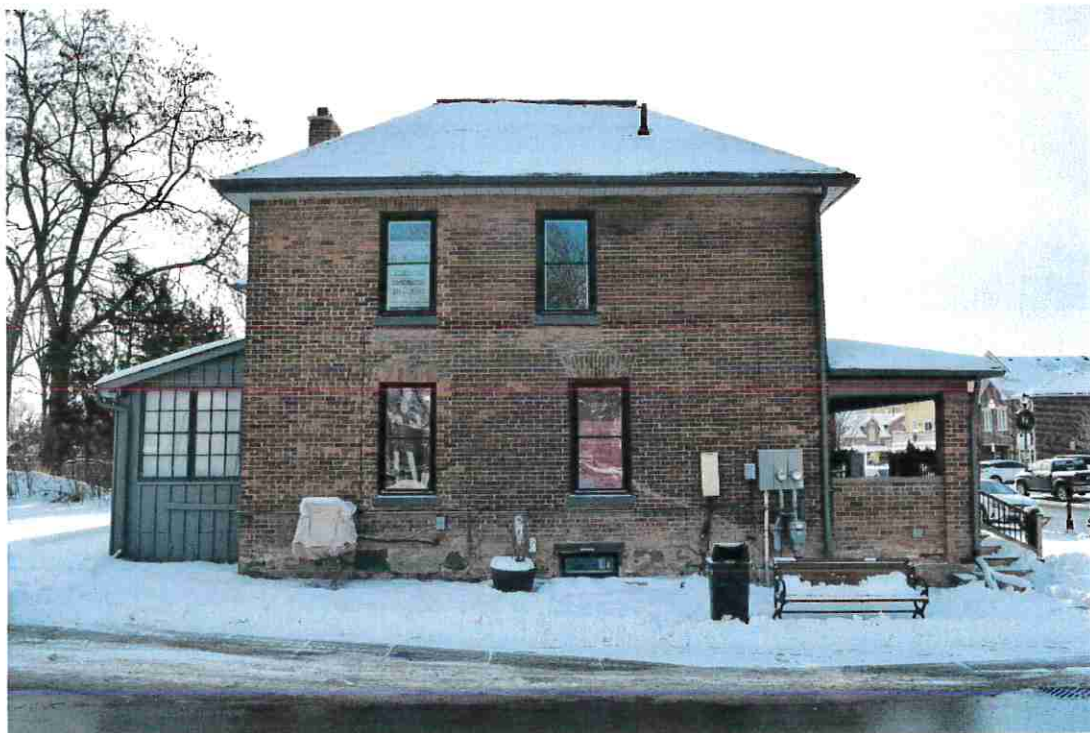
Figure 16: North façade of the house.

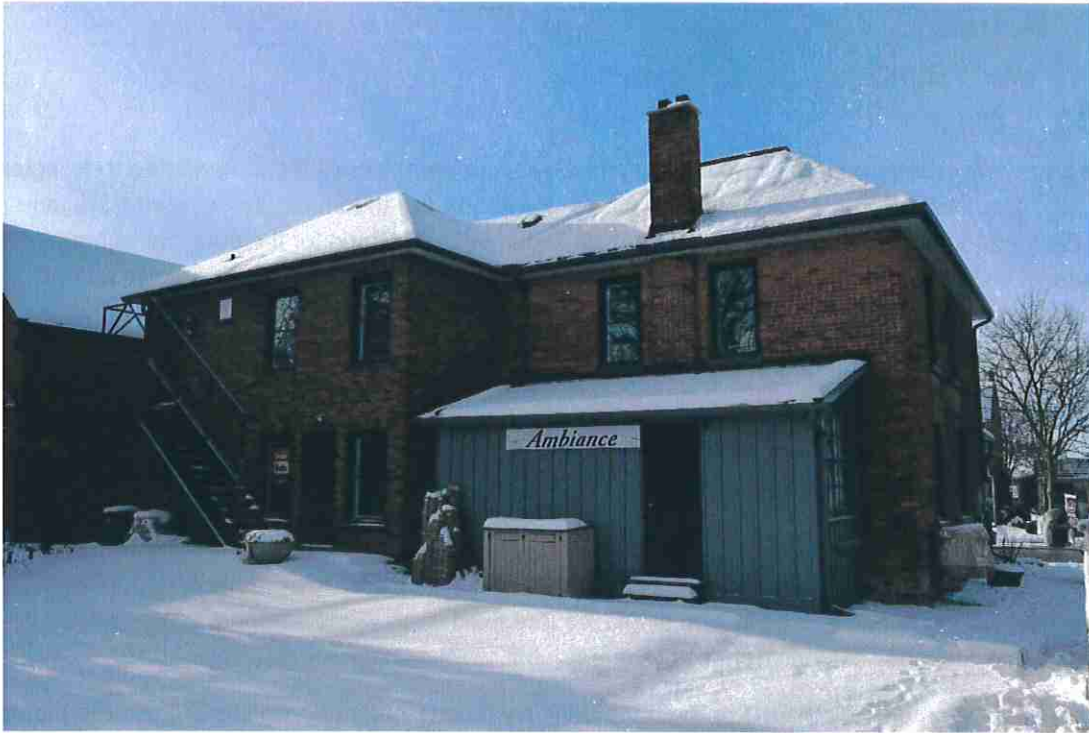
Figure 17: East and north façades of the house.

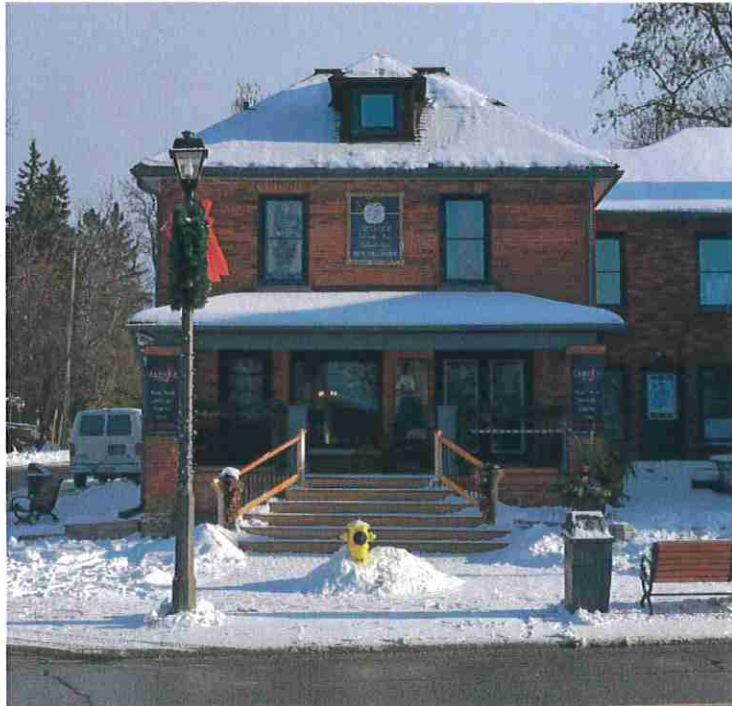
Figure 19: East façade of the main block.

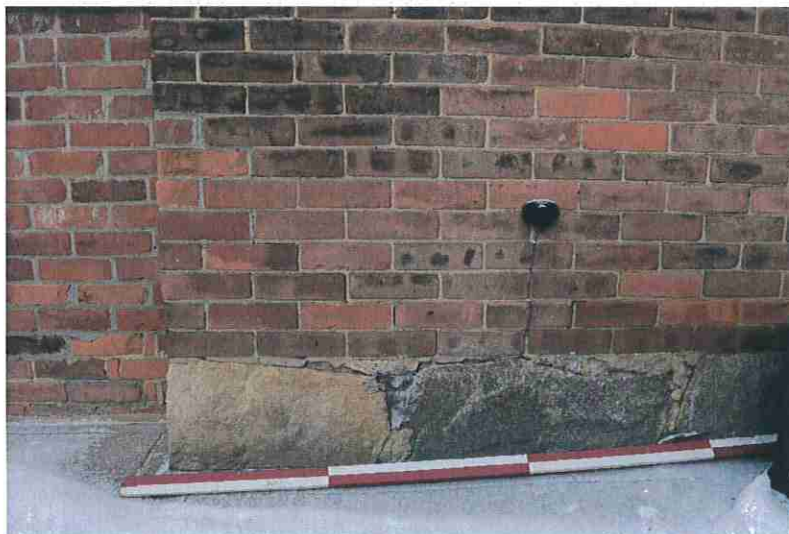
The three-bay, two-storey main block has a square plan, with the principal façade oriented to Islington Avenue (Figure 19). The foundation is partially visible above grade and is random-rubble squared fieldstone parged in mortar (Figure 20 and Figure 21). The walls are brick laid in stretcher bond for the principal Islington Avenue, the south facade, and interestingly, only two-thirds of the north wall; just west of the east windows on the latter facade the masonry transitions to one-in-four American or common bond, and is capped at the eave by a row of headers (Figure 22). For the east facade the bonding pattern is different again, this time stretcher bond for corner and for the wall below the upper level windows, then one-in-five common bond for the upper level, which are also capped by a row of headers. This indicates a major extension to the east (further seen in the basement, described below) at some point prior to 1925, when the house appears in a photograph little different from its current state. Apart from the varied bonding pattern and window treatments, there are no other wall details.

Figure 20: Random rubble fieldstone foundation and brick masonry at the southwest corner of the main block.

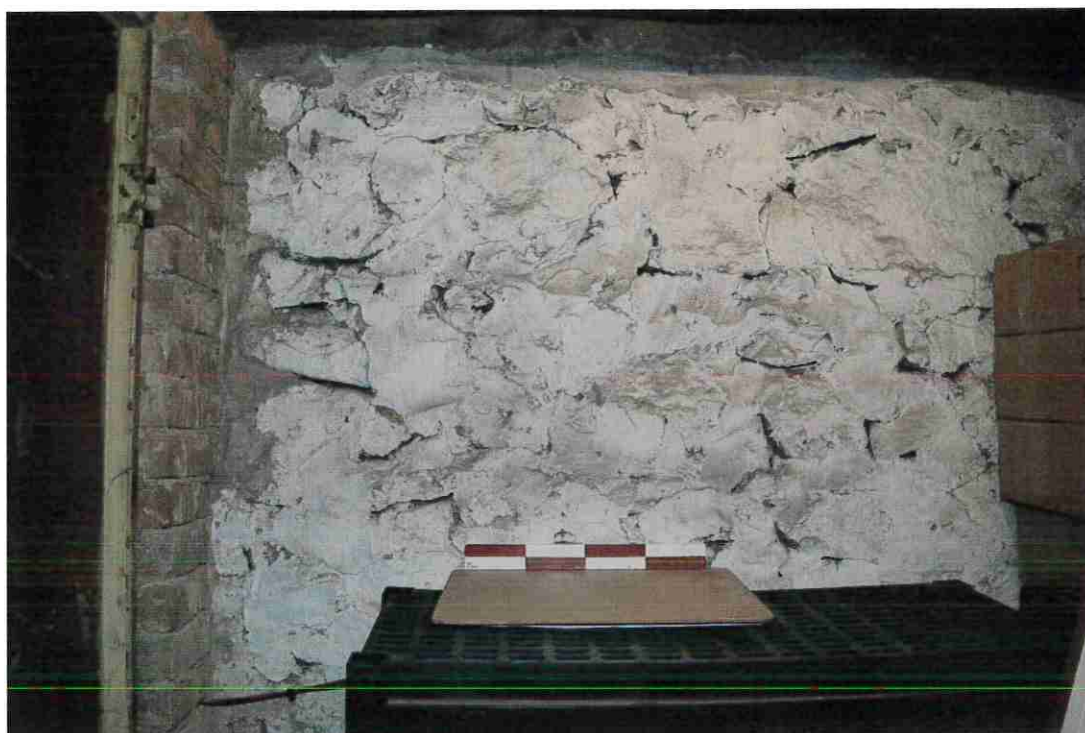
Figure 21: Rubble foundation masonry as seen from the basement.

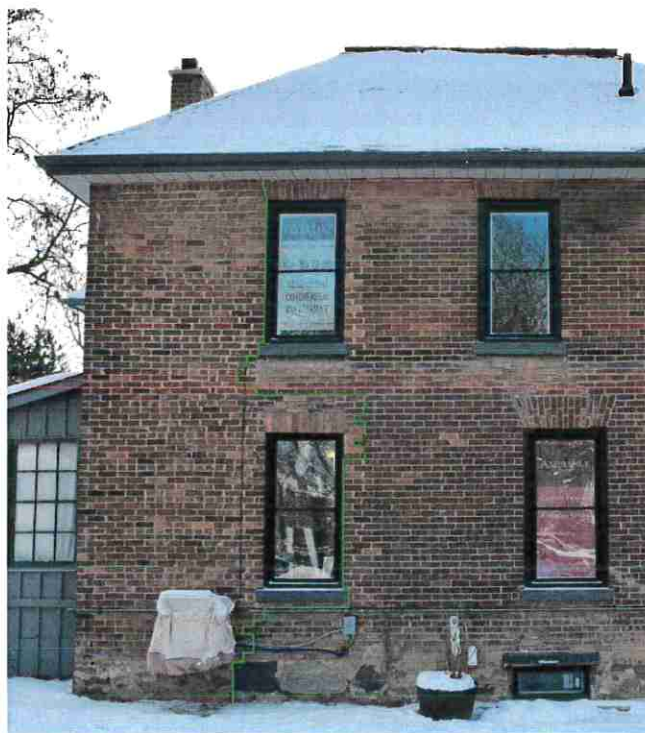
Figure 22: Mortar transition seen in the north wall of the main block.

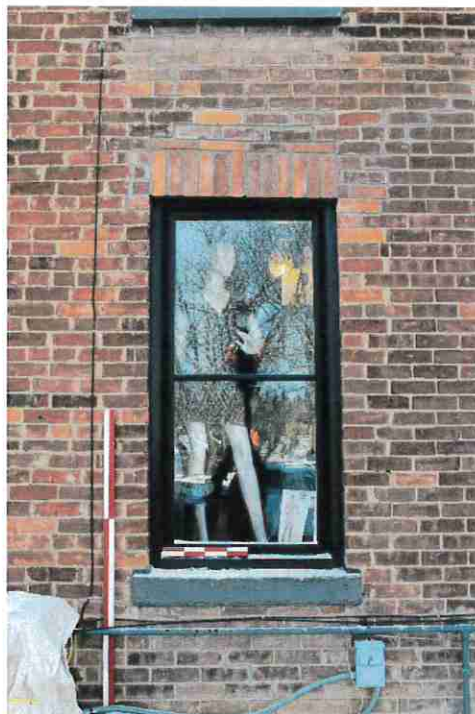
Figure 24: Window in the east extension.

Fenestration is asymmetrically placed on both the principal façade and north wall, and limited to the upper level on the east façade. With the exception of the large, fixed sash 'picture' window on the ground level on the principal facade, all windows are tall with flat heads, are one-over-one double hung, and have concrete lug sills, but the treatment of the window heads varies. On the principal facade the two balanced second level windows have jack arches made using soldier brick voussoirs, but the offset picture window lacks a similar decoration. The paired second level windows that are offset from the centre of the north facade wall match those of the second level on the principal facade, but the windows beneath them, which are also off-set, have varying forms. Over the west first level window is a jack arch with gauged rubbed brick voussoirs, while the east window has a flat arch, vertical joint head capped by a row of slip brick (Figure 24). The paired windows of the west facade second level have no head decoration at all, only the stretcher course of the wall. Two more windows are now under the rear addition and are blind from the interior, but have the original moulded wood frame and muntins (Figure 25).

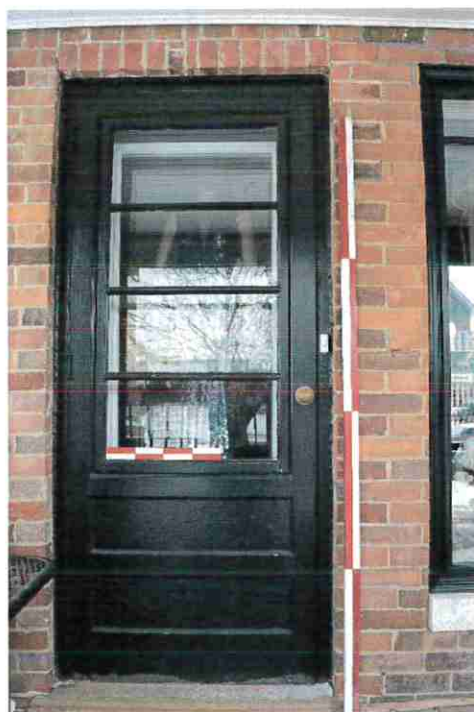
Figure 26: The north door on the west façade.

Access into the building from Islington Avenue is covered by the porch and through two off-centre entrances located asymmetrically either side of the central picture window. The north entrance has a single-leaf, glazed and panelled wood door with wood threshold and a flat arch head of header on face brick, while the south door is double-leaf, with glazed steel doors and a steel threshold, and a flat arch head of header on face brick (Figure 26 and Figure 27). Access from the rear of the building on Kellam Street is through the rear porch (described below).

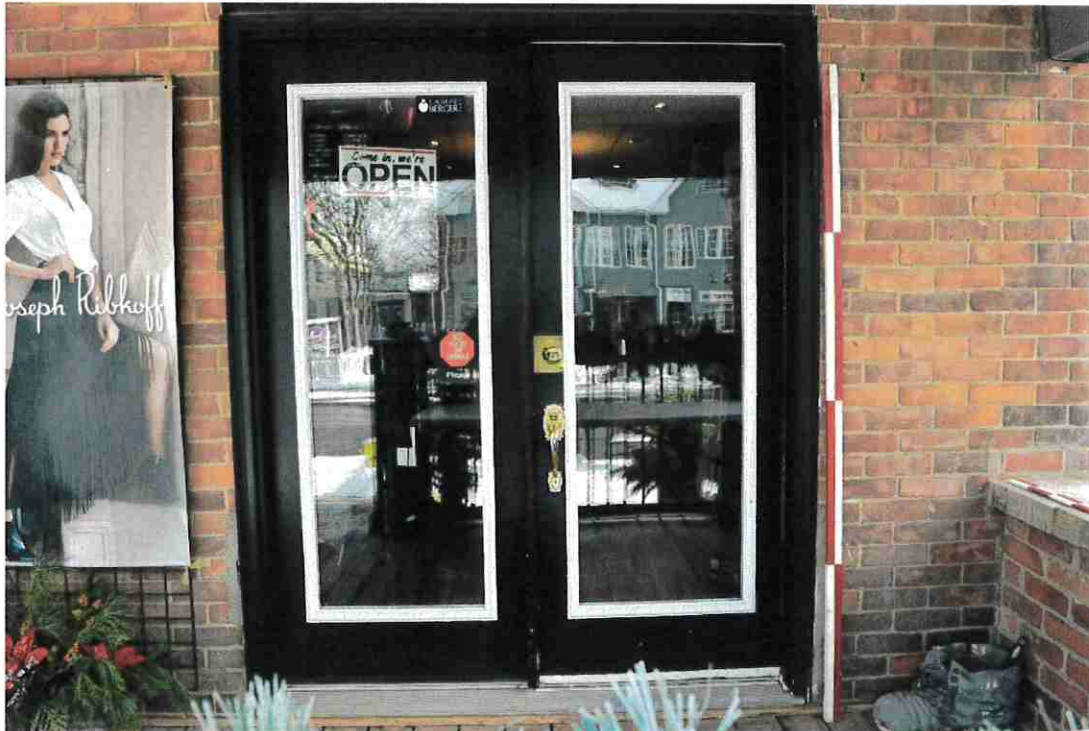
Figure 27: South doors on the west façade.

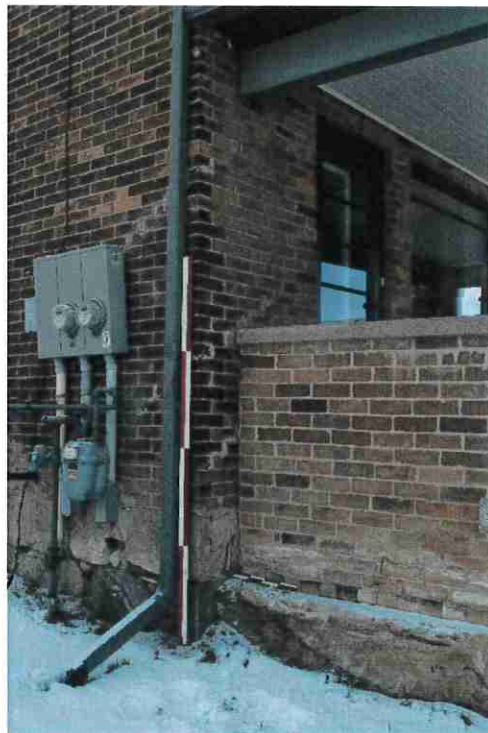
The open front porch has a fieldstone foundation and brick base that is not keyed into the main block wall, and wide brick piers at the corners that support a wide and notched frieze and a hip roof with projecting eaves (Figure 28 and Figure 29). The straight stairs leading to the porch deck are of diminishing width and have a railing combining wood for the top and bottom rails, and steel bar balusters. This balustrade is also used for the railing enclosing the deck, which run from the piers to two smaller panelled wood pillars. Both the decking and tongue-and-groove ceiling planks are wood, and a crown moulding lines the inside edge of the frieze where it meets the ceiling.

Figure 28: Connection between the verandah and main block.

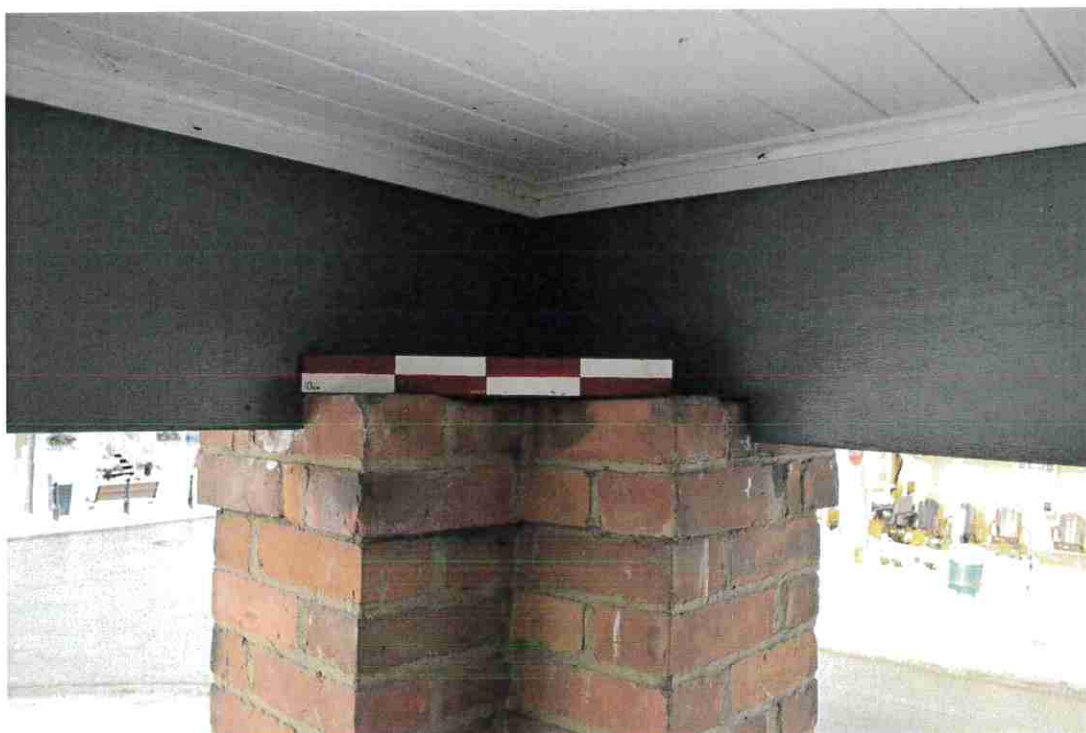
Figure 29: Brick pier, fascia, and ceiling of the main block.

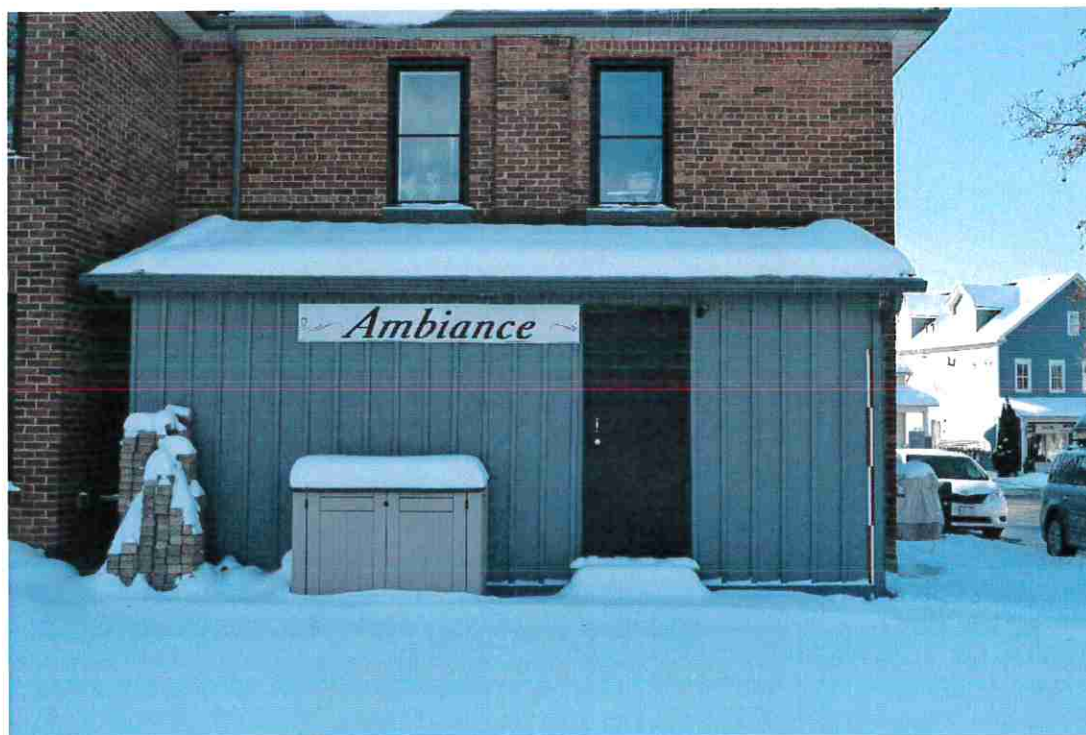
At the rear of the main block is a narrow addition with shed roof, board-and-batten cladding, and 3-over-9 casement windows on the north facade. On the east is an offset, single leaf entrance with plain steel door and straight steps (Figure 30).

Figure 30: East façade of the wood frame addition.

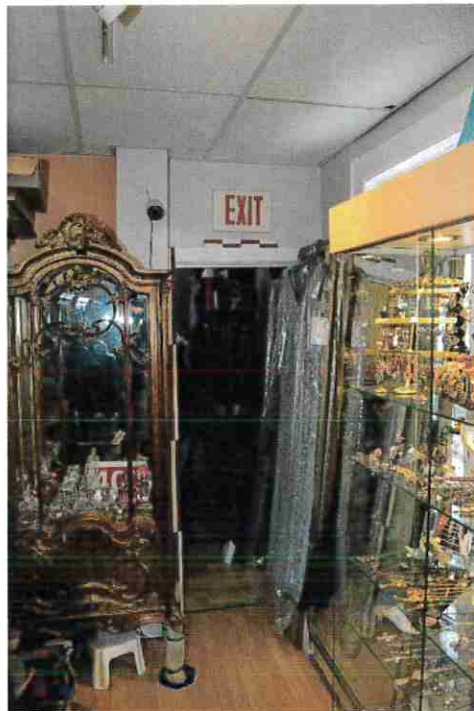
Figure 32: Modern ceiling, architrave and floor finishes on the interior of the main block.

The first level of the main block is divided into just three spaces: a large long room on the south entered through the double-leaf doors, and an entrance hall and large room with stairway on the north accessed through the north door (Figure 31). There are a number of contemporary finishes including laminate flooring, a mineral fibre panel suspended ceiling, and some prefabricated wood door surrounds, but earlier moulded wood door architraves and the tall moulded baseboard are also present in many places (Figure 32 and Figure 33). Also original is the quarter turn stairs with half-pace landing in the northwest quadrant of the first level, which has a moulded wall string, scotias under the nosings, and a balustrade with thick moulded handrail and turned balusters (Figure 34 and Figure 35). A door in the south room leads to the unfinished rear addition, where the brick exterior wall with blind wood windows of the main block, and 2x4-inch lumber and plywood sheet of the roof construction, is exposed.

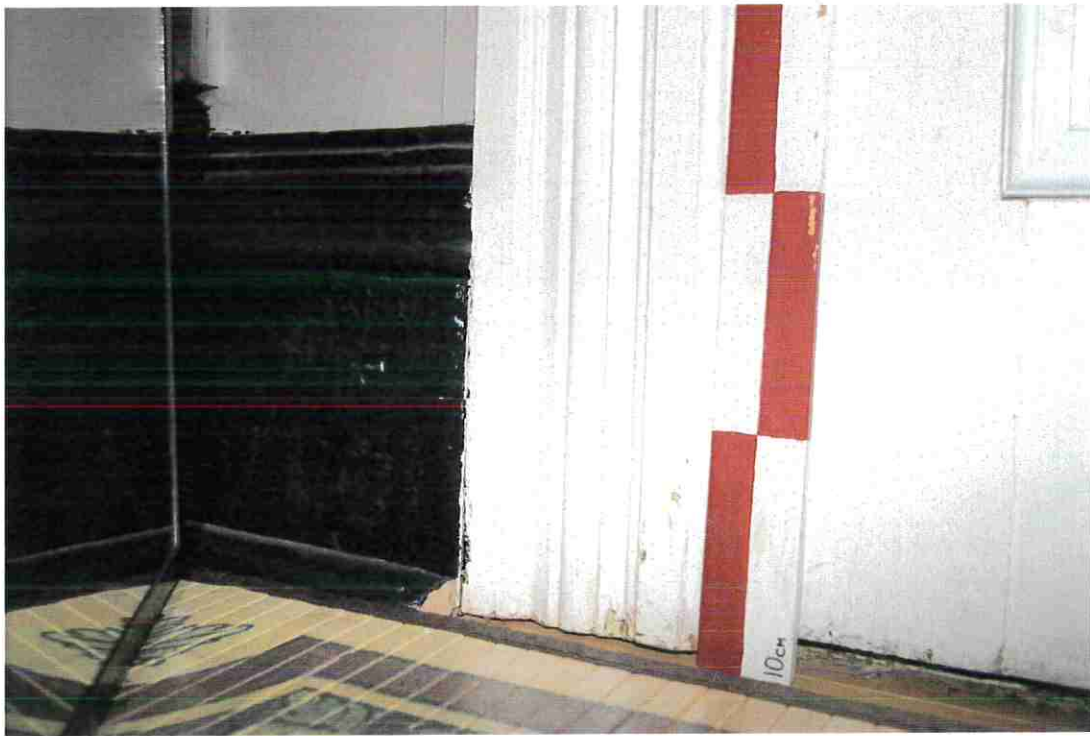
Figure 33: Original baseboard and door architraves in the main block.

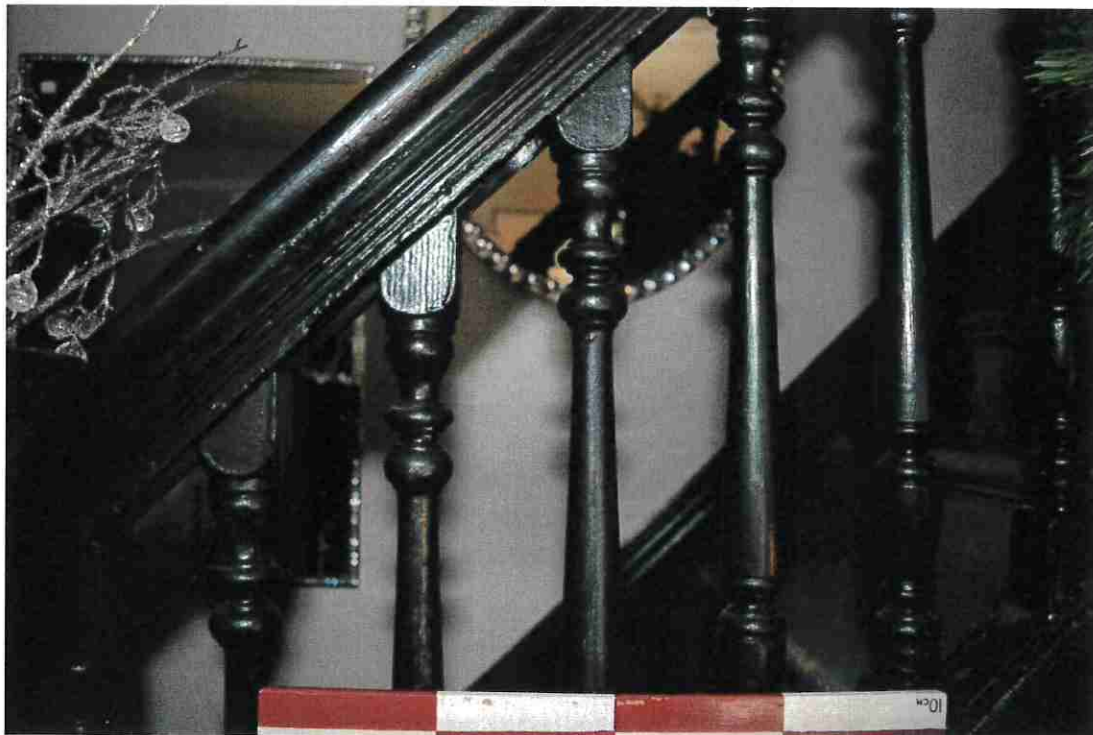
Figure 35: Balustrade of the stairs to the second level.

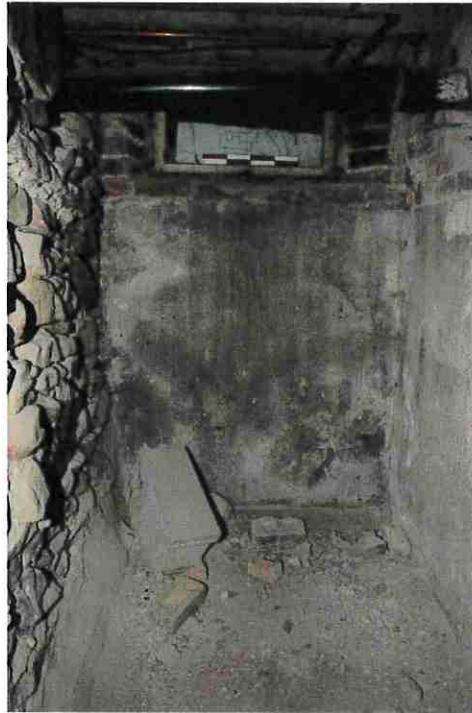
A central staircase leads to the large north and south rooms of the basement, which has exposed random fieldstone foundation and partition walls parged in cement and north-south running circular sawn joists with flooring planks above. These are bounded on the east by a 38-cm wide stone and brick wall that corresponds to the change in masonry seen on the exterior. In the rooms east of this wall, the foundation is poured concrete topped by brick and the joists are on a 40.6 cm (16-inch) centre instead of the 41.9 cm (16-1/2-inch) centre seen in the west side of the basement (Figure 37 and Figure 38). Like the exterior masonry, both the east fieldstone 'interior' wall and difference in foundation construction clearly indicate an extension was made to the building in the first quarter of the 20th century.

Figure 37: Rubble foundation of the original main block (left) and concrete and brick foundation of the extension as seen from the basement.

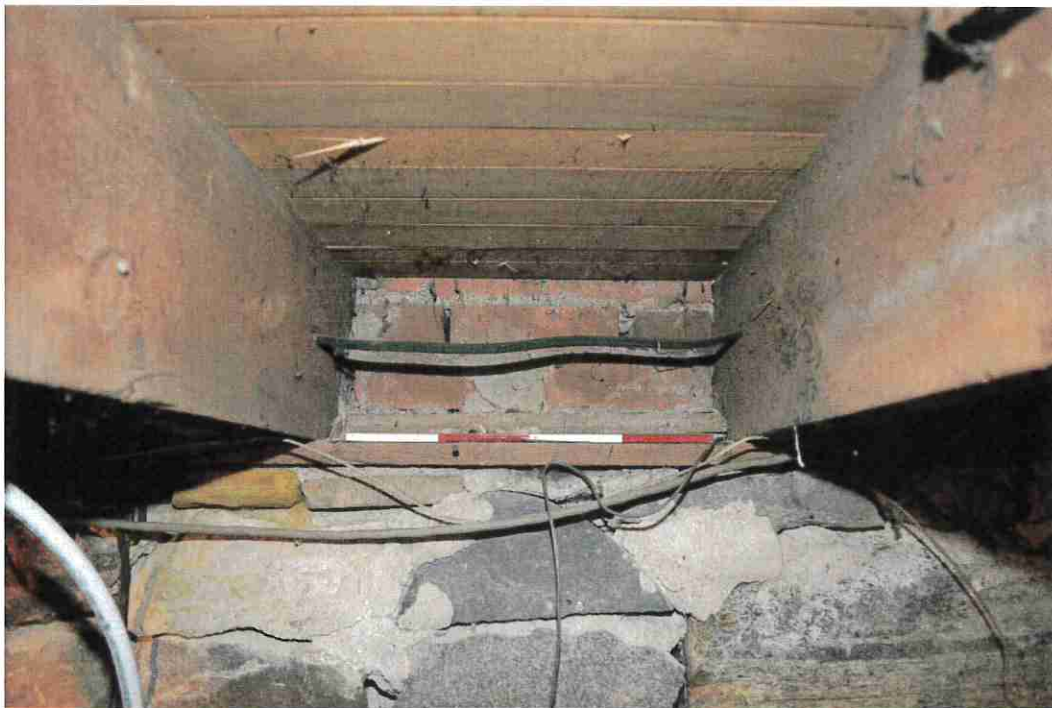
Figure 38: Joists and floorboards in the main block basement.

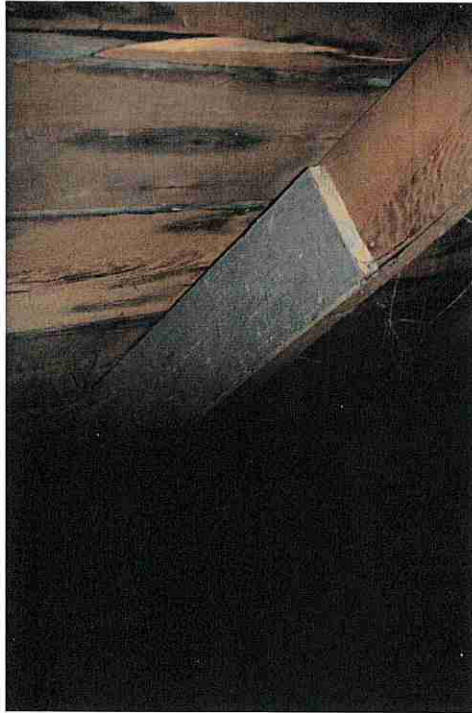
The attic space is accessible via a staircase near the northwest corner of the second level and finished with a modern suspended ceiling and fluorescent lighting (the panels have been removed), wood laminate wall covering, and flooring (Figure 39). The roof construction of thin common rafters with circular-sawn sheathing planks is visible in the northwest corner (Figure 40).

*Figure 40: View of the roof construction of the main block as seen from the attic access.*

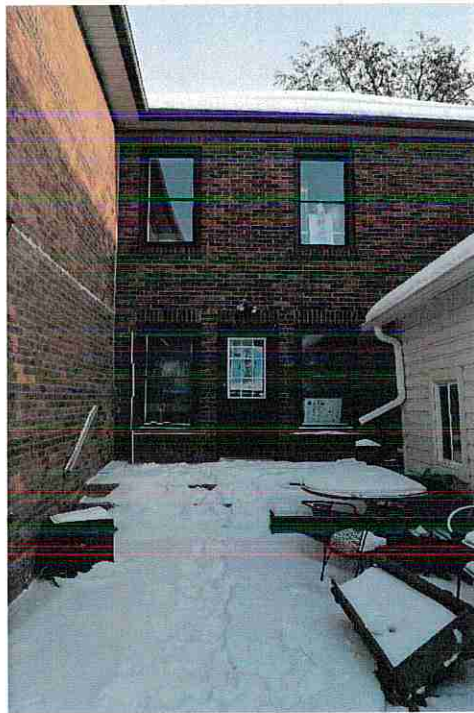
The two-storey and four-bay rear wing extends from the southeast corner of the main block and sits on a poured concrete foundation (Figure 41). It is constructed entirely in stretcher-laid 'overfired' machine-made brick to match the main block, and also has a hip roof, with a gable section connecting it to the main block, and prefabricated metal soffit and fascia, and gutters and rainwater leaders. There are two roof vents and a sanitary pipe on the roof on rear facing pitch but otherwise is plain.

Figure 41: West façade of the brick wing.

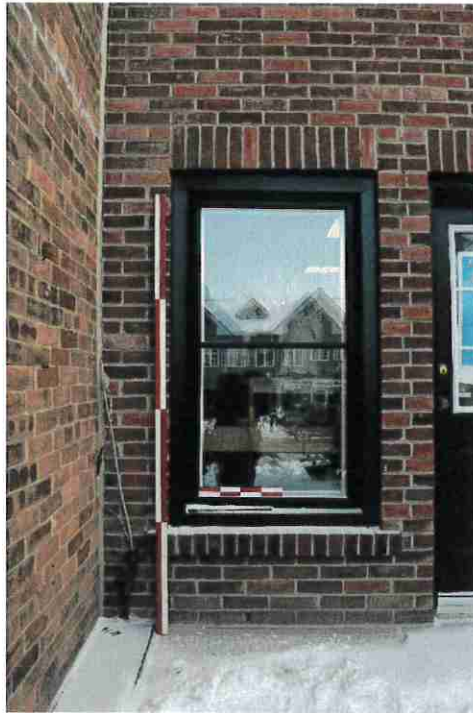
Figure 42: Typical window of the brick wing.

In contrast to the main block, the fenestration is aligned between levels and the window and door openings have flat arch heads formed of soldier brick, and sills of header on face brick (Figure 42). The west glazed steel door is offset to the north and between two windows, a pattern continued on the wing's east side. A plain steel door on the east facade is at the second storey and accessed via a metal fire escape stairway. An exception to the balance of the rear facade is a small square and blind window between the second level door and window, and at the first level is a blind window only recognizable due to its surviving soldier brick arch head.

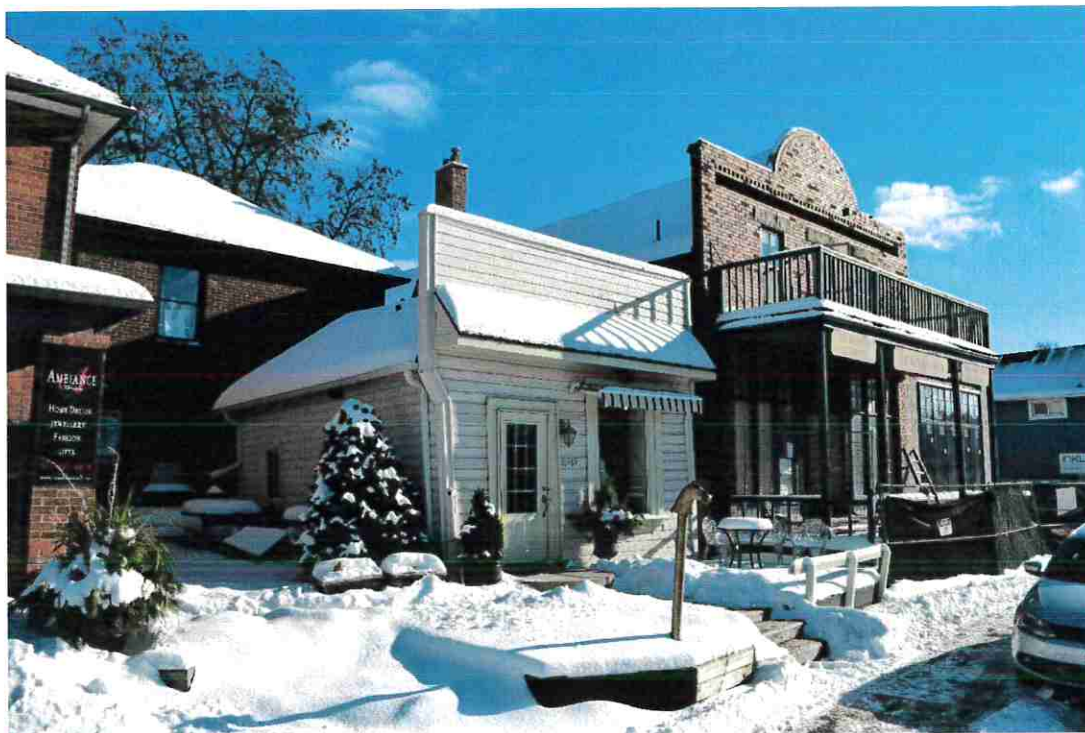
Figure 46: North and west façades of the shop.

The single storey, two-bay shop has a rectangular plan and is constructed of wood frame clad in wood shiplap siding with corner boards (Figure 45, Figure 46, Figure 47, and Figure 48). The foundation material is unknown but could be slab on grade or fieldstone masonry. The medium gable roof is covered in asphalt shingle and fronted by a boomtown front with shiplap cladding and crown moulding at the cornice of the parapet, and a lower pent roof section (Figure 49). Only short roof vents pierce the roof. On the gable roof the eaves and verges are projecting and have wood a wood fascia and tongue-and-groove board soffit, and on the east gable there is a moulded fascia and narrow frieze.

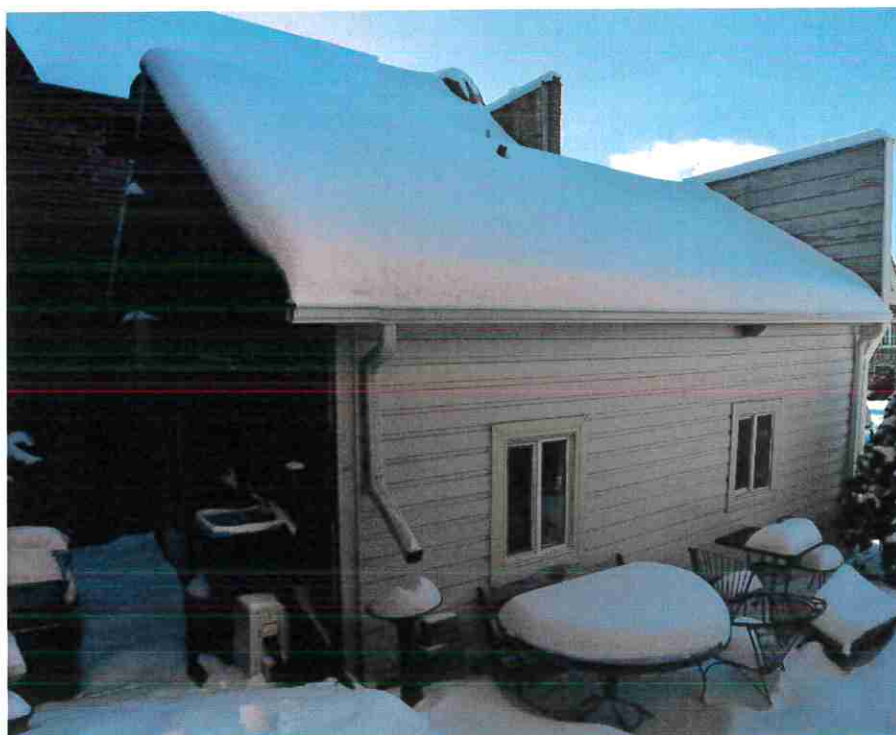
Figure 47: East and north façades.

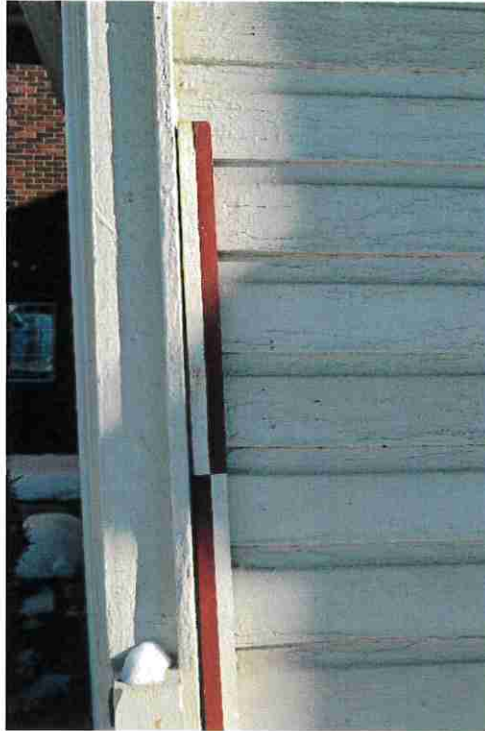
Figure 48: Detail of the corner board and shiplap cladding.

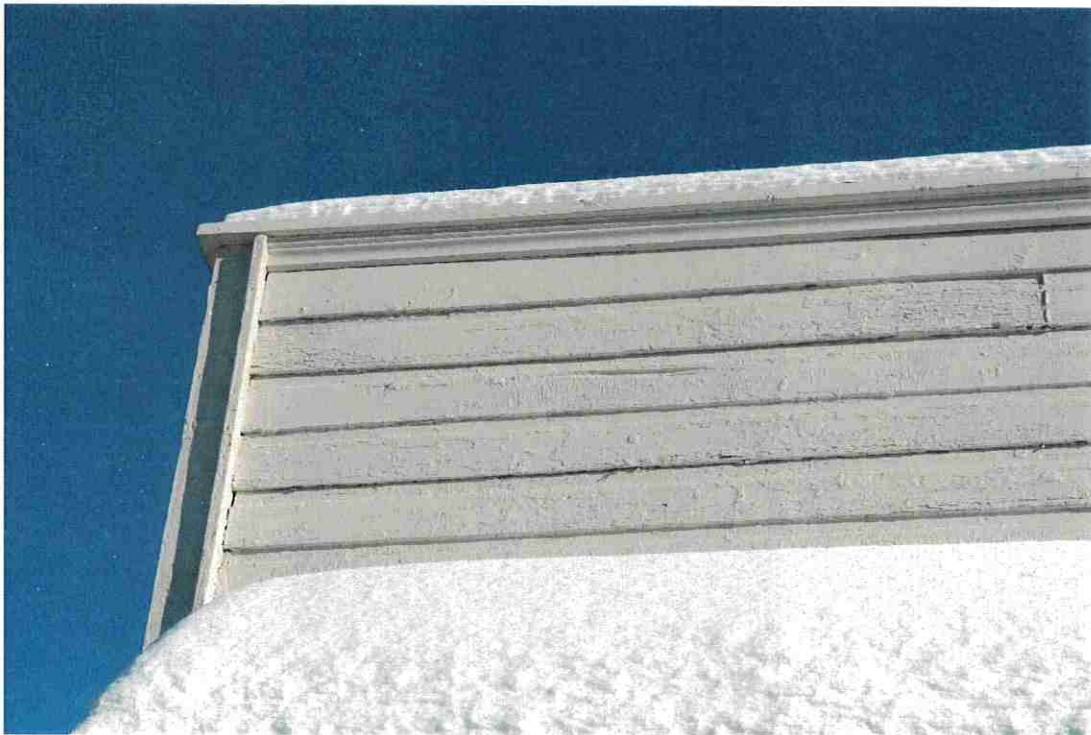
Figure 49: Cornice at the parapet on the west façade.

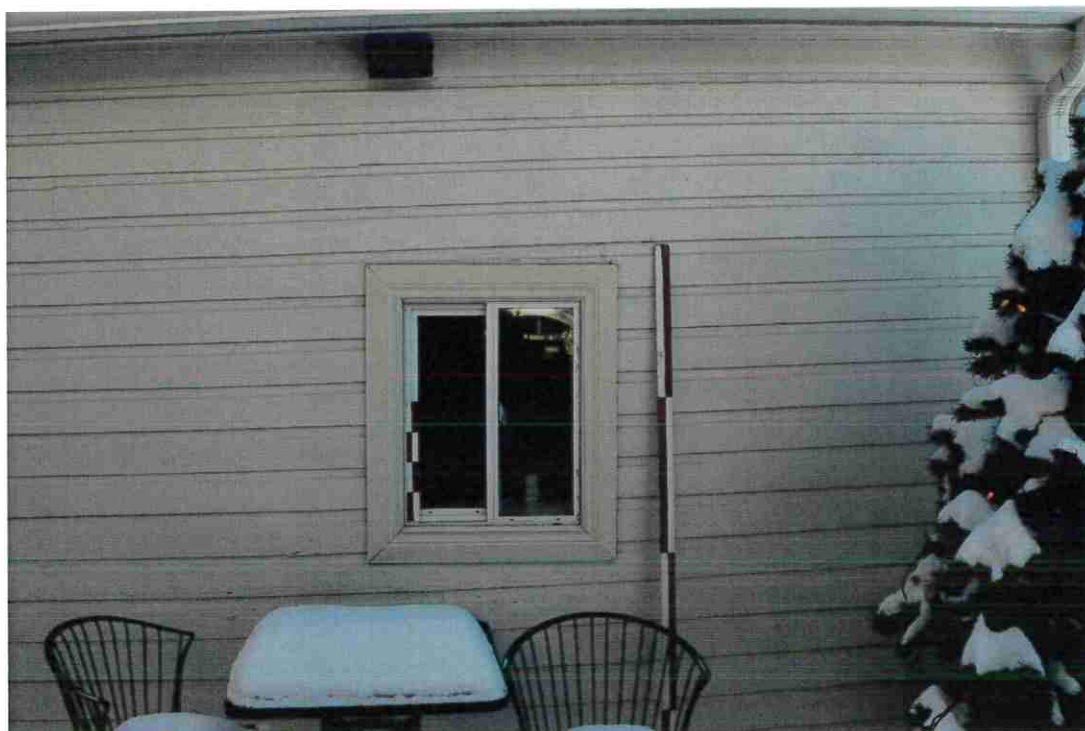
Figure 50: Window on the north wall.

On the principal, Islington Avenue, facade is a large, single fixed sash window with wood sill and architrave on the south, and an offset glazed steel door with architrave formed of boards and relief strips. On the north side are two evenly spaced short windows with moulded architraves and horizontal sliding vinyl insert windows (Figure 50), while on the east is a short window centred on the end wall, an entrance to the south with steel storm door, and a short, vertical board door with strap hinges centred in the gable (Figure 51). A tall, blind window is on the south wall near the building's southeast corner.

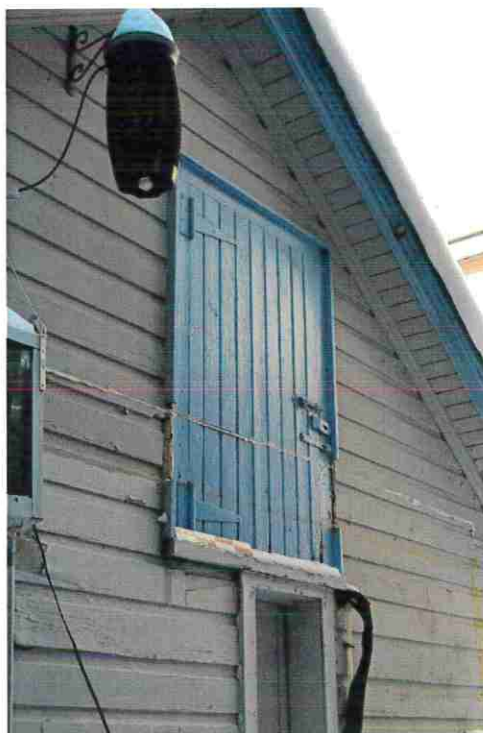
Figure 51: Door in the east gable.

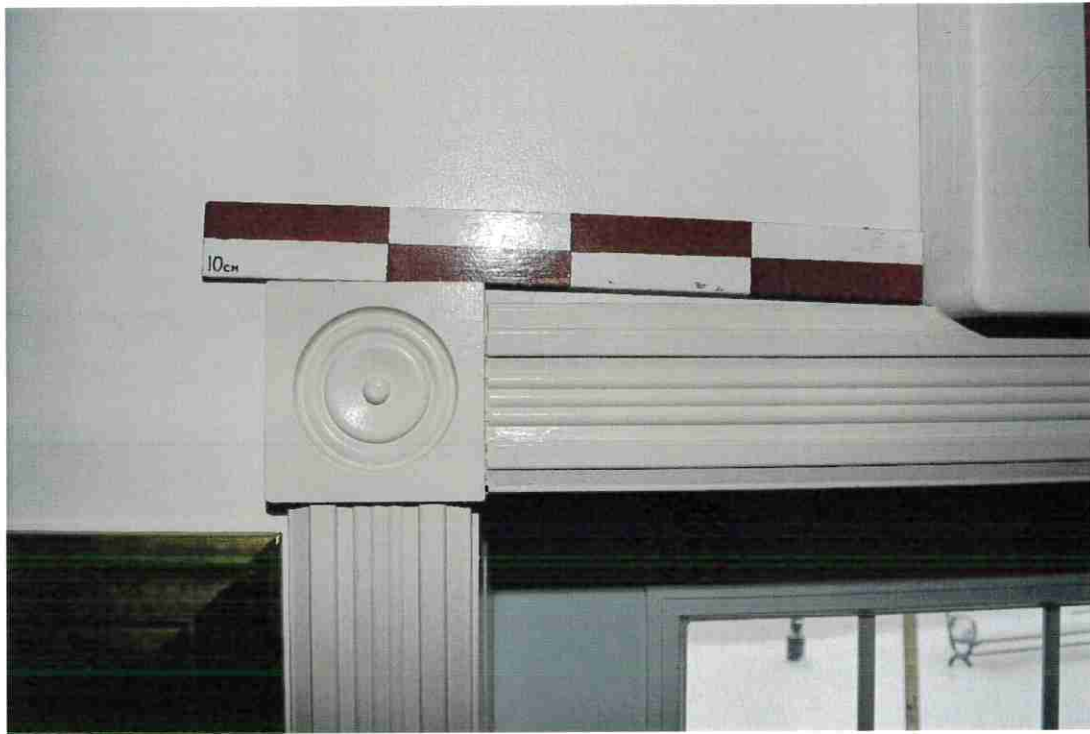
Figure 54: Rosette and moulding for the door architrave.

The interior is divided into just three spaces: a front room, a rear room, and attic. In the front room are exposed and painted joists ornamented with scotia and crown mouldings and the ceiling is formed of tongue-and-groove boards (Figure 52 and Figure 53). The front window, side window, door, and rear passage architraves have mouldings and corner rosettes but these may not be original, and the floor is wood laminate (Figure 54). In the

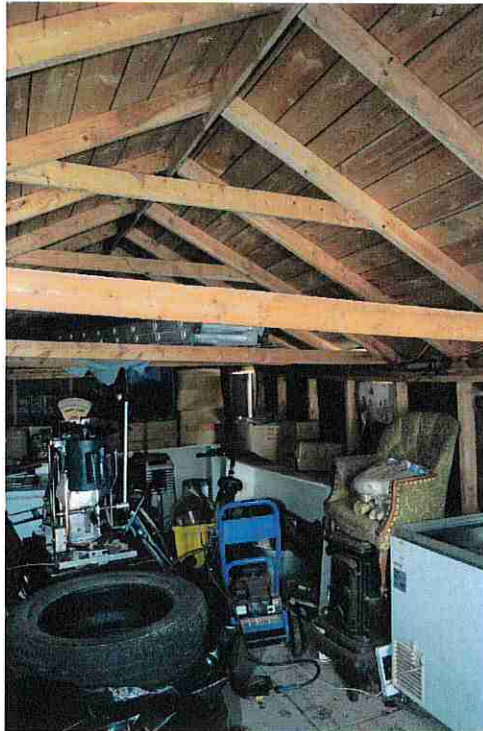
The single-storey garage with medium gable roof is oriented with the end wall facing Kellam Street (Figure 56, Figure 57, and Figure 58). Its balloon frame construction is exposed on the interior, and is clad on the exterior in wood clapboard and corner board for the walls, and vertical board for the gables. The foundation could not be seen but presumed to be poured concrete, and inside the floor is finished in large concrete pavers. Double-leaf wood doors on the end wall provide vehicle access from Kellam Street, but the structure is also entered via a single-leaf door near the southwest corner; there are no windows. Despite its condition and wood cladding, the garage's construction in dimensional lumber suggests it was built in the second half of the 20<sup>th</sup> century (Figure 59).

Figure 59: Dimensional lumber roof trusses in the garage.
