## **CULTURAL HERITAGE IMPACT ASSESSMENT**

**10489 Islington Avenue  
Lot 6, Plan 11, Nashville-Kleinburg Heritage  
Conservation District  
City of Vaughan, Ontario**

**Report Number: 1668503-R01**

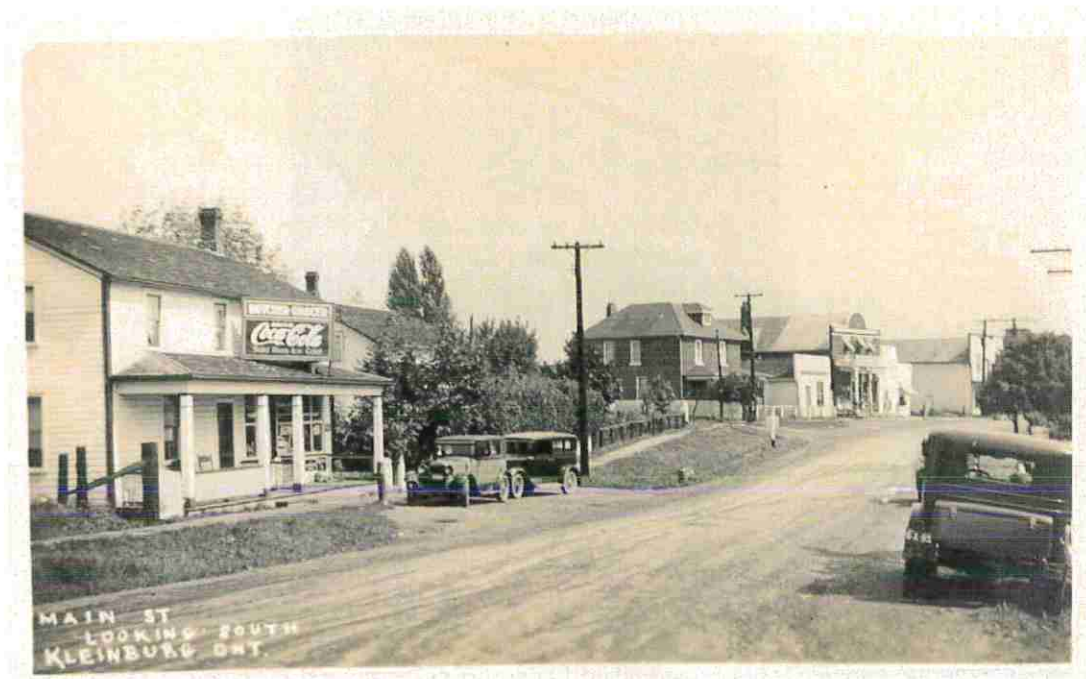
Figure 60: Circa 1925 view of the Study Area, facing south (courtesy City of Vaughan).

The earliest photograph clearly showing the main block and shop dates to 1925 (Figure 60), but another undated photograph provided by the City may have been taken around the same time (Figure 61). In 1929 a portion of the shop was included in a painting by A.J. Casson, a member of the renowned group of Canadian artists known as the Group of Seven (Figure 63). A third photograph, taken in 1935 also shows a portion of the shop (Figure 65). All but the 1925 image were reconstructed by Golder in 2016 (Figure 62, Figure 64, and Figure 66).

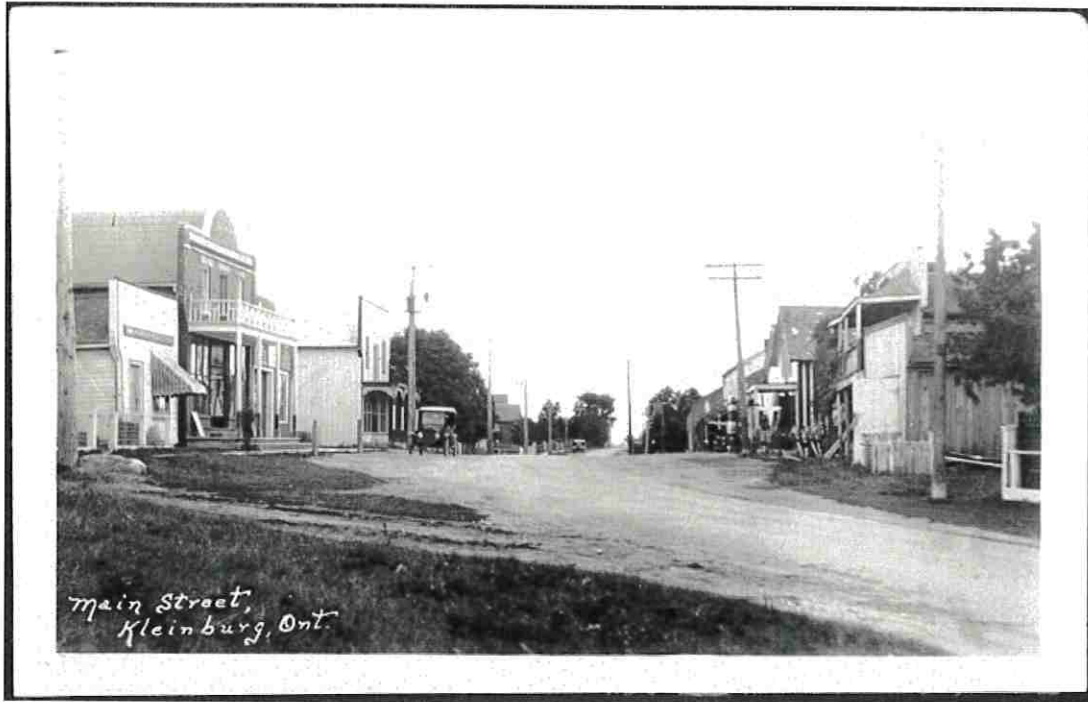
Figure 61: Circa 1920s photograph of Islington Avenue showing the shop at far left (courtesy City of Vaughan).
