PROJECT: 239-251 WOODBRIDGE AVE WOODBRIDGE, ON

TITLE: TREE PROTECTION PLAN

PROJECT NO: 23006
SCALE: 1:150
DRAWN BY: JA
REVIEWED BY: NT
PRINT DATE: 12/23/2024

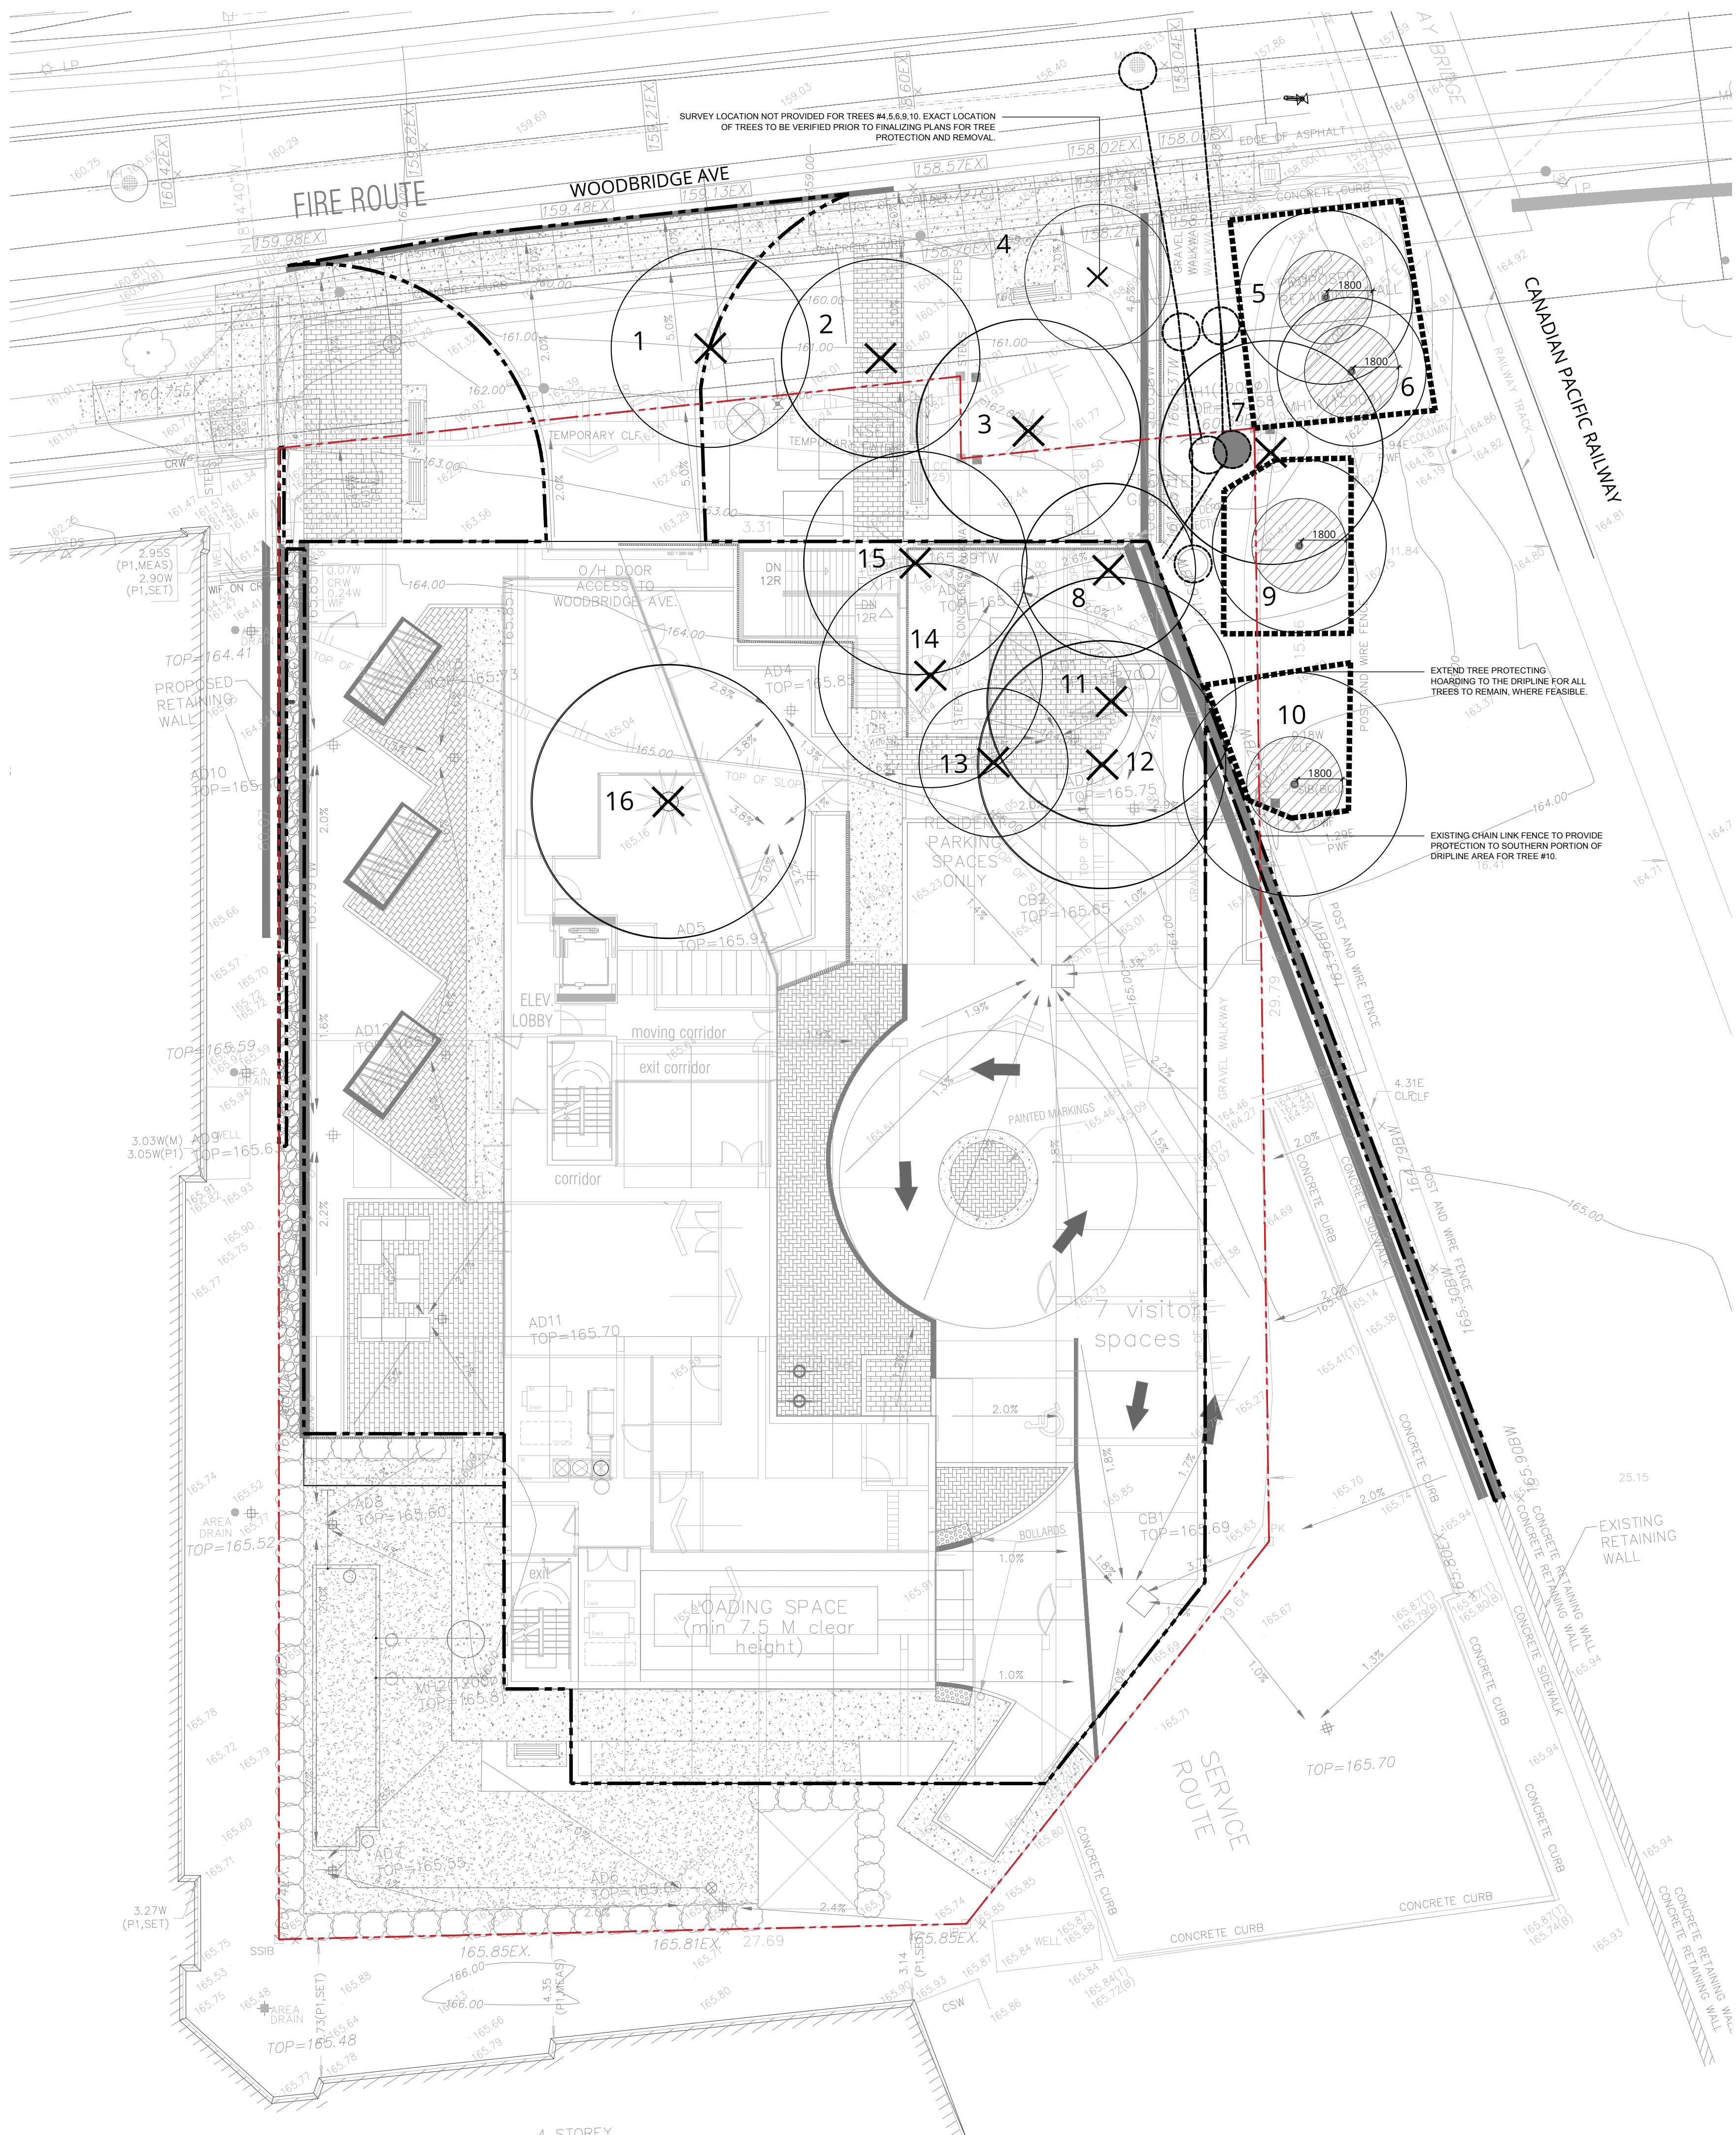
NOTE: TREE INVENTORY CONDUCTED BY ISA CERTIFIED ARBORIST, JILLIAN ALBERT ON MARCH 14, 2023. LOCATIONS OF TREES NOT LOCATED ON THE SURVEY ARE APPROXIMATE.
