HERITAGE VAUGHAN REPORT

TITLE: ALTERATION OF HERITAGE DWELLING LOCATED AT 10555 ISLINGTON AVENUE IN THE KLEINBURG-NASHVILLE HERITAGE CONSERVATION DISTRICT

**Heritage Evaluation of Existing Dwelling
10555 Islington Avenue, Kleinburg, ON
In the City of Vaughan**

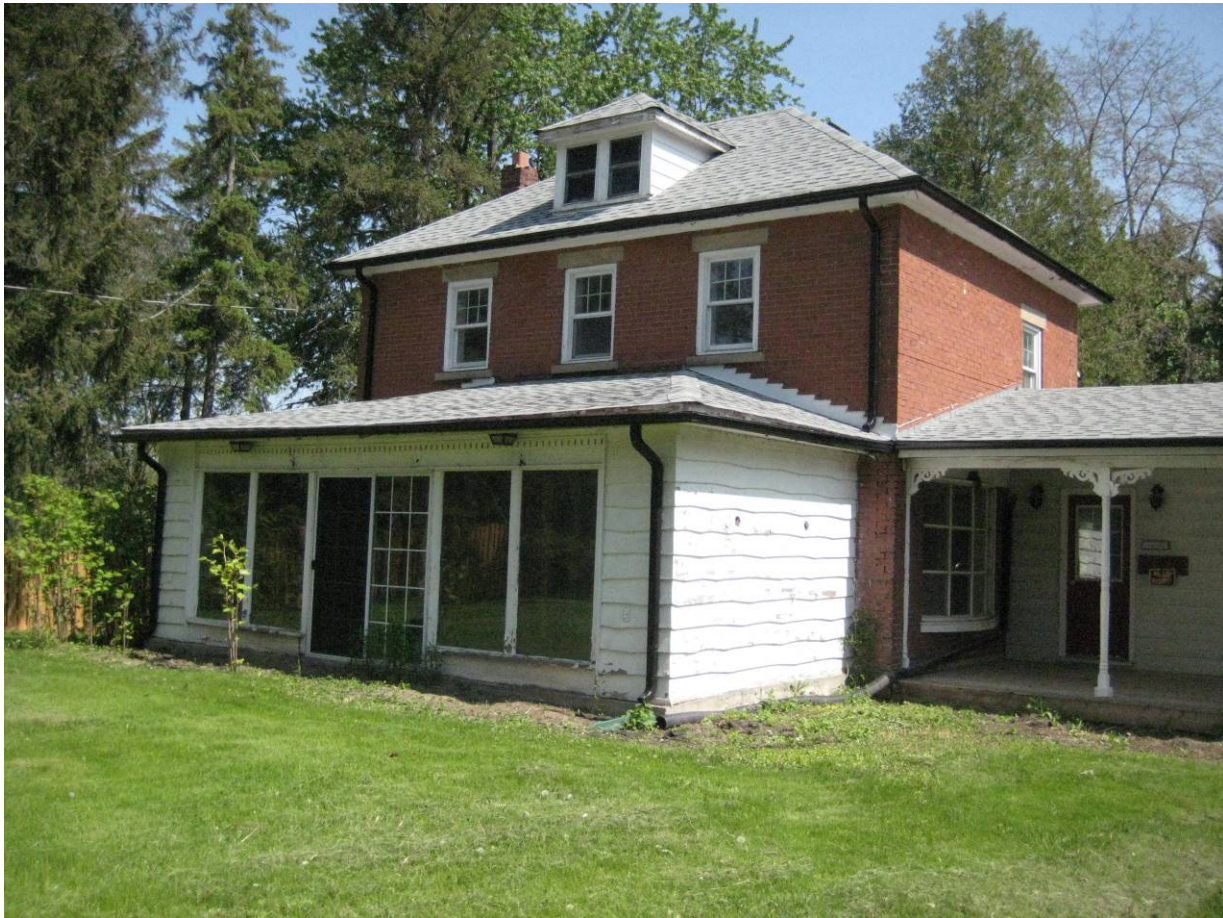
View of dwelling from the southwest. Nothing visible is original.

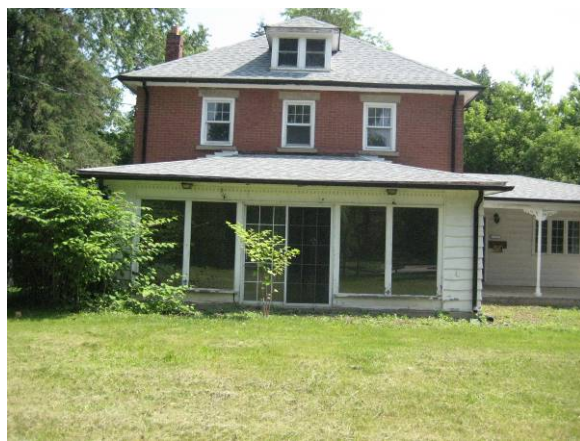
Figure 1. Front (west) view of the house. Front and south additions are relatively recent.

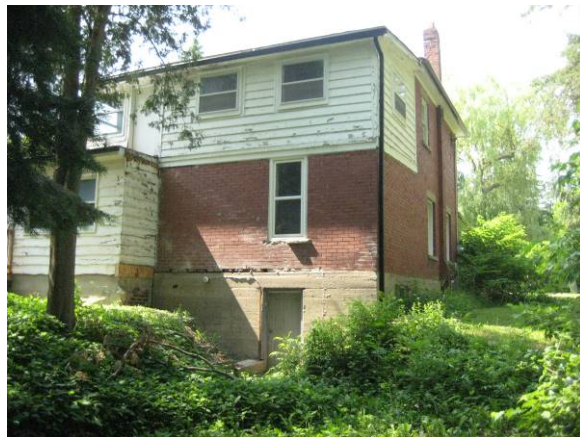
Figure 2. North east view.

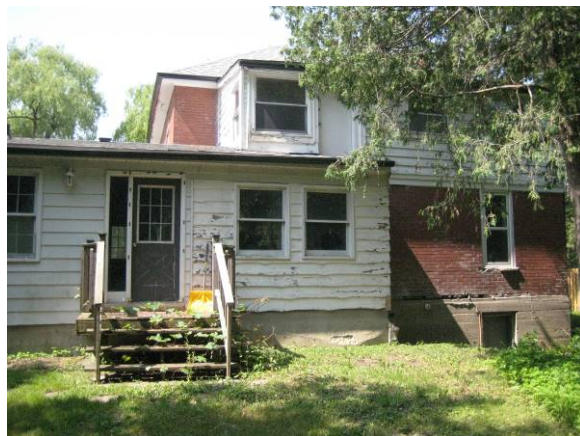
Figure 3. Southeast view.

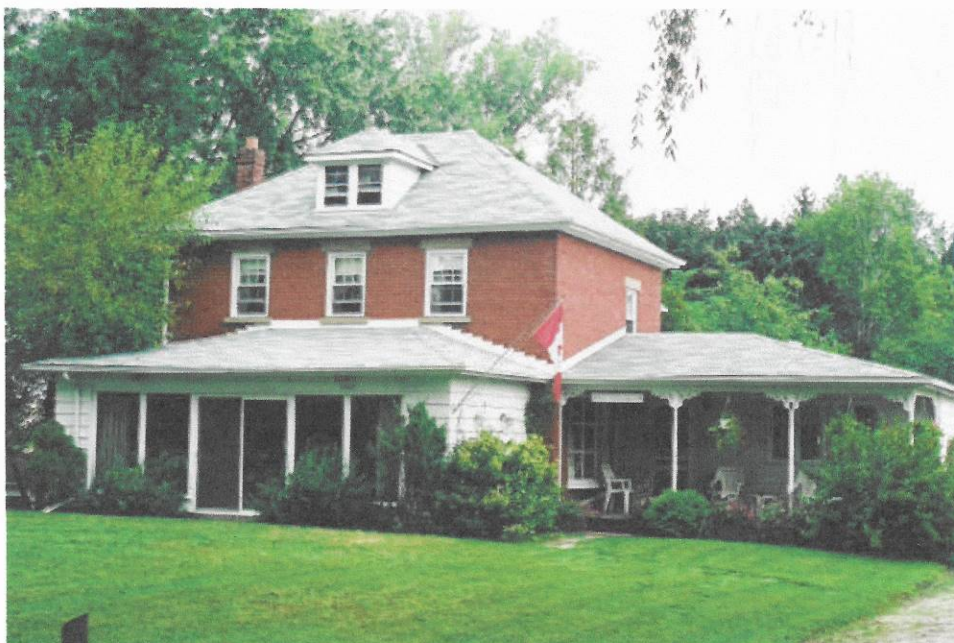
10555 Islington Avenue

- Two-storey, hipped-roof, red-brick house with central third-floor dormer and with (altered) full-width front verandah and later verandah and addition to south side (c. 1920).

- Comments – House is something of a mixture, especially method of enclosing former front verandah with large, modern glazing. In contrast, recent second floor windows have small multiple panes, reflecting Georgian tradition. Bow window and addition to south are evidently later newer, but more or less in keeping with Kleinburg norms. A more traditional method of enclosing front sun-room, and replacement of rustic waney-edged siding, would be welcome improvements to an attractive house. Similarly, glaring white aluminum flashings over low, pitched roofs might be both smaller, and in a less conspicuous colour, and chimney needs repointing. See the Guidelines for suggestions on how to proceed with these aspects.

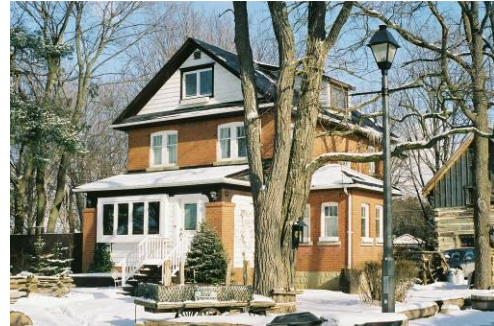
Figure 9. Neighbouring 1921 Edwardian house at 10499 Islington. PO

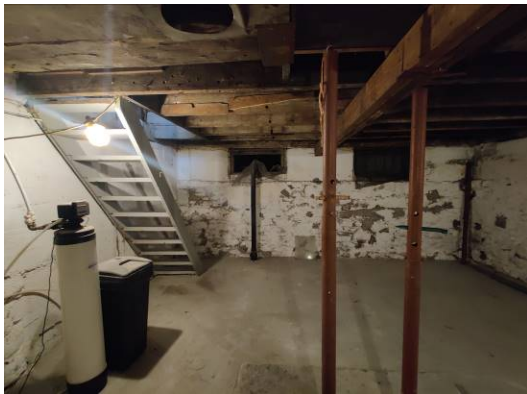
Figure 11. The basement extends under the original house, and additions are unexcavated. This view is from the middle of the main body of the house to the northeast corner. A steel post and timber beam have been installed to support the original heavy timber summer beam, which is also supported by a second steel post.

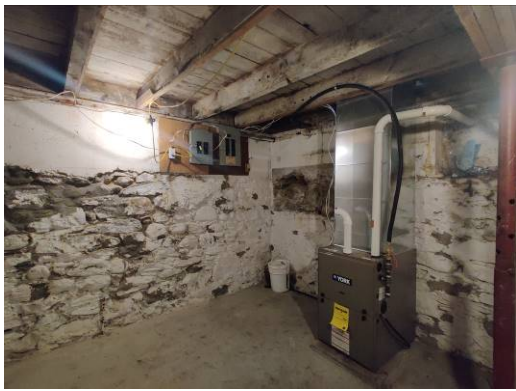
Figure 12 looking to the southeast corner. Note lower foundation of fieldstone & concrete above.

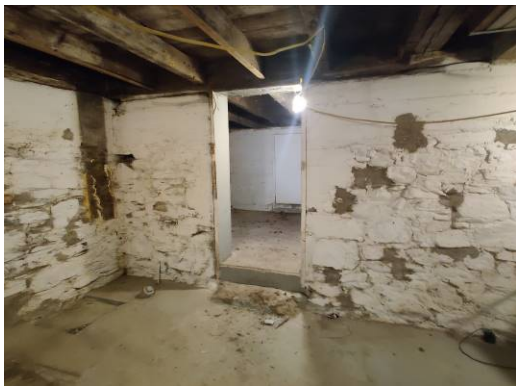
Figure 13. Looking into foundation of the tail, with the exterior door beyond.

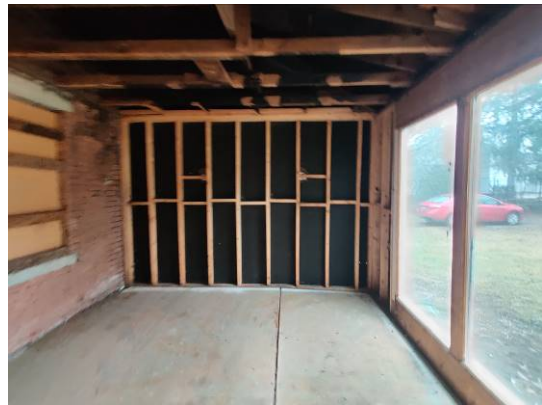
Figure 14. Looking south in the front verandah. Wall construction is relatively recent.

The applicant is proposing to remove existing walls within the verandah (attachment 3), leaving the roof, which is to be supported by new posts. The posts are currently being sourced and upon satisfaction of the City, they will be approved. Additionally, the south addition will be re-painted. The colour of the paint will be the same as it is now, in white. Both the verandah and south addition are not original to the home. The addition to the south of the house does not appear on the 1972 survey (attachment 4), which suggests a younger build date. Soffits and Fascia will be replaced in aluminum and will be black in colour. There is no construction proposed for this project, as this is simply a 'clean-up' of the property.

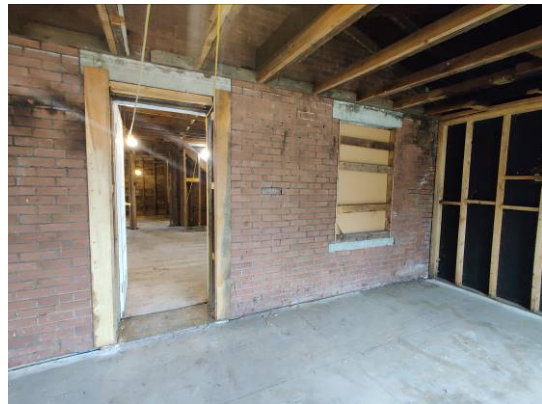
Figure 15. Looking from the verandah into the house.

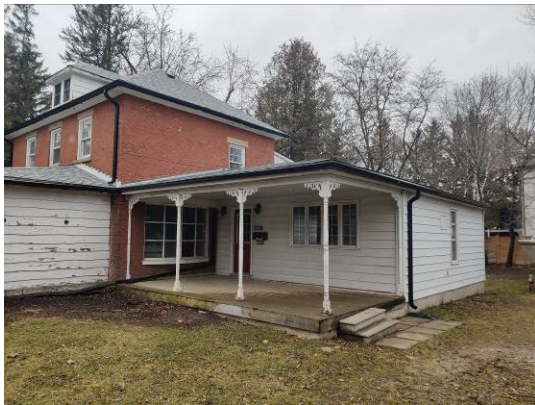
Figure 17. The south addition is relatively recent and the porch is constructed with dollar store posts and gingerbread. This has no heritage interest.

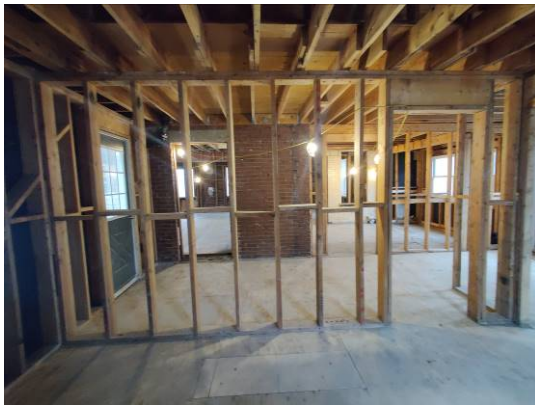
Figure 18 Near the south end of the south addition, looking north. The brick panel is the southeast corner of the main house.

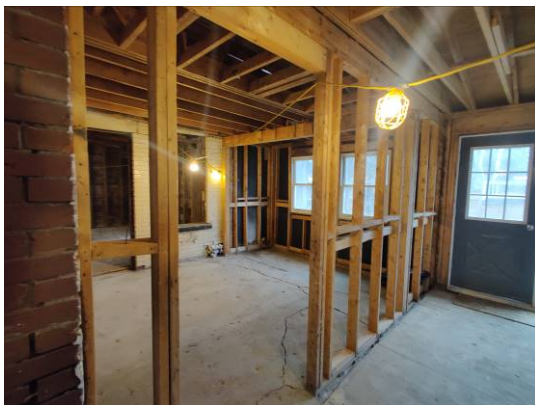
Figure 19. Standing by the SE corner of the main house looking northeast. B This is all relatively recent construction. Buy beyond the pale brick wall is the kitchen tail of the original house.

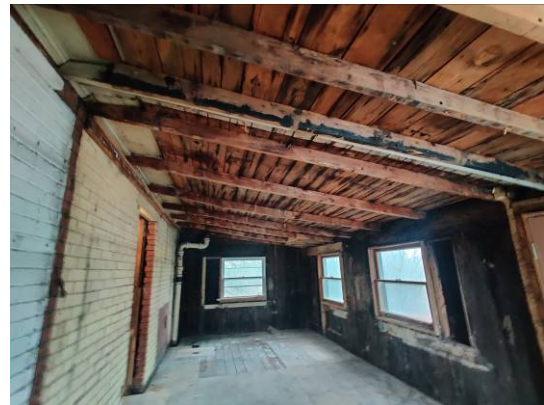
Figure 20. Standing in the east room on the second floor, looking north. Because the brick has already been installed on the main house, we know that this room is a later addition.

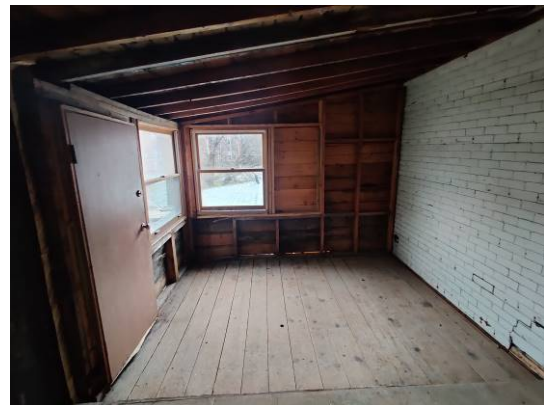
Figure 21. Same room as Figure 20 but looking south.

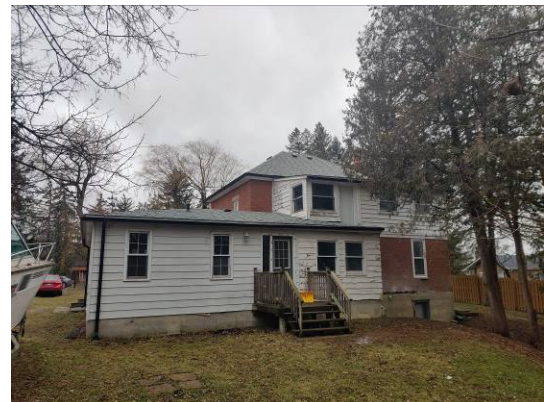
Figure 22. Rear (east) side of the house. We know from the foregoing that all of the “clapboard” bits—wood or aluminum—were constructed after the main body of the house.

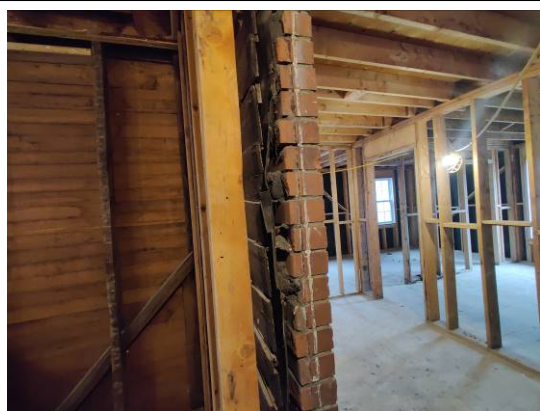
Figure 23. Surprise! Underneath the brick veneer is the previous cladding of untapered clapboard—very much old style.

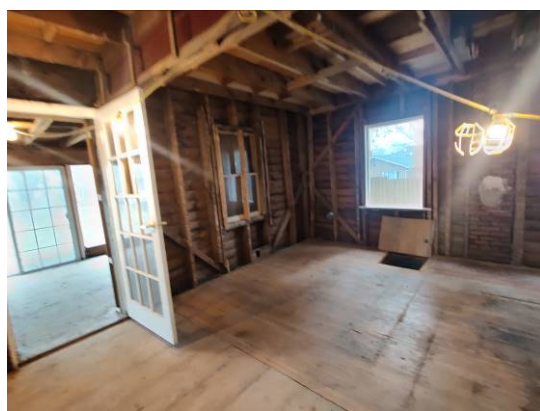
Figure 24. Northwest corner of the ground floor. The diagonally-braced corner post and door post are evident, as is the clapboard siding on both exterior walls.

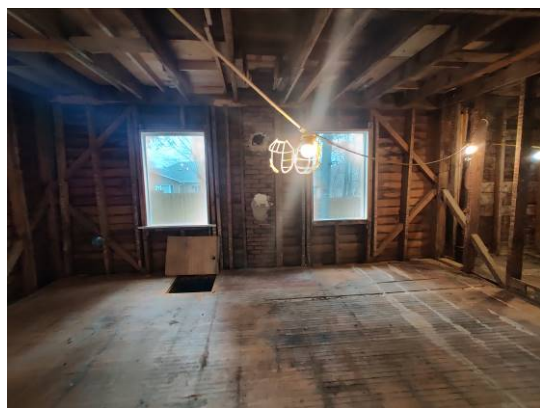
Figure 25. Northeast corner, with kitchen tail to the right. The mortised bracing of the corner post is very evident here.

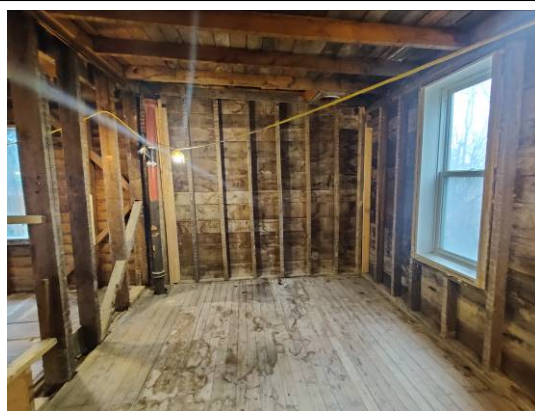
Figure 26. Kitchen tail, looking north. Note that walls are of sheathing, not clapboard. There may have been a different exterior finish. Board and batten was a common siding on kitchen tails.

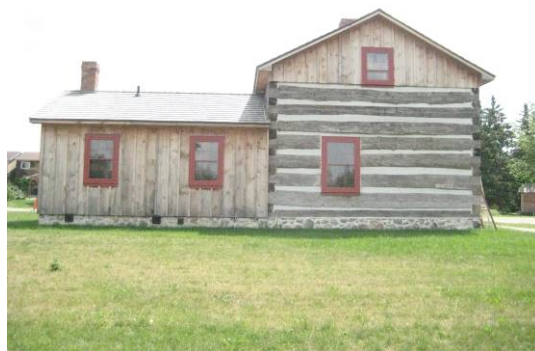
Figure 28. Board and batten kitchen tail of the relocated Pendergast Log House, Brampton. The footprint of the log house is almost identical to that of the original house at 10555 Islington Avenue. This house was also covered in brick in the 1920s. Photo by Vic Snow.

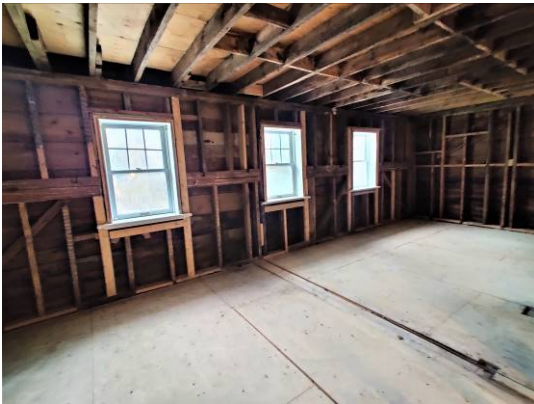
Figure 29. Looking to the northwest corner upstairs: another surprise. The house was once a half-storey smaller.

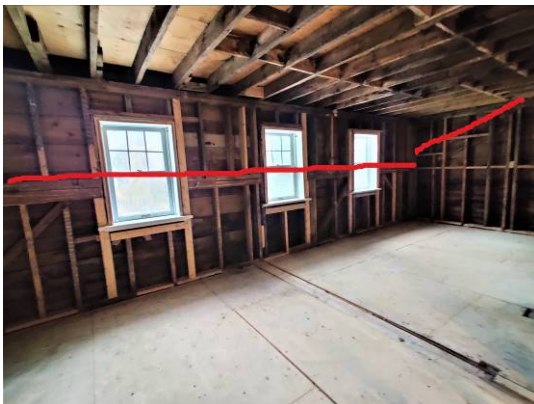
Figure 30. The red line on the left follows the top of the original header beam. It has been cut to fit the windows. The red line to the right follows the line of the original gable header. Everything above these lines was added—most likely at the time of the brick veneer installation.

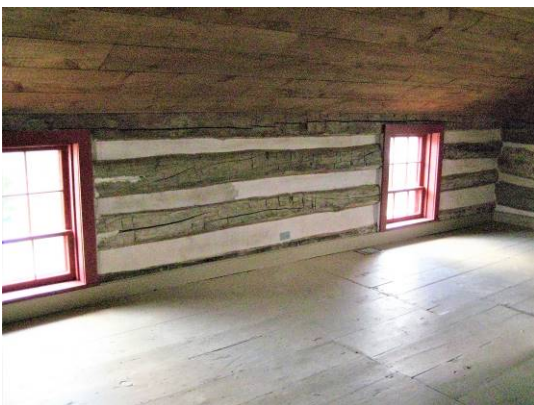
Figure 31. Original house may have had low 2nd floor windows, as in the Pendergast Log House shown here. Photo by Vic Snow.

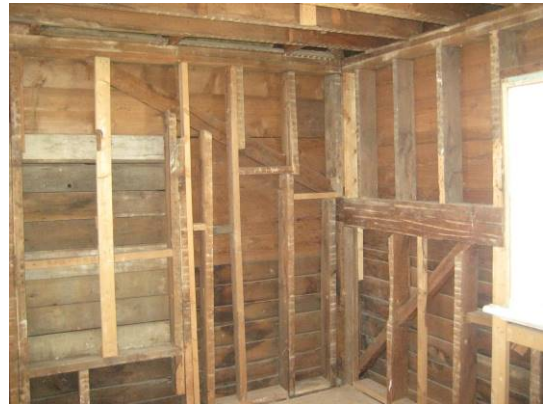
Figure 32. On the left, you can see filled-in original window in the south gable end. Note that its head is higher than the header beam to the right.

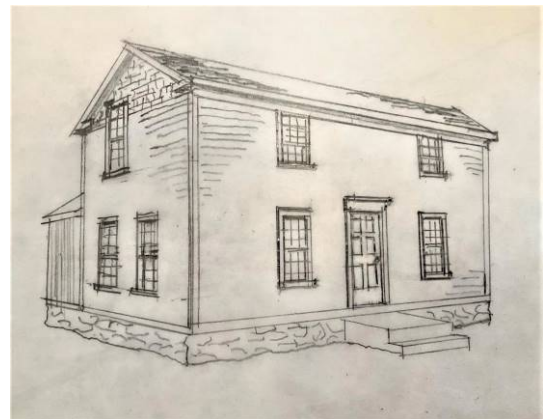
Figure 33. Conjectural sketch of the original house, based on the physical evidence described above.

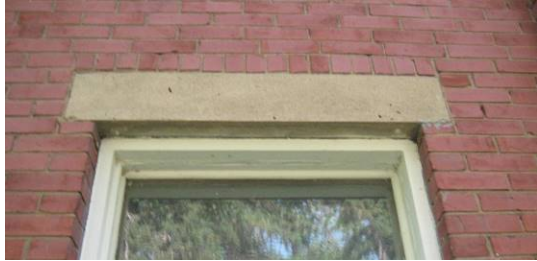
Figure 34. Lintels appear to be of homemade concrete castings rather than limestone or factory precast.

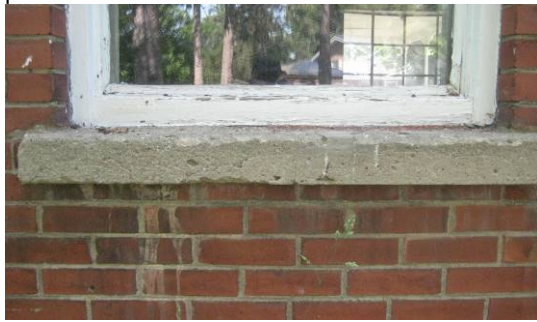
Figure 35. Likewise the windowsills.

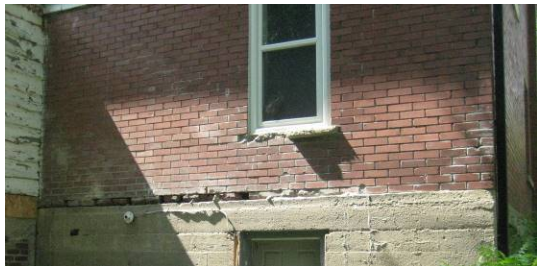
Figure 36. This sill on the rear wall has almost completely fallen apart. The bottom course of brick is crumbling, for reasons unknown, and the mortar has eroded in the lower right corner.

In my professional opinion, the conditions shown are problematic for the long-term use of the dwelling. Settlement cracking on a brick veneer that may not be well-secured is a prelude to failure of the masonry. Deteriorating lintels would exacerbate this. The failure of the lower brick course near the northeast corner (see Figure 36) is particularly troubling since it is not obvious what caused such a large failure. It may be due to rain penetration of the masonry gathering at the bottom of the air gap, which has no weep holes. If that is the case, insulation of the walls will limit the ability of the building's heat to drive moisture back out through the masonry. The bearing situations of the upper studding and the steel beam on the ground floor are non-ideal but less problematic than the deficits in the building envelope.

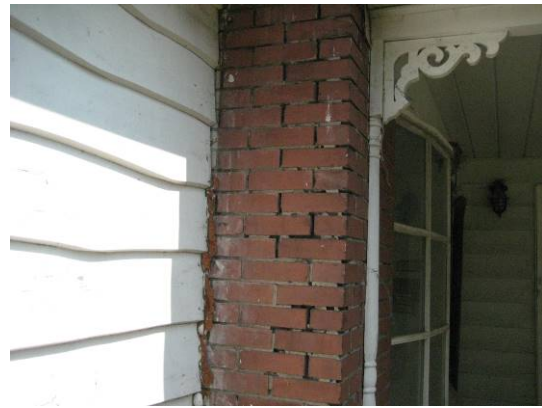
Figure 38. Mortar erosion on southwest corner of the house.

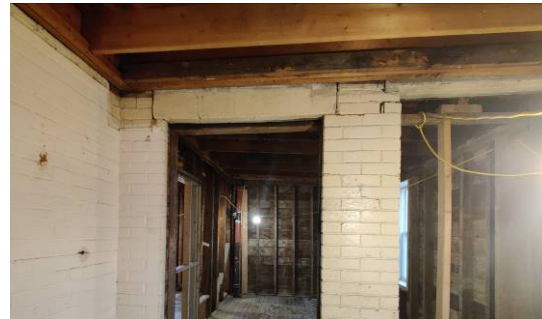
Figure 39. Settlement cracking at lintels on original ground floor kitchen tail.

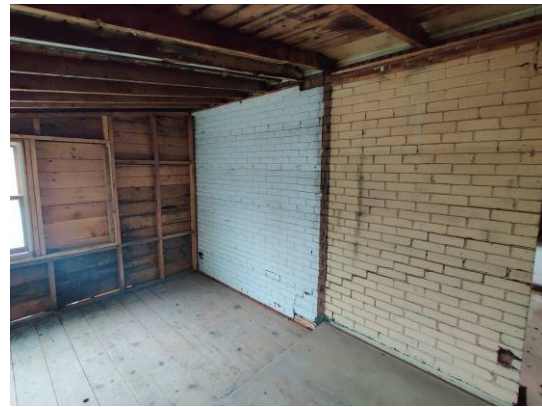
Figure 40. Settlement cracking, second floor rear wall.

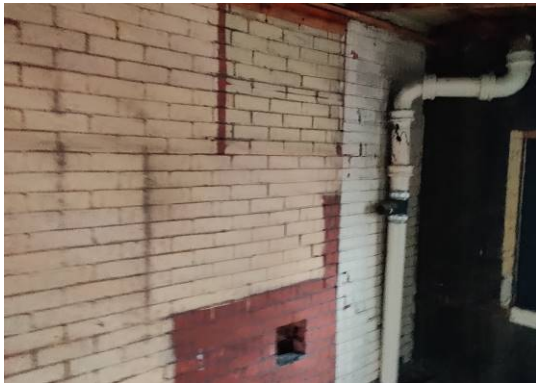
Figure 41. Settlement cracking second floor rear wall.

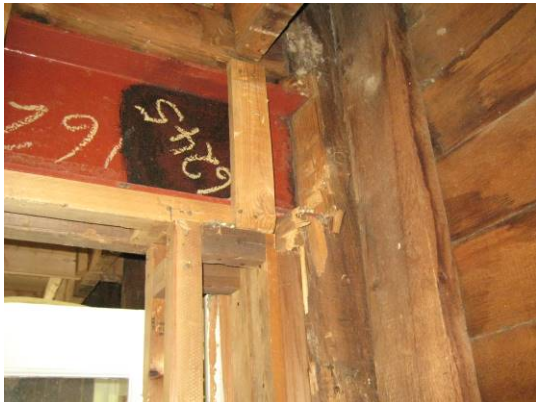
Figure 42. At some point a bearing wall on the ground floor was removed and replaced with a steel beam. It rests on a notch in the original framing and this timber salad. In my professional opinion, this is not proper bearing. My photo.

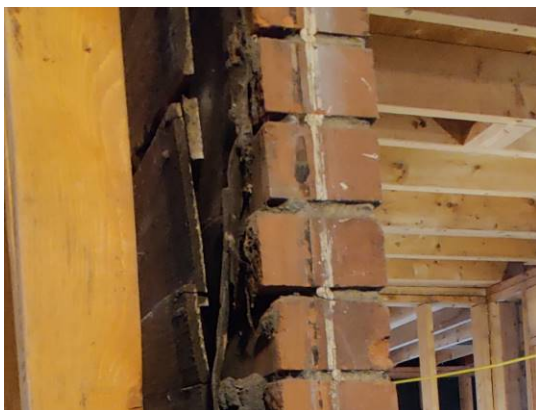
Figure 43. This was once an exterior wall: from left (inside) to right (outside)—stud, clapboard, roofing felt, air gap, brick. There might be some kind of ties between the brick but we haven't found any.

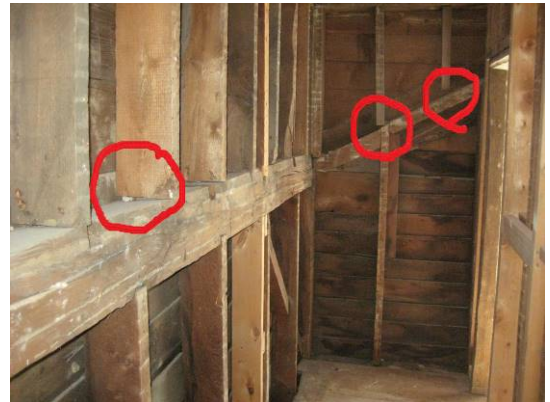
Figure 44. Some of the upper addition studs are not properly seated on the original top plate. My

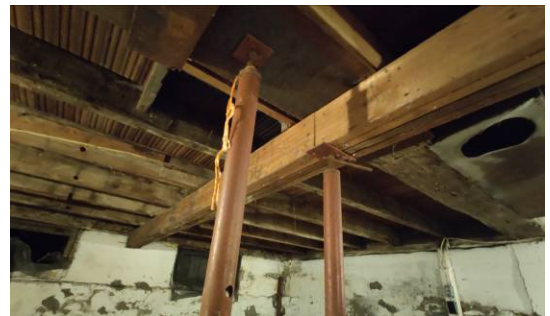
Figure 45. The ground floor framing, including the summer beam, has required some additional support. Unknown if this is related to the steel beam installed above.

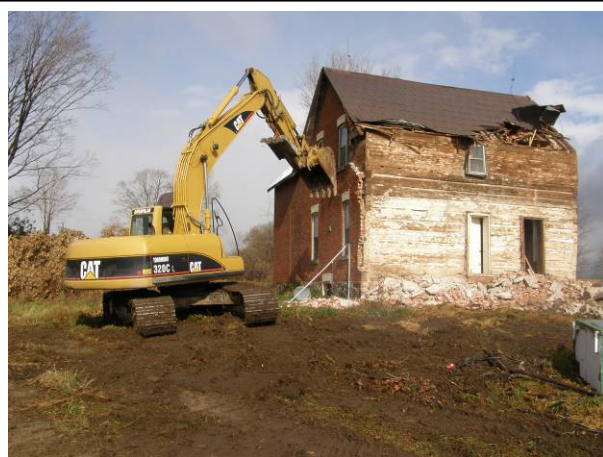
Figure 45. Stripping brick veneer from another log house, this one in Stroud. It's fast work for a skilled operator. Photo by Vic Snow.

I would propose a step-by-step dismantling of the dwelling, with photographic documentation in concert:

- Remove all the additions, which are without heritage value.
- Remove the brick veneer to expose the original clapboard exterior.
- Remove the roof
- Remove walls above original top plates. What remains is the general form of the original house.
- Supply photographic documentation to Vaughan Archives.
- Advertise original clapboard, timber, and fieldstone for salvage.
