CULTURAL HERITAGE RESOURCE IMPACT ASSESSMENT

980 MAJOR MACKENZIE DRIVE WEST AND 10244 BATHURST STREET, VAUGHAN

Issued: October 30, 2014 (Revised: April 12, 2016, **September 11, 2019**)

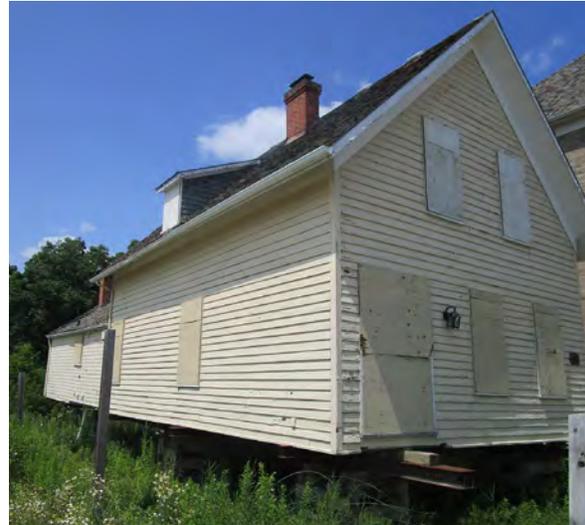
5. Current condition of the George Munshaw House (ERA, 2019).

Overall, the Munshaw house is in fair to poor condition with areas of defective condition. It is currently sitting on temporary structure - steel beams and wood cribs. The area at the seam of the two storey and one storey structure appears to be in poor condition and is bowing in this location. This section should be repaired and levelled as soon as possible to prevent further deterioration to the structure.

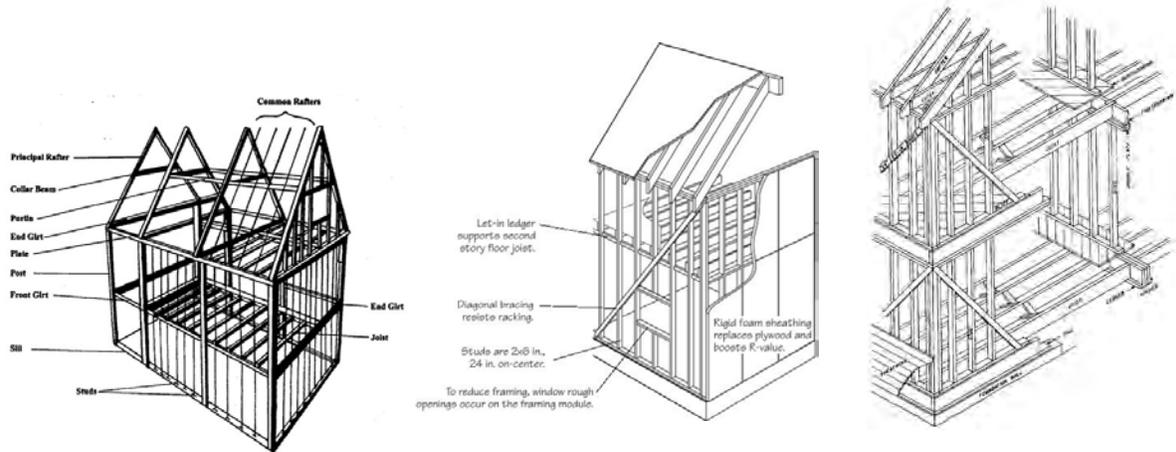
6. Timber post & beam frame diagram

7. Balloon frame diagram

8. Platform frame diagram

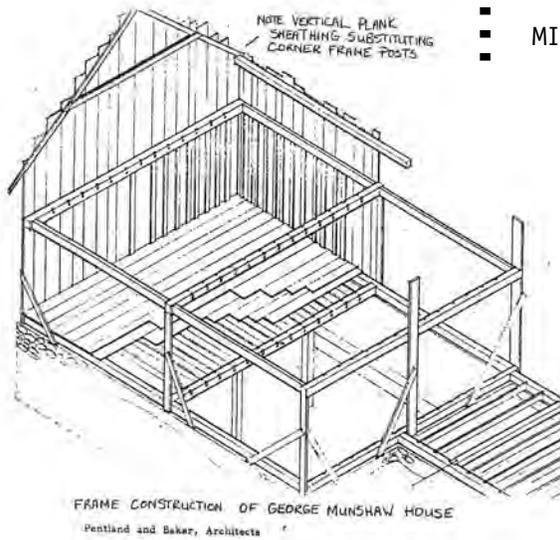
9. Frame construction of the George Munshaw House

The frame of the house is unique in that it has vertical plank sheathing as the frame support. The structure resembles post and beam construction except that the posts are replaced by vertical planks. This type of construction was used between 1825 - 1850 during the transition from early post and beam construction to balloon framing.¹ The method of construction used to build the Munshaw House resembles balloon framing, in that the vertical supports press beside the horizontal supports and not underneath them. The horizontal beams are held up by spikes driven through the planks. This method of construction was more economical than post and beam, as it eliminated the posts and the complicated joinery.

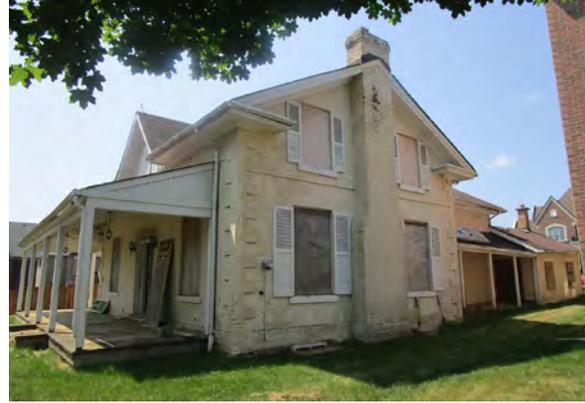
13. Bassingthwaite House - exterior (ERA, 2019).

Research provided in *Archeological Services Inc., March 2005, and titled "Cultural Heritage Impact Assessment for Helmhorst Investment Limited,"* states that the house was renovated and enlarged in the 1980s. A two storey rear addition was constructed to the south elevation.

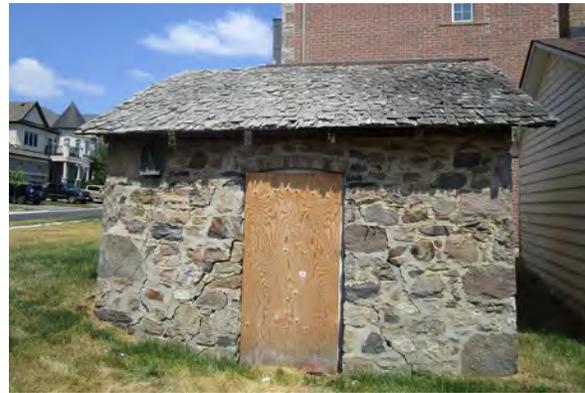
A single storey brick and stone structure, identified by the *Archeological Services* report as a smokehouse, is located at the rear of the house (see figure 14).

14. Single storey brick and stone smokehouse (ERA, 2019).

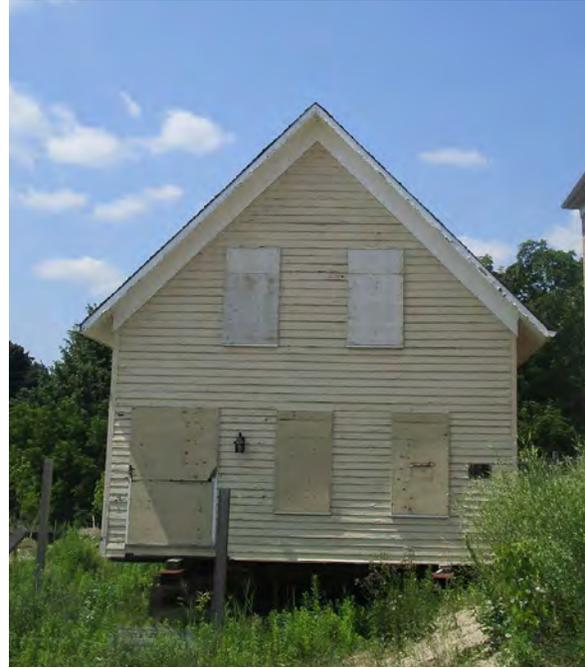
16. East elevation (ERA, 2019).

The wood siding appears to be in poor to fair condition with some areas of rot and deterioration and paint flaking and peeling. There also appears to be some defective areas at the base of the one-storey section where there is missing wood siding.

The exterior wood work appears to be in fair condition with some areas of the roof fascia and soffit boards showing paint flaking and peeling.

The eavestroughs and downspouts appear to be in fair condition with some areas of warping. The eavestroughs and downspouts on the north side of the one-storey section are missing.

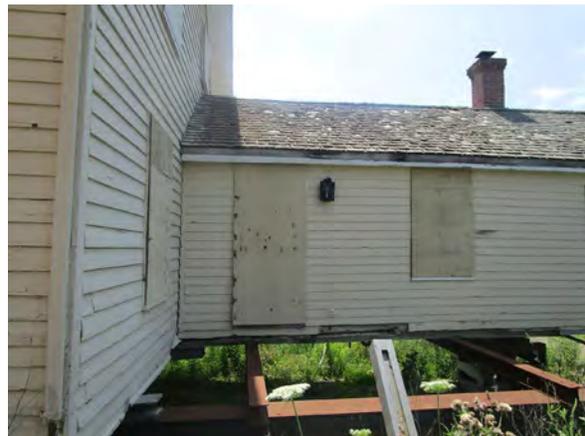
17. North elevation (ERA, 2019).

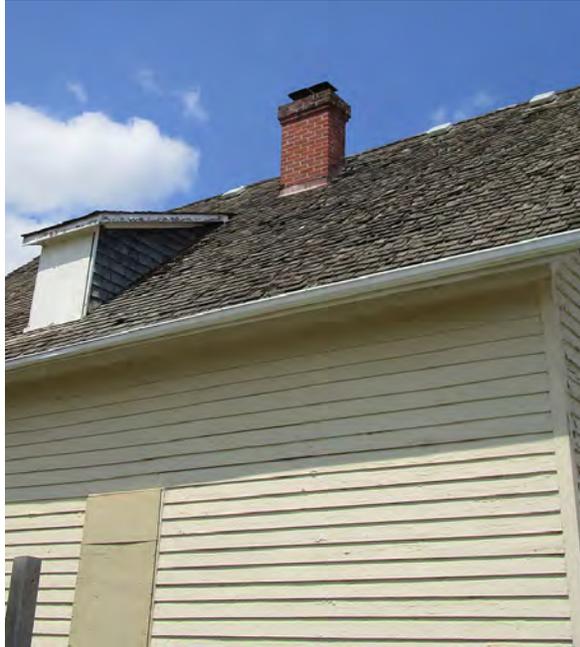
18. South elevation with view of cedar shingled roof and easternmost chimney (ERA, 2019).

The cedar shingle roof appears to be in poor condition with areas of missing shingles, deterioration and warping. The roof flashing appears to be in fair condition.

The brick chimneys appear to be in fair condition with some environmental staining at the peaks.

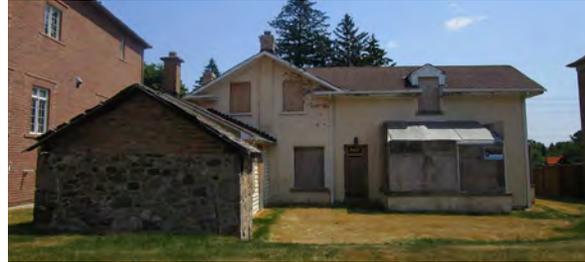
Brick Masonry: The brick façade has been painted in a beige colour and appears to be in fair to poor condition with areas have paint flaking, mortar loss, brick deterioration, brick delamination, environmental staining and obsolete metal fasteners. There also appears to be mortar cracks above window and door lintels, below window sills and at the base of the structure.

20. West elevation of the structure including the stone smoke house (ERA, 2019).

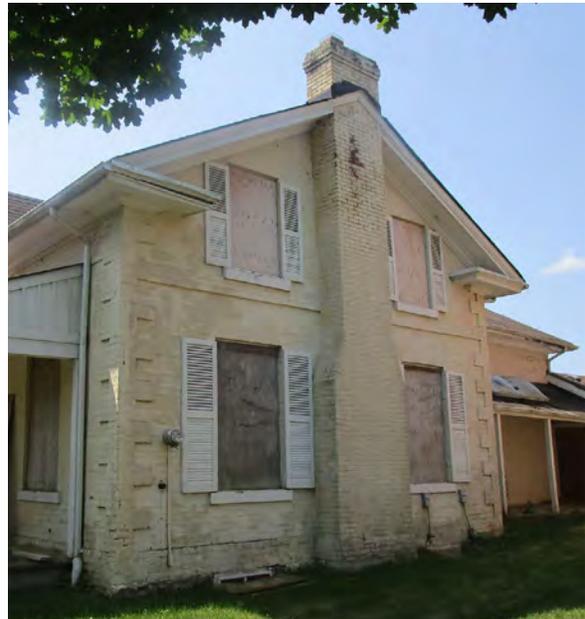
21. North chimney (ERA, 2019).

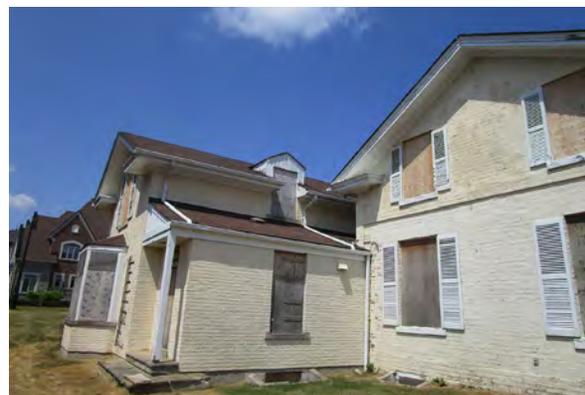
22. 1980s addition (left) viewed from the southwest (ERA, 2019).

The wood siding on the one storey addition appears to be in fair to poor condition with areas of paint flaking, damaged and deteriorated wood.

As noted in the CHRIA, dated April 12, 2016, the size and configuration of the building may complicate relocation efforts. As such, relocation will require the removal of the 1980s addition, which will reveal the original massing of the building. No negative impacts are anticipated as a result of the removal of this 1980 addition.

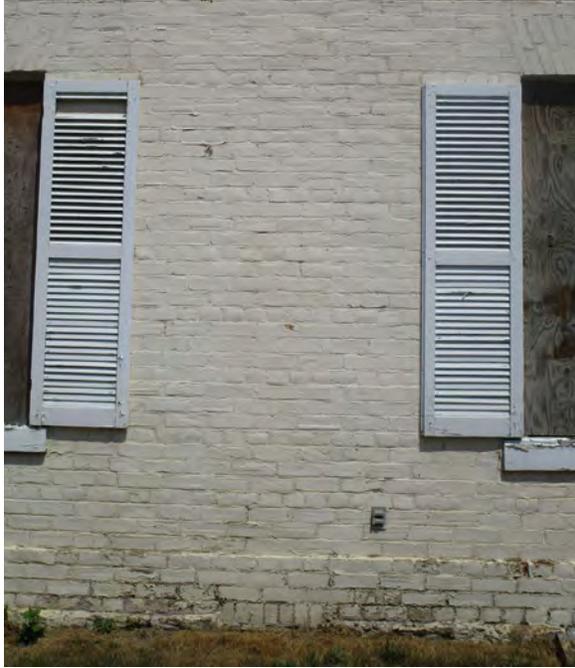
23. North Elevation brickwork and shutters (ERA, 2019).

The remaining wood window shutters appear to be in fair condition with areas of paint flaking. The north elevation has all the window shutters installed, the south elevation is missing one window shutter, and the east elevation is missing three window shutters with one uninstalled and in defective condition.

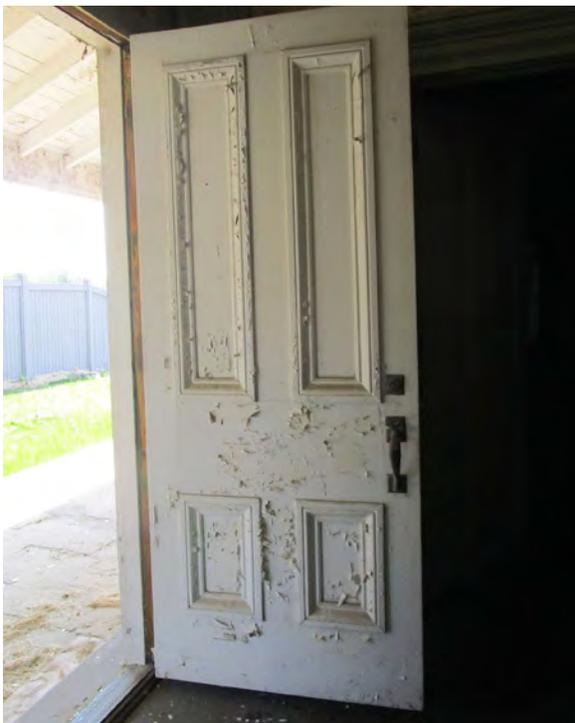
24. Main wood door (ERA, 2019).

Openings: All the window and door openings have been boarded up with plywood on the exterior except the basement windows, and so the windows were reviewed only from the interior. The wood windows in the original Bassingthwaite House appears to be historic and in fair condition. The remainder of the windows at the one- and two-storey later additions are vinyl windows and appear to be in fair to poor condition. The main wood door and wood surround appears to be in fair condition with areas of paint flaking.

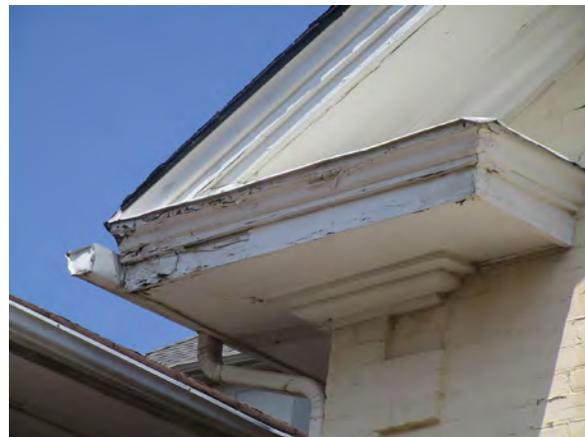
25. Soffiting and moulding on south elevation (ERA, 2019).

The wood soffits, fascias and eaves appear to be in fair to poor condition with some areas of paint flaking and peeling, wood rot, deterioration and delamination.

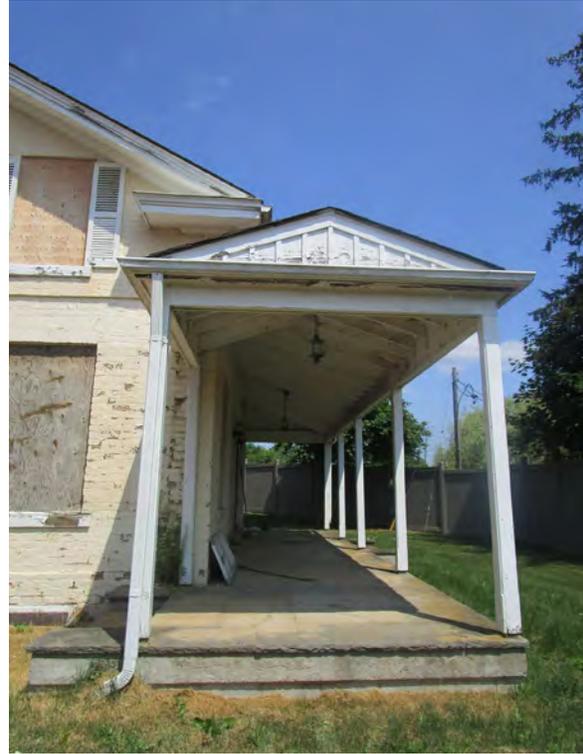
The main and side wood porches appear to be in fair condition with areas of paint flaking and some wood deterioration at the base of the columns.

26. Main wood porch (ERA, 2019).

The rain management system is in fair to poor condition with damaged and warped areas on the main porch and the one-storey building's eavestroughs, missing downspouts and downspout diverters.

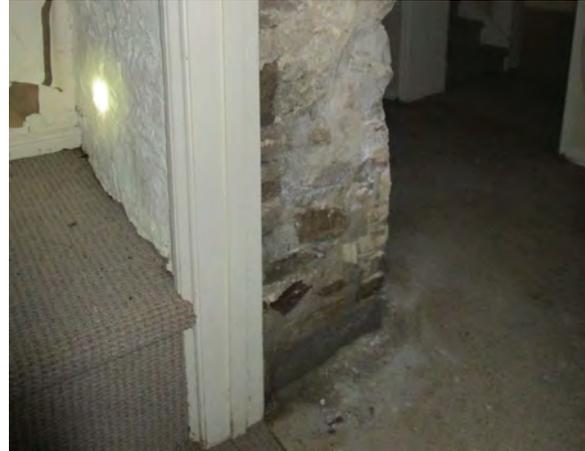
Interior: Generally, the basement interior appears to be in fair condition. The majority of the exterior walls are covered in drywall except the north wall which shows the exposed stone rubble foundation. The stone foundation wall (west wall of original footprint of the Basingthwaite House) is exposed and appears to be in fair condition. A multi-wythe interior brick wall spanning east to west in the original footprint of the Basingthwaite House appears to be in fair condition. A section of wood floor joists and wood floor boards are exposed in the north side of the original Basingthwaite House footprint and appears to be in fair condition.

27. Stone rubble foundation (ERA, 2019).

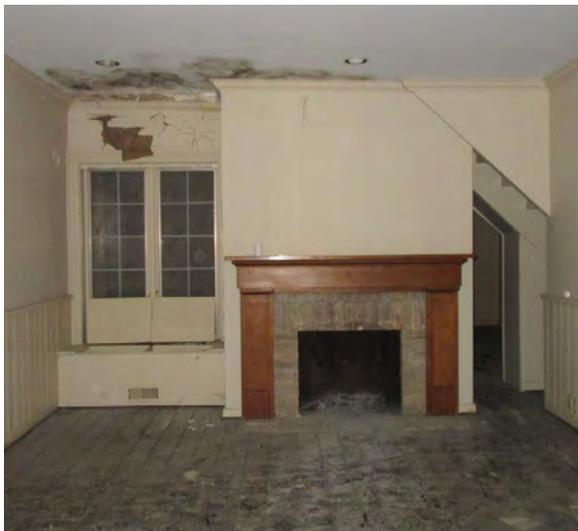
30. View of dining room, with evidence of mould on the ceiling and wall from defective roofing area (ERA, 2019).

Generally, the ground floor interior appears to be in fair condition with an isolated area of poor condition in the north west side of the two-storey house below the hole in the roof where there appears to be mould and water damage in the ceiling and wall. The original Bassingthwaite House interior appears to retain its original wood flooring, wood door and window trim, baseboards, wainscoting and ceiling trim, which appears to be in fair condition. The walls in the original Bassingthwaite House interior appears to be in fair condition with areas of paint flaking and peeling. The later addition interior walls are covered in drywall and tile (in the kitchen), which appears to be in fair condition.

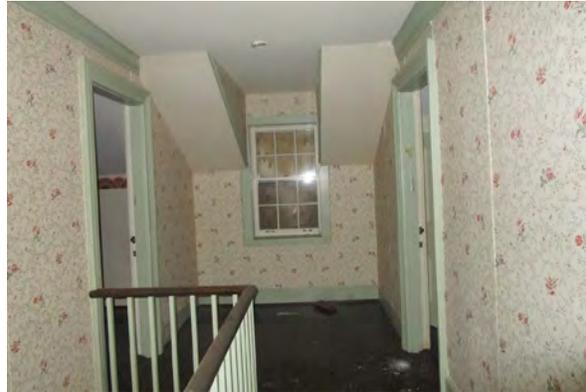
31. Upstairs hallway (ERA, 2019).

Generally, the second floor interior appears to be in fair condition with areas of paint flaking and peeling from the walls and an interior door. There appears to be a defective area in the north west side of the two-storey house where there is a three foot by four foot hole in the roof that exposes the interior to the elements, which has damaged the ceiling, walls and floor in that area. This hole should be repaired as soon as possible so that further deterioration to the interior elements can be avoided.

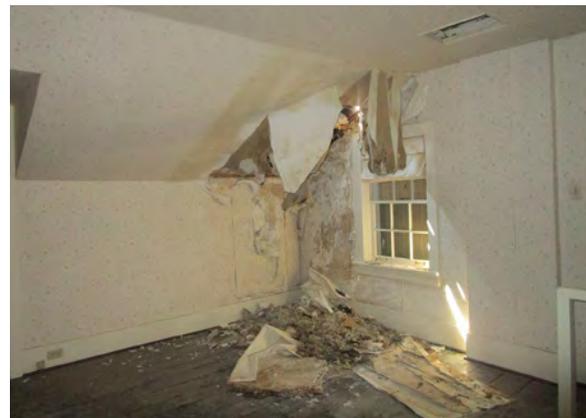
Roof, Flashing and Rain Management System: Generally, the roof, flashing and asphalt shingles are in fair condition, with the exception of a defective area in the north west side of the two-storey house where there is a three foot by four foot hole in the roof which exposes the interior to the elements. This hole should be repaired as soon as possible so that further deterioration to the roof and interior structure can be avoided.

32. Evidence of defective roofing in southwest corner of the house (ERA, 2019).

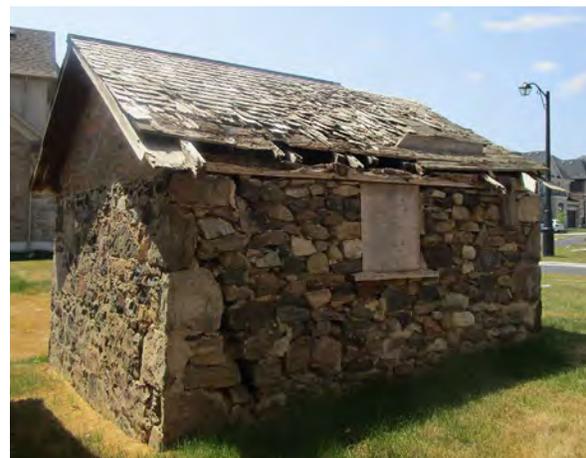
One-storey Stone Smoke House: The one-storey stone smoke house appears to be in defective condition. The south and west stone walls have multiple vertical cracks along the entire wall and the north façade has mortar loss on the majority of the wall. The roof is in defective condition with rotted roof rafters, roof boards and shingles exposing the interior to the elements.

33. Smokehouse structure requires rebuilding and repointing of walls(ERA, 2019).

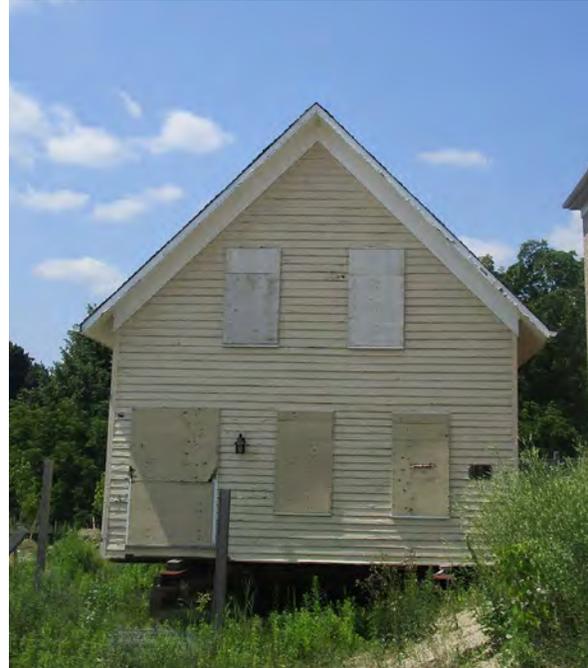
35. George Munshaw House (east elevation) (ERA, 2019).

The current location and position of the George Munshaw House on the Subject Site **is within lot 104 of the Subject Site along Fanning Mills Circle**. The Munshaw House **was moved here from its previous 1984 location**, as it **did** not fit into the configuration of streets and blocks within the draft plan of subdivision. **The rationale for its current location was to integrate** the house into the regular pattern of development, to allow for the most efficient plan.

The current location is the result of two previous relocations (refer to figure 10). Its current context, backing onto a natural heritage system and adjacent to larger scale single-detached houses is not ideal, as it does not reflect the historic rural character of the house.

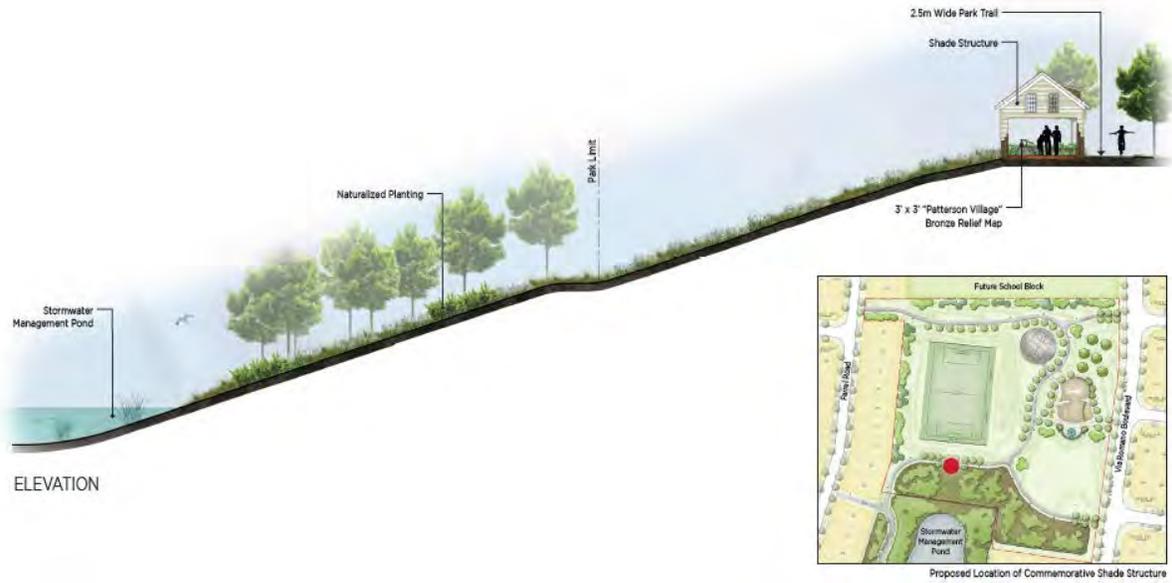
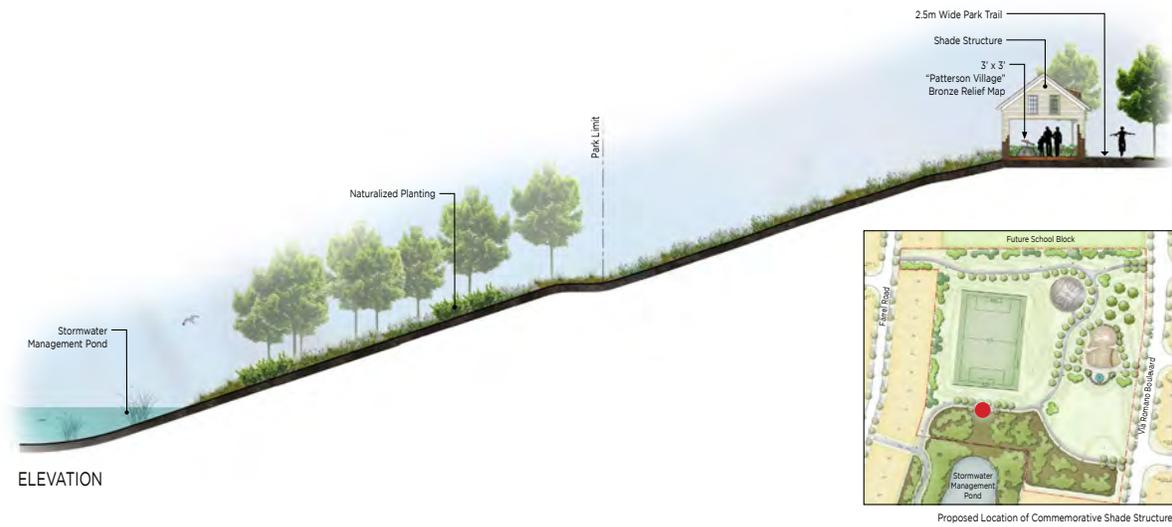
LONGYARD PARK
CITY OF VAUGHAN
COMMEMORATION CONCEPT
JULY 21, 2004
SCALE 1:200

Figure 42, shows what the commemorative shade structure and other commemorative elements may look like.

In order to meet the size requirements for structures in public parks, the shade structure will need to be scaled at 80% of the actual house. The structure will provide protection from the elements without compromising safety by maintaining clear sight lines within and outside the structure (see figure 42).

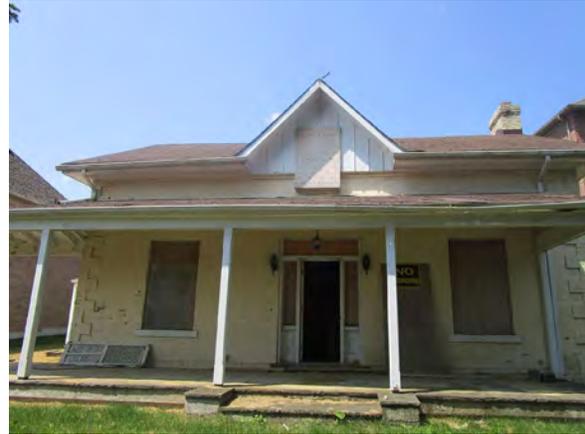
43. Bassingthwaite House main entry along eastern elevation (ERA, 2019).

As noted in the CHRIA, dated April 21, 2016, the siting, condition and architectural integrity of the house suggests it may be adapted for future uses within the proposed **Subject Site**. Interior work would be limited to ensure historic trim and other significant heritage features are conserved.

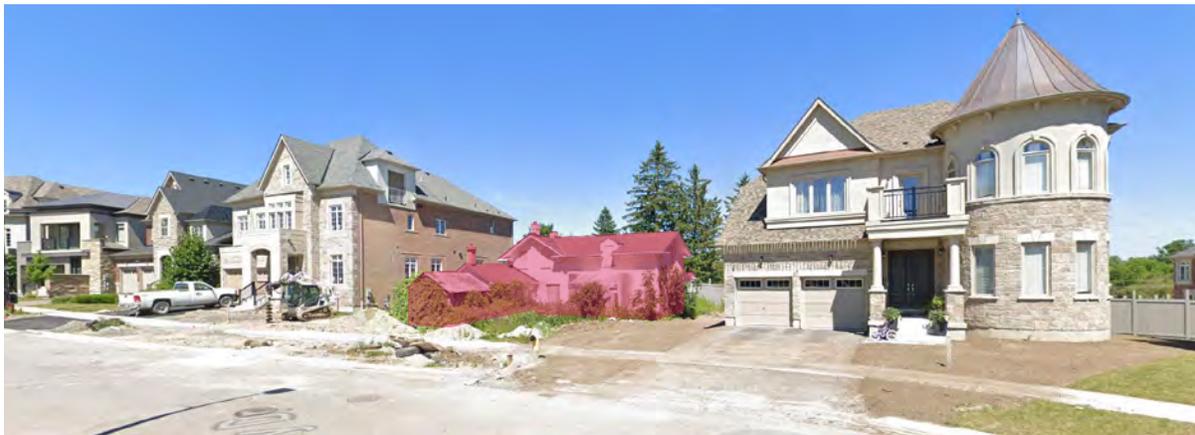
44. Bassingthwaite House (west elevation) on Lot 35 along Keatley Drive (in pink), adjacent to newly constructed homes on the Subject Site (Google, 2018. Annotated by ERA, 2019).

However, since the Longyard Subdivision has been constructed, Bassingthwaite House's current context and location adjacent to larger scale single-detached houses is proving to not be ideal, as it does not reflect the houses' historic rural character.
