## CITY OF VAUGHAN

**10. RELOCATION OF ONE DESIGNATED PART IV HOUSE (58 FANNING CIRCLE) AND A LISTED HOUSE (39 KEATLEY DRIVE) TO 10090 BATHURST STREET, VICINITY OF BATHURST STREET AND MAJOR MACKENZIE DRIVE WEST**

To forward a recommendation from the Heritage Vaughan Committee for the proposed relocation and restoration of the George Munshaw House (Designated under By-law 403-87 as Amended by By-law 103-2016) located at 58 Fanning Mills Circle, and the relocation of the Bassingthwaite House (Listed under Section 27 of the *Ontario Heritage Act*) currently located at 39 Keatley Drive (formerly 10244 Bathurst) to a new location known as 10090 Bathurst Street.

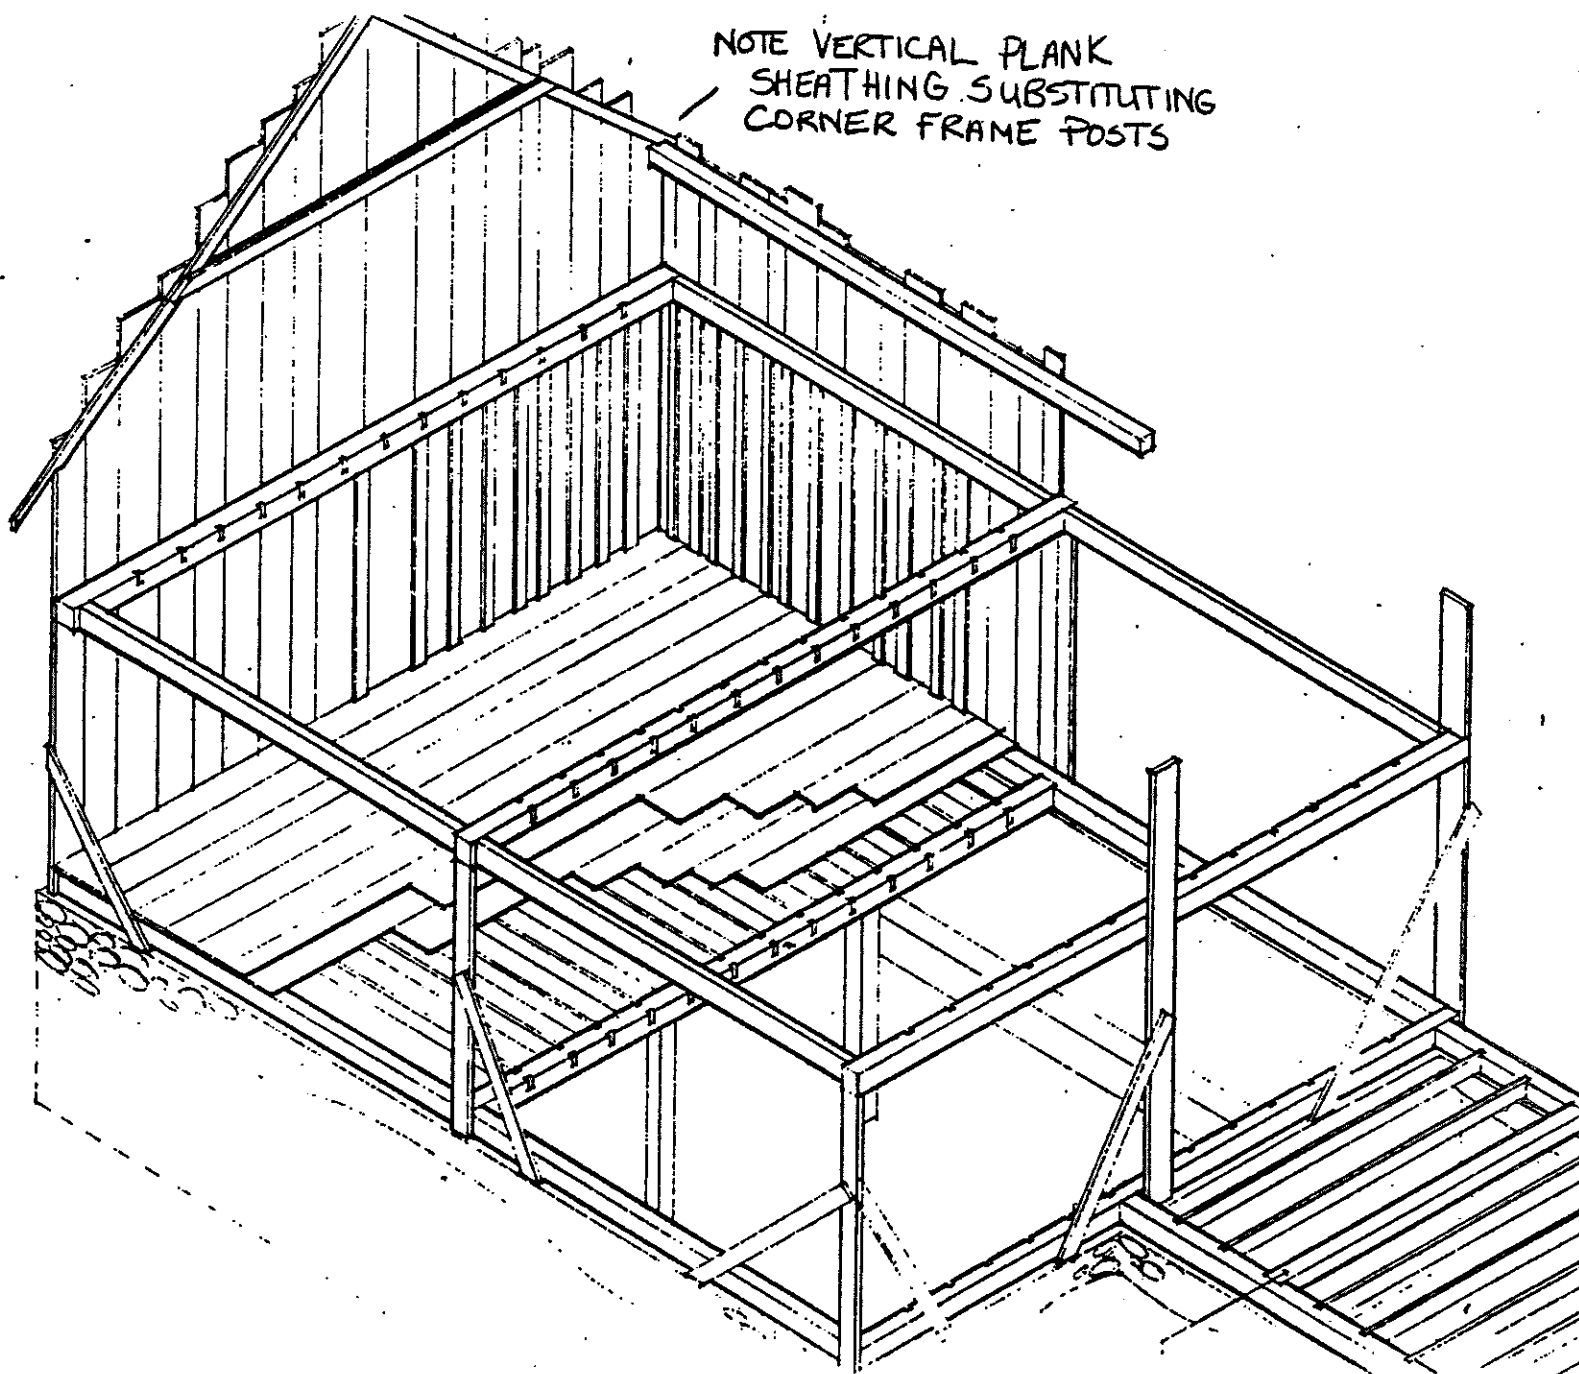
The frame of the house is unique in that it has vertical plank sheathing as the frame support. The structure resembles post and beam construction except that the posts are replaced by vertical planks. This type of construction was used between 1825 - 1850 during the transition from early post and beam construction to balloon framing.<sup>1</sup> The method of construction used to build the Munshaw House resembles balloon framing, in that the vertical supports press beside the horizontal supports and not underneath them. The horizontal beams are held up by spikes driven through the planks. This method of construction was more economical than post and beam, as it eliminated the posts and the complicated joinery.

FRAME CONSTRUCTION OF GEORGE MUNSHAW HOUSE

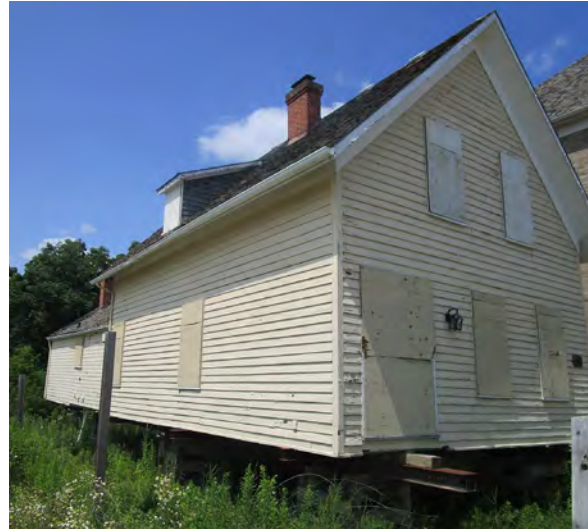
5. Current condition of the George Munshaw House (ERA, 2019).

Overall, the Munshaw house is in fair to poor condition with areas of defective condition. It is currently sitting on temporary structure - steel beams and wood cribs. The area at the seam of the two storey and one storey structure appears to be in poor condition and is bowing in this location. This section should be repaired and levelled as soon as possible to prevent further deterioration to the structure.

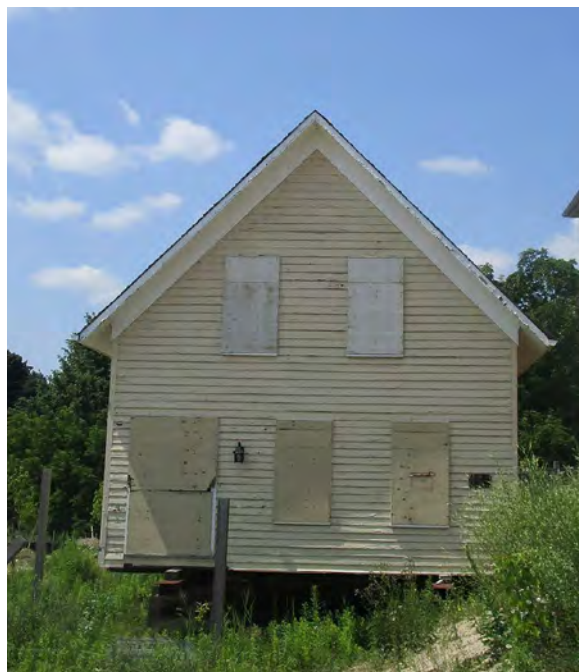
16. East elevation (ERA, 2019).

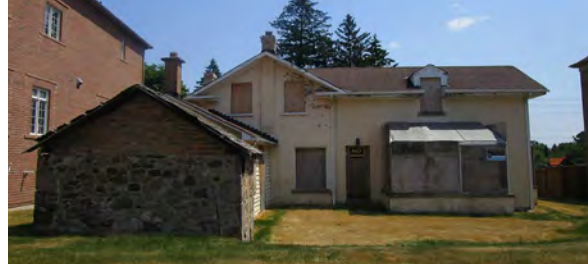
**Brick Masonry:** The brick façade has been painted in a beige colour and appears to be in fair to poor condition with areas have paint flaking, mortar loss, brick deterioration, brick delamination, environmental staining and obsolete metal fasteners. There also appears to be mortar cracks above window and door lintels, below window sills and at the base of the structure.

20. West elevation of the structure including the stone smoke house (ERA, 2019).

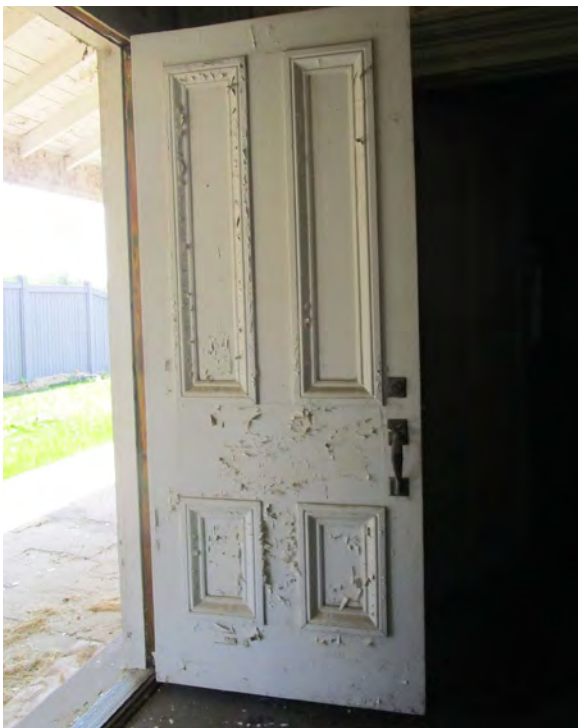
24. Main wood door (ERA, 2019).

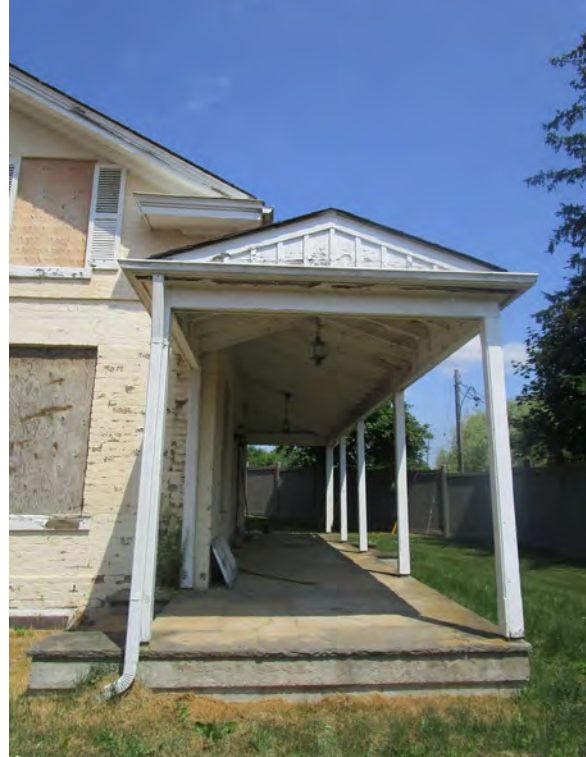
**Roof, Flashing and Rain Management System:** Generally, the roof, flashing and asphalt shingles are in fair condition, with the exception of a defective area in the north west side of the two-storey house where there is a three foot by four foot hole in the roof which exposes the interior to the elements. This hole should be repaired as soon as possible so that further deterioration to the roof and interior structure can be avoided.

26. Main wood porch (ERA, 2019).

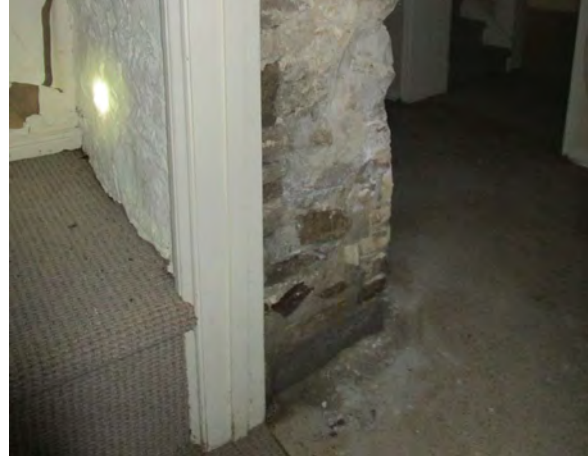
Interior: Generally, the basement interior appears to be in fair condition. The majority of the exterior walls are covered in drywall except the north wall which shows the exposed stone rubble foundation. The stone foundation wall (west wall of original footprint of the Basingthwaite House) is exposed and appears to be in fair condition. A multi-wythe interior brick wall spanning east to west in the original footprint of the Basingthwaite House appears to be in fair condition. A section of wood floor joists and wood floor boards are exposed in the north side of the original Basingthwaite House footprint and appears to be in fair condition.

27. Stone rubble foundation (ERA, 2019).

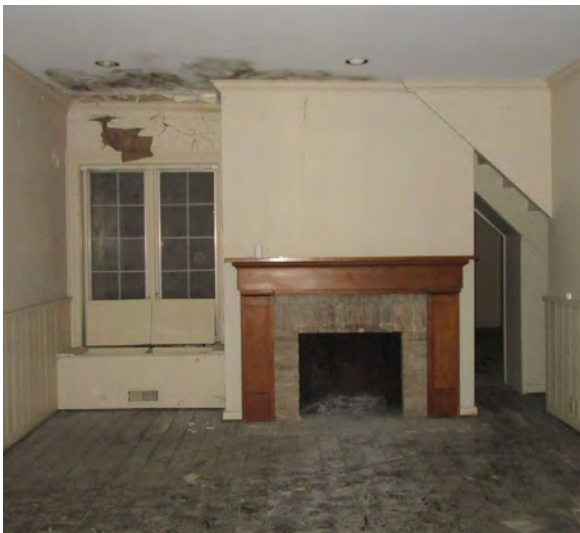
30. View of dining room, with evidence of mould on the ceiling and wall from defective roofing area (ERA, 2019).

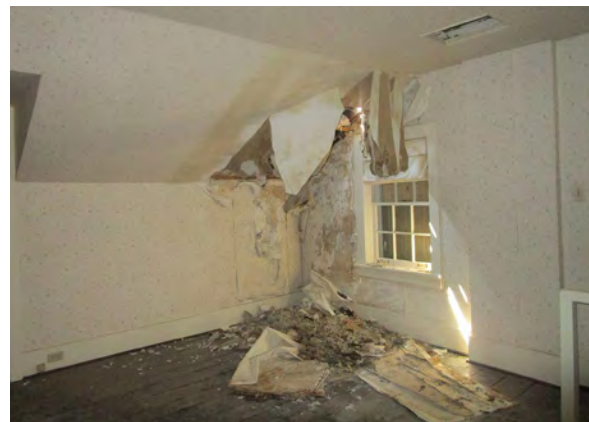
32. Evidence of defective roofing in southwest corner of the house (ERA, 2019).

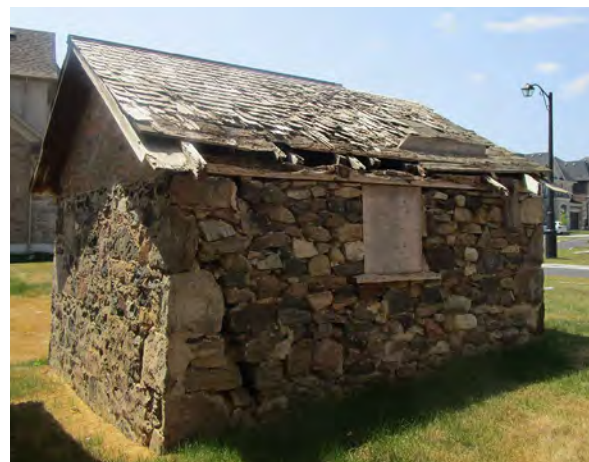
**One-storey Stone Smoke House:** The one-storey stone smoke house appears to be in defective condition. The south and west stone walls have multiple vertical cracks along the entire wall and the north façade has mortar loss on the majority of the wall. The roof is in defective condition with rotted roof rafters, roof boards and shingles exposing the interior to the elements.

33. Smokehouse structure requires rebuilding and repointing of walls(ERA, 2019).

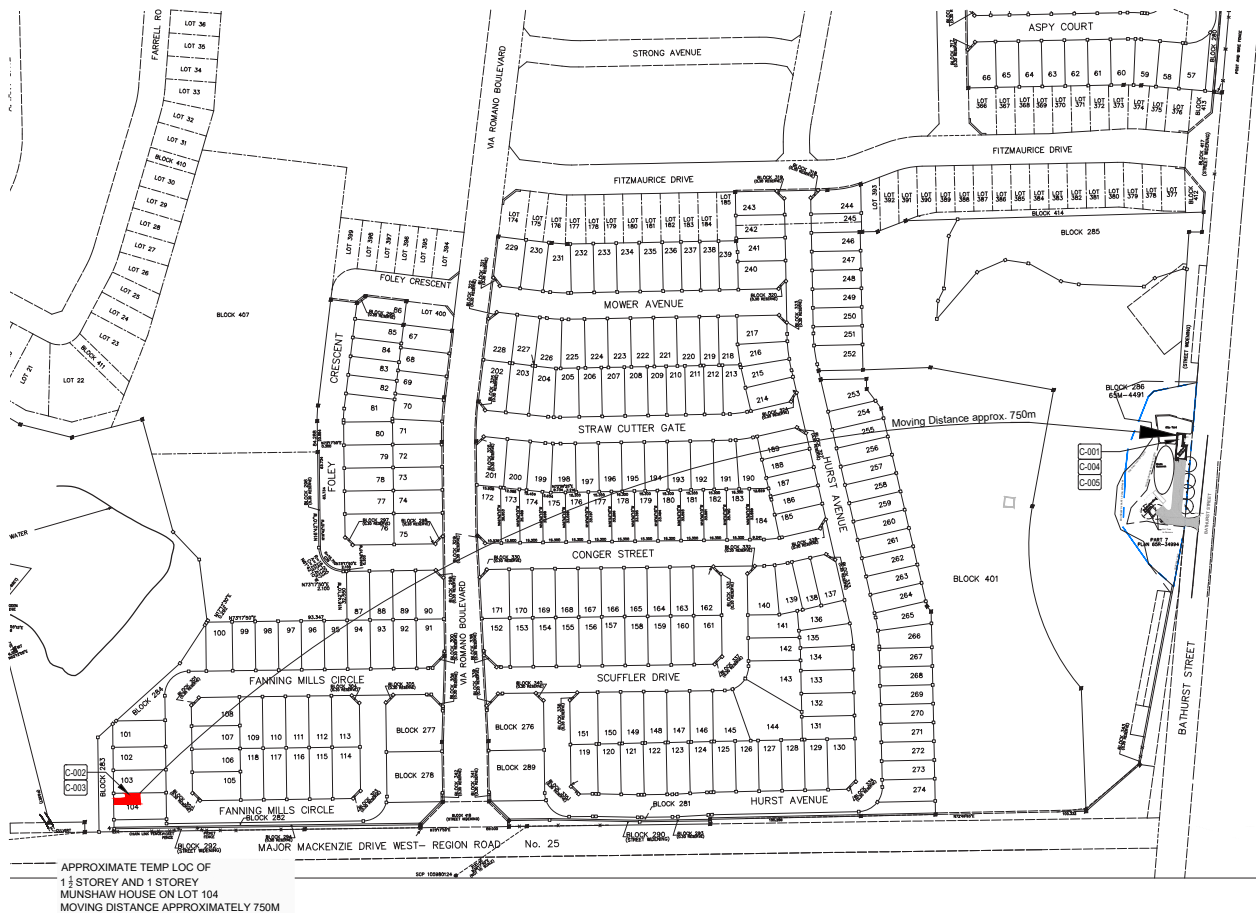
Site plan drawing (HA001) showing the relocation of Munshaw House from its current position (in red) approximately 750 metres to its proposed location at the municipal address of 10090 Bathurst Street (ERA, 2019).

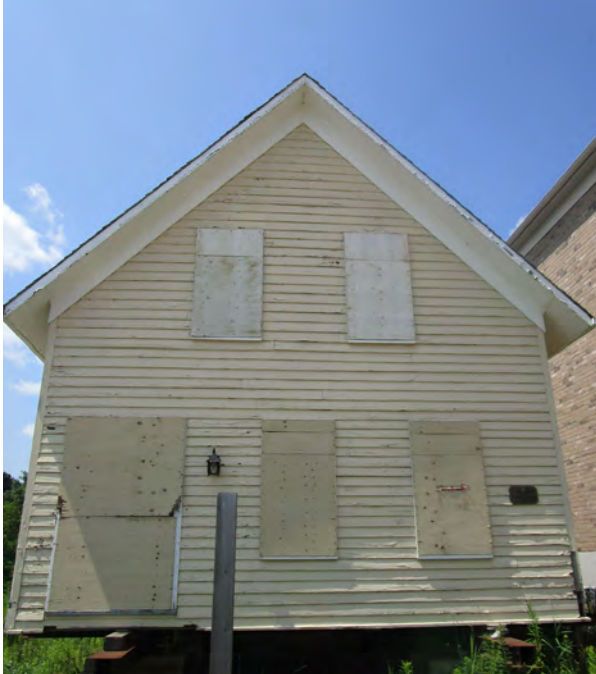
Eastern facade of the Munshaw House (ERA, 2019).

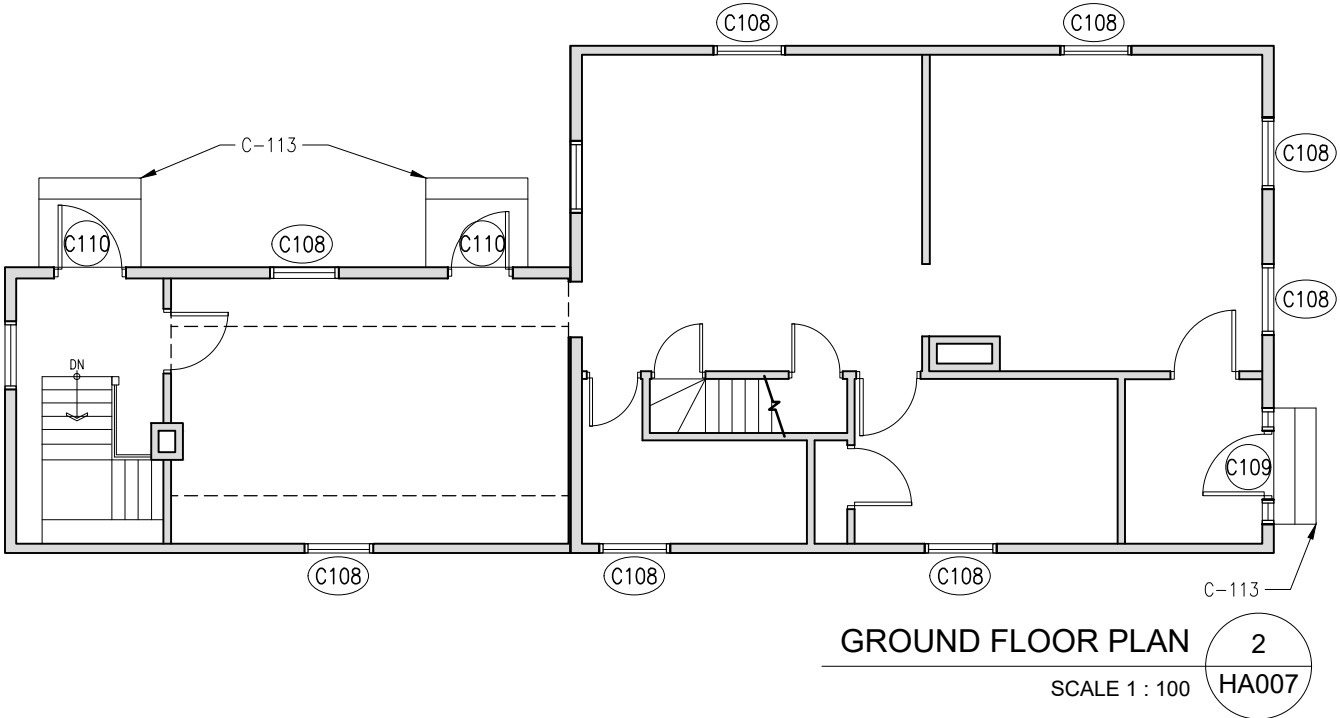
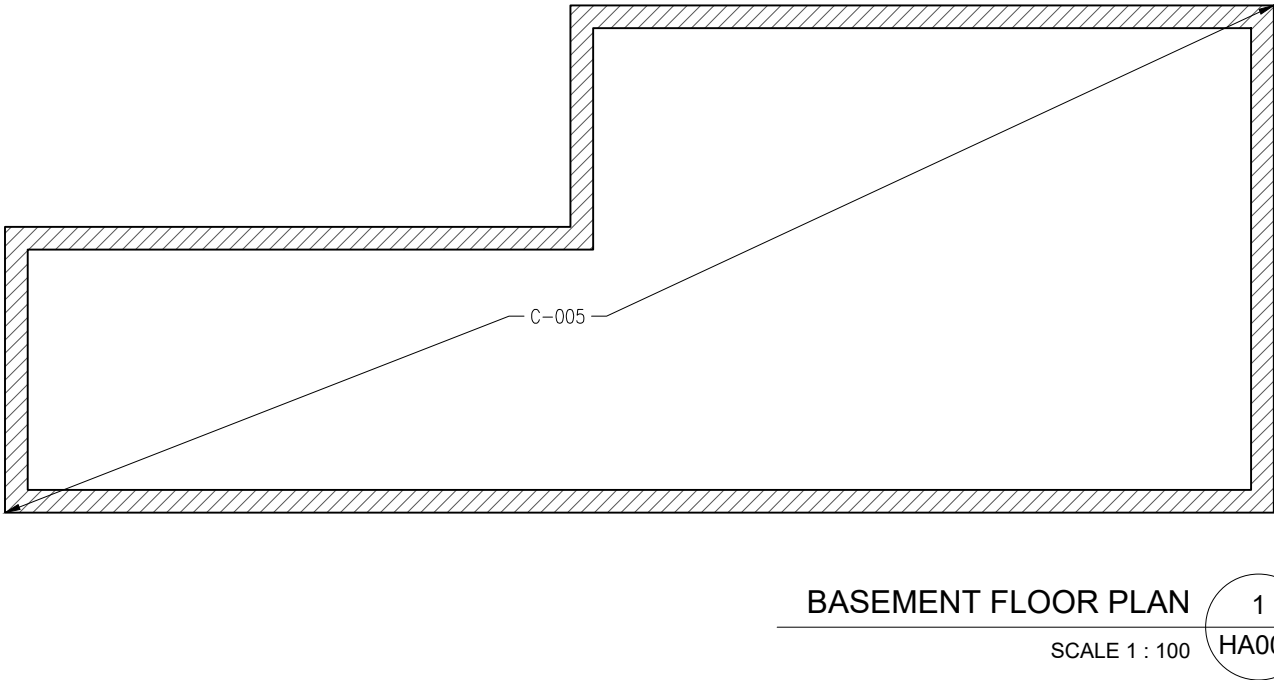
C-005: EXCAVATE AND CONSTRUCT NEW STRIP FOOTINGS AND FOUNDATION WALLS IN NEW LOCATION.

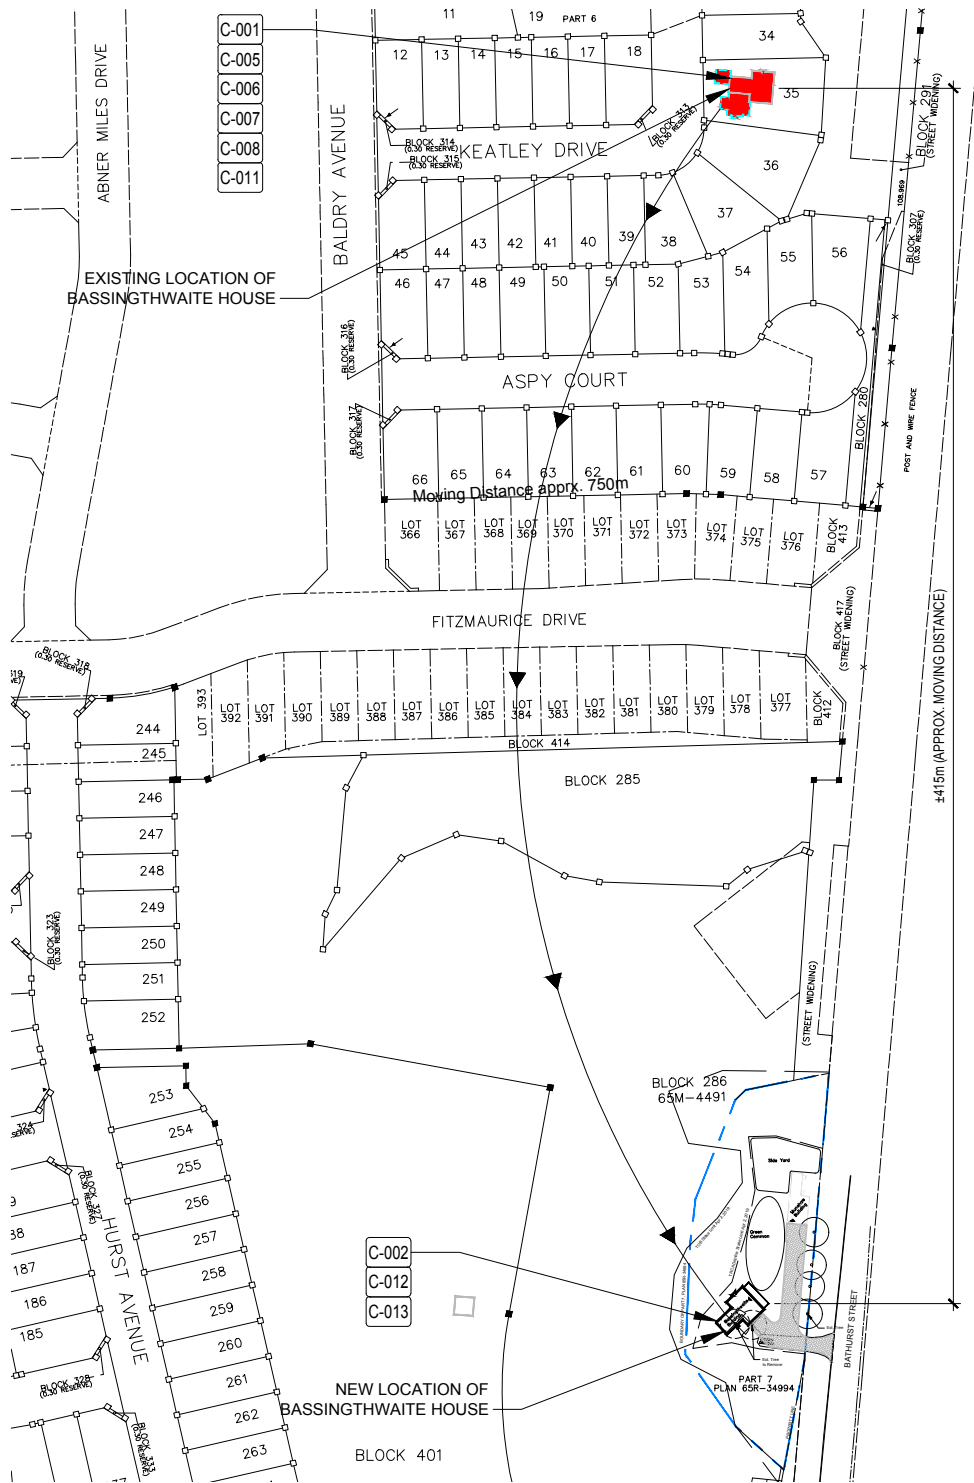
Proposed relocation plan for the Basingthwaite House, approximately 750m south to the Proposed Site (ERA, 2019).

- Cut 2 inches in to the brickline where the house will be removed from its old foundation;
- Install 2-1/2 foot angle iron around the perimeter of the house;
- Cut 4 holes for the 2 main beams (in old foundation);
- Cut holes every 4 inches in the foundation in order to install crosser beams on top of the main beams;
- Shim up all floor joists and support beams off crosser beams;
- Pressure up the grid of steel to 50% of the weight of the house;
- Pressure up each one of the crosser beams off of the main beams to the load each crosser beam will support (preload crossers);
- Raise house off of old foundation;
- Set rollers up on cribs and roll house off of old foundation;
- Set house on firm ground and remove pressures off the jacks, calculating where each hydraulic dolly will be placed under the 2 main beams; and
- Set house on power dollies to be moved to Proposed Site.

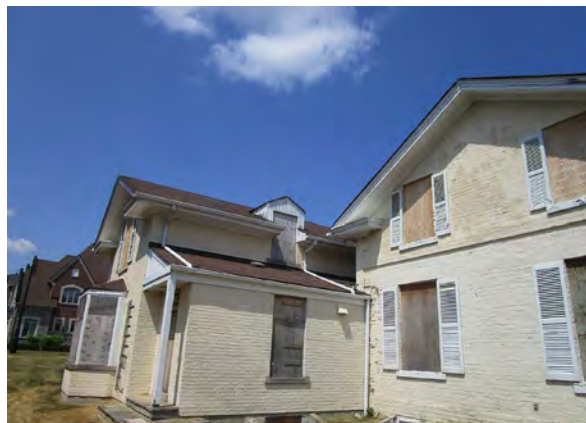
The wood siding on the one-storey addition appears to be in fair to poor condition with areas of paint flaking, and damaged and deteriorated wood.

View of southeast elevation. The 1980s addition is seen on the left (ERA, 2019).

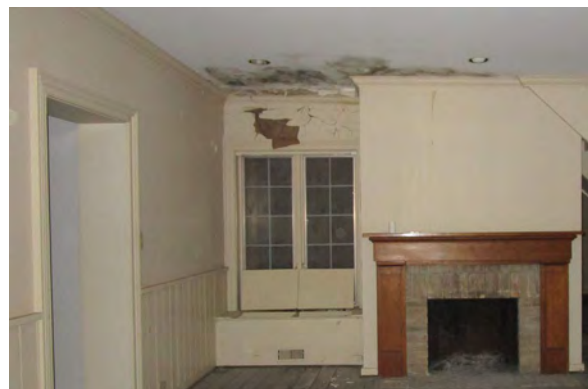
Ground floor interior depicting mould and water damage on wall and ceiling (ERA, 2019).

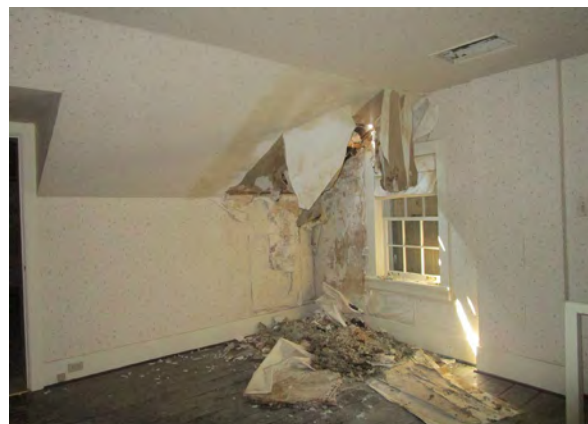
Generally, the second floor interior appears to be in fair condition with areas of paint flaking and peeling from the walls and an interior door. There appears to be a defective area in the north west side of the two-storey house where there is a three-foot by four-foot hole in the roof, which exposes the interior to the elements, damaging the ceiling, walls and floor in that area. This hole should be repaired as soon as possible so that further deterioration to the interior elements can be avoided.

Second floor interior depicting defective roofing area (ERA, 2019).

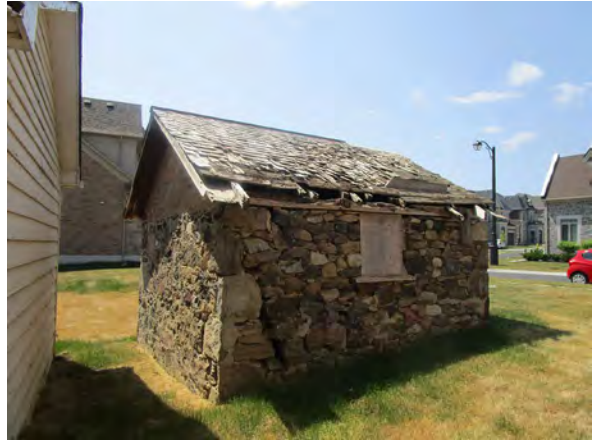
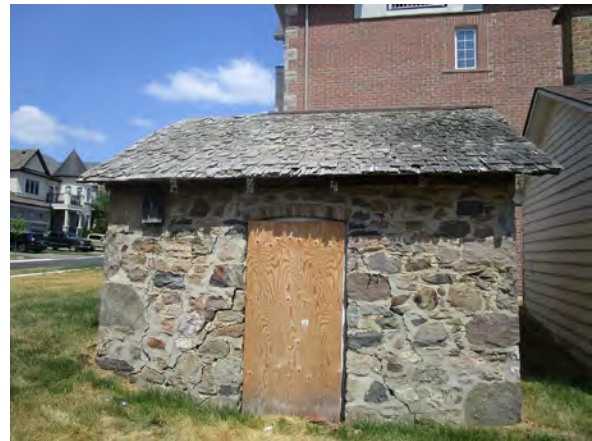
The one-storey stone smoke house appears to be in defective condition. The south and west stone walls have multiple vertical cracks along the entire wall and the north elevation has mortar loss on the majority of the wall. The roof is in defective condition with rotted roof rafters, roof boards and shingles exposing the interior to the elements.

One-storey smokehouse (ERA, 2019).

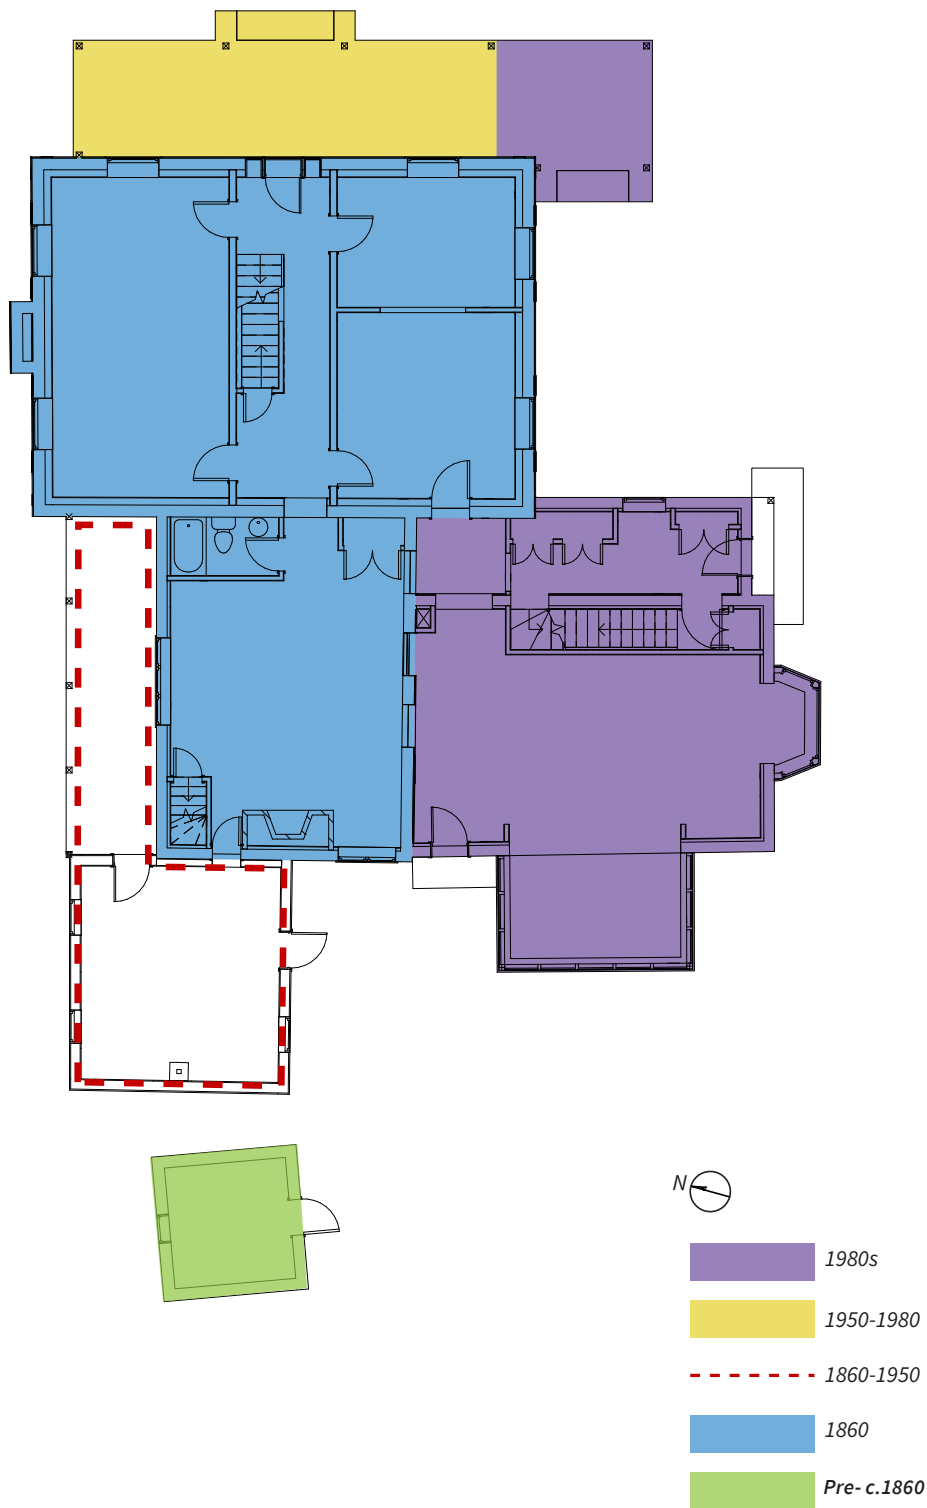
Building evolution diagram from Bassingthwaite House (ERA, 2019).
