CULTURAL HERITAGE IMPACT **ASSESSMENT REPORT**

"Nathaniel Clark Wallace House"
249 Clarence Street,
Woodbridge, Vaughan, ON

Date:
October 29, 2019

Prepared for:
C.Y. Lee Architect Inc.

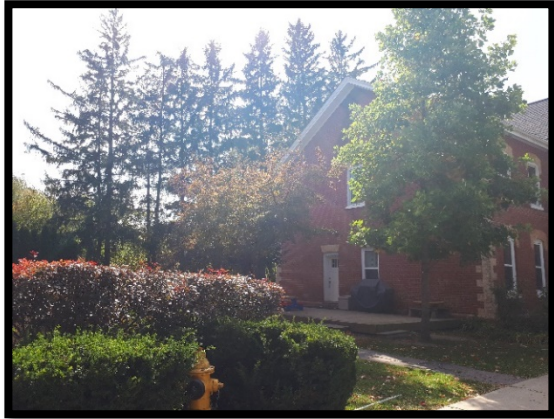
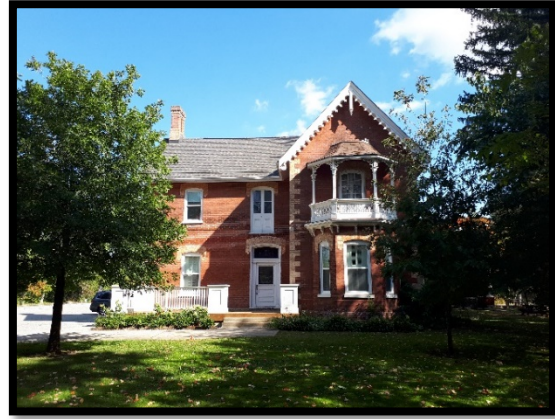
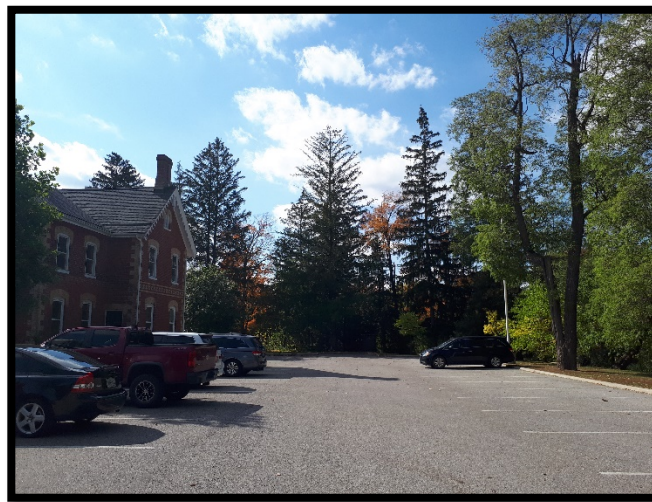
Figures 6, 7 & 8: Above left) View of the rear façade and surrounding vegetation; (Above right) View of the front façade and surrounding vegetation (Below) View of parking lot from eastern side of parking lot (MHBC, 2019)

A majority of the Woodbridge Heritage Conservation District consists of open space (Schedule 11 of the HCD Study and Plan, 2009). The subject property includes an expanse of open space which includes several mature trees. To the north of the house is an asphalt parking lot to facilitate the parking for the Rock Community Church and caretaker who resides in the heritage house.

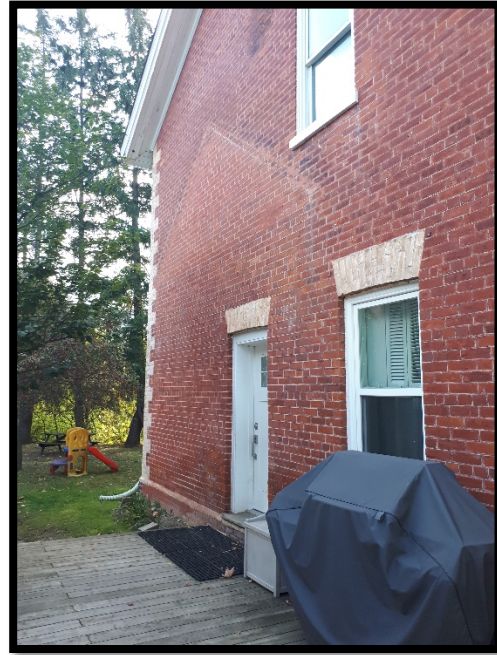
Figures 13 & 14: (Left) View of markings of former addition on the south elevation (Right) Markings on east elevation from former addition (MHBC, 2019)

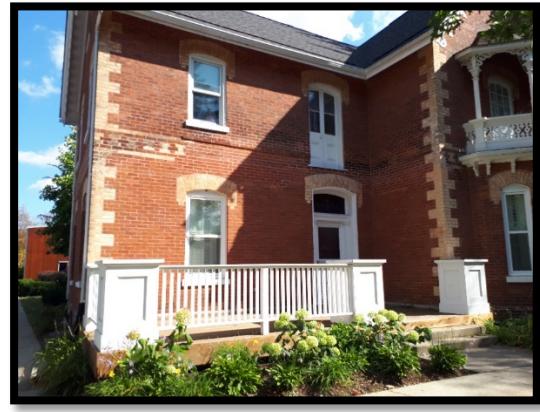
The west elevation consists of two bays: one of which is reminiscent of a Georgian home with the interjection of a second bay which includes a bay window supported by an upper semi-hexagonal balcony below an open gabled roof. The main entrance has Classical Revival elements with its Doric pilasters and a large transom window. The bay to the left of the façade no longer has its original porch/verandah which decontextualizes the upper balcony French door walkout. This bay include two windows and two door openings. The windows have arching yellow brick headers; windows have been replaced with contemporary single, double hung windows whereas the original door frames remain.

The second bay includes a bay window (3 window openings) and wooden decorative brackets and corncicing that support the balcony above. The balcony is embellished with various woodwork design and includes one door opening. The balcony is composed of four bases with capitals which support four columns with decorative brackets. The open gabled roof includes decorative wooden trim moulding and lower half of a finial. There is alternating brick detailing in the form of yellow brick quoins and a portion of yellow brick ribbons with 'X' detailing. The current porch is a basic construction of large capitals with basic spandrel handrails.

Figures 15 & 16: (Left) View of front façade including bay window and balcony;(Right) Close view of reconstructed porch on front façade; (MHBC, 2019)

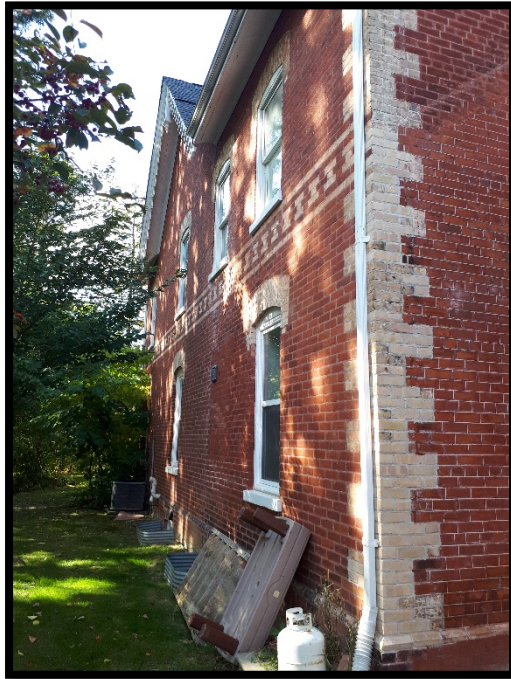
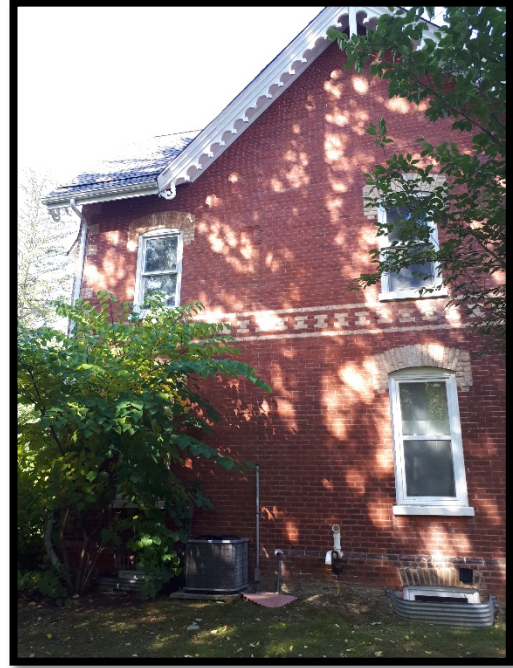
The south elevation consists of an open gable roof with similar decorative trim mouldings as the front façade as well as finial. A yellow brick ribbon course divides the first and second storey levels. Yellow brick headers are above each window. Windows have been replaced with contemporary, single, double hung windows. Either side of the façade is adorned with a yellow brick quoin. There are three (3) window sills at the basement level, three (3) window openings on the first storey and four (4) window opening on the second storey level. The window sill openings include brick headers. Part of the brick foundation sill is apparent on this elevation.

Figures 17, 18: & 19 (Left) View of south elevation from the south-east corner of the house; (Right) View of the left side of the south elevation including gabled roof detail; (Below) View of entirety of south elevation from south yard (MHBC, 2019)

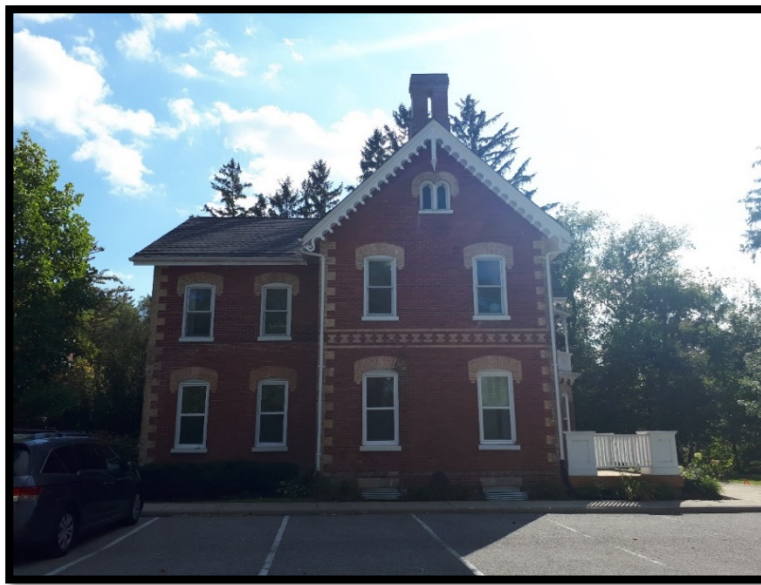
Figure 22: View of north elevation from parking lot to the north of the property.

The north elevation consists of two bays. The bay closest to the front façade includes two window openings with arched yellow brick headers divided from the second storey by a yellow brick ribbon course with 'X' brick motifs. The second storey includes two window openings with yellow brick headers. The upper half storey includes a paired arched window with yellow arched headers. Either side of the bay includes a yellow brick quoin. The open gabled roof includes decorative trim moulding. The stone chimney can be viewed along this elevation. The second bay to the rear of the building includes two window openings on the first floor and two window openings on the second floor; all have arched, yellow brick headers. There is a yellow brick quoin to the left of this bay. This elevation shows the contrast between the medium pitched gabled roof of the main portion of the house versus the low pitched gable at the rear.

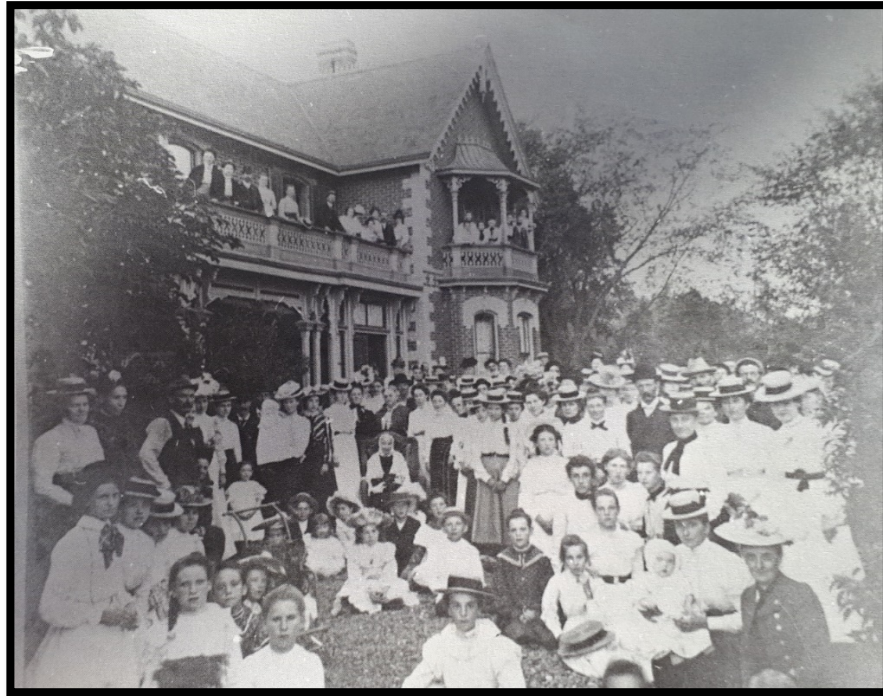
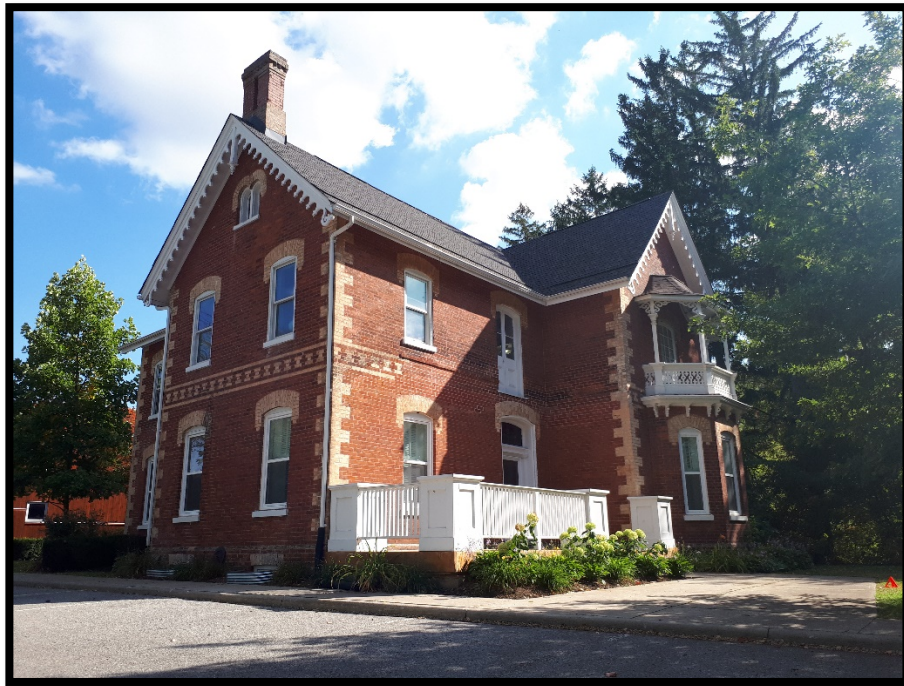
Figures 26: & 27: (Above) Photograph of the house at 249 Clarence Street, "Wallace Farm Home" from Wood's Pictorial Woodbridge c. 1915 (Below) Perspective view of heritage home from parking lot (MHBC, 2019).

The Wallace Family had considerable amount of influence on the local community. The house stayed in the Wallace Family for several years. The photograph in Figure 26, demonstrates the original aesthetic appearance of the house in the early 20th century including the front verandah with upper balcony which has since been removed (see Figure 27).

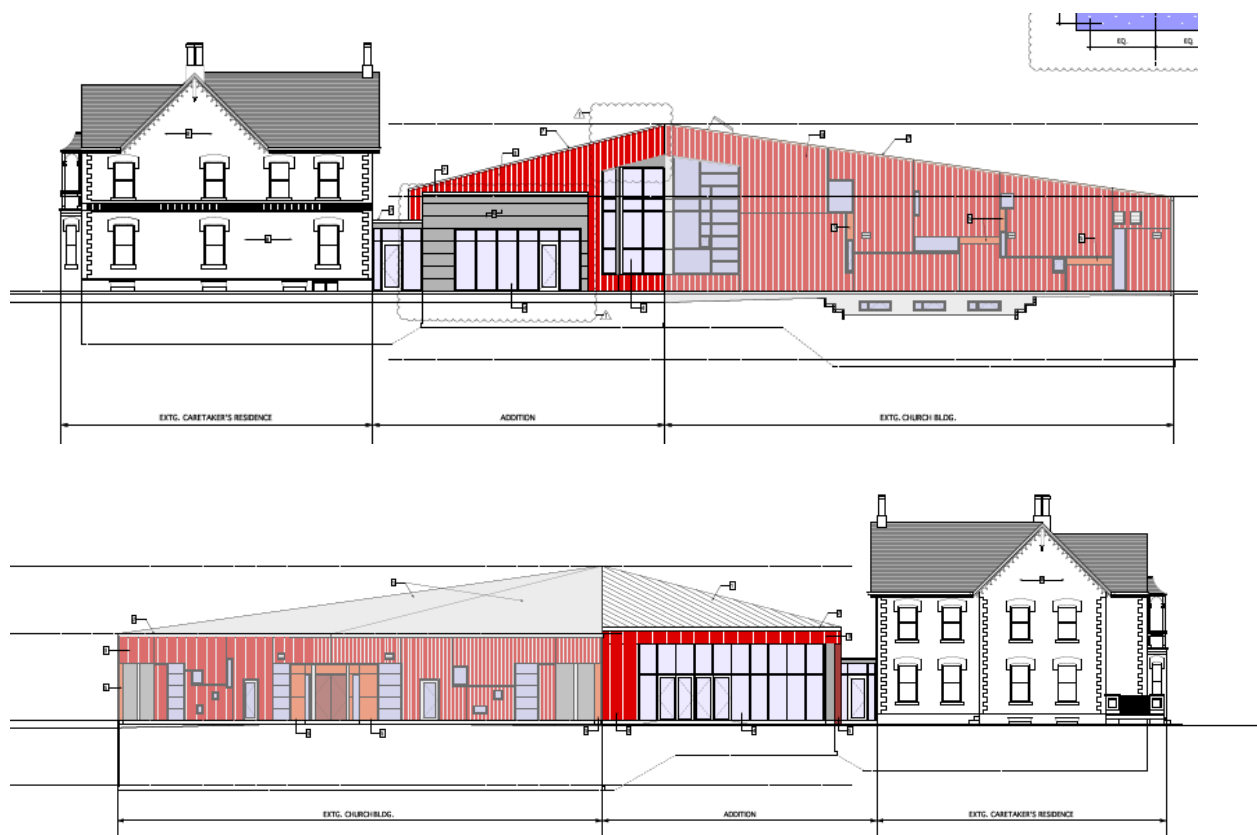
The architectural elevations of the proposed development demonstrate that while, the new construction is abutting the heritage house, it is lower in height and subordinate to the building (see Figures 35 & 36). Furthermore, due to its linkage at the rear of the building, the new construction does not impact the overall presence of the building from the Clarence Street streetscape.

Figure 35 & 36: (Above) Architectural drawing of the south elevation of Rock Community Church (proposed development in deeper red colour) in relation to the heritage building; (Below) Architectural drawing of the north elevation of the Rock Community Church (proposed development in deeper red colour) in relation to the heritage building (C.Y. Lee Architect Inc, 2019)

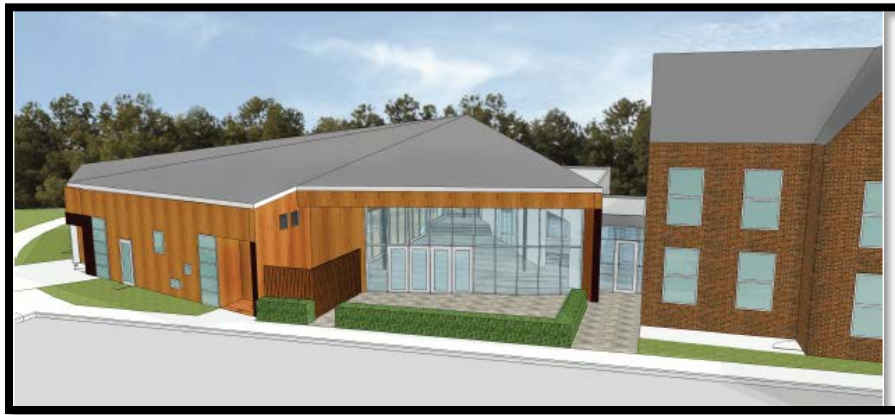
Figure 37: Rendering of addition and vestibule looking south-east (C.Y. Lee Architect Inc., 2019)

The proposed development is of a “Contemporary Design”; the new Fellowship Hall addition includes the use of Cedar siding and aluminium and glass window curtain wall with a galvanized standing seam metal roof. The proposed glass vestibule is contemporary but “fits” into the character of the context and does not attempt to inappropriately borrow historical details Sub-section 6.3.2. of the HCD Study and Plan, 2009).

The vestibule is one storey and is subordinate and distinguishable from the heritage building. The proposed vestibule is primarily composed of glazing, however, it is not in the view of the public realm and the glazing allows for building elements of the north elevation to be visible (i.e. door brick header). The vestibule is of a smaller scale and mass than both the church and heritage building and includes simplistic details so as to not detract from the heritage building as being a point of focal interest.

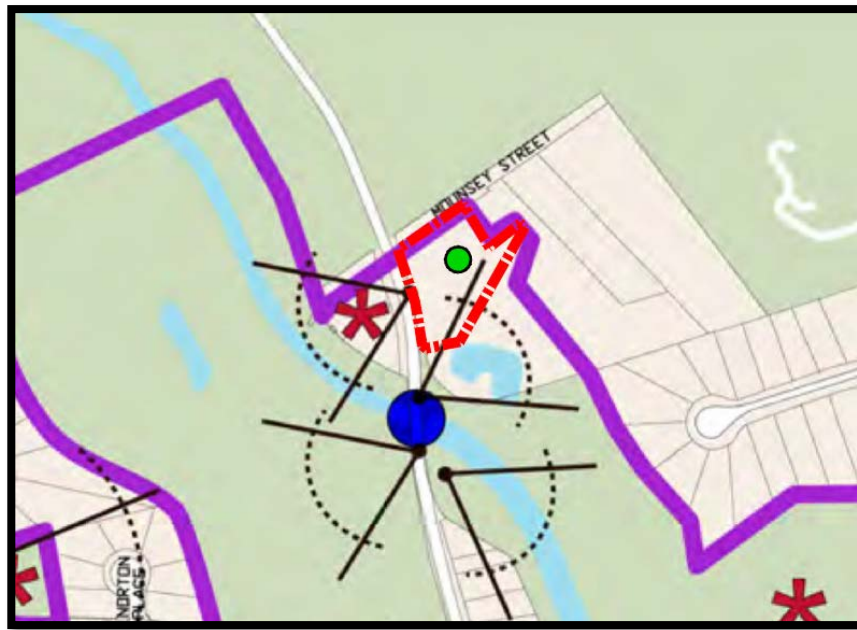
Figure 38: Excerpt of Schedule 19 of the Woodbridge HCD Study and Plan (2009); red dotted line indicates the location of the subject land; Green dot indicates approximate location of heritage house (MHBC, 2019)

Appendix 'A' of this report shows an overlay of Schedule 19 of the HCD Study and Plan (2009) on the subject land exhibited in Figure 38 to identify the subject property in relation to identified views, landmarks and bridges in the HCD. The property adjacent (non-contiguous) to the west of the subject property is identified as special landmark, open space. The Humber River Bridge is also within close proximity of the subject property.

There is an identified view from the Humber River Bridge that included a portion of the subject property, however, the house is exempted from this view. There is also a view identified *from* the front property line of the subject property along Clarence Street and is within close distance of the house on-site, however, the intent is to view the adjacent special landmark open space identified along the south side of Claddamour Place (see Appendix A from a map overlay of views in relation to subject land).

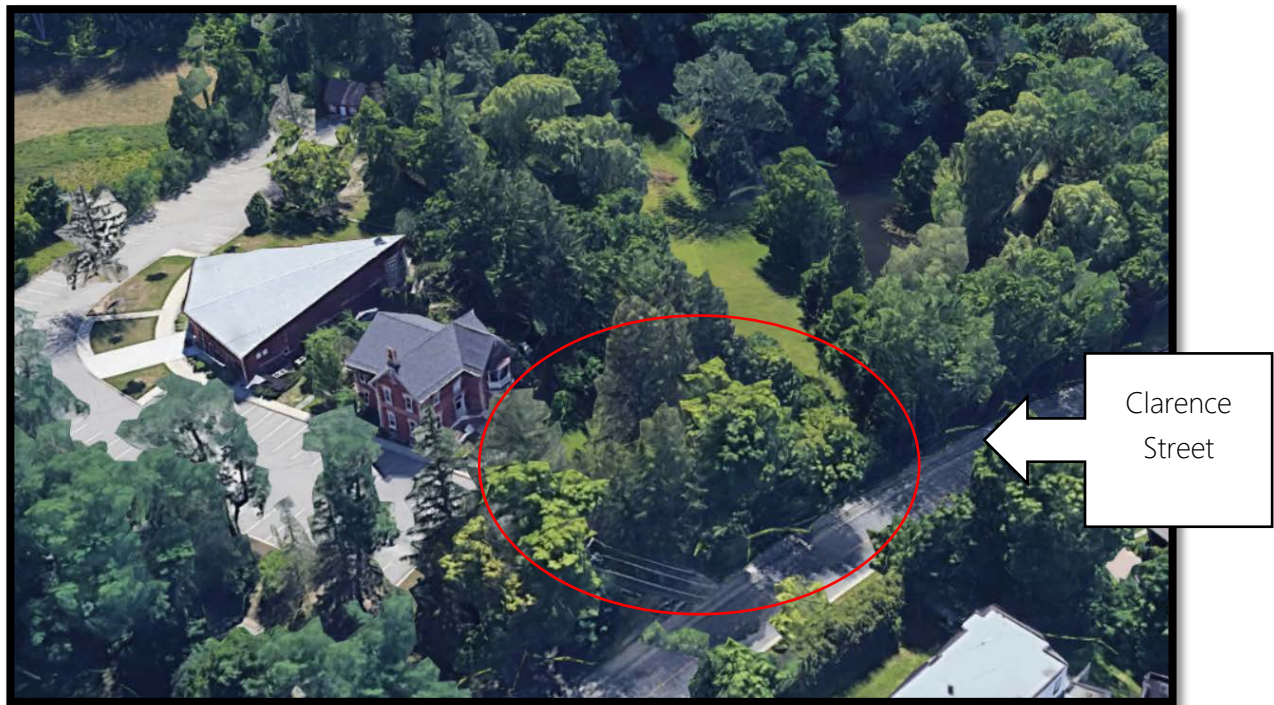
Views from the Clarence Street streetscape is obstructed by several mature trees (see Figure 40-42) which is exacerbated by an incline from the streetscape to the heritage house. The views that are available will not be altered by the proposed development.

Figures 39, 40 & 41: (Above) Aerial of heritage house and Rock Community Church demonstrating the extent of mature vegetation obstructing views of the heritage house from the streetscape identified by red circle (Source, Google Earth Pro, 2019); (Below left) View of heritage house from front yard before decline in elevation to streetscape; (Below right) View of mature coniferous trees at the edge of the front yard before the decline to the streetscape (MHBC, 2019)

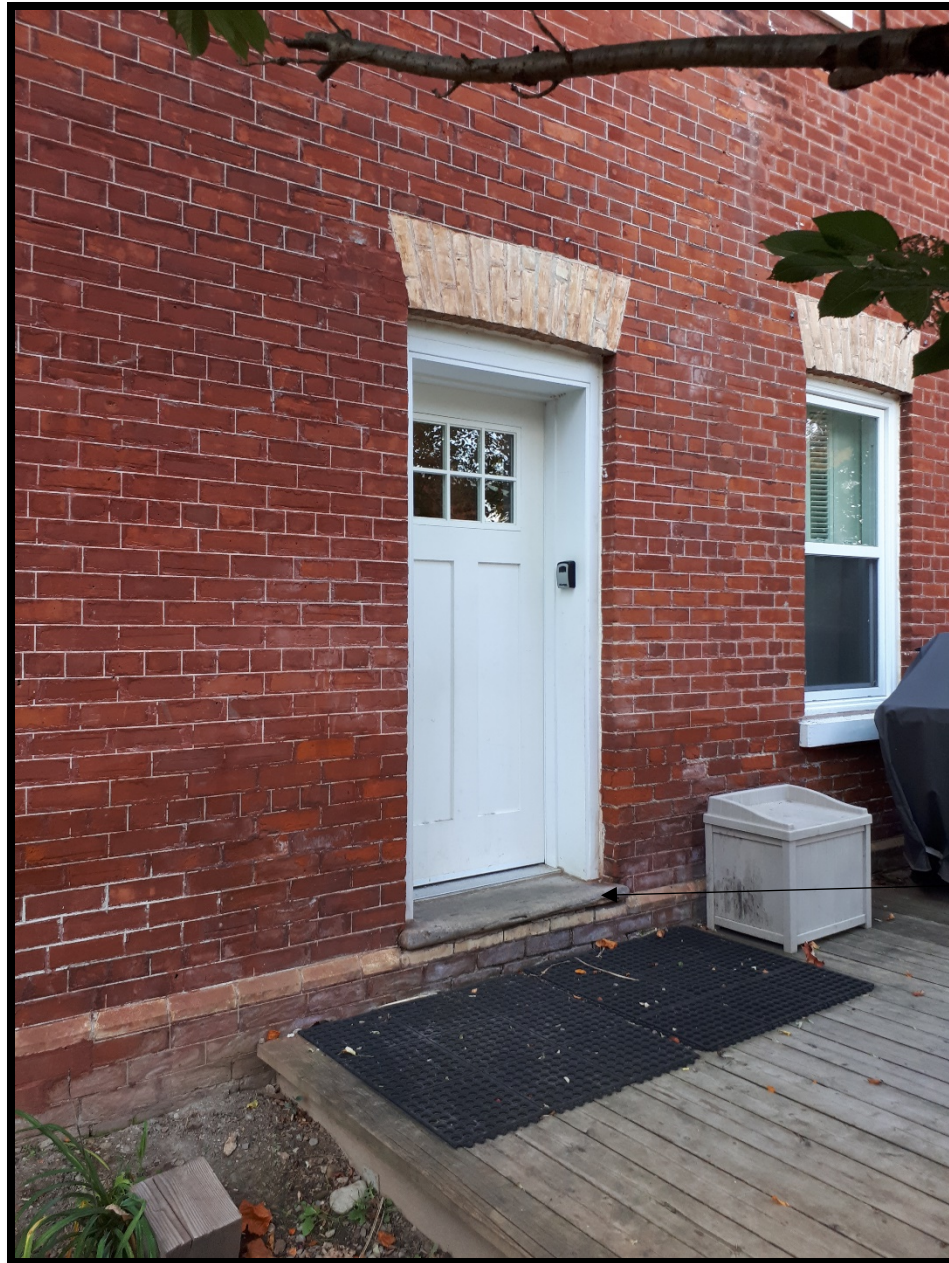
Wooden door threshold

The new construction proposes to retain the original wooden threshold which is above grade. During the new construction, the wooden threshold should be repaired in accordance with Section 4.5.2 Guidelines for Wood and Wood Products (See Appendix G).

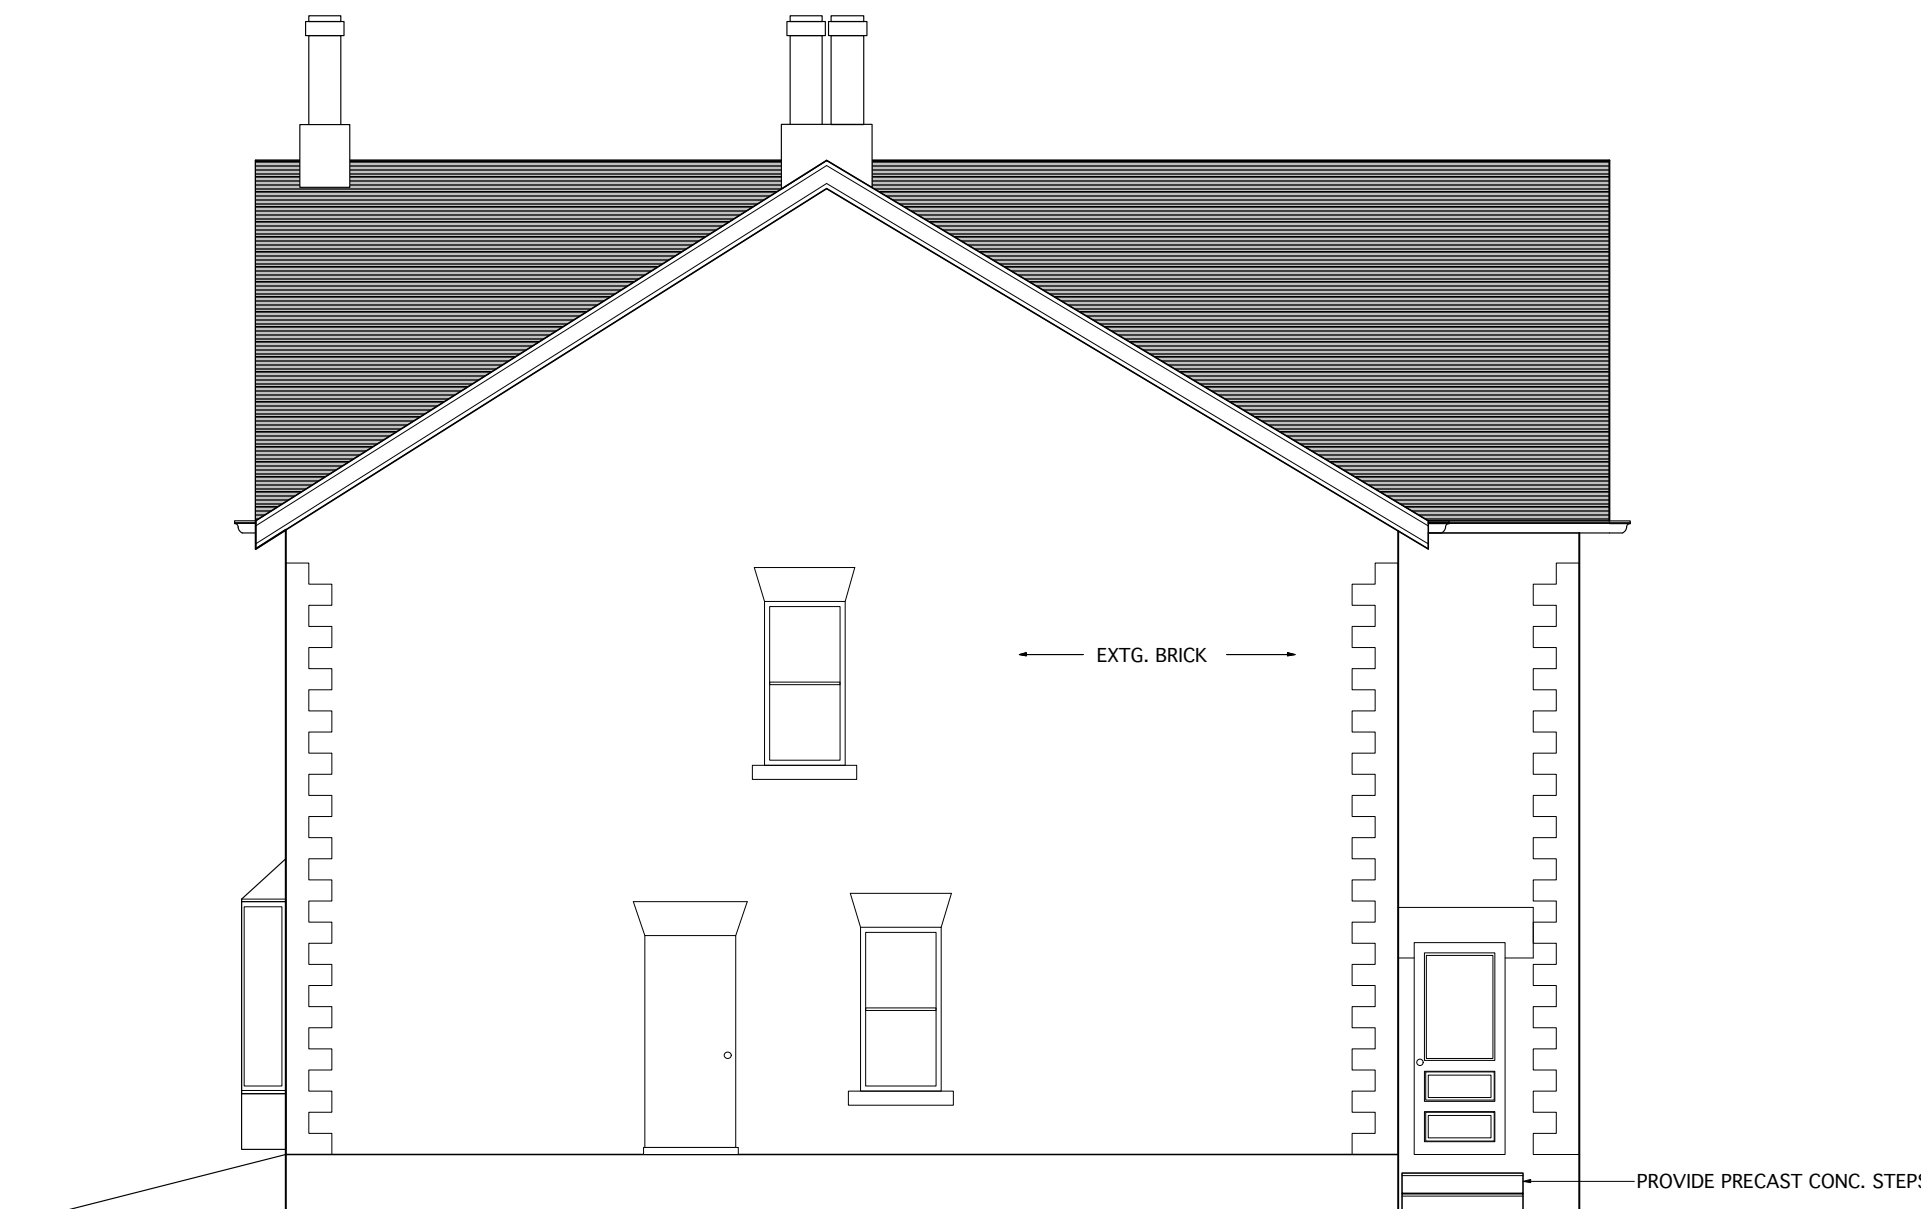
3 EAST ELEVATION
A4.1 Scale: 1:75

REPLACE EXTENSIVELY DAMAGED BRICKS AND FILL THE VOID CREATED BY REMOVAL OF BAY WINDOW. REPOINT WITH LINE MORTAR. NEW BRICKS SHALL MATCH IN SIZE AND COLOUR.
IBSTOCK BRICKS - "HERITAGE RED BLEND" & "LEICESTER MULTICREAM STOCK" / "ONTARIO" SIZE MORTAR - NATURAL HYDRAULIC LINE TYPE 3
CLEAN BRICK SURFACE (CARBON REMOVAL) USING LOW PRESSURE CLEANING METHOD WITH AN ENVIRONMENTALLY FRIENDLY CLEANING AGENT. HAND METHOD WITH BRUSH IS PREFERRED BUT WATER WASHING IS ALSO ACCEPTABLE AT 400psi OR LOWER.
REFERENCE: WOODBRIDGE HERITAGE CONSERVATION DISTRICT GUIDELINES SECTION 6.2.8 & SECTION 7.1.1

REPAIR DECAYED WINDOW OPENINGS AND PROVIDE APPROPRIATE WOOD STORM WINDOWS. WINDOWS FRAME, MULLION, MUNTIN SIZES AND PROFILES SHALL MATCH THE EXISTING WINDOWS. WOOD WINDOW BY "FIELD-WIN" OR "LOWEN" OR PVC WINDOW BY "WINDOW CITY"
WEATHER RESISTANT PAINT COLOUR TO MATCH THE EXISTING WINDOWS. BENJAMIN MOORE; "HISTORICAL COLOURS OR TORONTO HERITAGE COLLECTION"; WHITE COLOUR TO MATCH EXISTING.
REFERENCE: WOODBRIDGE HERITAGE CONSERVATION DISTRICT GUIDELINES SECTION 6.2.8, SECTION 7.1.8 AND SECTION 7.1.12

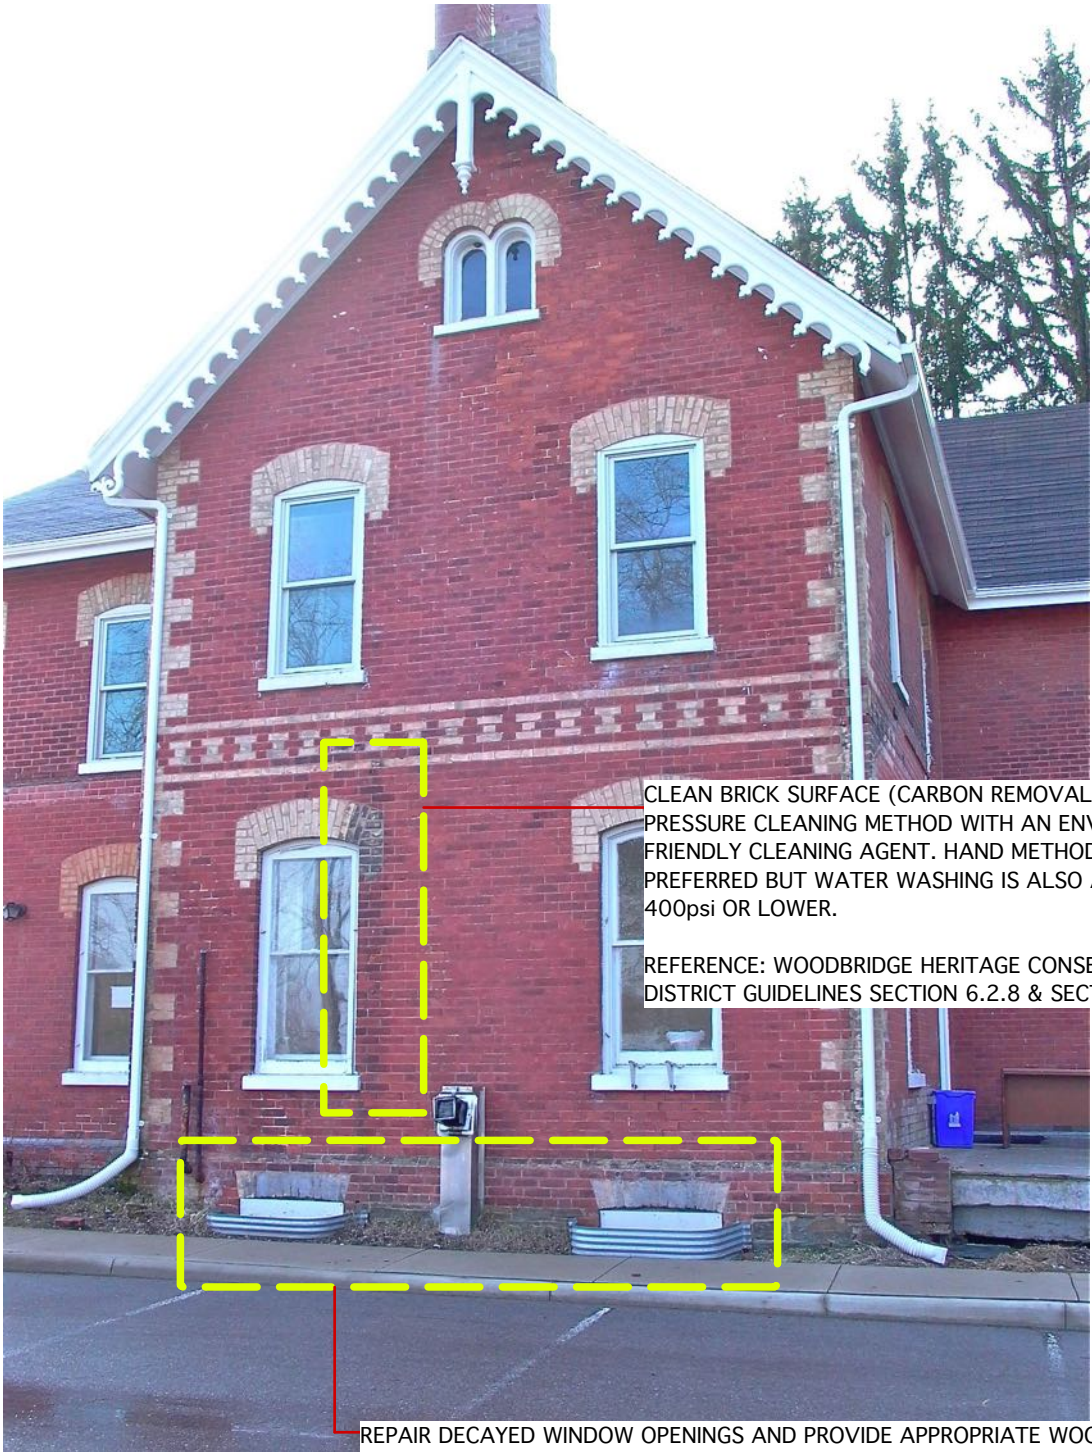
FIGURE 8

CLEAN BRICK SURFACE (CARBON REMOVAL) USING LOW PRESSURE CLEANING METHOD WITH AN ENVIRONMENTALLY FRIENDLY CLEANING AGENT. HAND METHOD WITH BRUSH IS PREFERRED BUT WATER WASHING IS ALSO ACCEPTABLE AT 400psi OR LOWER.

REPAIR DECAYED WINDOW OPENINGS AND PROVIDE APPROPRIATE WOOD STORM WINDOWS. WINDOWS FRAME, MULLION, MUNTIN SIZES AND PROFILES SHALL MATCH THE EXISTING WINDOWS. WOOD WINDOW BY "JELD-WEN" OR "LOWEN" OR PVC WINDOW BY "WINDOW CITY"

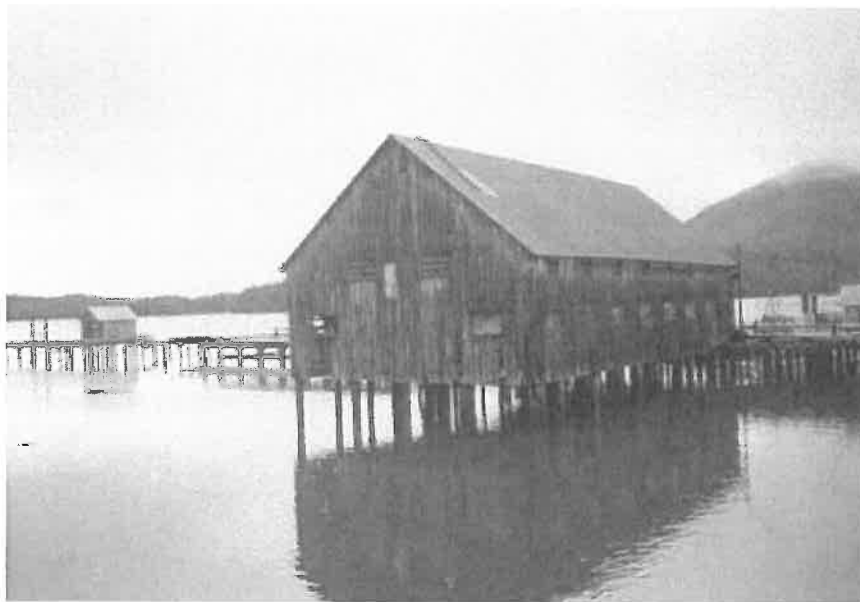
It is important to identify the cause of any damage to a wooden building element before beginning a Preservation treatment. For the former machine shop of the North Pacific Cannery in Port Edward BC, exposure to marine conditions caused the exterior wood cladding to deteriorate.

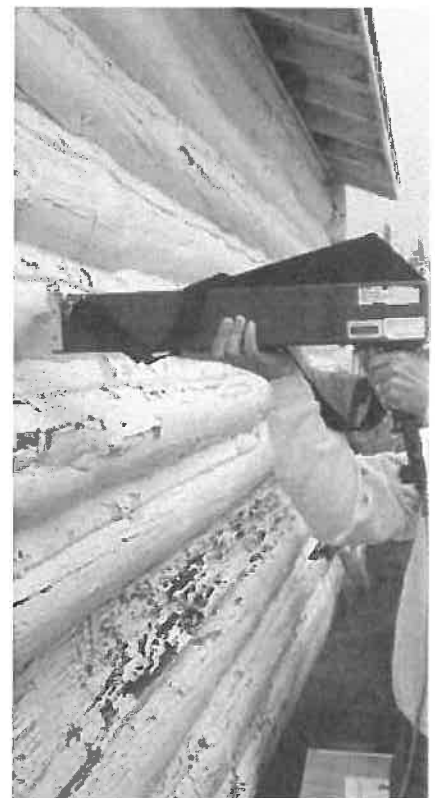
Using minimally destructive testing methods can help evaluate the condition of wood without damaging it. Here a resistance measuring micro drill is being used to evaluate the condition of a log wall at Fort Walsh, NHSC in Saskatchewan. A drilling needle penetrates the wood at a constant speed and measures the resistance encountered to advance the drill bit. The resistance the wood offers indicates its condition: low resistance can indicate decay.

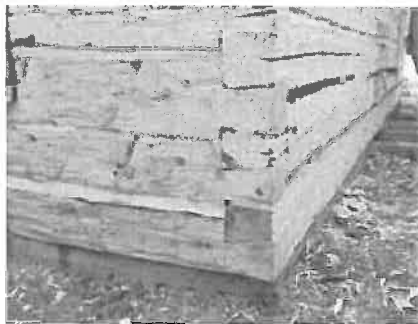
Deteriorated logs at the John Walter Historic Site in Edmonton were replaced in kind with hewn logs that used the originals as templates to reproduce tooling marks on visible surfaces. On close inspection, this distinguishes the new materials if the logs are separated in the future.

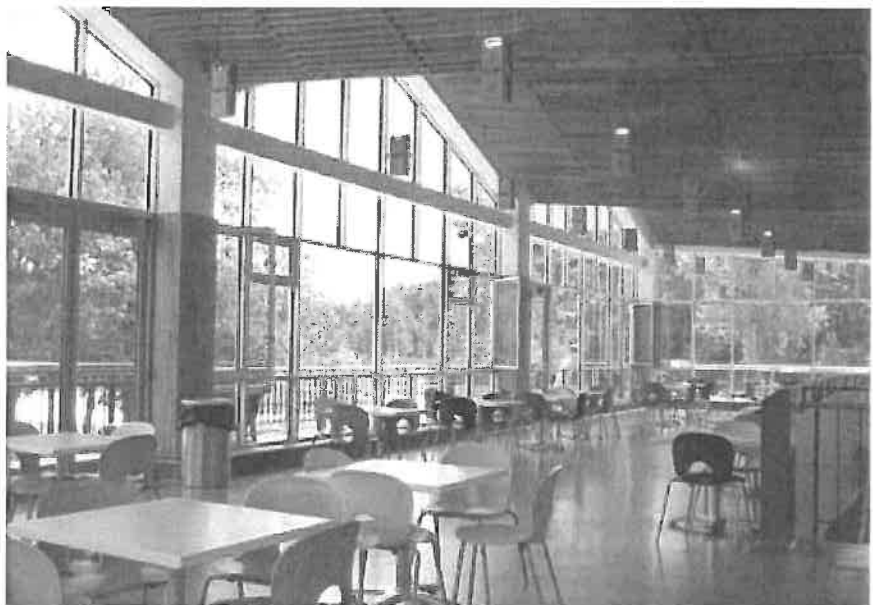
Wood was often used in modern buildings as a finish to contrast with more industrial materials, or as part of an acoustical treatment on ceilings and walls. The wood ceiling and column claddings of the Beaver Lake Pavilion in Montreal were carefully preserved as part of the recent rehabilitation of the pavilion.
