FINAL REPORT

Cultural Heritage Impact Assessment

John Fleming House, 9151 Huntington Road, Lot 15, Concession 9, City of Vaughan, Regional Municipality of York, Ontario

18107463-R02-Rev1

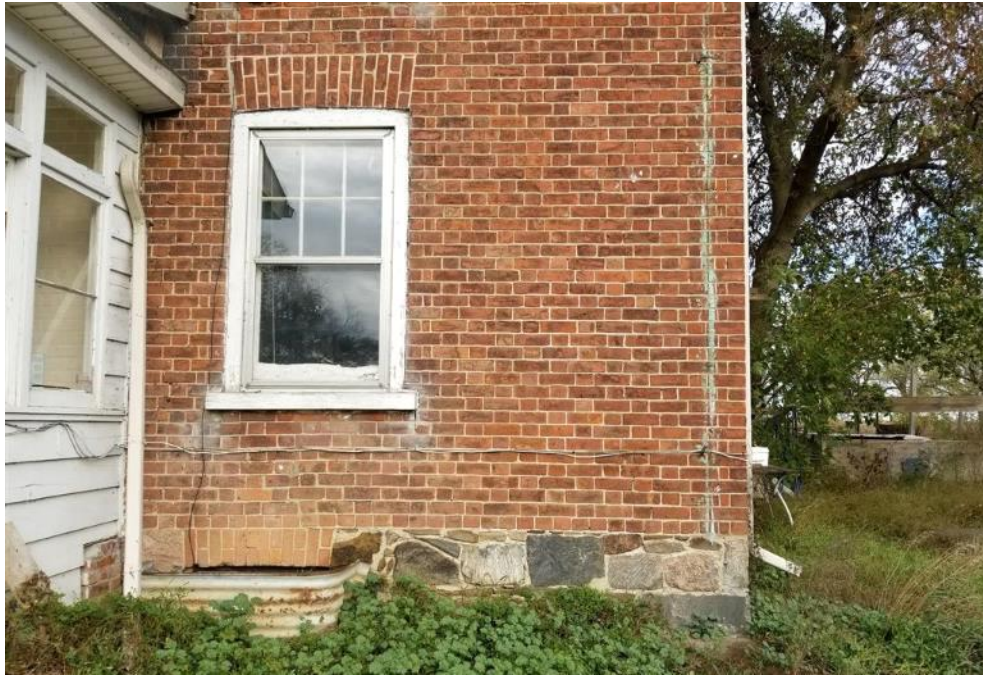
The Main Block is rectangular, measuring 11.3 m north-south and 7.3 m east-west. It is a single-detached, two-storey, three-bay brick farmhouse with a rectangular plan. It sits above a fieldstone foundation and full basement. Constructed from red brick, the main façade is built with Flemish Bond (Figure 22), while the other three sides of the building are 1:5 Common Bond (Figure 23).

Figure 22: Detail of Flemish Bond and coursed rubble foundation on the west façade of the Main Block.

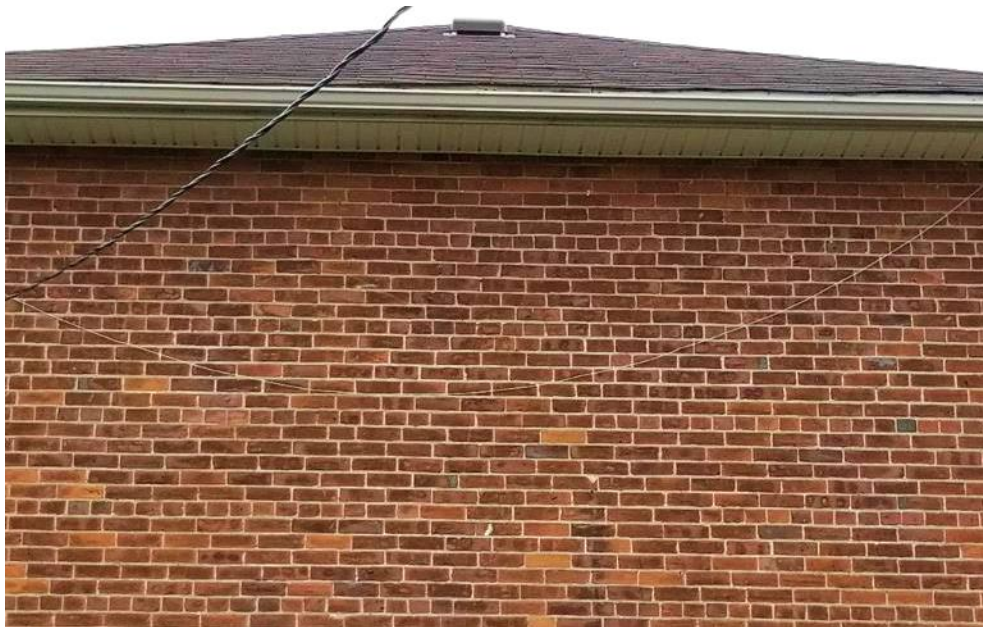
Figure 23: Detail of Common Bond on the north façade.

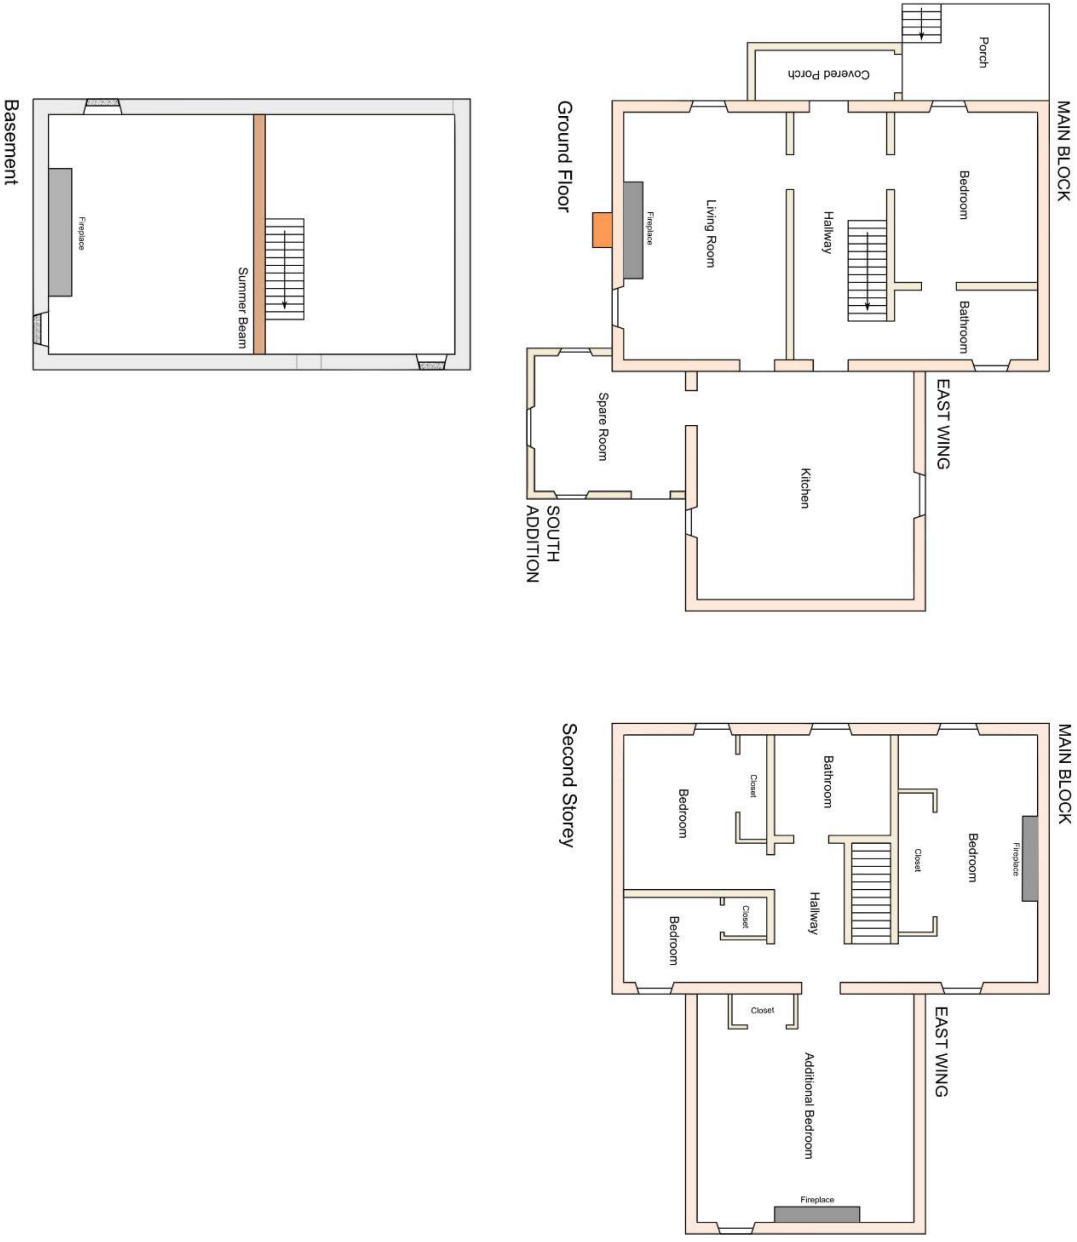
Figure 29: 9151 Floorplan (not to scale)

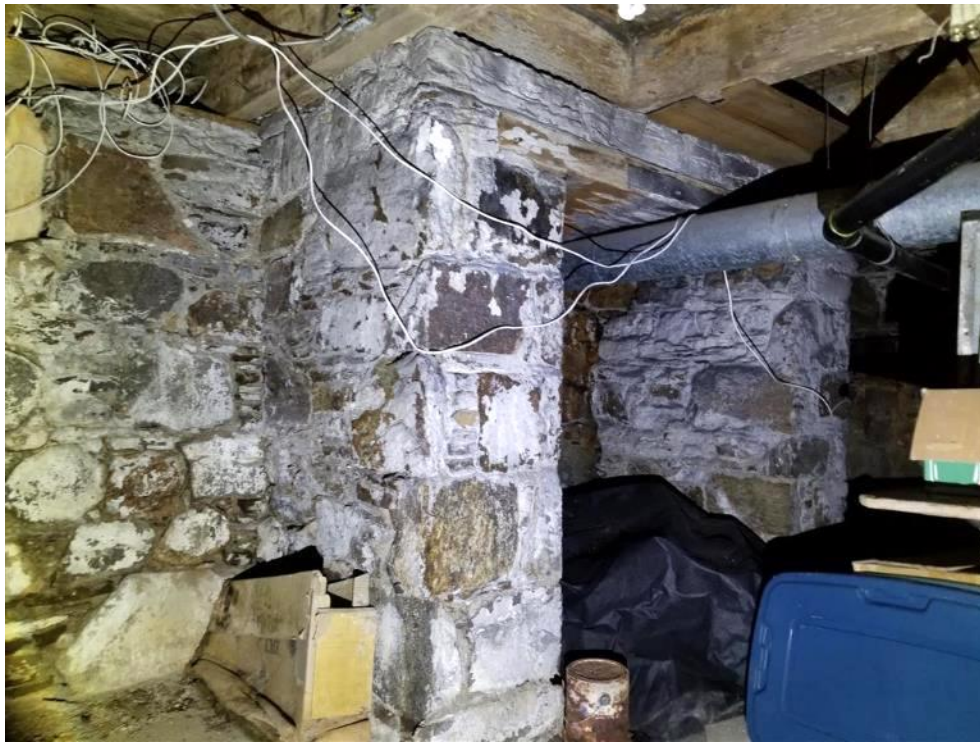
The Main Block has a full basement that is accessible from the first level hall (Figure 44). The basement is comprised of a single rectangular room with coursed rubble walls and a cement floor. A large central fieldstone fireplace is on the south wall with a wood mantel beam to function as part of the winter kitchen (Figure 45).

Figure 45: Stone fireplace in the basement below the Main Block, on the south wall of the foundation.

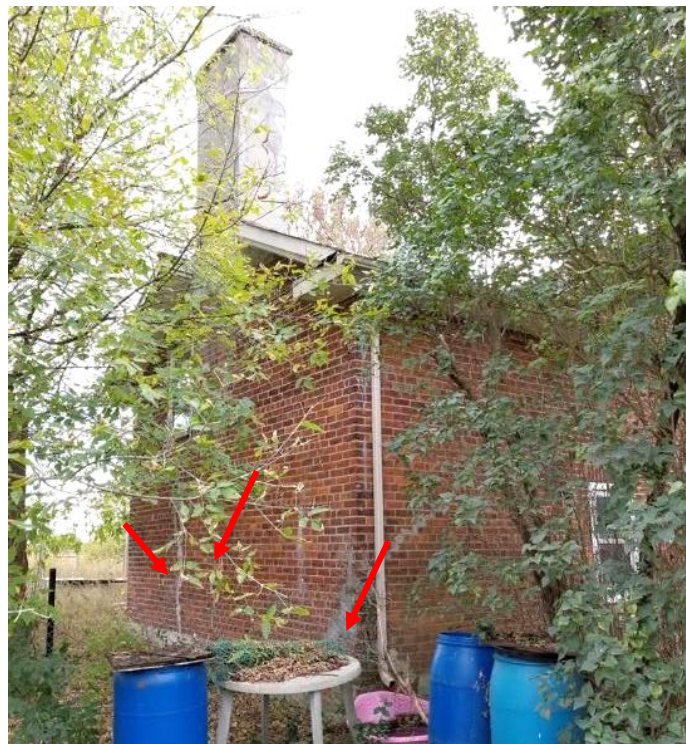
The north, east and west walls of the East Wing have experienced significant structural damage, as evidenced by the presence of tie rods, repaired cracking and patchy color of large brick areas (Figure 50). Thus, relocation of the East Wing may be difficult.

Figure 49: North and east façades of the East Wing. Note, extensive damage and repair to the east wall (red)

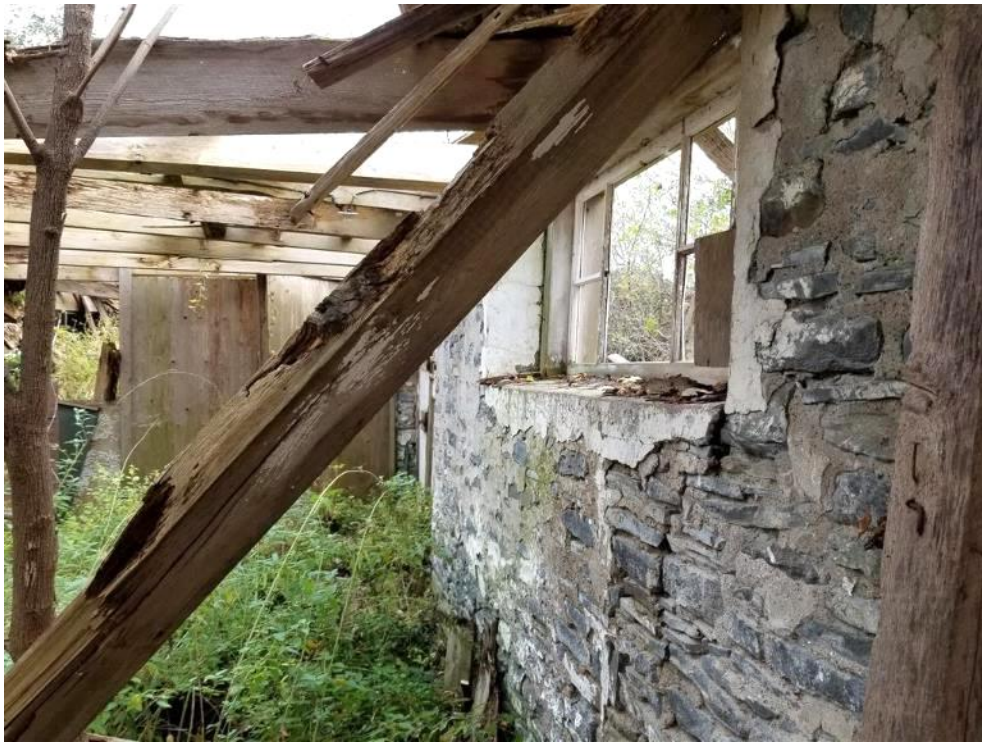
All that remains of the barn is a portion of the stone foundation. The coursed stone foundation presents asymmetrical fenestration with 10-pane fixed wood windows with flat head openings and no exterior decoration (Figure 60 and Figure 61). Exterior doors on the surviving west wall are plain wood. Interior beams which would have supported the floor above have decayed and cracked, and there is not much left inside the barn (Figure 62 to Figure 64).

Figure 62: Interior of the collapsed barn.

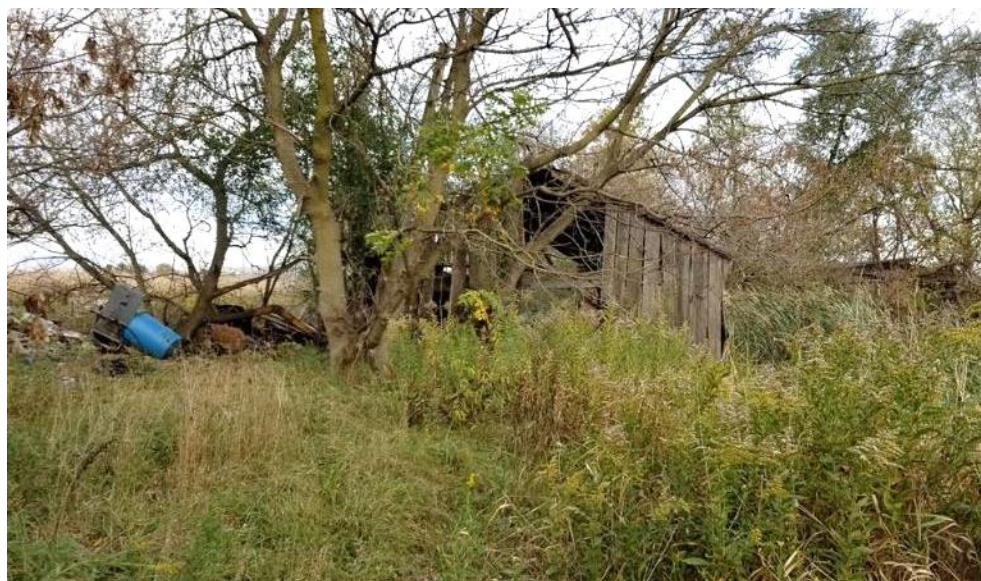
This 20th-century structure has a medium gable roof with a wood frame, currently in a state of collapse. Much of the wall material has rotted away, leaving the support posts in place (Figure 65). It was sided with vertical wood planks and is currently leaning to the east (Figure 66).

Figure 66: The west façade of the northeast outbuilding.
