7. PRESERVATION AND REHABILITATION OF THE JOHN FLEMING HOUSE, LISTED UNDER PART IV, LOCATED AT 9151 HUNTINGTON ROAD

18107463-R02-Rev1

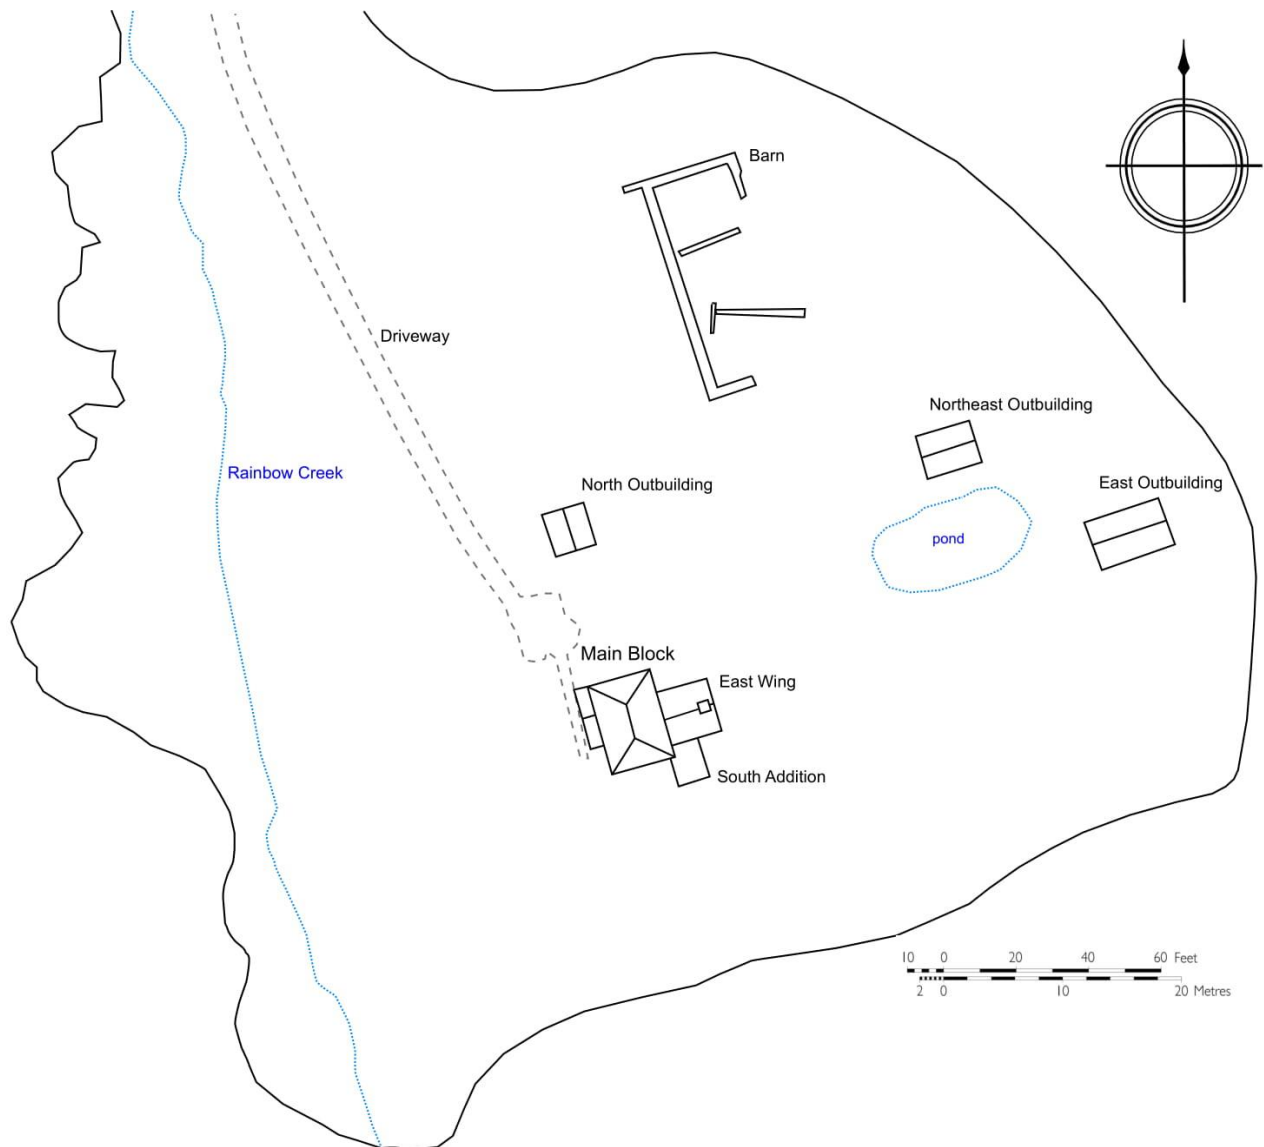
Figure 15: Schematic key plan for built elements in the central-west portion of the property.

The property's built environment includes the house (John Fleming House), the foundation of a barn, and three outbuildings (Figure 15). The house is a single-detached, two-storey and three-bay farmhouse with a rectangular plan (the 'Main Block'), a storey-and-a-half addition extending from the east wall of the Main Block (the 'East Wing'), a one-story addition extending from the south wall of the East Wing (the 'South Addition'), and two porches (Figure 16 to Figure 21). The barn is in a state of ruin, and all three outbuildings are dilapidated. The built environment is described in further details below.

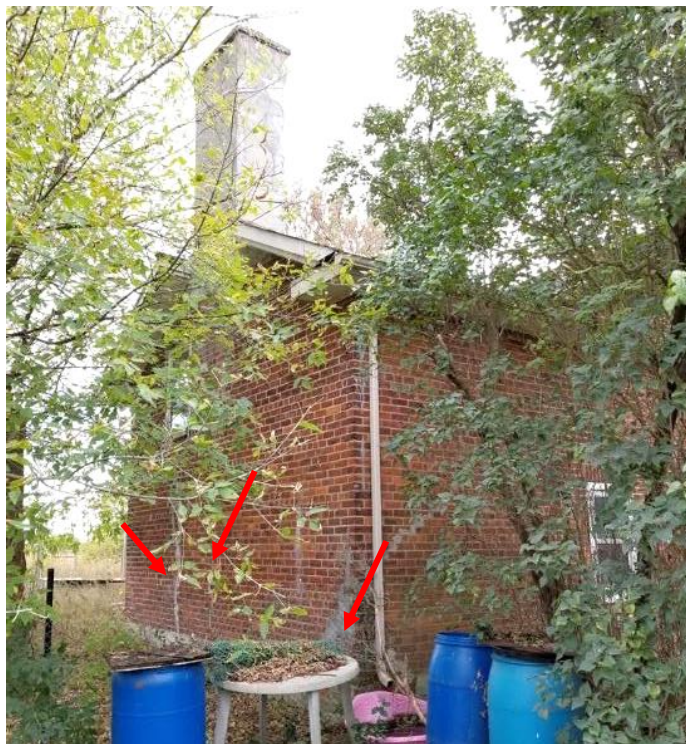
Figure 49: North and east façades of the East Wing. Note, extensive damage and repair to the east wall (red)

The north, east and west walls of the East Wing have experienced significant structural damage, as evidenced by the presence of tie rods, repaired cracking and patchy color of large brick areas (Figure 50). Thus, relocation of the East Wing may be difficult.

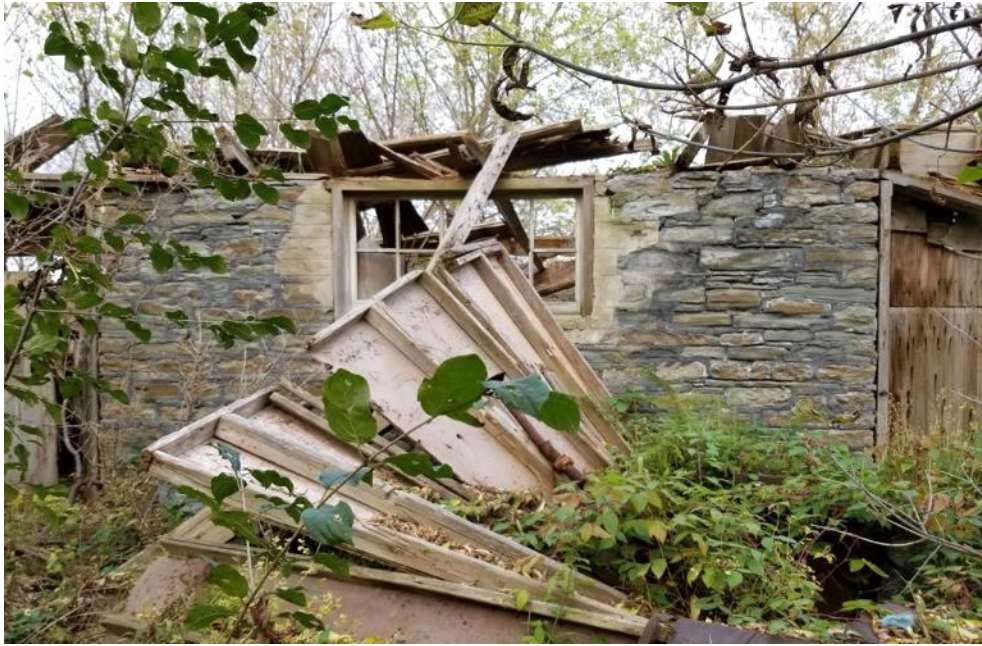
Figure 60: West façade of the stone barn foundation.

All that remains of the barn is a portion of the stone foundation. The coursed stone foundation presents asymmetrical fenestration with 10-pane fixed wood windows with flat head openings and no exterior decoration (Figure 60 and Figure 61). Exterior doors on the surviving west wall are plain wood. Interior beams which would have supported the floor above have decayed and cracked, and there is not much left inside the barn (Figure 62 to Figure 64).

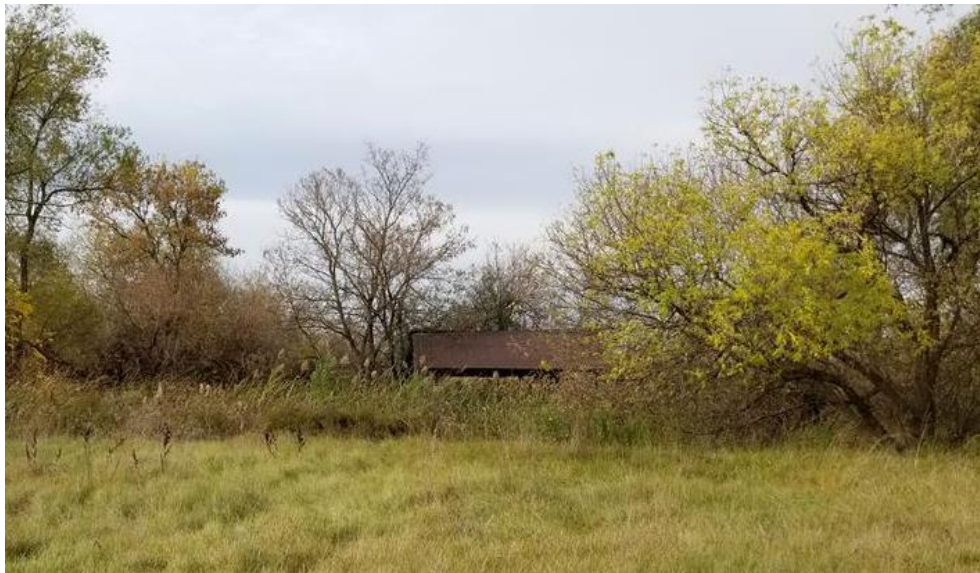
Figure 65: Northeast outbuilding, looking north.

This 20th-century structure has a medium gable roof with a wood frame, currently in a state of collapse. Much of the wall material has rotted away, leaving the support posts in place (Figure 65). It was sided with vertical wood planks and is currently leaning to the east (Figure 66).

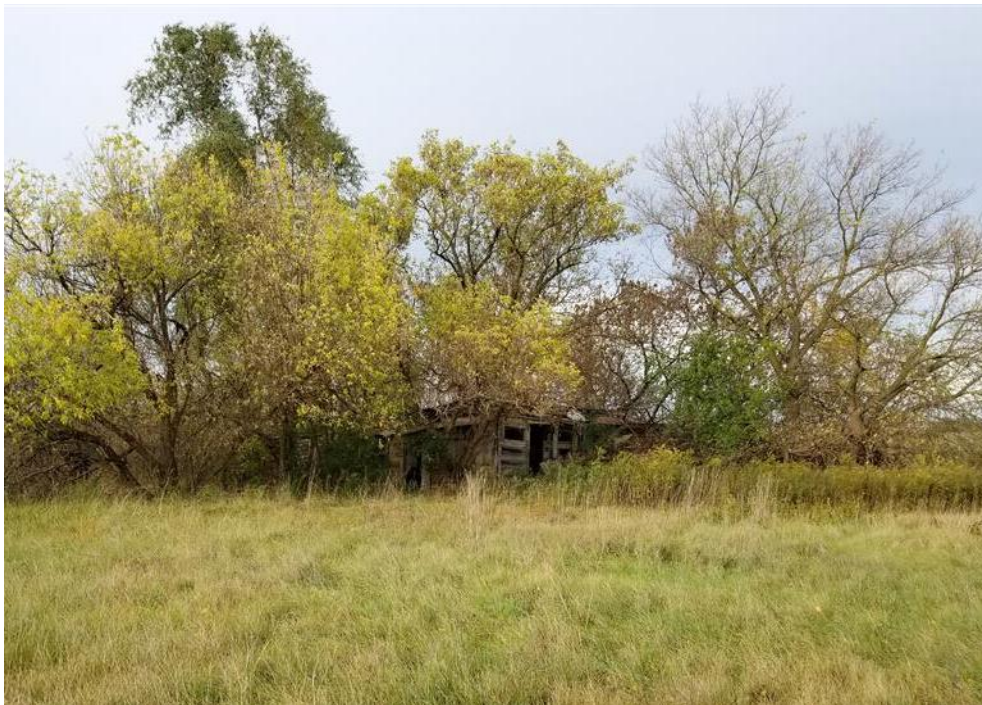
Figure 67: East outbuilding.

The mid-20th century East Outbuilding is a one-storey, wood frame structure with a low gable roof (Figure 67). It is currently surrounded by trees on the east side of the residential area and is barely visible within the trees and bushes that are growing through the structure.

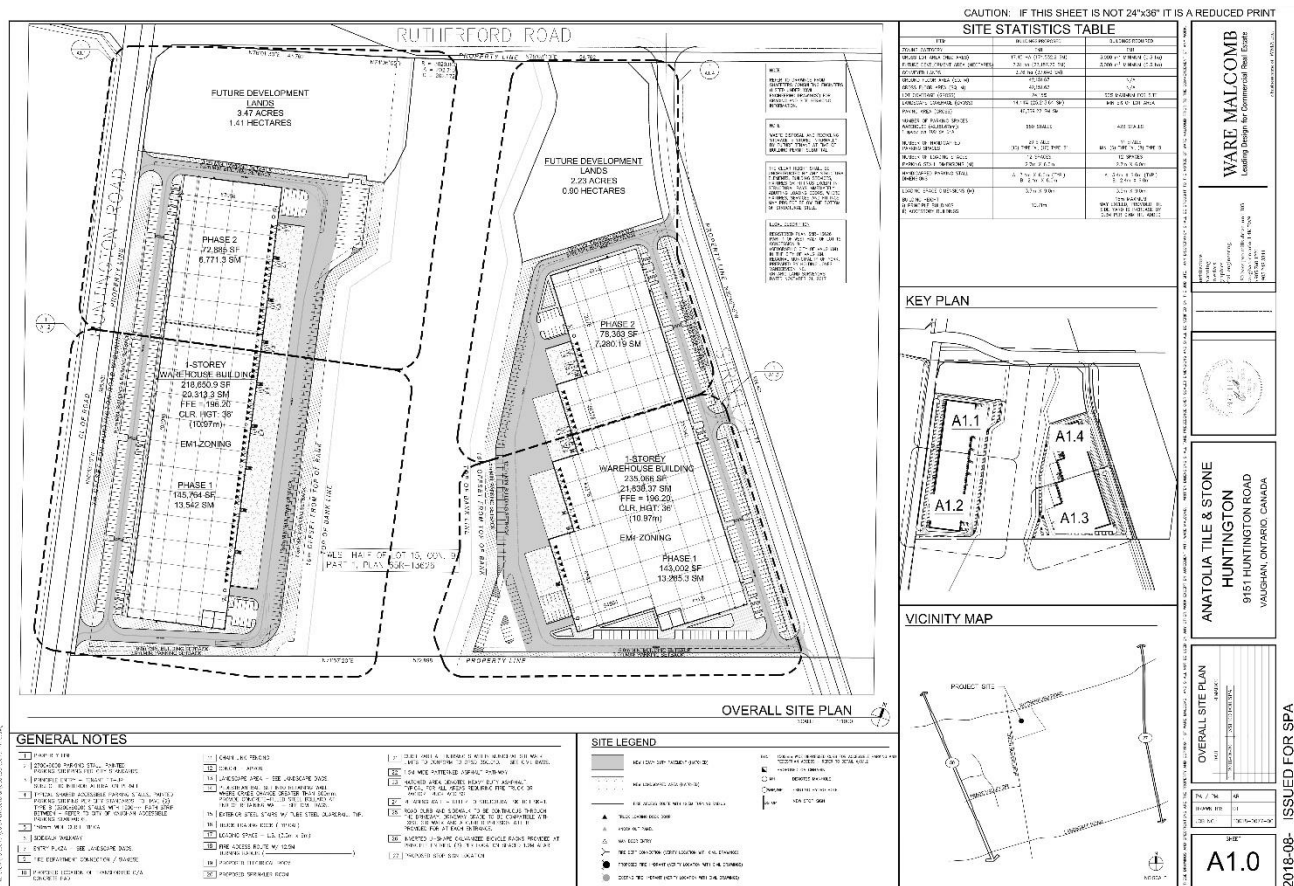
Figure 69: Proposed site plan from ACC

A two-lane road oriented north-to-south extending south from Rutherford Road and east of easternmost industrial building. John Fleming House is partially located within the 10.0 metre buffer from the natural heritage system. According to the City of Vaughan Development Approval Planning Application for this development, the structures on the property, including John Fleming House are proposed to be demolished. Therefore, although the John Fleming House falls within the protected open space, given the development application proposes to demolish this structure, this impact assessment will assess the property based on its demolition.
