FINAL REPORT:

CULTURAL HERITAGE IMPACT ASSESSMENT

9773 Keele Street,
Maple, Vaughan, Ontario

**Letourneau
Heritage
Consulting Inc.**

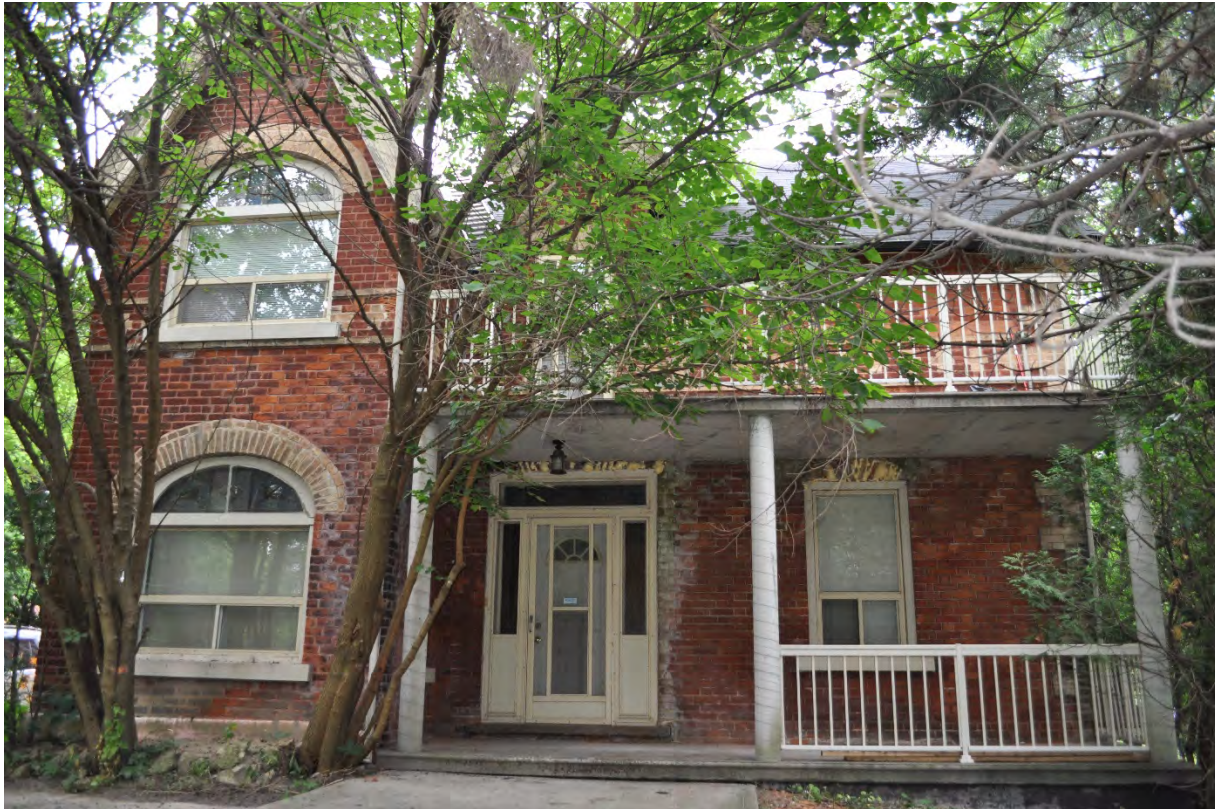
Figure 7: Front view of 9773 Keele Street (CU 2019).

There is one structure associated with the property, a 1 ½ storey single-detached brick dwelling with a two-storey bay on the west facade and L-shaped plan (Figure 7). A rear, kitchen wing is clad in stucco on the first storey. A wood framed garage is attached to this rear wing. The property is accessed via a private driveway fronting on Keele Street (Figure 6).

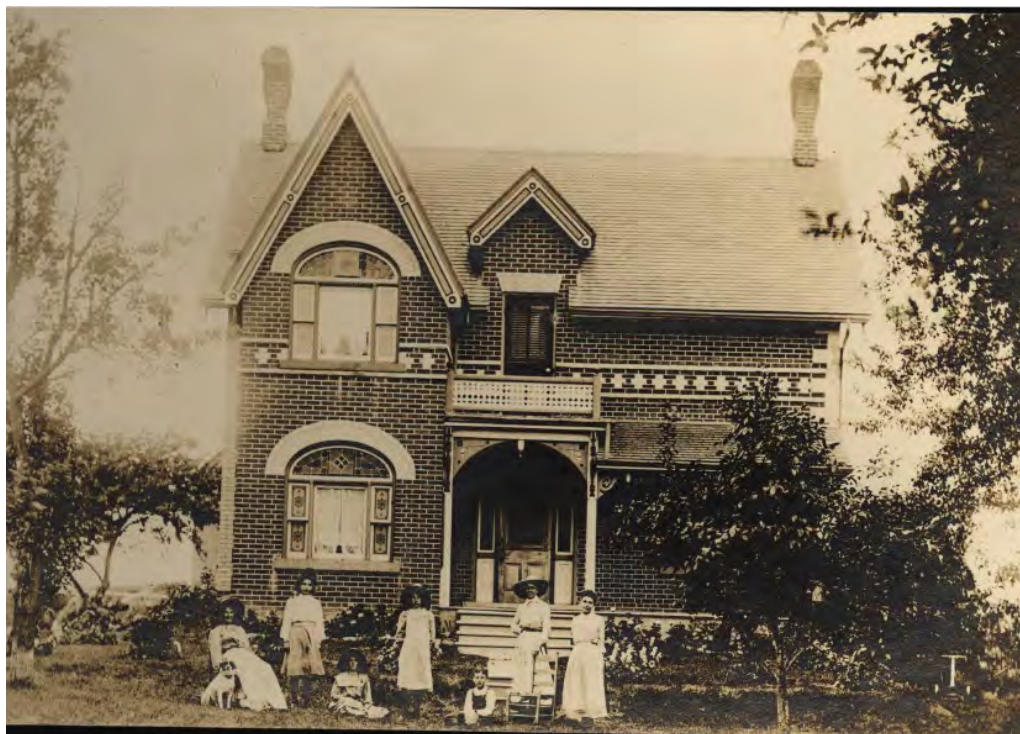
Figure 17: Photo of 9773 Keele Street c. 1905 the subjects are Mary Keffer (confirmed left), and possibly her children Anna, Elmo, and Emma (Photo provided by City of Vaughan Archives).

The front porch, in its current state, is unsympathetic to the original structure. It is a two-level porch made of concrete with concrete pillars and aluminum railings (Figure 44). The second storey of the porch interrupts the header above the door and front window (Figure 45). An earlier iteration of the porch, which featured narrow pillars, an arched entrance, and decorative moulding, is shown in Figure 17 to Figure 19.

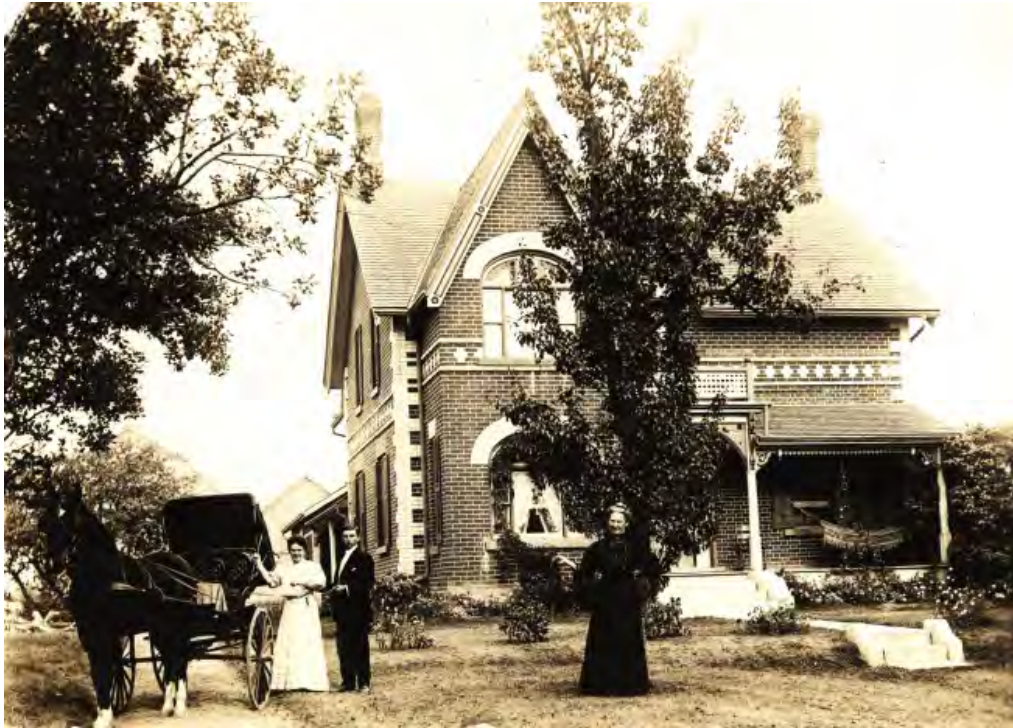
Figure 18: Photo of 9773 Keele Street. c. 1922. The photograph identifies the subjects as Mary Keffer with her son Elmo and his spouse, Janet Strong. Elmo and Janet Strong were married (Photo provided by City of Vaughan Archives).

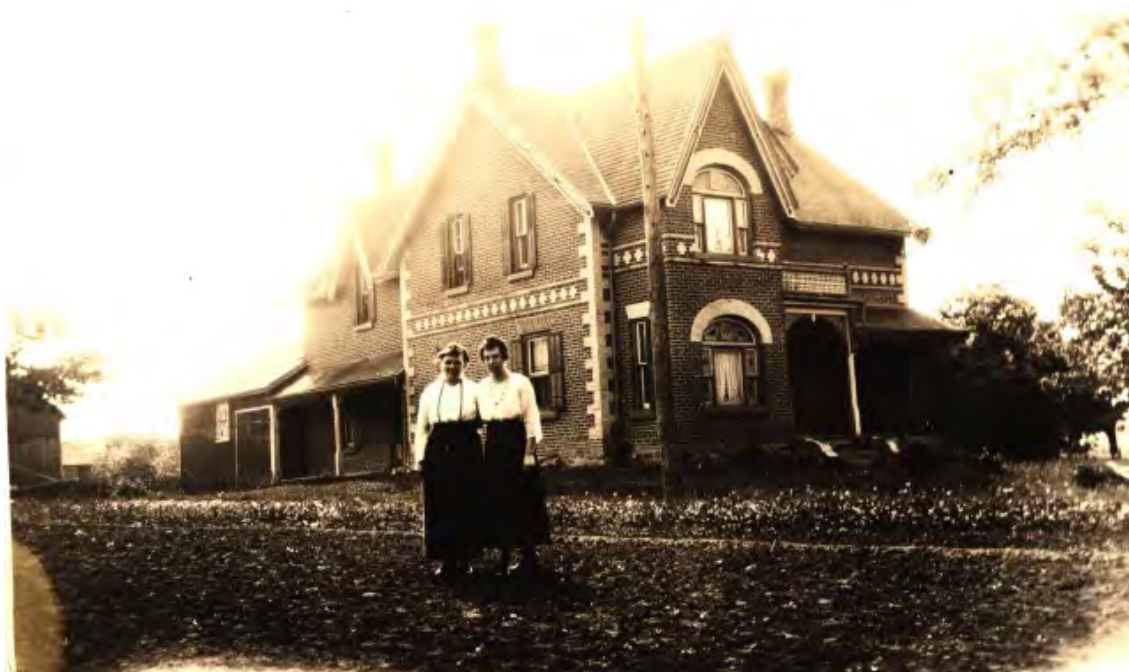
Figure 19: 9773 Keele Street. c. 1930. The women in the photograph appear to be the same as in Figure 16. They may be Mary Snider (Keffer) and Emma Osler (Keffer) or relatives. The utility pole at the front of the house confirms that this image post-dates Figure 20 (Photo provided by City of Vaughan Archives).

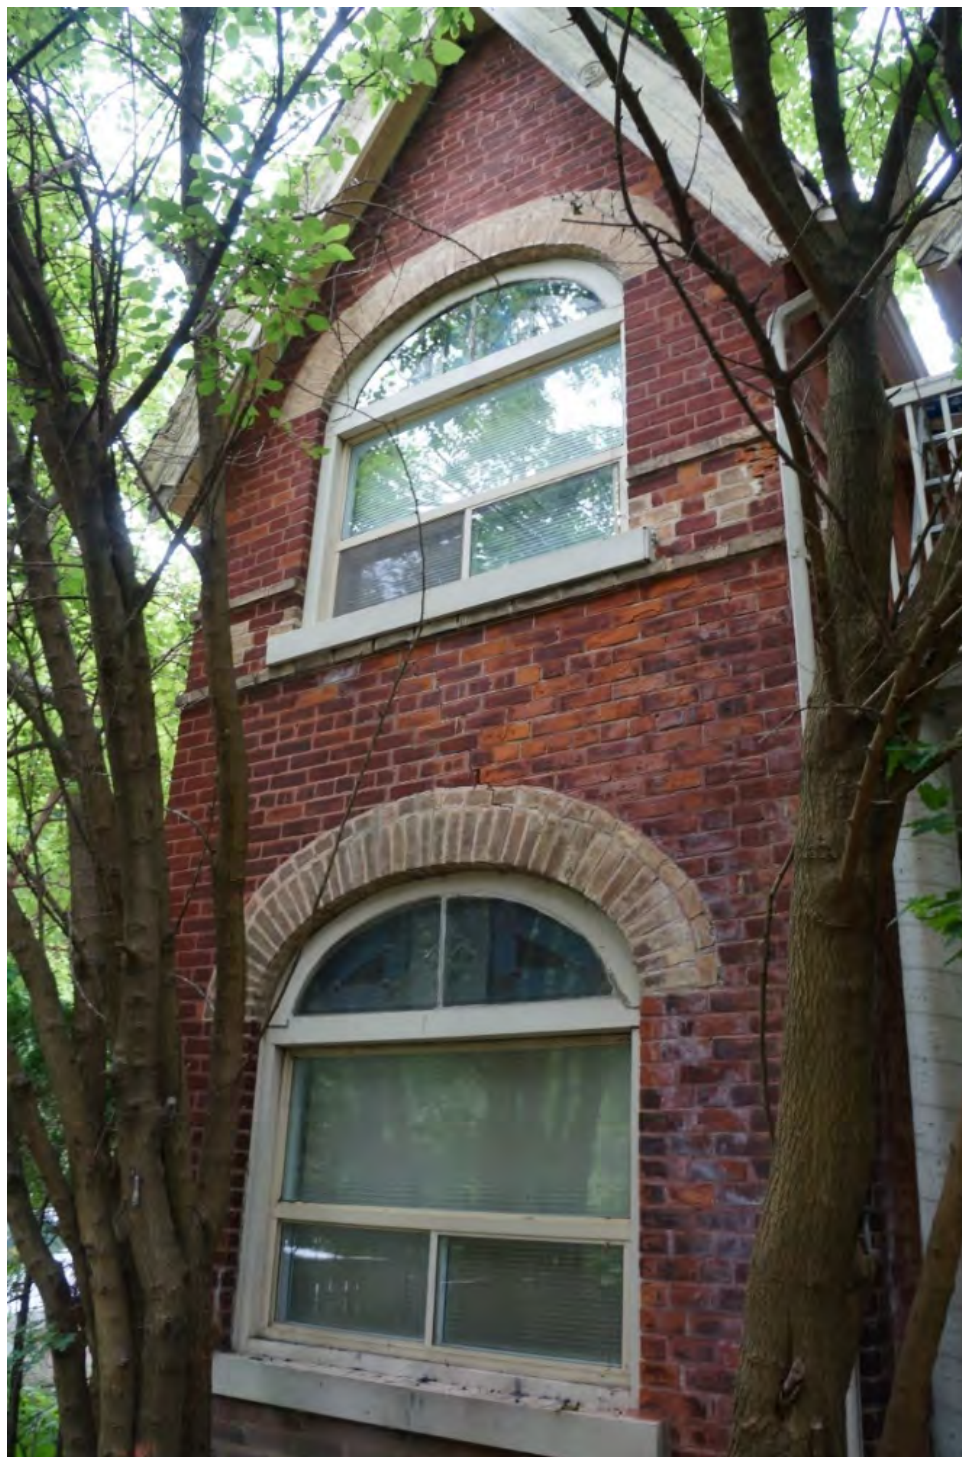
Figure 21: West Façade Projecting Bay (APL 2019).

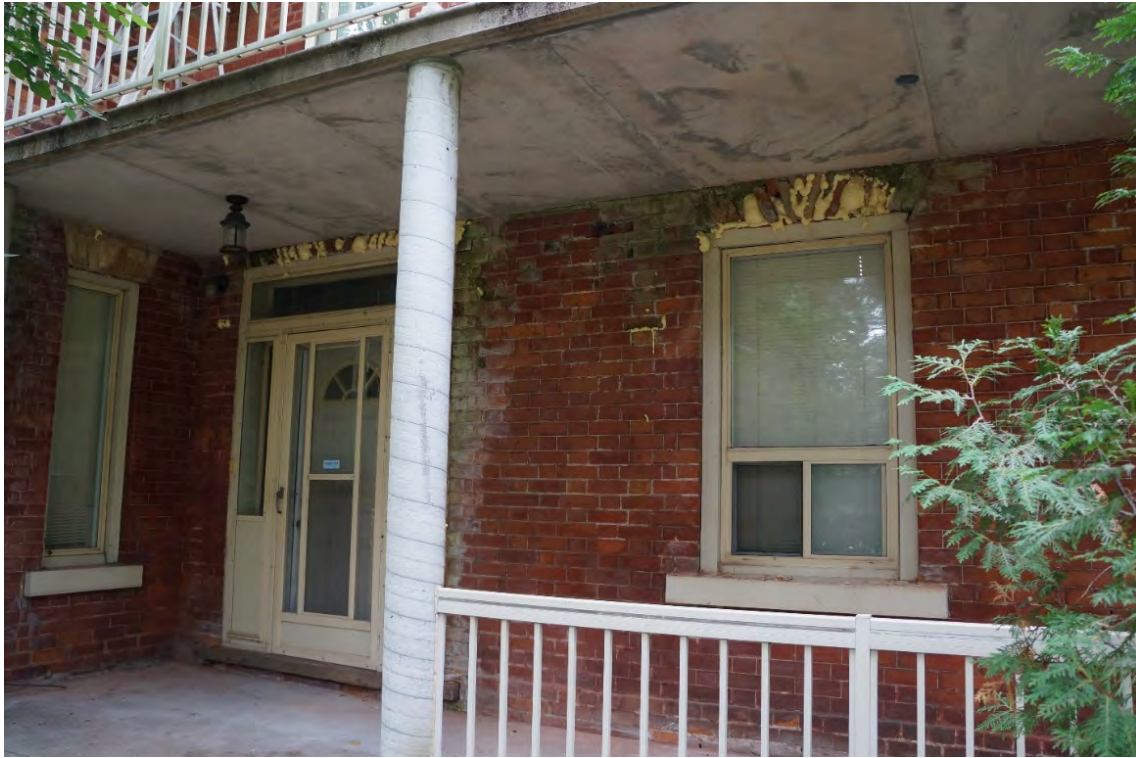
The north elevation features the same buff brick bandcourse with row of central crosses and buff brick quoins on the main portion of the structure. These decorative elements are not continued on the rear kitchen portion of the structure. There are four vinyl sliding windows on the south portion of the main structure divided into three lites. Windows are topped by red brick voussoirs and appear to have replacement sills (Figure 22).

Figure 22: West Façade, main entrance, porch, first storey window, and concrete column (APL 2019).

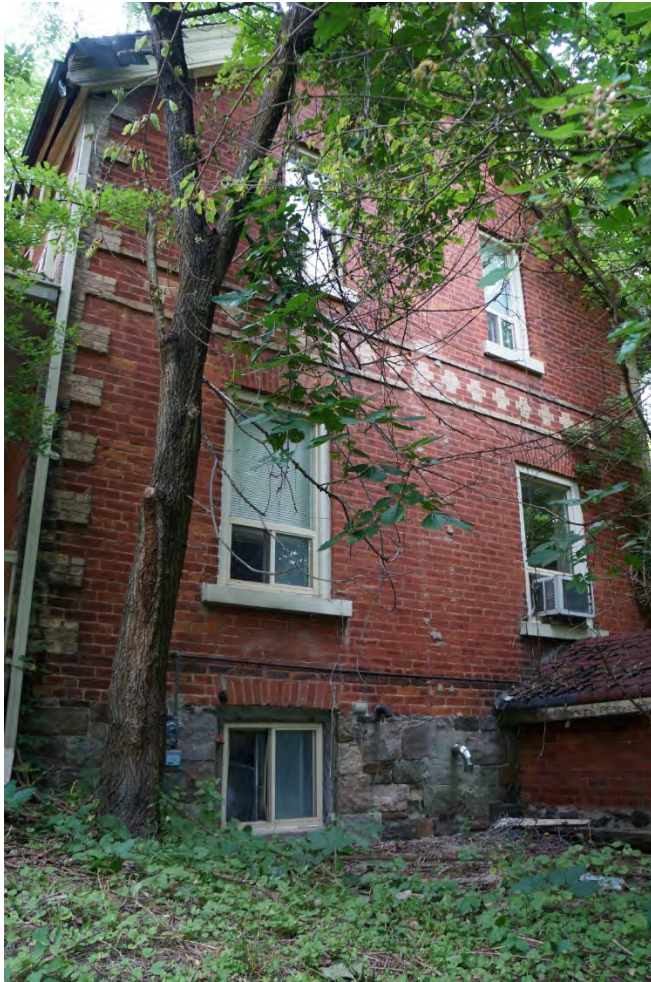
Figure 26: South Facade (APL 2019).

decorative bargeboard. The south façade features a basement entrance, additional main level entrance, and porch roof (Figure 25 and Figure 26).

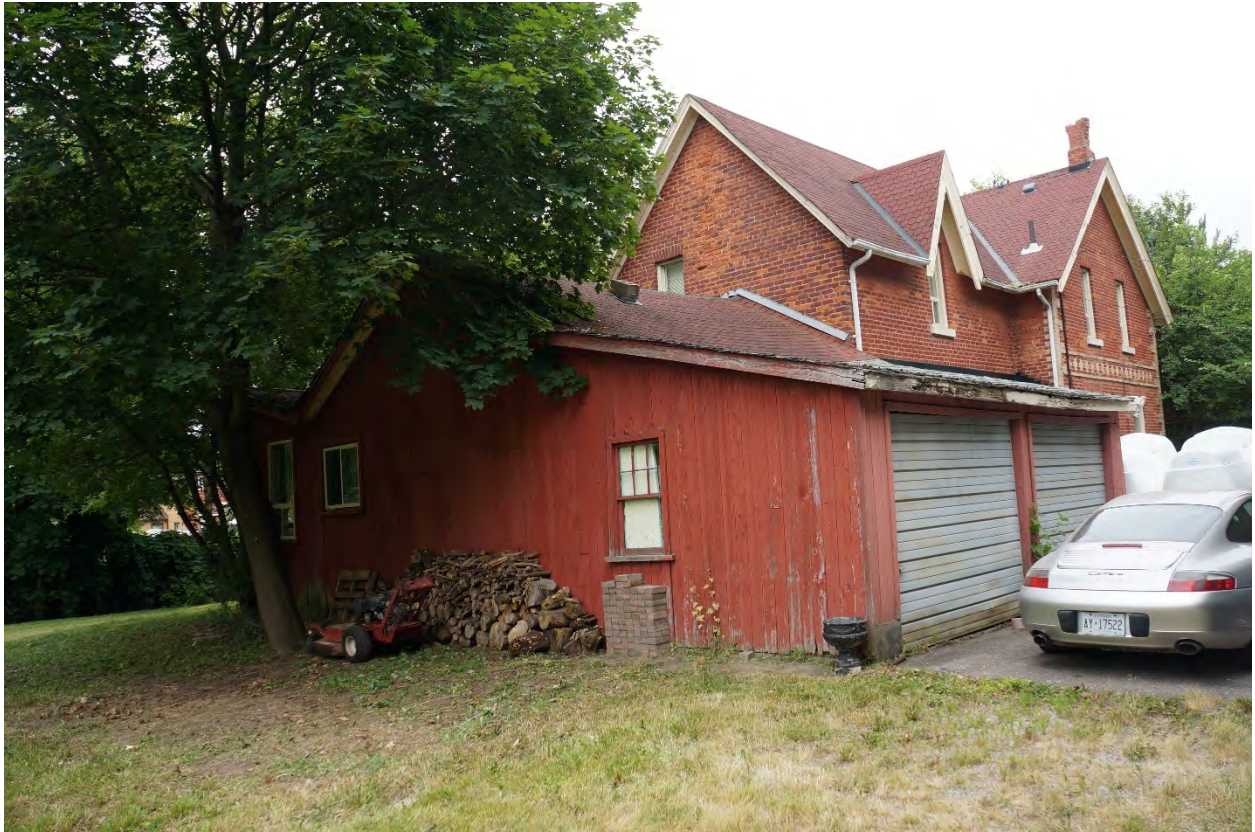
The east side of the structure features a frame addition, which appears to have been used both as a garage and as living space. The addition includes two garage doors on the south façade and an external chimney and large fixed window on the north façade (Figure 28).

Figure 28: Garage/storage space viewed from the east (APL 2019).

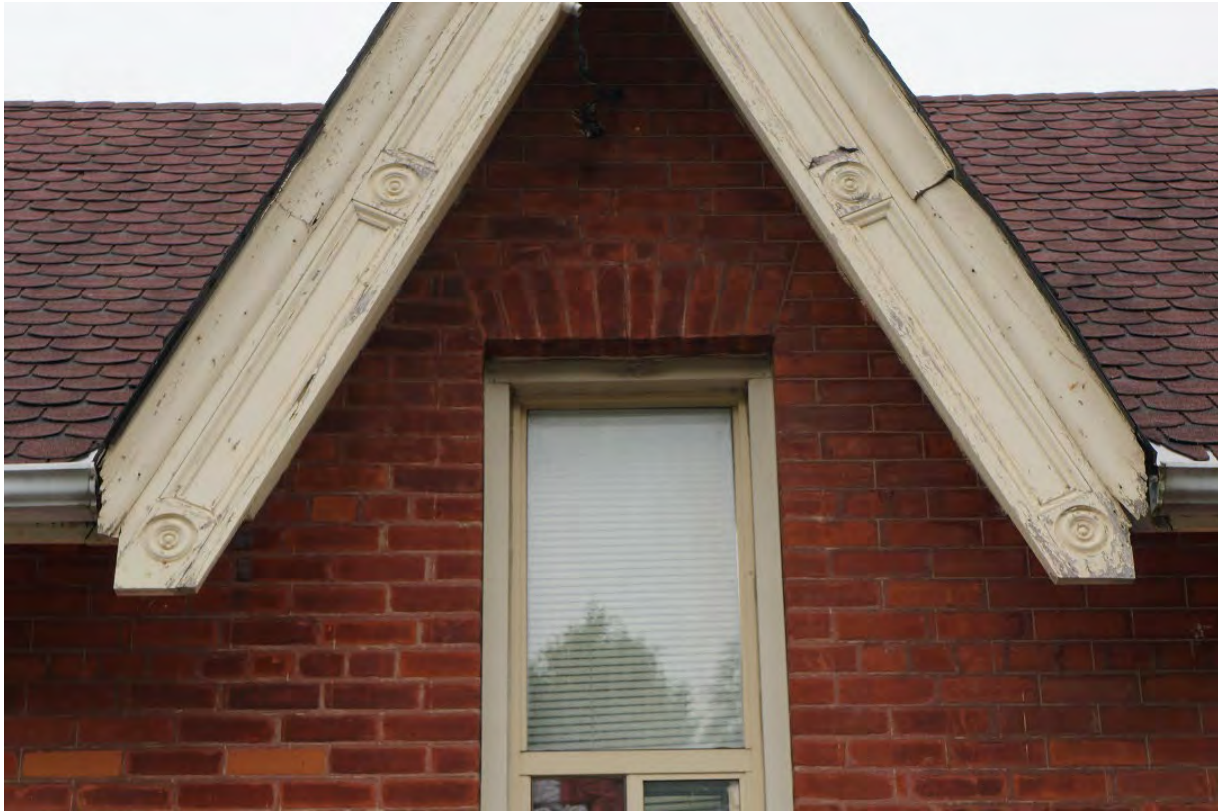
Figure 30: Decorative bargeboard detail, north elevation (APL 2019).

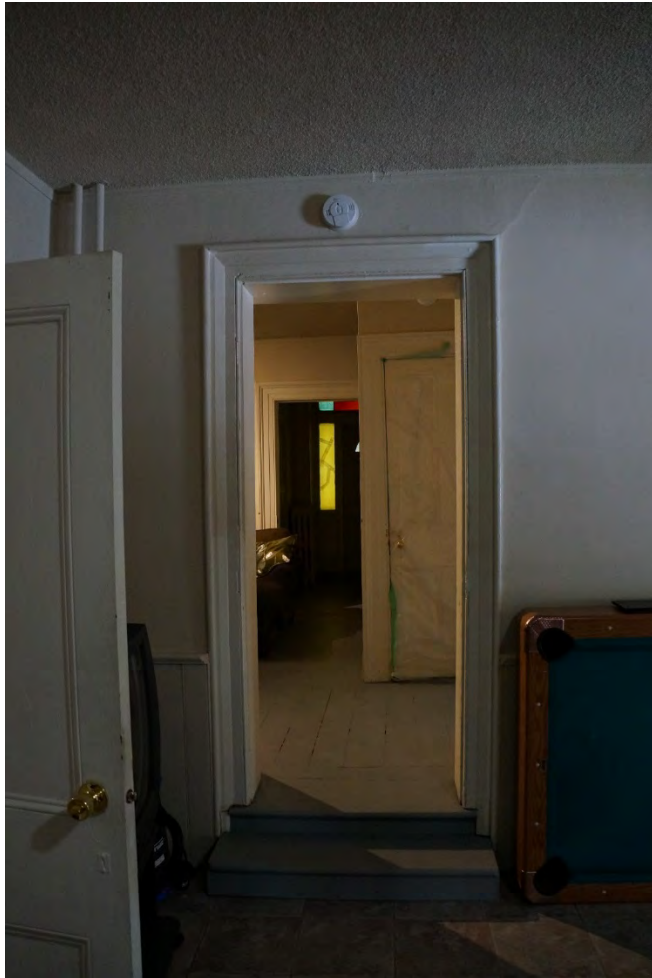
Figure 33: Transition from main house and rear kitchen looking west (APL 2019).

Review of the interior provides evidence that the kitchen tail is not contemporaneous with the ca. 1870s portion of the structure. First, the thickness of the east wall between the two indicates that it is designed as an exterior wall (Figure 39). The transition between the two wings of the structure also requires a step down (on both the first and second floor) as the kitchen tail was constructed along a lower grade.

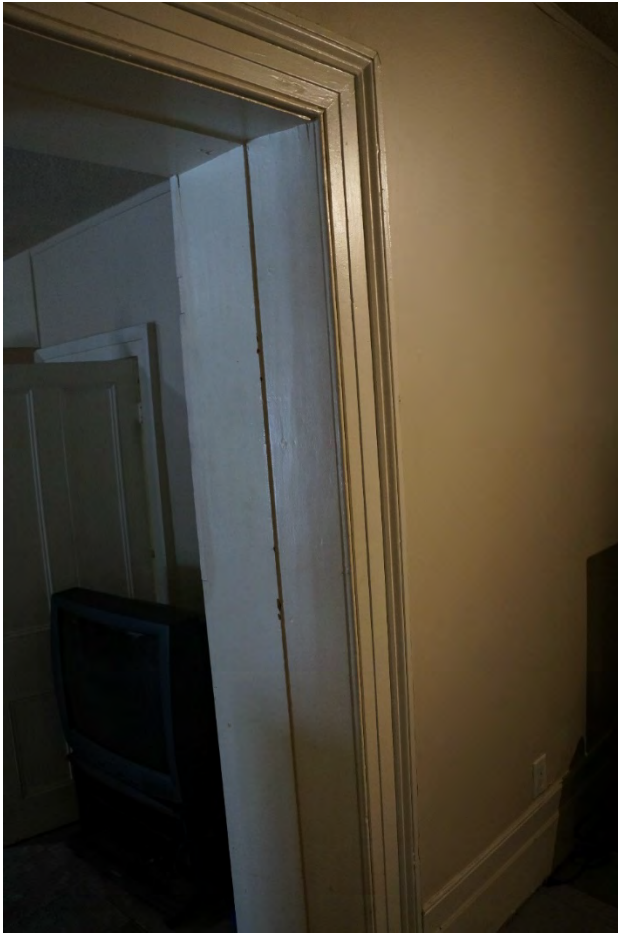
Figure 39: Transition between kitchen and living room (A. Plunkett-Latimer June 2019).

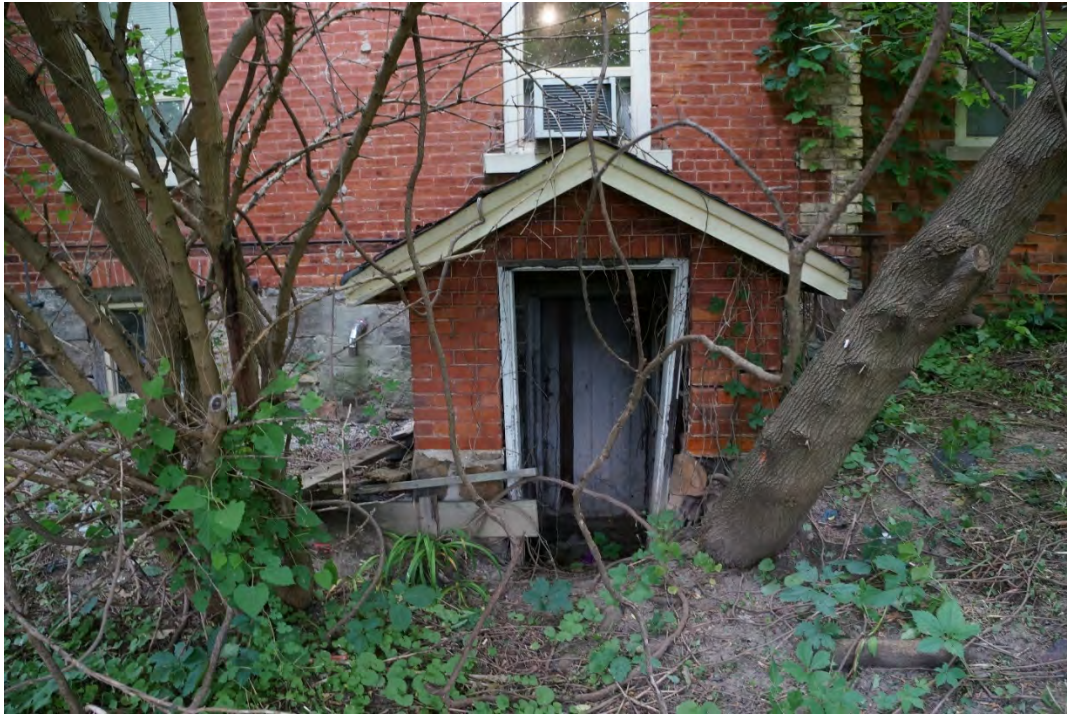
The property surrounding the residence comprises a lawn and many mature trees which are concentrated around the periphery of the property and adjacent to the main structure. The Tree Specialists Inc. identified 56 regulated trees. These trees have grown in a largely uncontrolled state, crowding the heritage structure and rendering it invisible from the street (Figure 40 to Figure 42).

Figure 40: Trees crowd the heritage structure. South elevation (A. Plunkett-Latimer, June 2019).

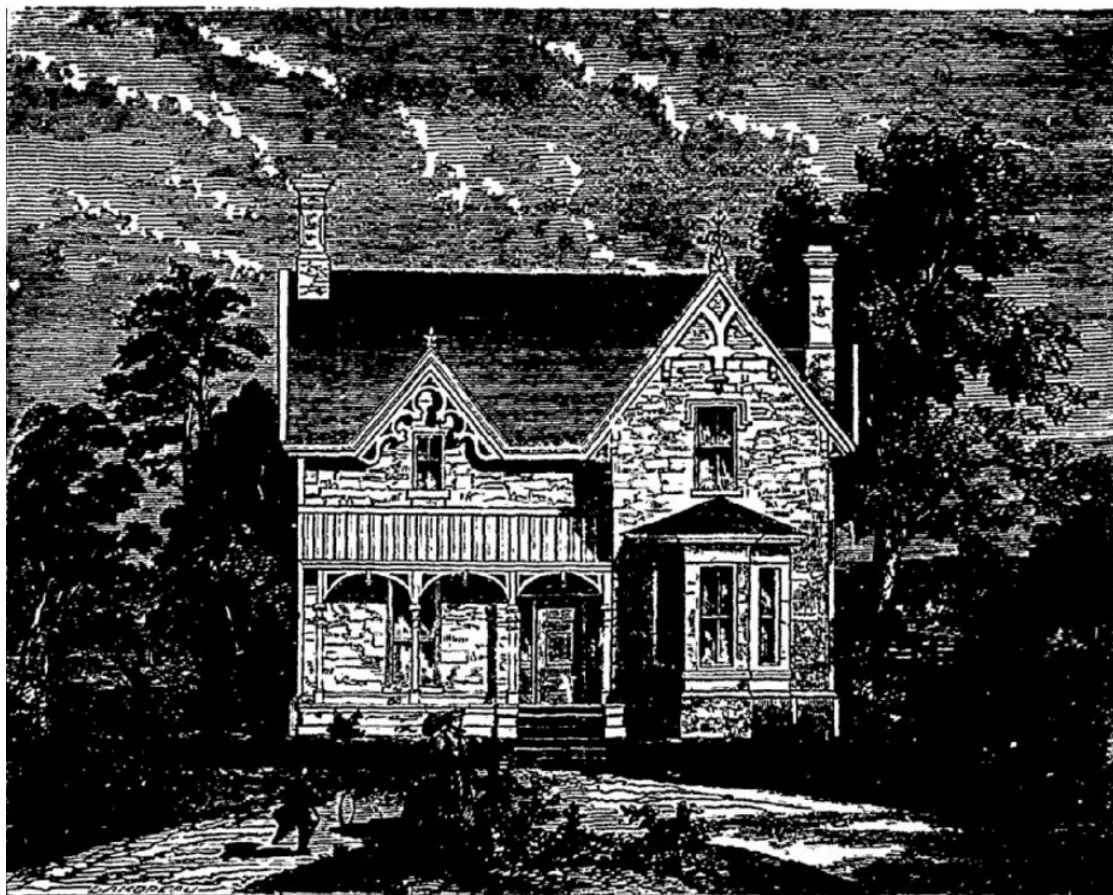
. FRONT ELEVATION.

Figure 43: "Simple suburban or farm house of moderate size". (The Canada Farmer: Vol 1. No. 9 May 16, 1964)

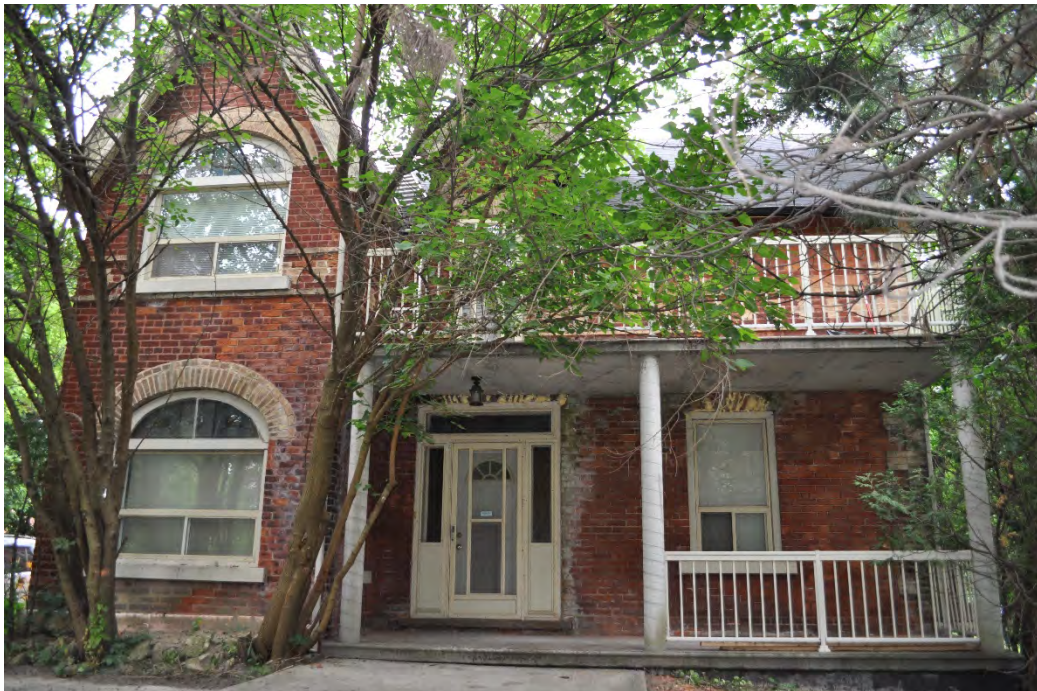
Figure 44: Front facade showing porch (CU 2019)

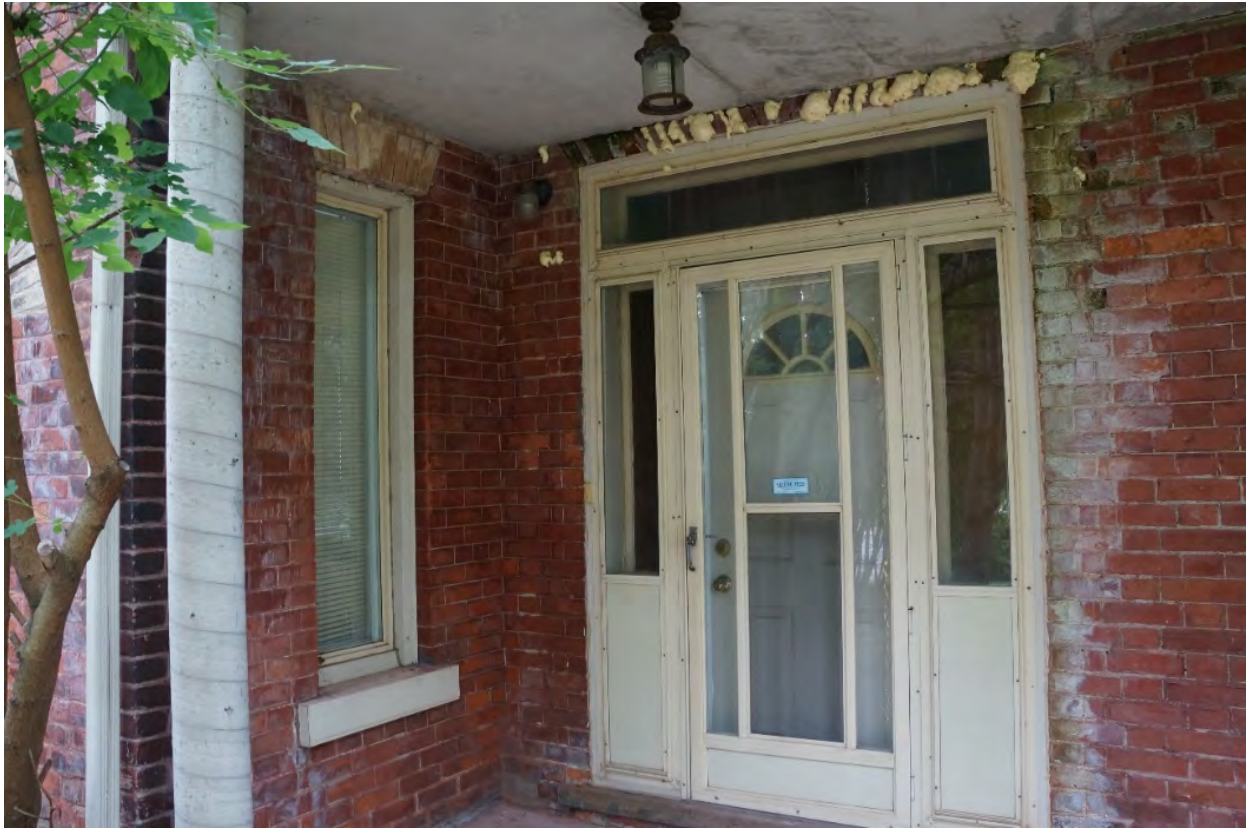
Figure 45: Detail of front entrance with header interrupted by porch (APL 2019).

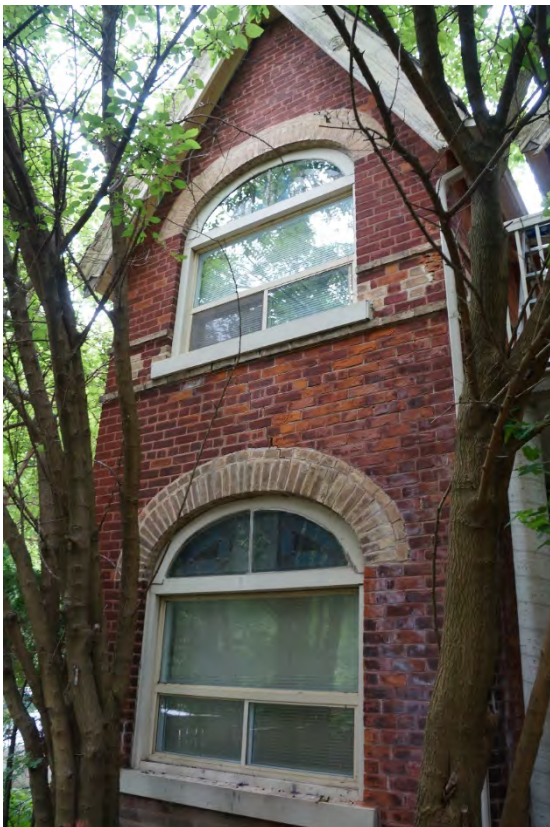
Figure 46: Projecting bay (APL 2019).

Historical photographs reveal that the original windows were 1 over 1 and 2 over 2 sash windows with wooden shutters. The projecting bay on the front façade included highly ornate windows with decorating moulding on the first and second storeys. These have all been replaced with modern vinyl windows. One exception is the small elliptical window on the front bay, which may be original (Figure 46).

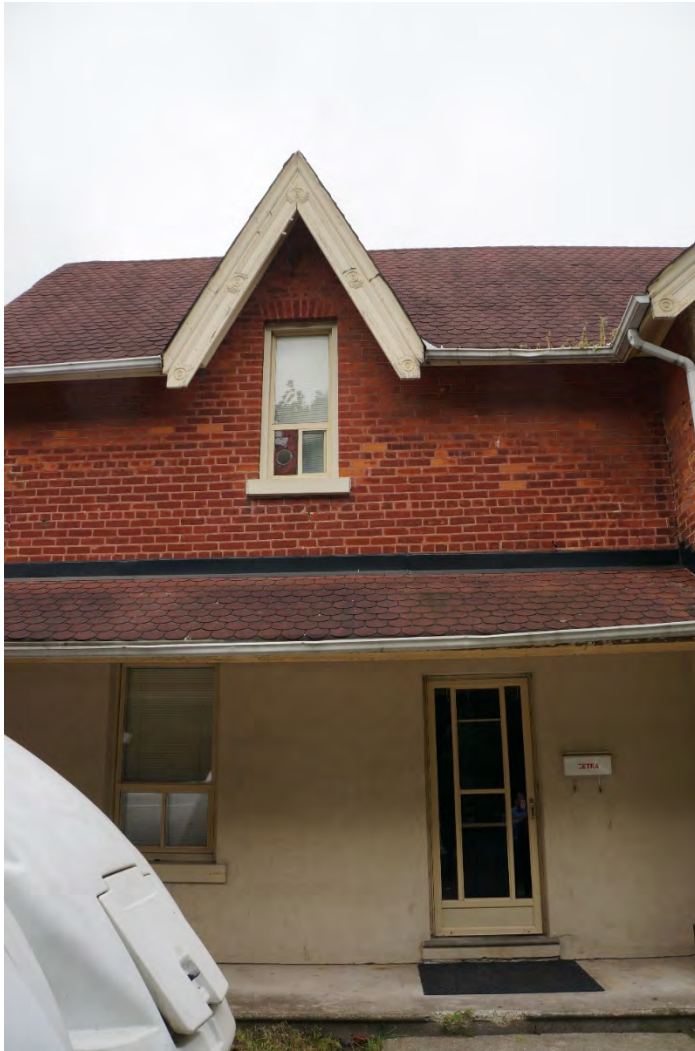
Figure 47: Rear kitchen tail showing stucco below porch (APL 2019)

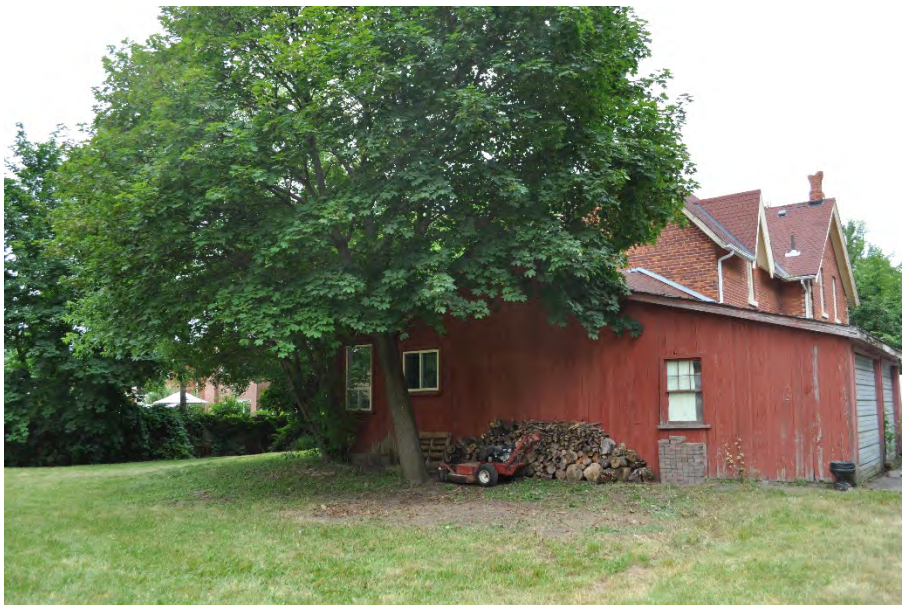
The wood frame shed/garage to the rear of the structure is unsympathetic in design and materials (Figure 48).

Figure 48: Kitchen tail and attached garage/storage (APL 2019)

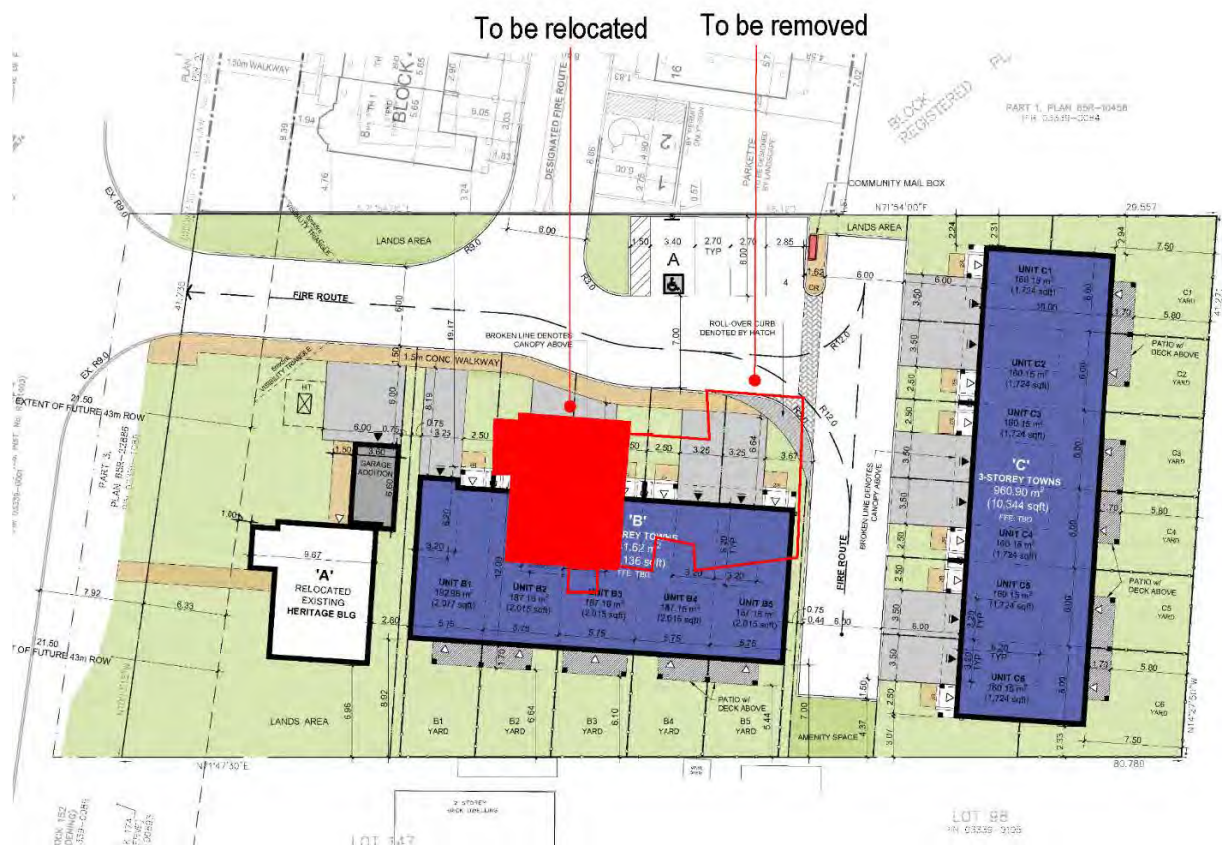
The proposed development seeks to relocate the existing heritage structure from its current location at the approximate centre of the property with a front yard setback of approximately 26 metres to a location nearer to the street with a front yard setback of approximately 1 metre. The building would be placed upon a new cement foundation. The proposal seeks to retain the 7.3 x 11 metre "main" house and demolish the rear kitchen wing and frame garage/storage room (Figure 49). The proposed development will seek to remediate damage to the George Keffer house by removing unsympathetic elements such as the rear, frame addition and cement porch, and will repair existing damage to exterior and interior finishes outlined in Section 6. This process is designed to retain core heritage attributes identified by the Maple Heritage Conservation Plan, creating a greater visual presence from the public realm and greater prominence on the site.

Figure 49: Proposed site plan with location of existing structure and portions to be removed annotated in red by LHC.

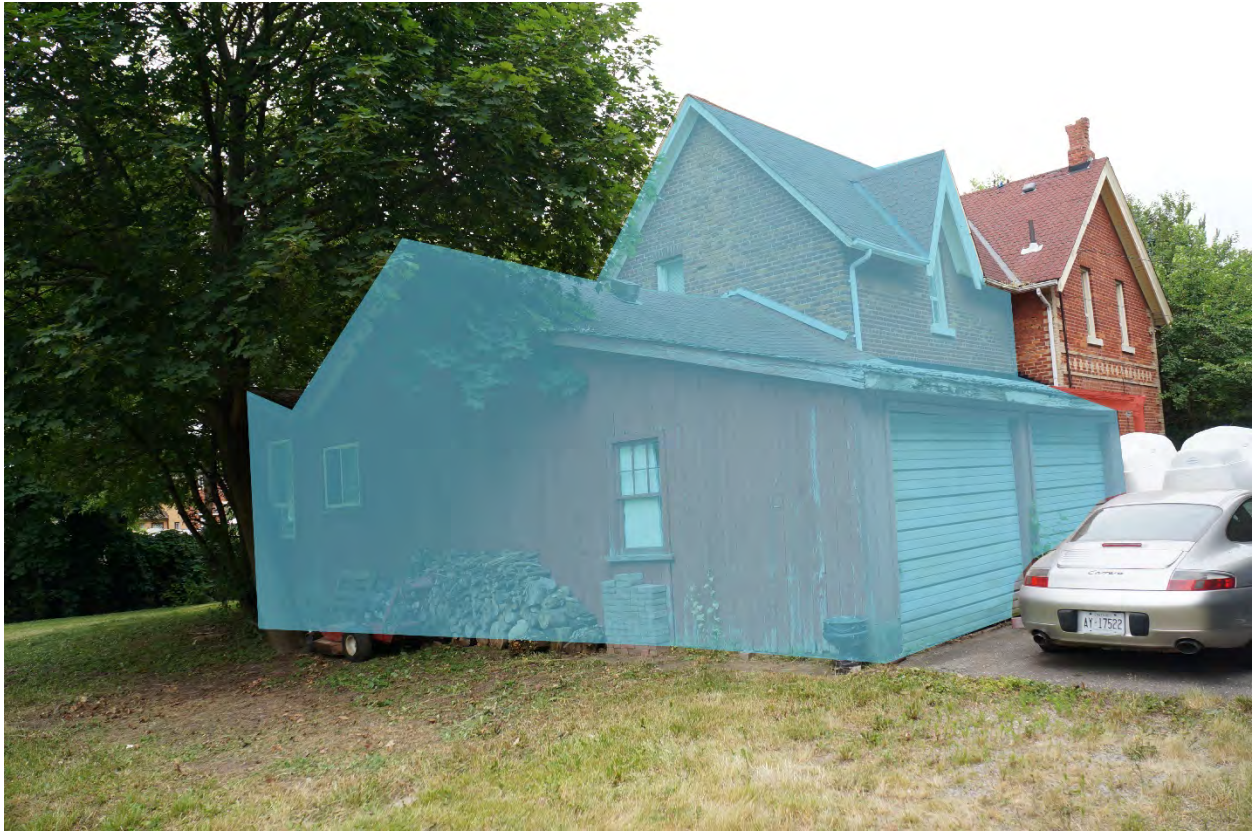
Figure 50: Portions of building to be demolished. Annotation by LHC.

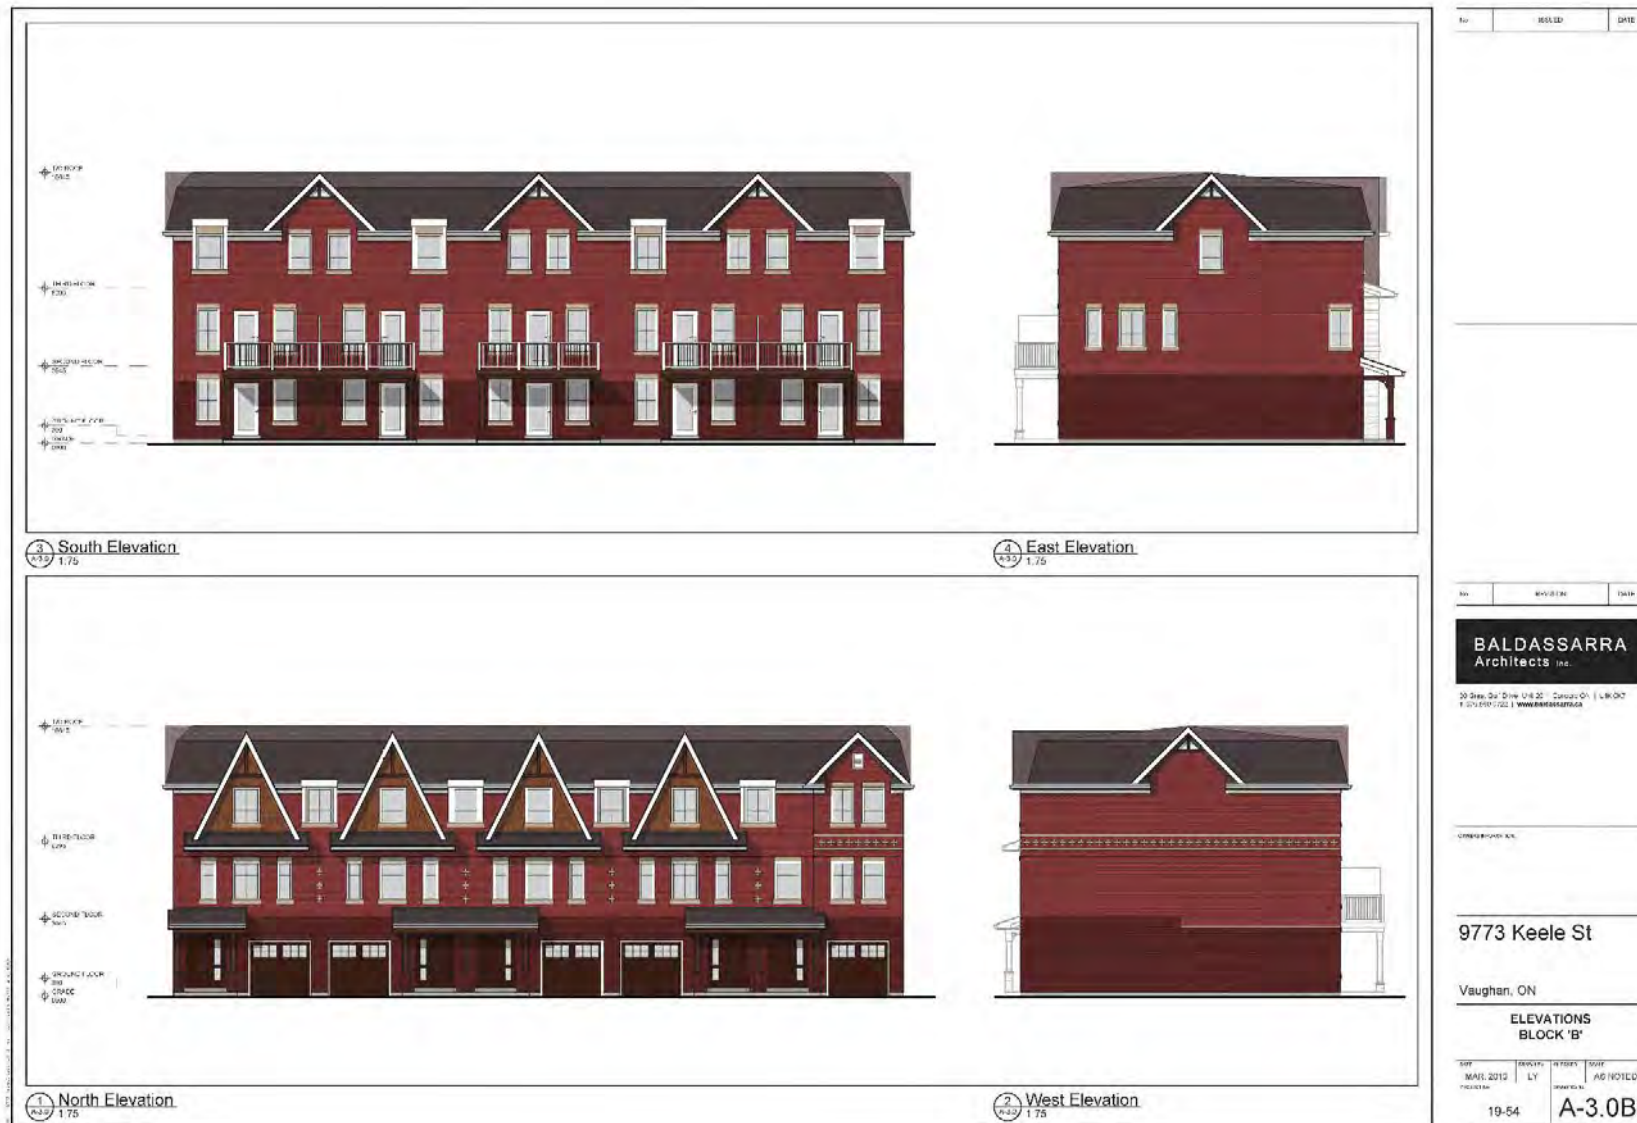
Figure 53: 9773 Keele Proposed Elevations, Block "B" (Baldassarra Architects Inc., 2019).

The townhouse blocks measure 28.75 metres by 12 metres and 36 metres by 12 metres deep and, as such, are larger than the current adjacent buildings. The massing of these larger buildings is broken up by design elements, such as gable peaks and porches. Elevations for Blocks "B" and "C" are presented, below, as Figure 53 and Figure 54, respectively.

The design of the townhouses is modern, but makes reference to Victorian vernacular design elements including:

- High peaked front gables;
- Brick cladding;
- Transom windows and sidelites at main entrances;
- Shingled roofs; and,
- Buff brick crosses and bandcourses.

The overall visual impact of the new townhouses to the rear of the George Keefer House was considered. In general, the materials, scale, and aesthetic of the proposed townhouses are sympathetic to the extant resource; however, City staff has noted some concern that the Block B townhouses may be legible from the street as a rear extension of the extant resource. As such, they may appear out of scale with the George Keefer House or may affect the legibility of the house's roofline. A comparative example of this effect can be seen at the north end of the Thornhill HCD (Figure 55 and Figure 56). In order to mitigate this illusion, a mansard or hipped roof (or similar) is recommended for the unit nearest the George Keefer House, rather than a side gable. This way roof shingles, not a brick wall, form the backdrop visible above the heritage resource. As depicted in Figure 53, the design of the side elevations of Blocks "B" and "C" have been revised to address staff concerns.

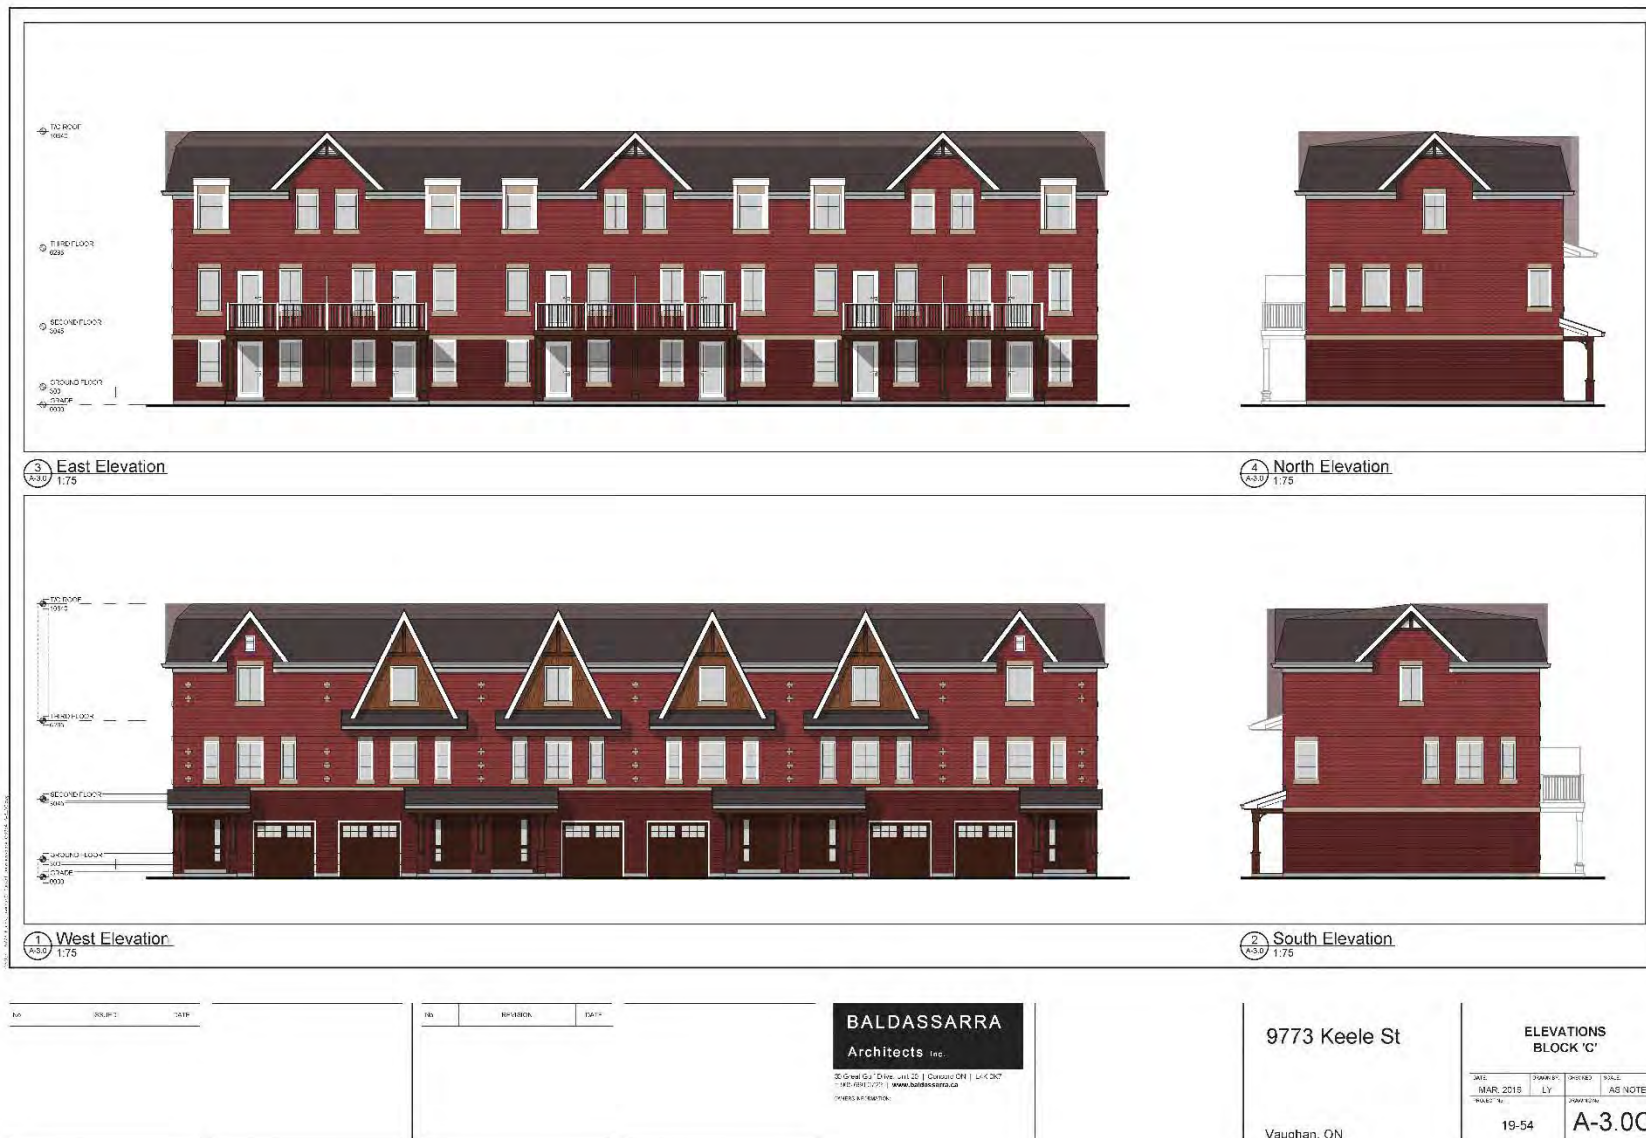
Figure 54: 9779 Keele Proposed Elevations, Block "C" (Baldassarra Architects Inc., 2019).
