FINAL REPORT:

CULTURAL HERITAGE IMPACT ASSESSMENT

9773 Keele Street,
Maple, Vaughan, Ontario

**Letourneau
Heritage
Consulting Inc.**

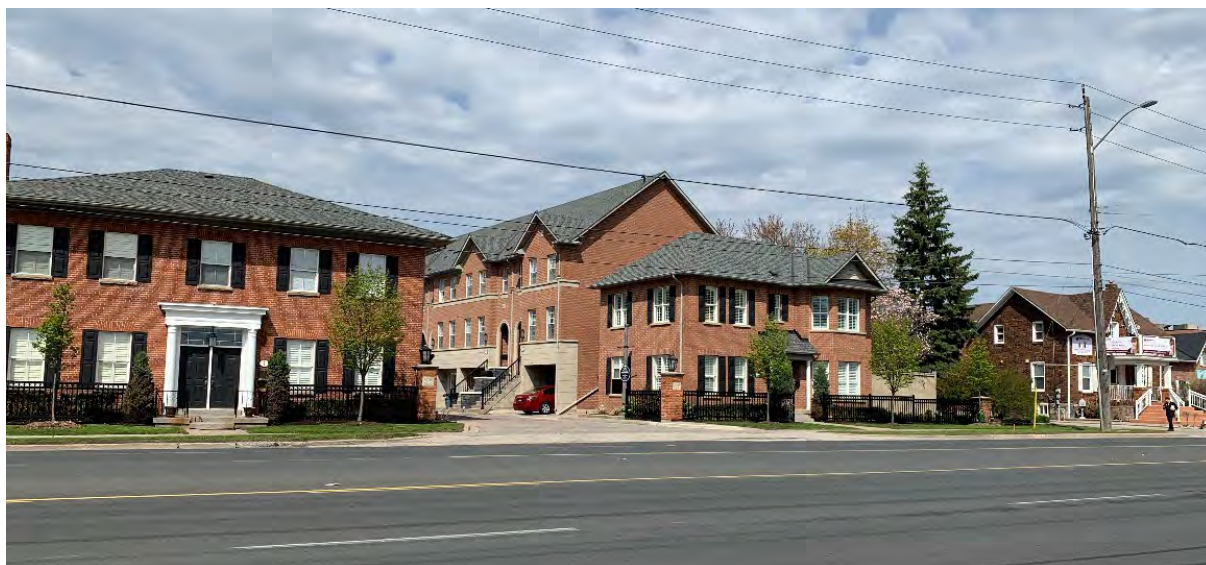
Figure 55: 8038 Yonge Street. Example of the effect of a side gable on an adjacent roof line/structure of the same cladding (CU 2019)

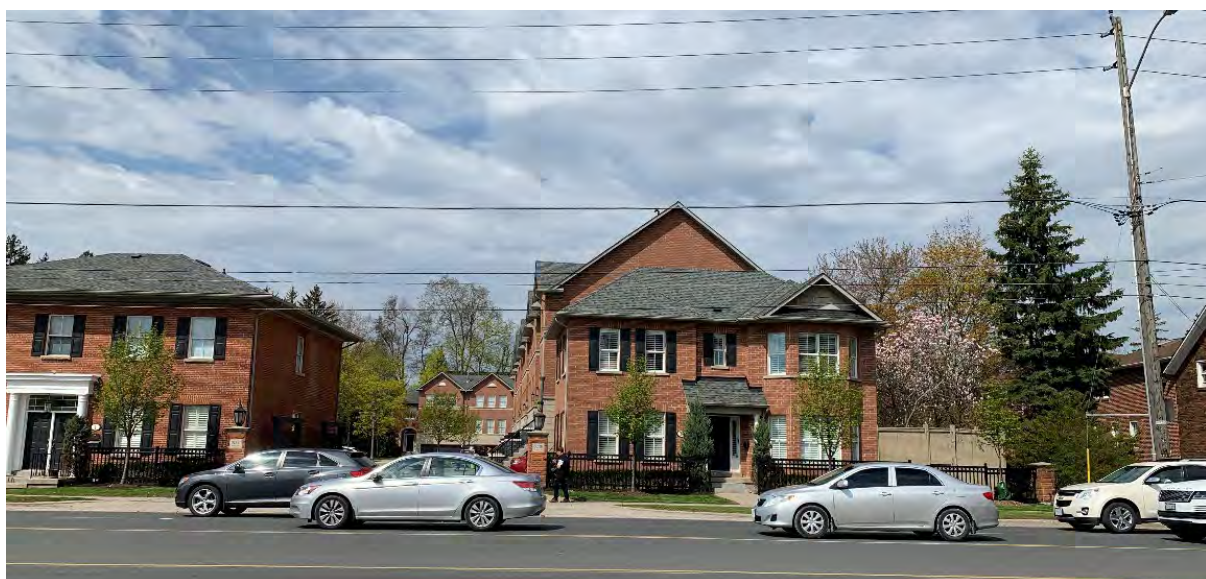
Figure 56: 8038 Yonge Street. Example of the effect of a side gable on an adjacent roof line/structure of the same cladding (CU 2019)

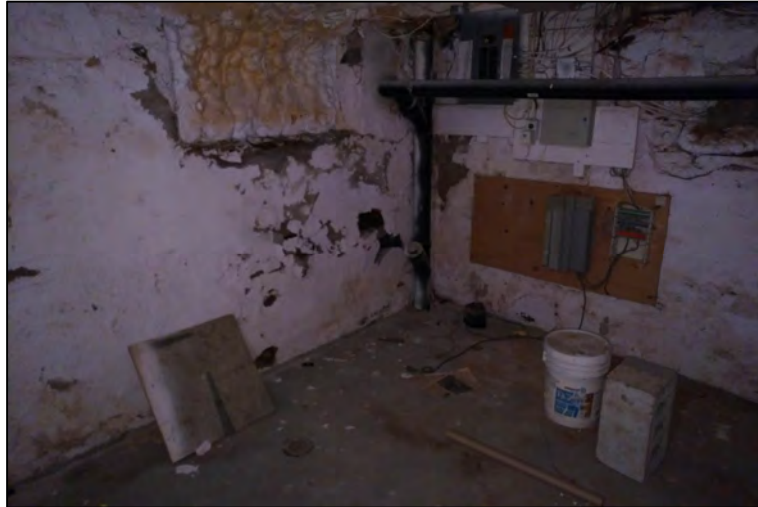
The building is proposed to be relocated and placed on new reinforced concrete foundation walls and footings. As such, the conditions of the existing stone foundations do not affect the short-term plans to relocate the building on the site.

Photograph 1: Rubble stone basement walls

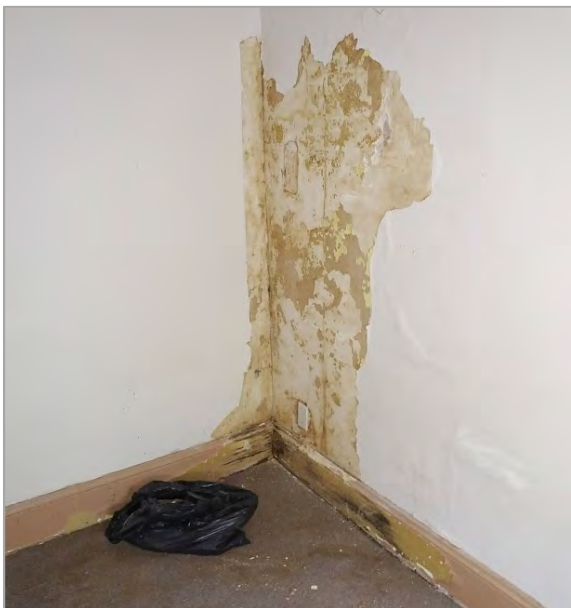
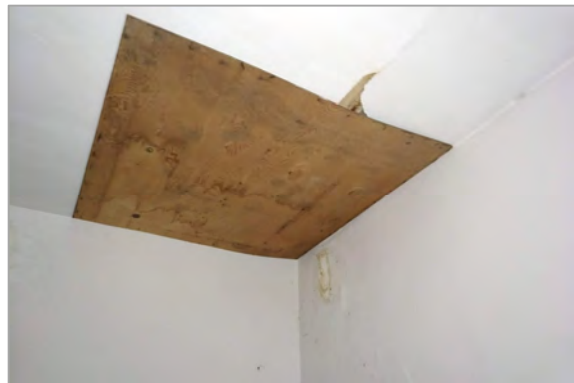
Photograph 2: Interior of living areas

In several rooms, long term moisture damage was noted. This was reported to be from failed roofing materials, as well as damage from deteriorated bricks discussed later in this report.

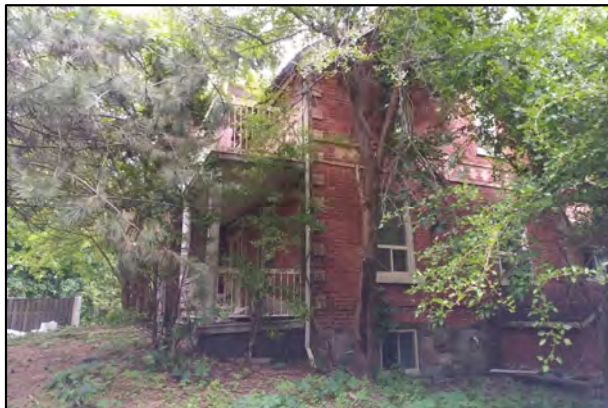
The building is founded on rubble stone foundations of unknown depth. Gables, dormers and bay windows are characterized with bargeboard wood trim, which is mostly intact, but in need of maintenance to address peeling paint and cracks.

Photograph 3 (left): South elevation, quoin and cross pattern

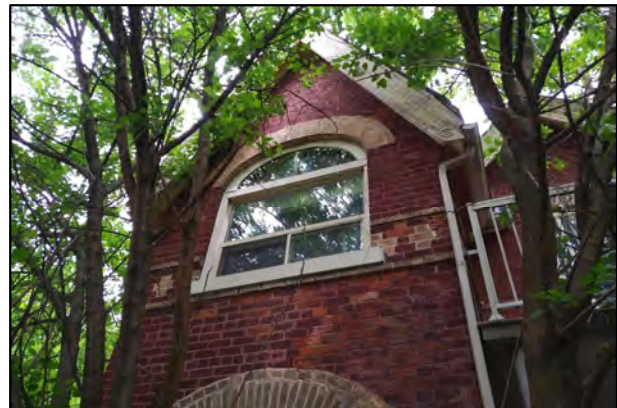
Photograph 4 (right): West elevation, decorative trim and arches

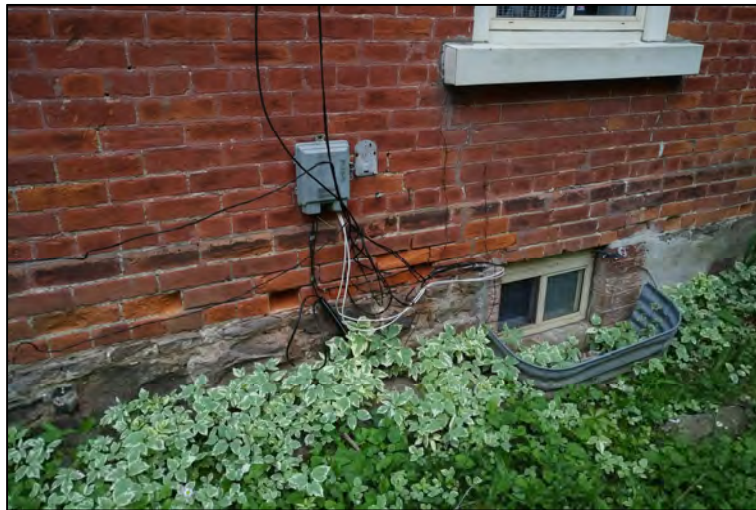
Damage was found on the building exterior in a few isolated locations. Improperly maintained downspouts are often a major area of damage caused by long term exposure to rain water and freeze-thaw cycles. Around the perimeter of the building, the bottom 2' to 3' of brick will need to be repaired to ensure that the wall is structurally sound.

Photograph 5: Brick damage at base of wall

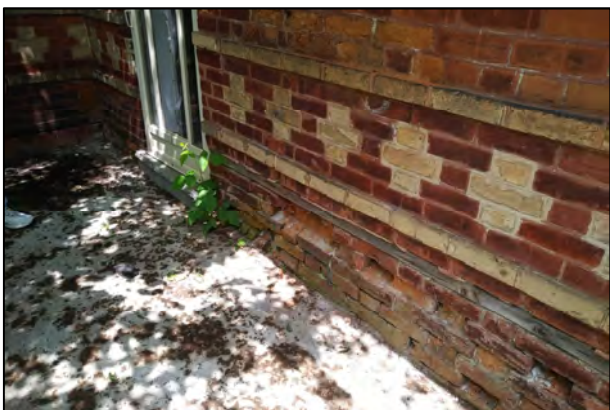
Photograph 6 (left): Brick Damage from above porch

It is recommended that the concrete porch be removed, to both prevent further damage to the brick, and so that the brick can be properly repaired and restored prior to moving. Depending on how the porch was tied into the brick, repairs may be required which are currently hidden by the presence of the porch.

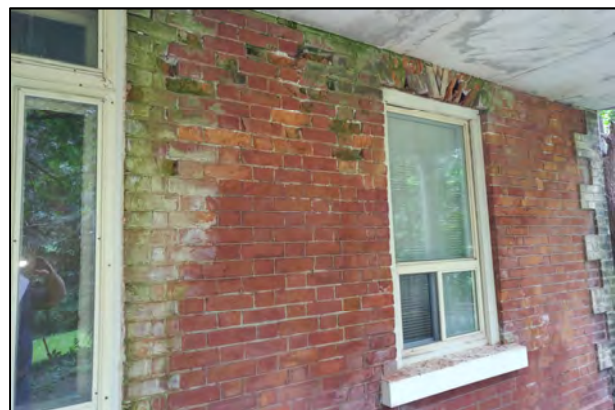
Photograph 7 (right): Brick damage from below porch

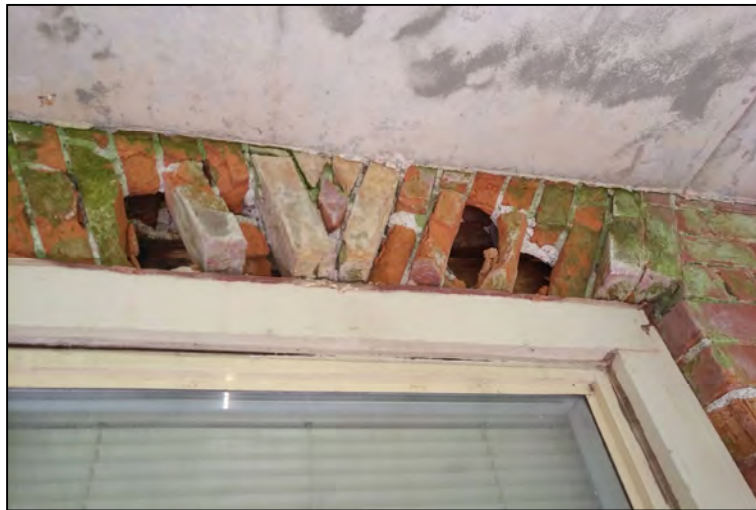
Photograph 8: Brick damage over window

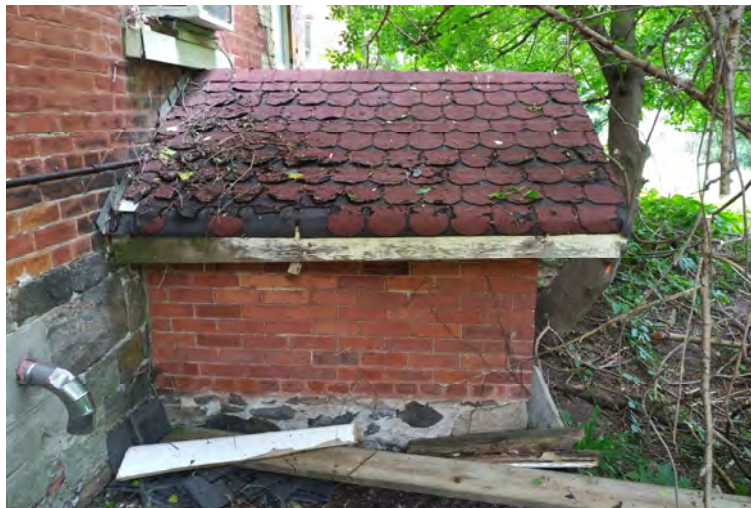
The south elevation contains a small structure, providing cover to the stairs into the basement. From the inside it appears this opening in the foundation wall has been enclosed. The small doghouse structure is in very poor condition and will not likely tolerate any type of move. If the structure is to be maintained, it would be best to disassemble and rebuild at the new location. Masonry materials are likely to be salvaged, but the wood framing, and rubble stone foundation are likely in need of replacement.

Photograph 9: South basement entry

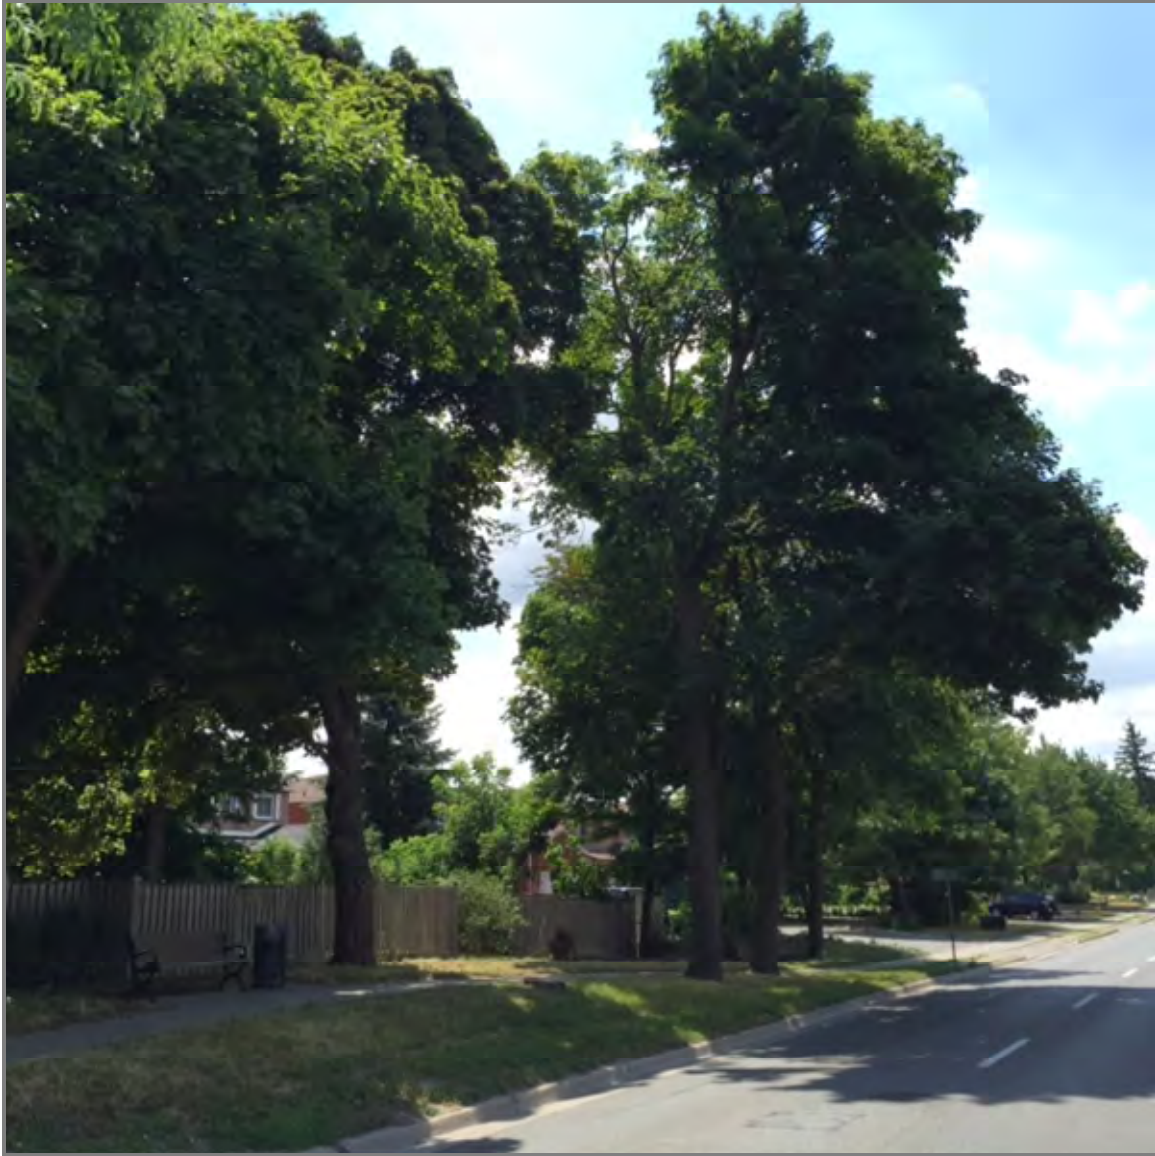
Photo #1: Trees no. 103-108 looking southeast.

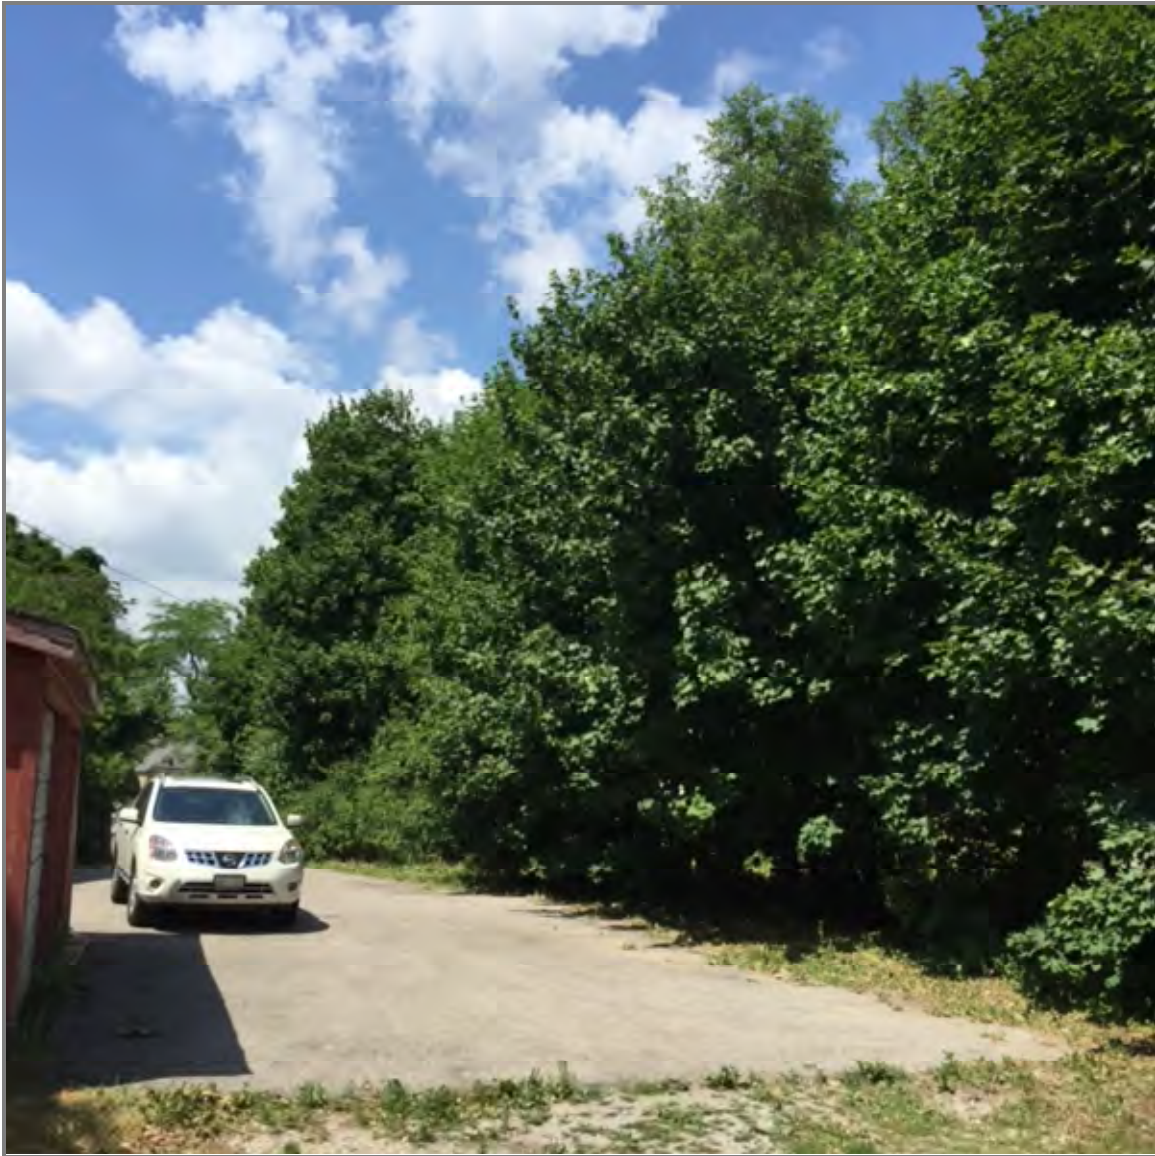
Photo #2: Trees no. 113-118 and non-regulated trees looking west.

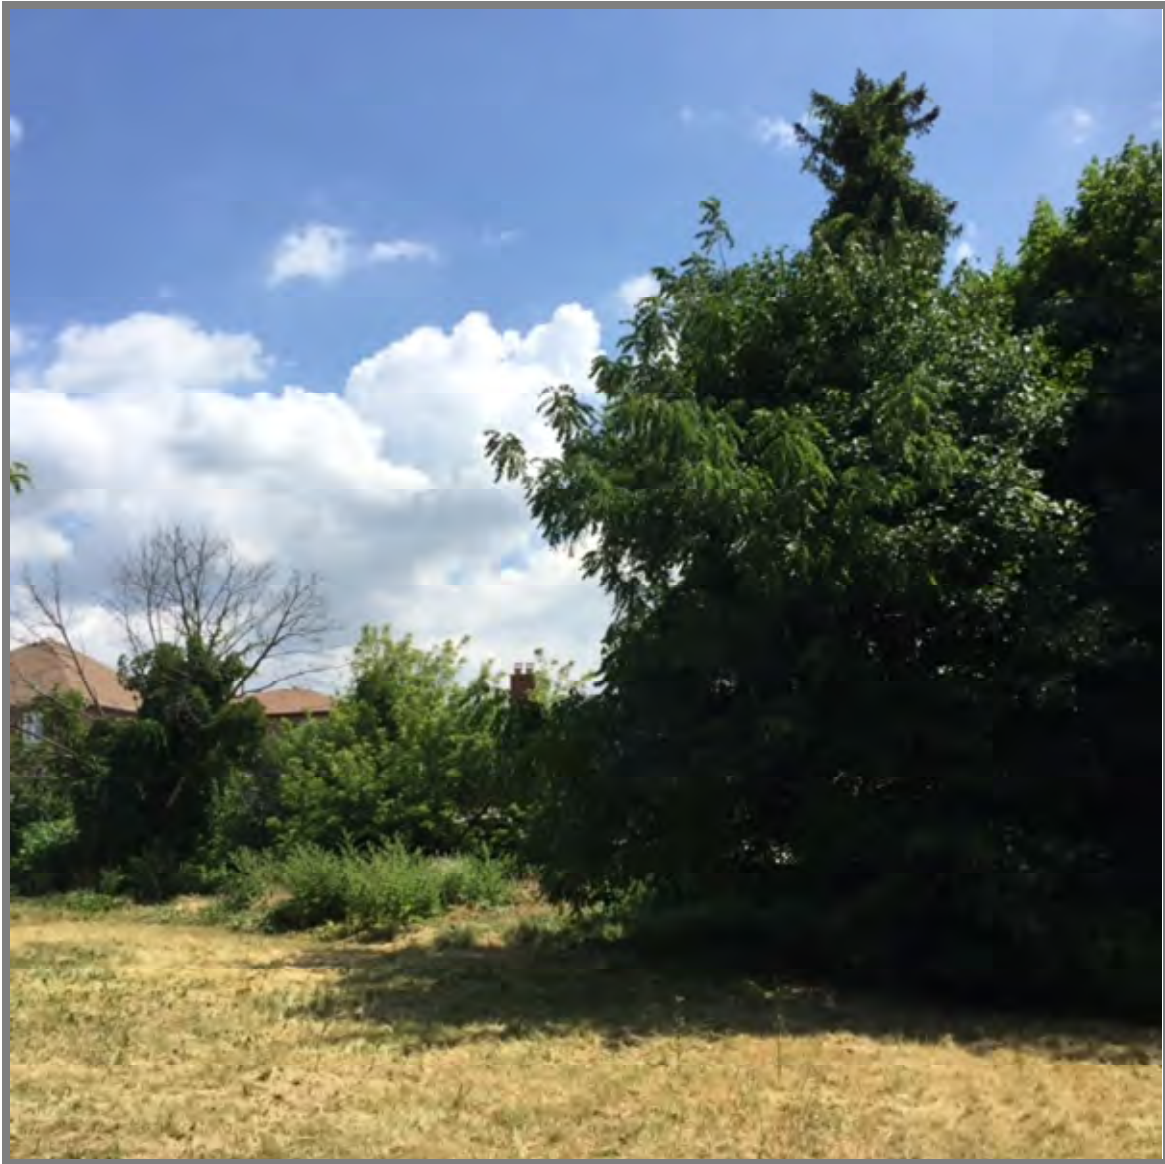
Photo #3: Trees no. 123-126 and non-regulated trees looking northeast.

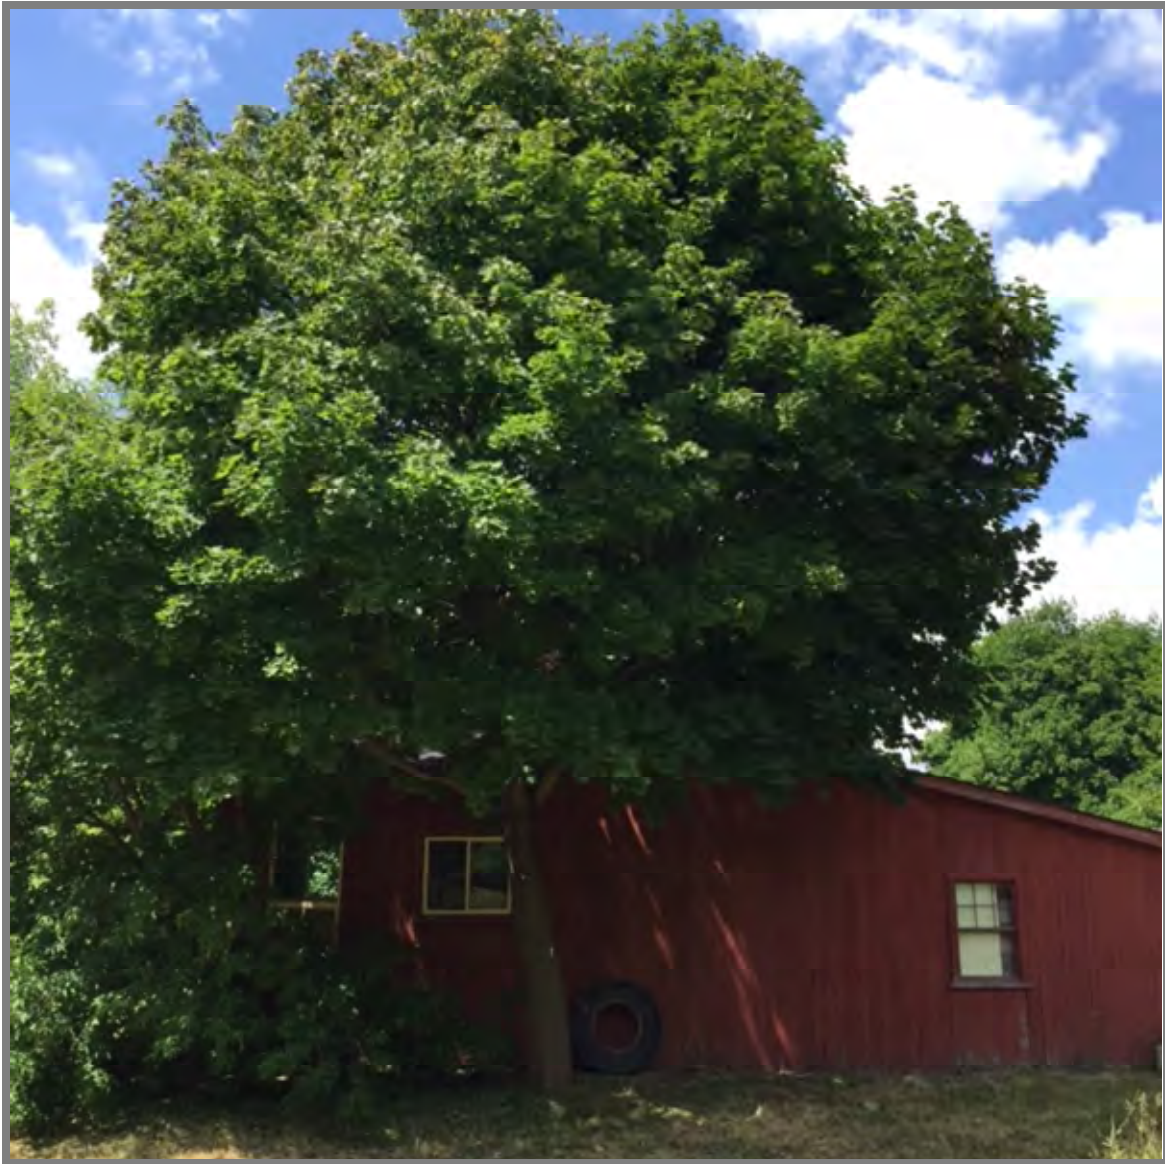
Photo #4: Trees no. 135-136 looking west.
