10. NEW CONSTRUCTION – SINGLE DETACHED DWELLING, 77 CLARENCE STREET, WOODBRIDGE HERITAGE CONSERVATION DISTRICT

TITLE: NEW CONSTRUCTION – SINGLE DETACHED DWELLING, 77 CLARENCE STREET, WOODBRIDGE HERITAGE CONSERVATION DISTRICT

CULTURAL HERITAGE IMPACT ASSESSMENT

**77 CLARENCE STREET
CITY OF VAUGHAN, ONTARIO**

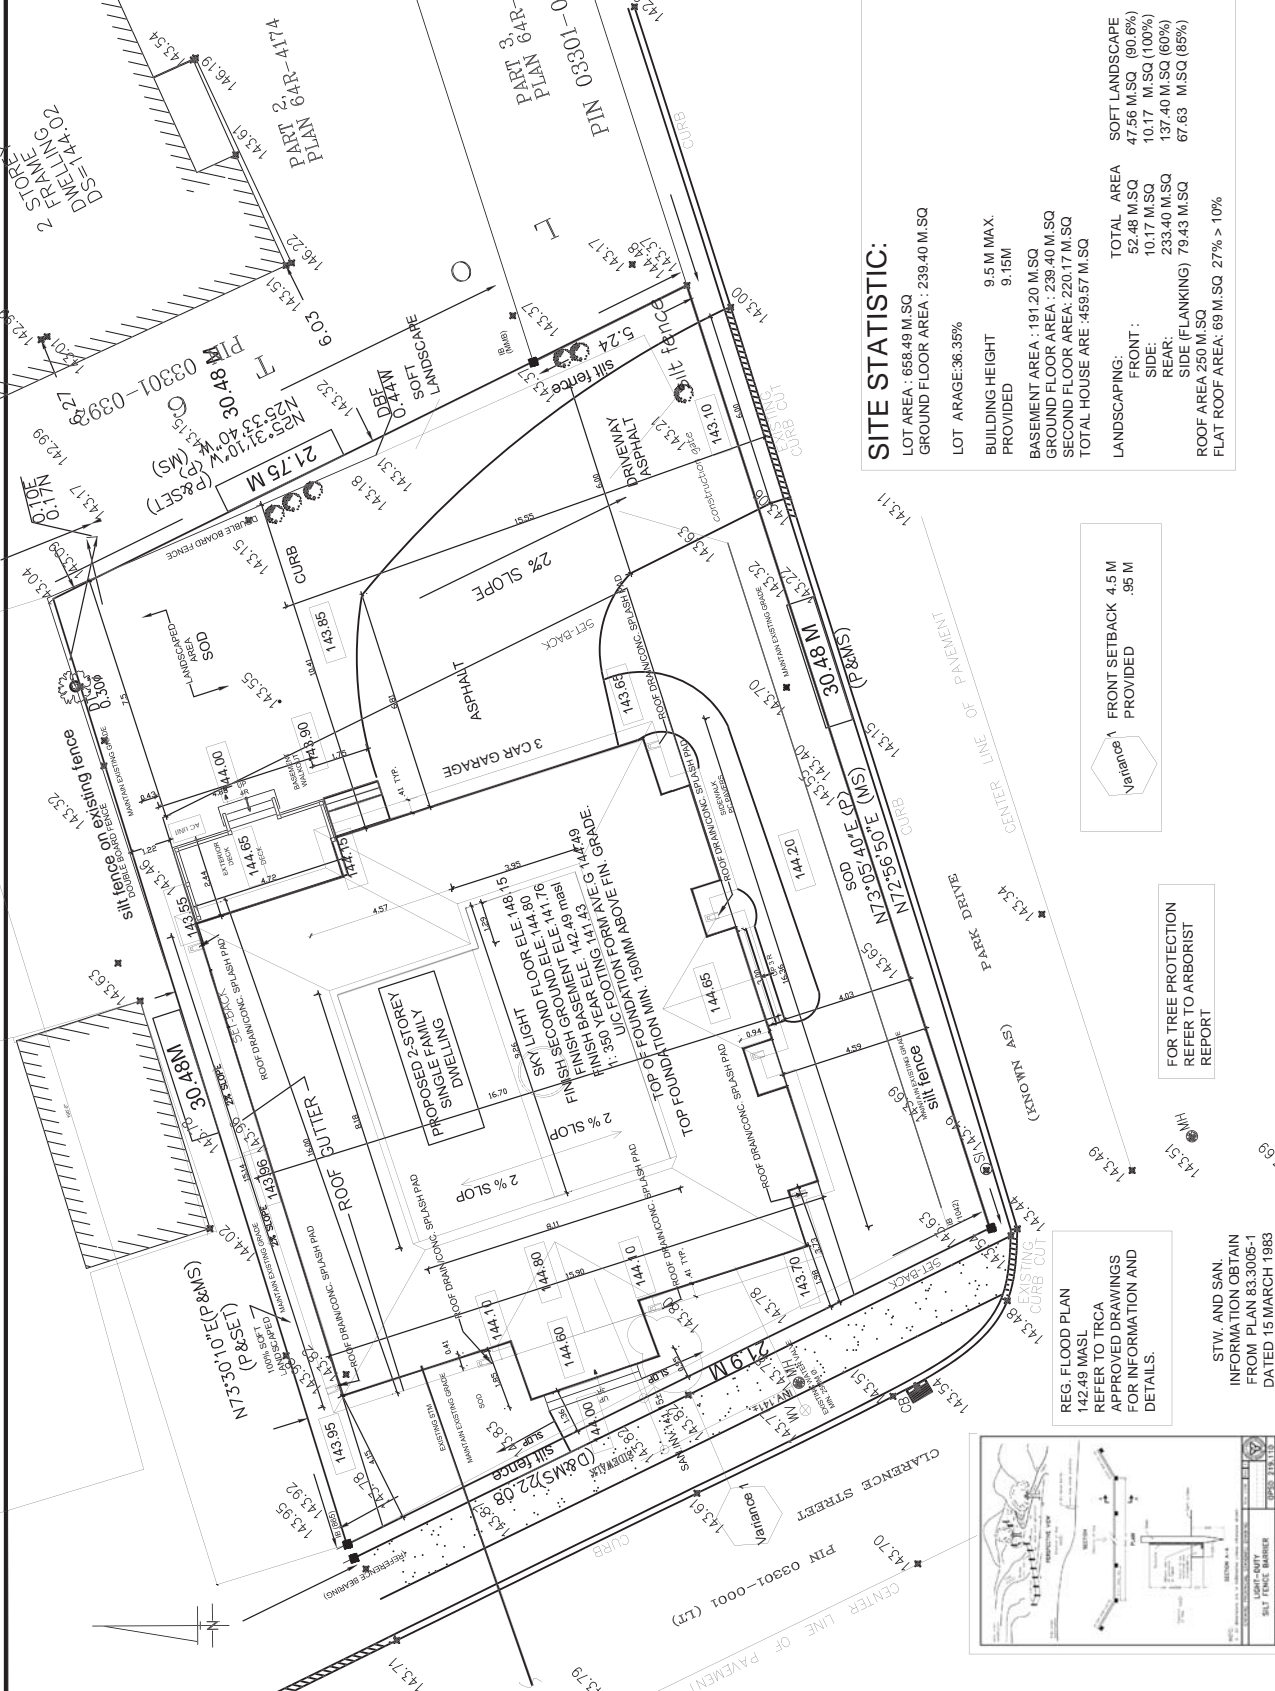
SITE STATISTIC:

LOT AREA:	658.49 M.SQ
GROUND FLOOR AREA:	239.40 M.SQ
LOT ARAGE:	36.35%
BUILDING HEIGHT PROVIDED:	9.5 M MAX. 9.15M
BASEMENT FLOOR AREA:	191.20 M.SQ
GROUND FLOOR AREA:	239.40 M.SQ
SECOND FLOOR AREA:	220.17 M.SQ
TOTAL HOUSE ARE:	459.57 M.SQ
LANDSCAPING:	TOTAL AREA 52.48 M.SQ (90.6%) FRONT: 10.17 M.SQ (100%) SIDE: 233.40 M.SQ (60%) REAR: 137.40 M.SQ (85%)
ROOF AREA:	250 M.SQ
FLAT ROOF AREA:	69 M.SQ 27% > 10%

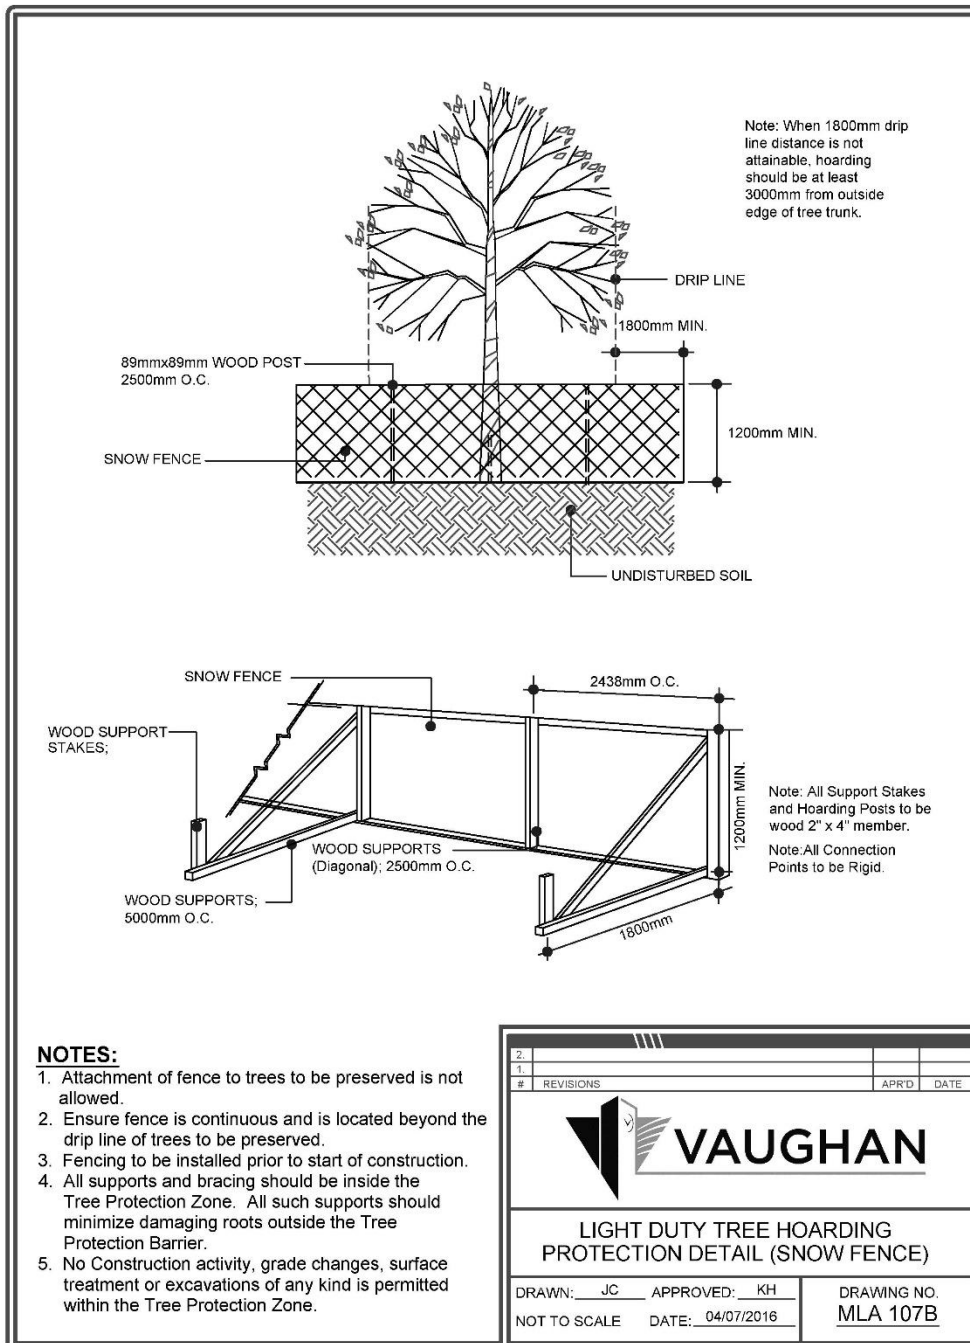
Tree protection plan details: Light Duty

Establishing a TPZ is necessary to prevent physical harm to the stem and branches of the tree which may otherwise be incurred due to proximity of construction or demolition activities. The TPZ will encompass the tree's critical root area, protecting the roots from being damaged during excavation and from soil compaction which may occur due to the presence of heavy machinery.

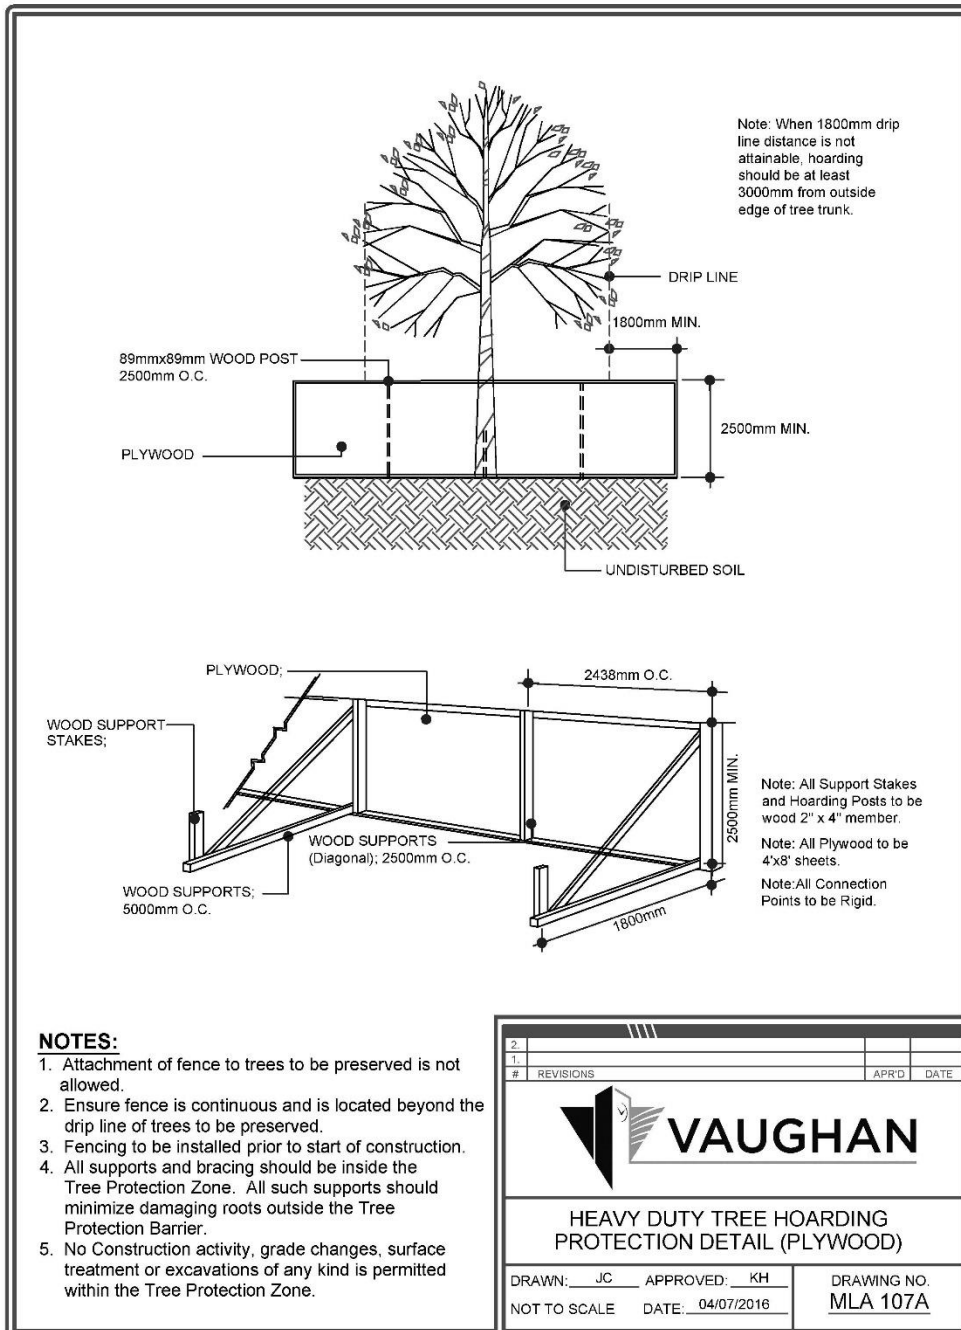
Tree protection plan details: Heavy Duty

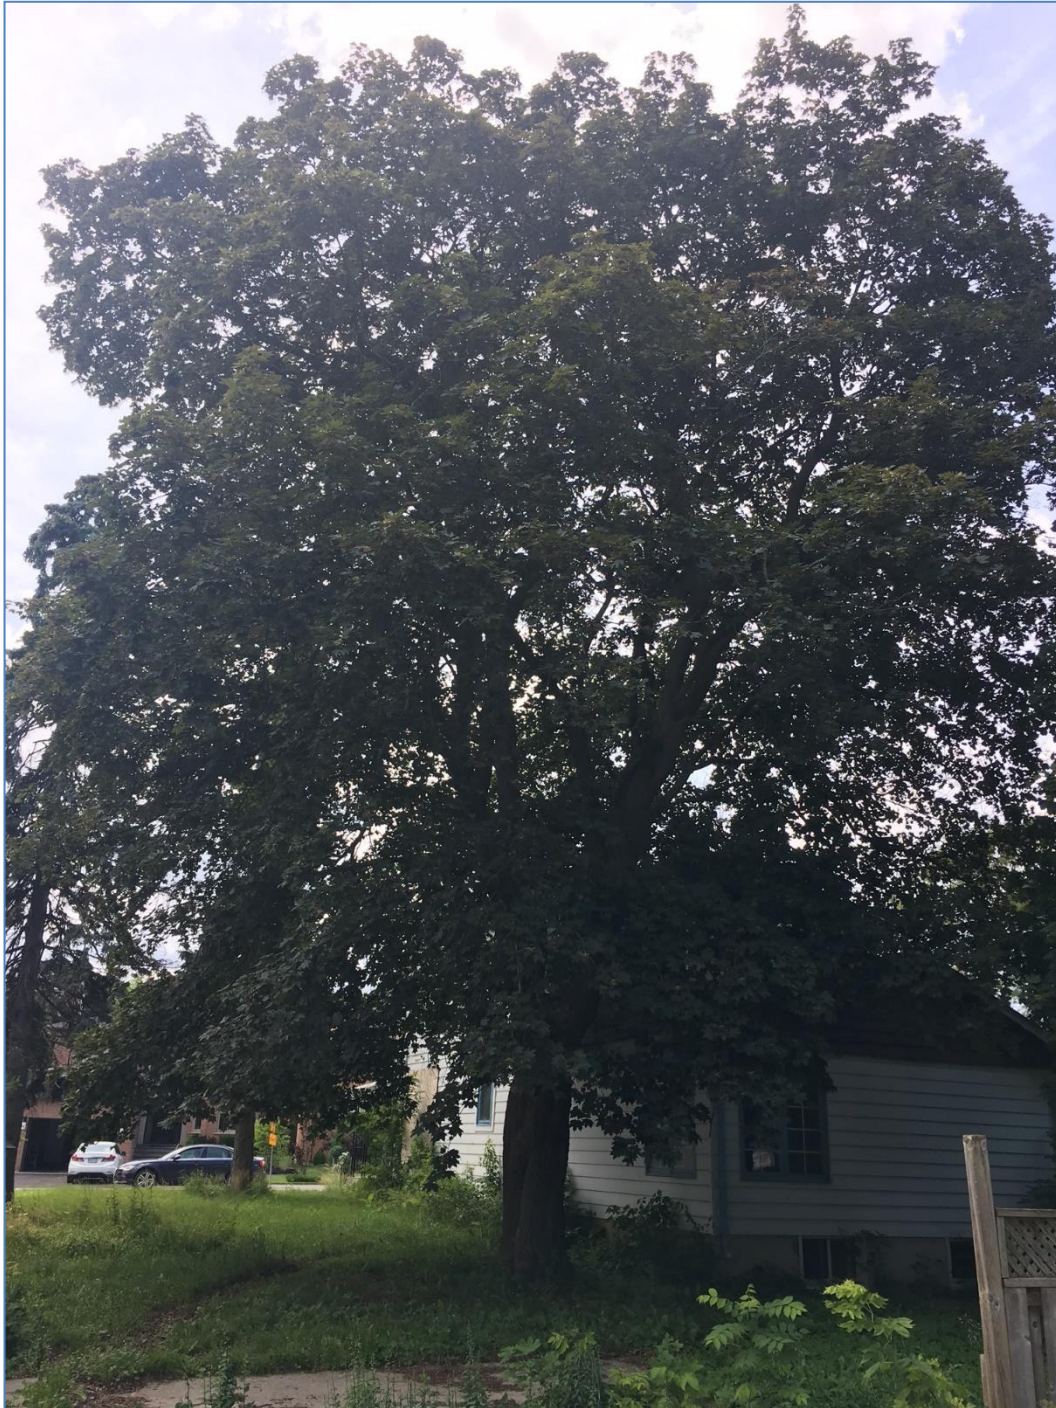
Tree 1: Norway Maple (Acer platanoides)

Tree 1 is an 87-cm. mature Norway Maple located on private property, within the footprint of the proposed development at 77 Clarence Street. This tree cannot be preserved and therefore, we are requesting a permit for removal. For a tree removal of this size (50 cm. + base diameter), the City of Vaughan requires 4 replacement trees as compensation. Please see the section titled, “Replanting Plan” for more details.

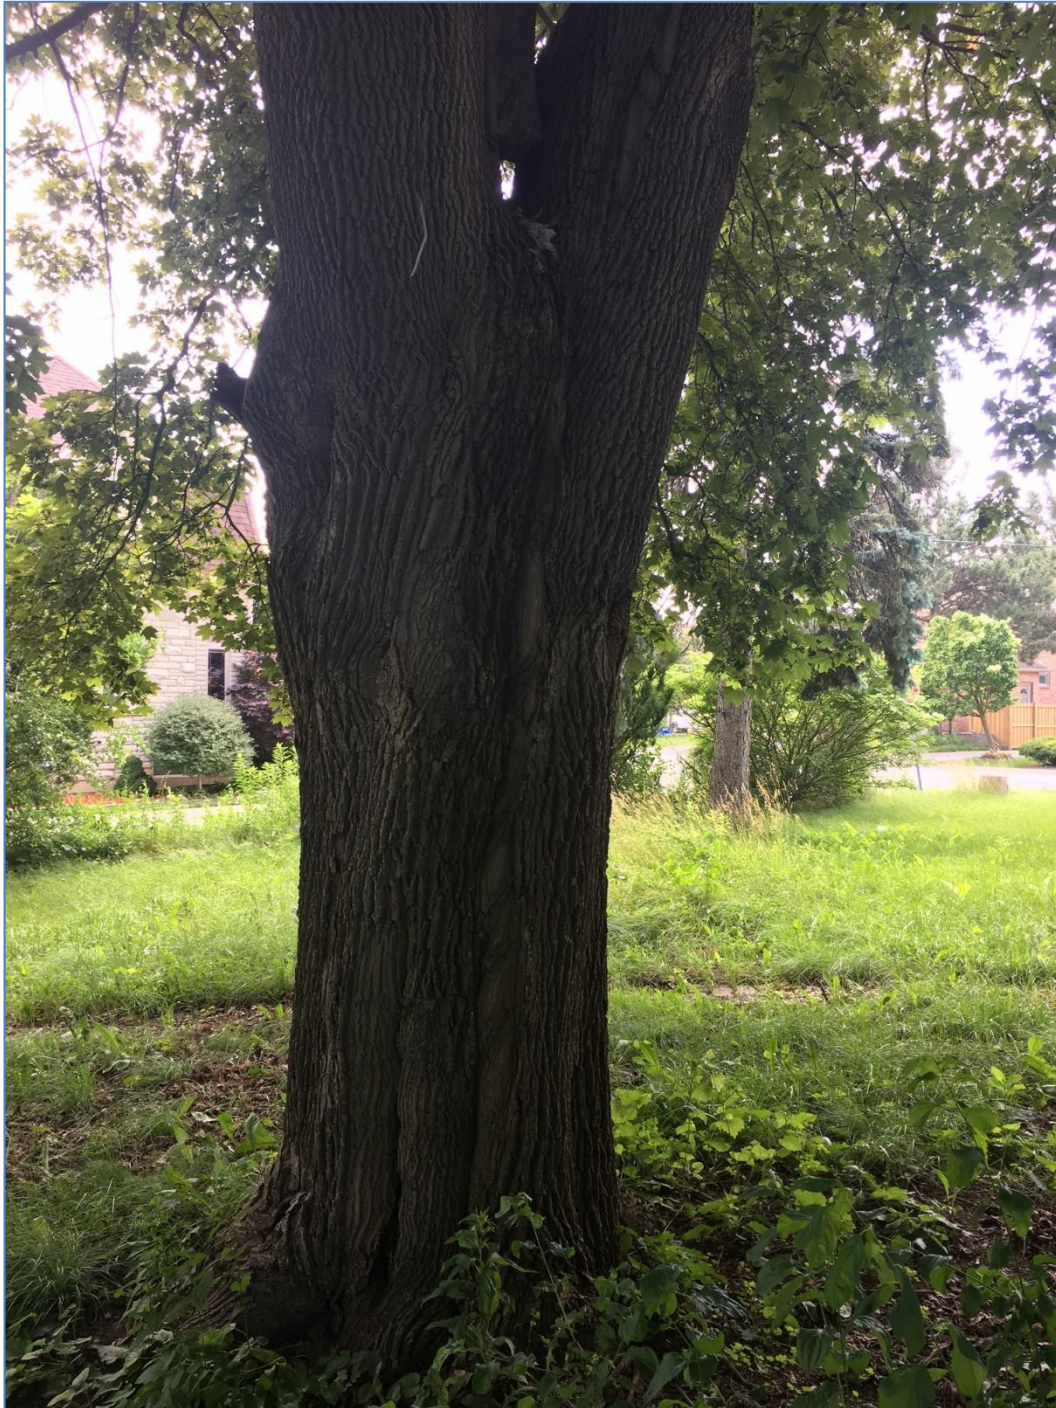
Tree 1: 2.5-meter include bark seam on backside of tree

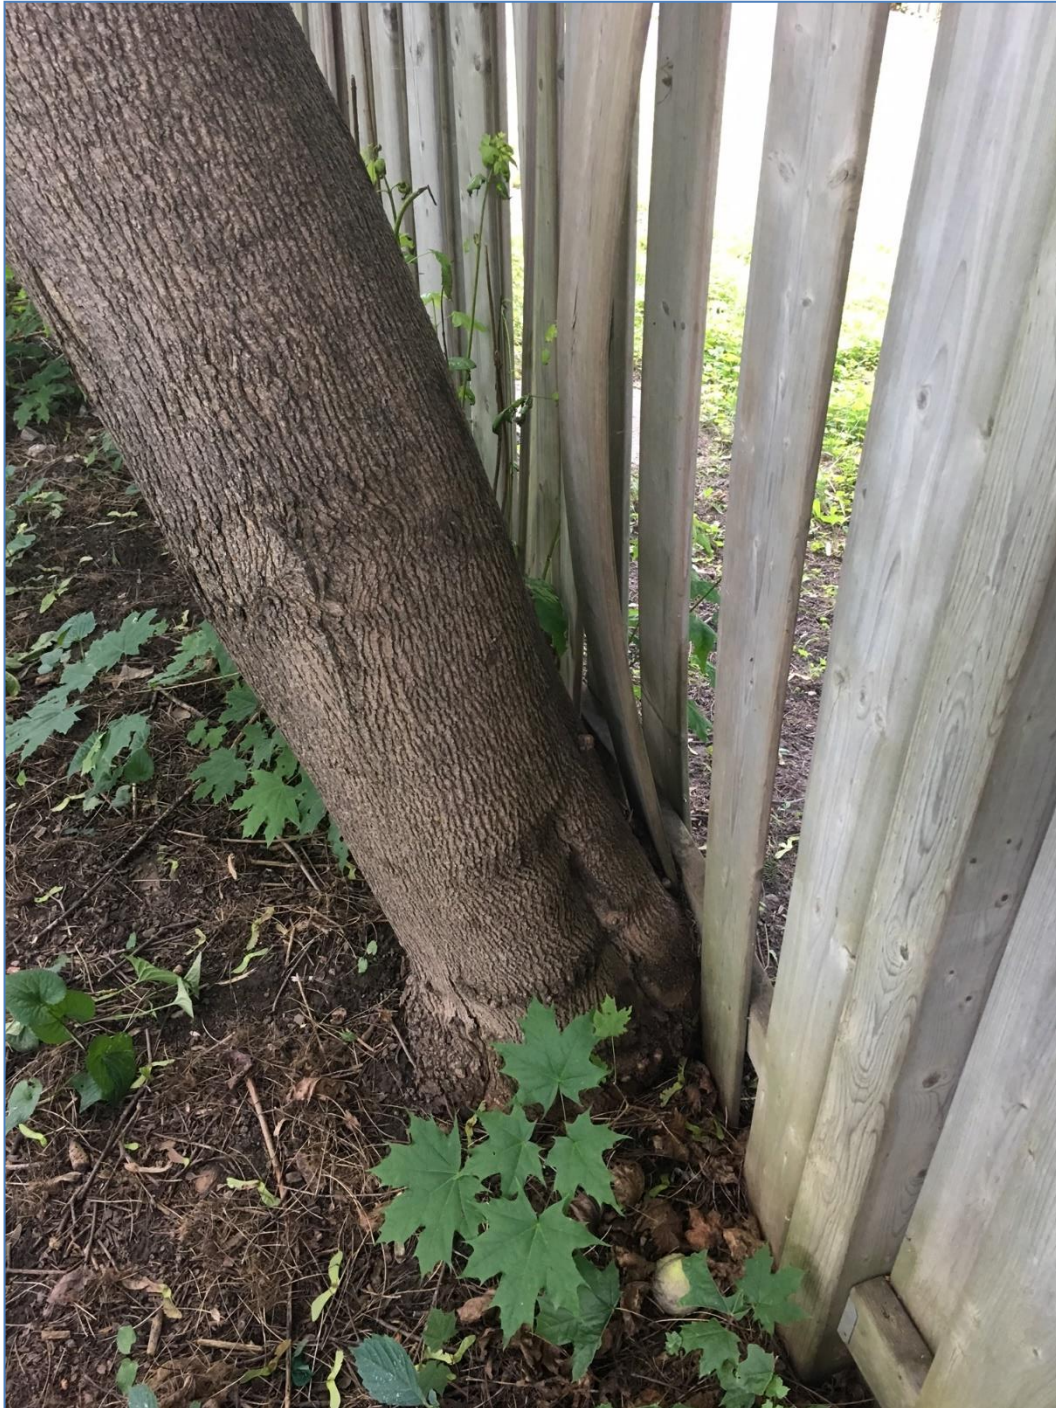
Tree 2: Visible lean, minor fence damage, source of basal girdling

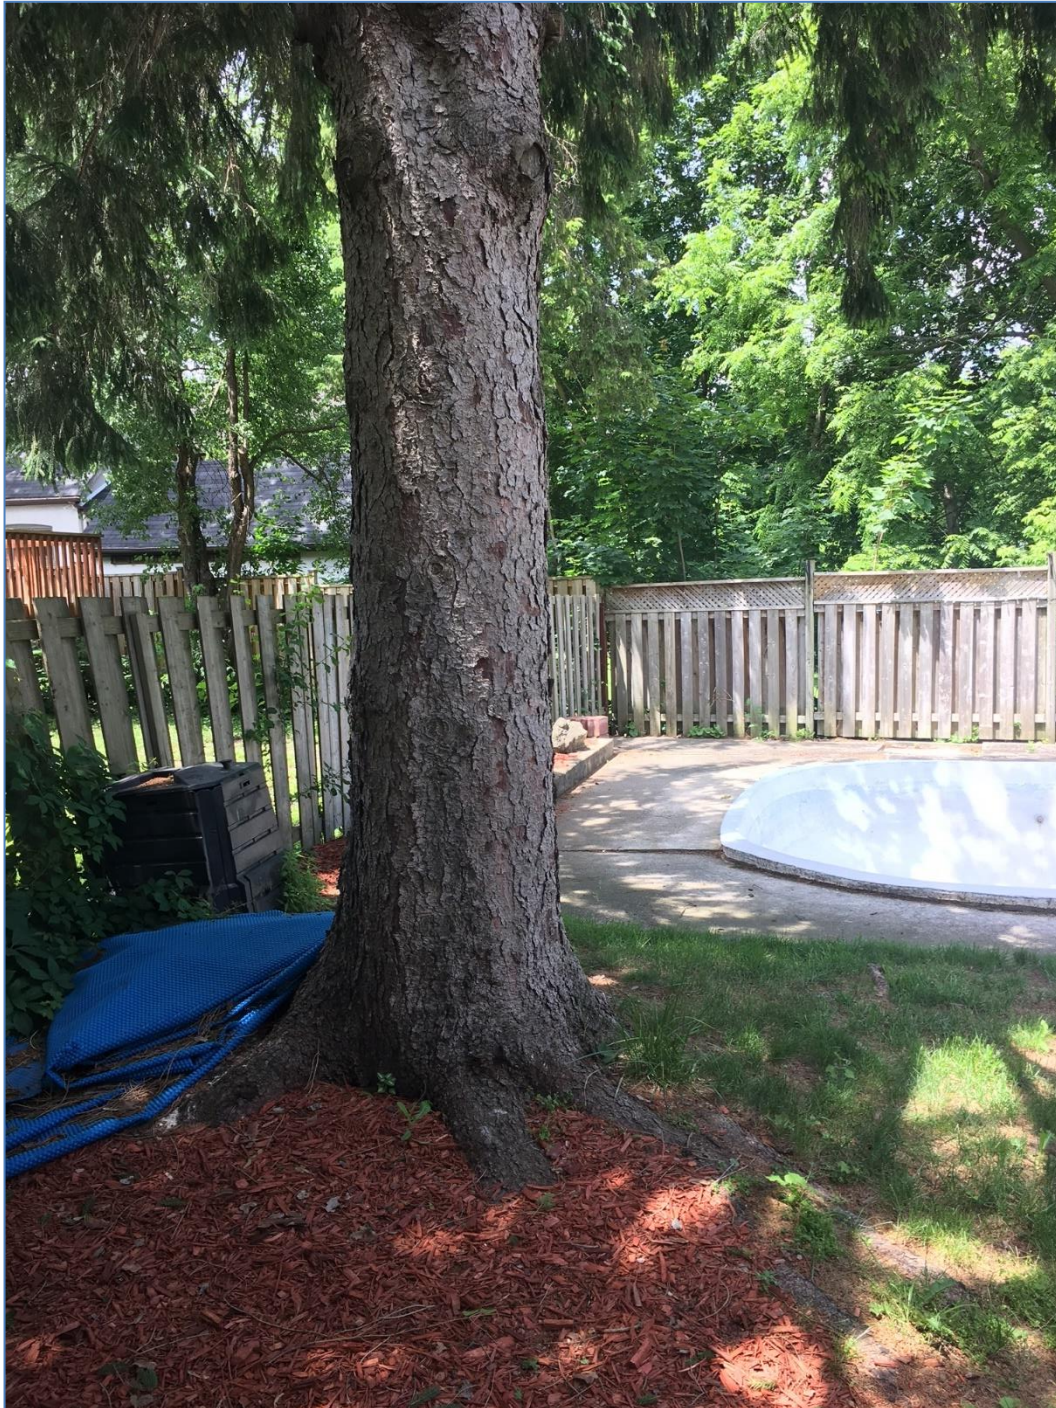
Tree 3: Well-established root flare with pronounced surface rooting

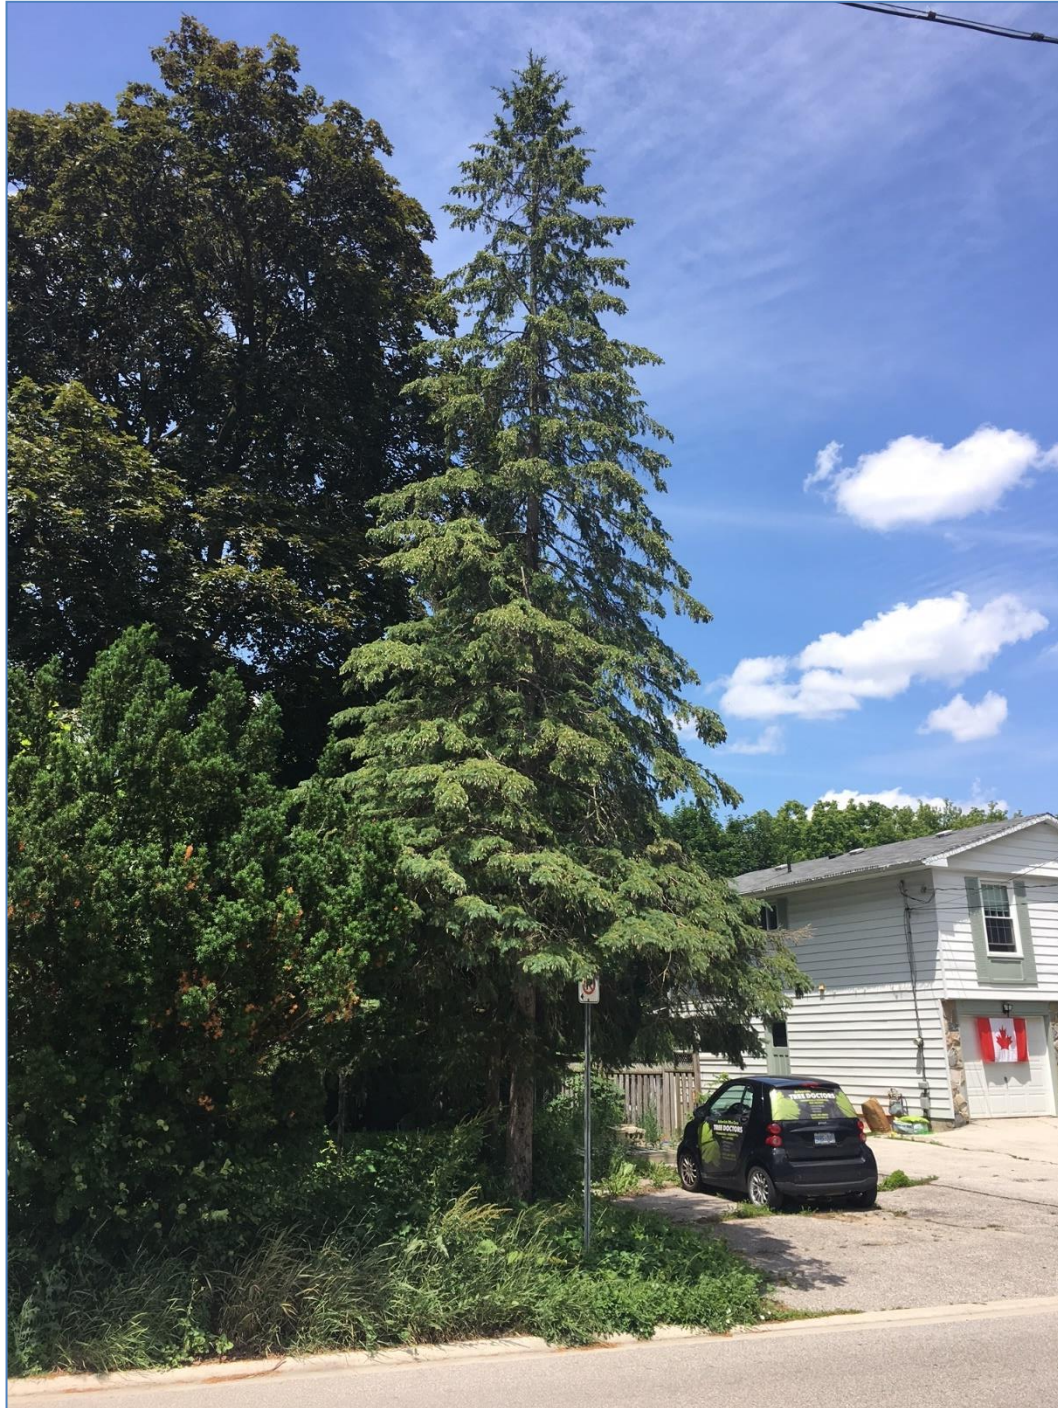
Tree 4: White Spruce (Picea alba)

Tree 4 is a 22-cm. White Spruce in fair condition located within just West of the existing driveway at 77 Clarence Street. The proposed construction encroaches on the 1.8-meter Tree Protection Zone by up to 1.4 meters. The tree cannot be retained in safe and healthy condition at this level of encroachment. Therefore, we are requesting a permit for removal. For a tree removal of this size (20-30 cm. base diameter), the City of Vaughan requires 1 replacement tree as compensation. Please see the section titled, “Replanting Plan” for more details.

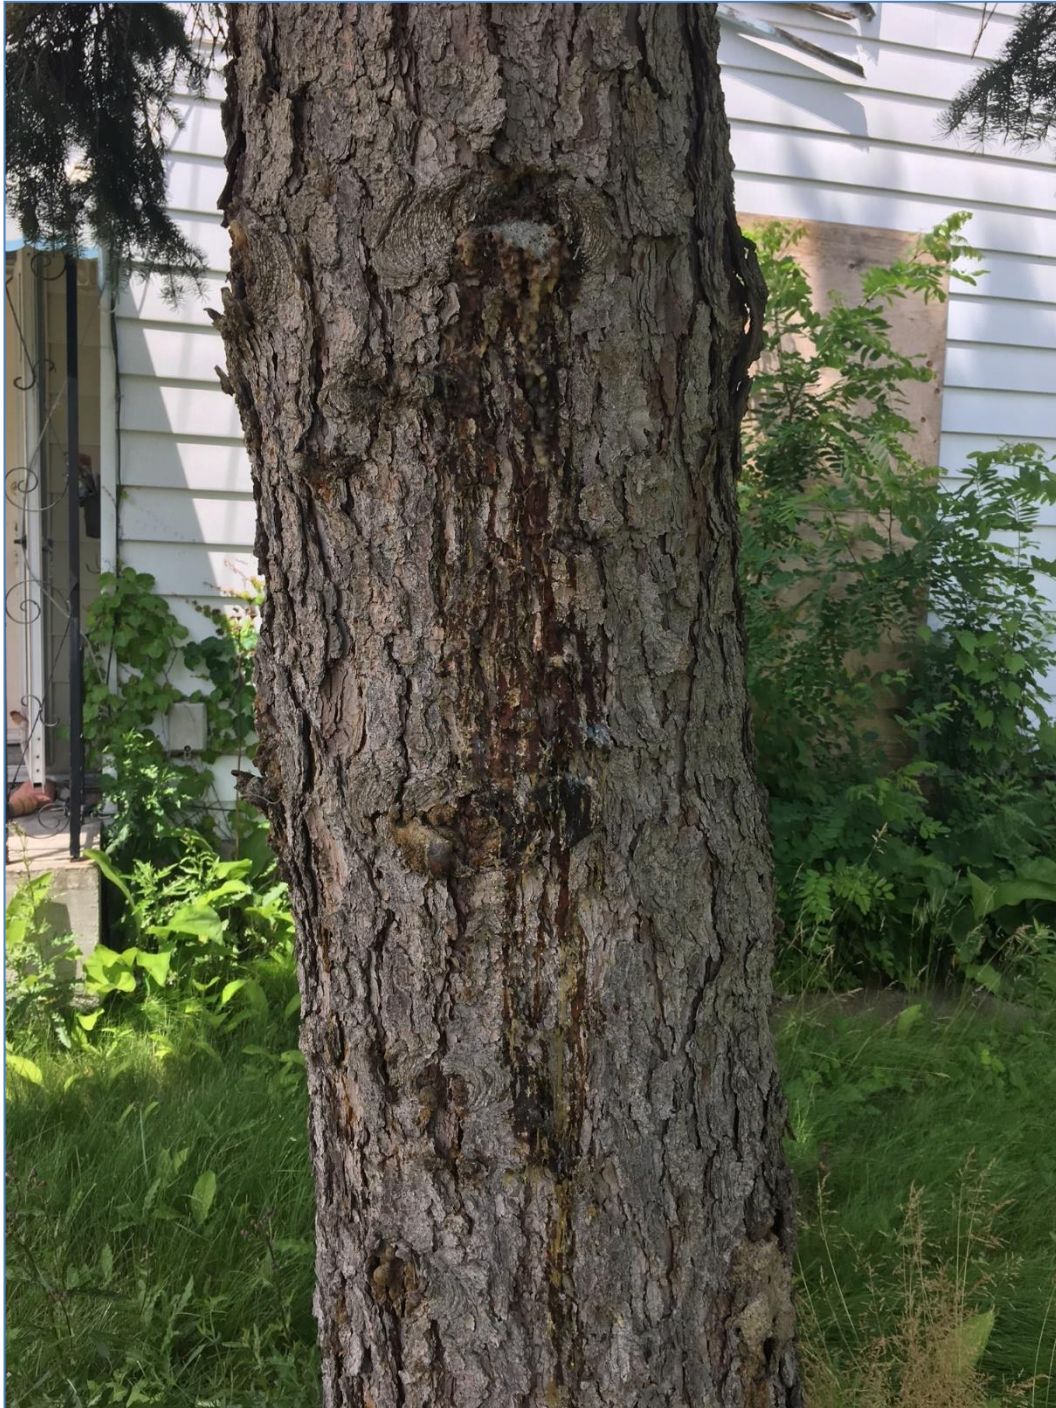
Tree 5: Gummosis on main stem

Tree 5 is a 41-cm. Colorado Spruce in poor condition located within just within the limit of excavation required for the proposed development at 77 Clarence Street. The tree cannot be retained in safe and healthy condition and therefore, we are requesting a permit for removal. For a tree removal of this size (41-50 cm. base diameter), the City of Vaughan requires 3 replacement trees as compensation. Please see the section titled, “Replanting Plan” for more details.

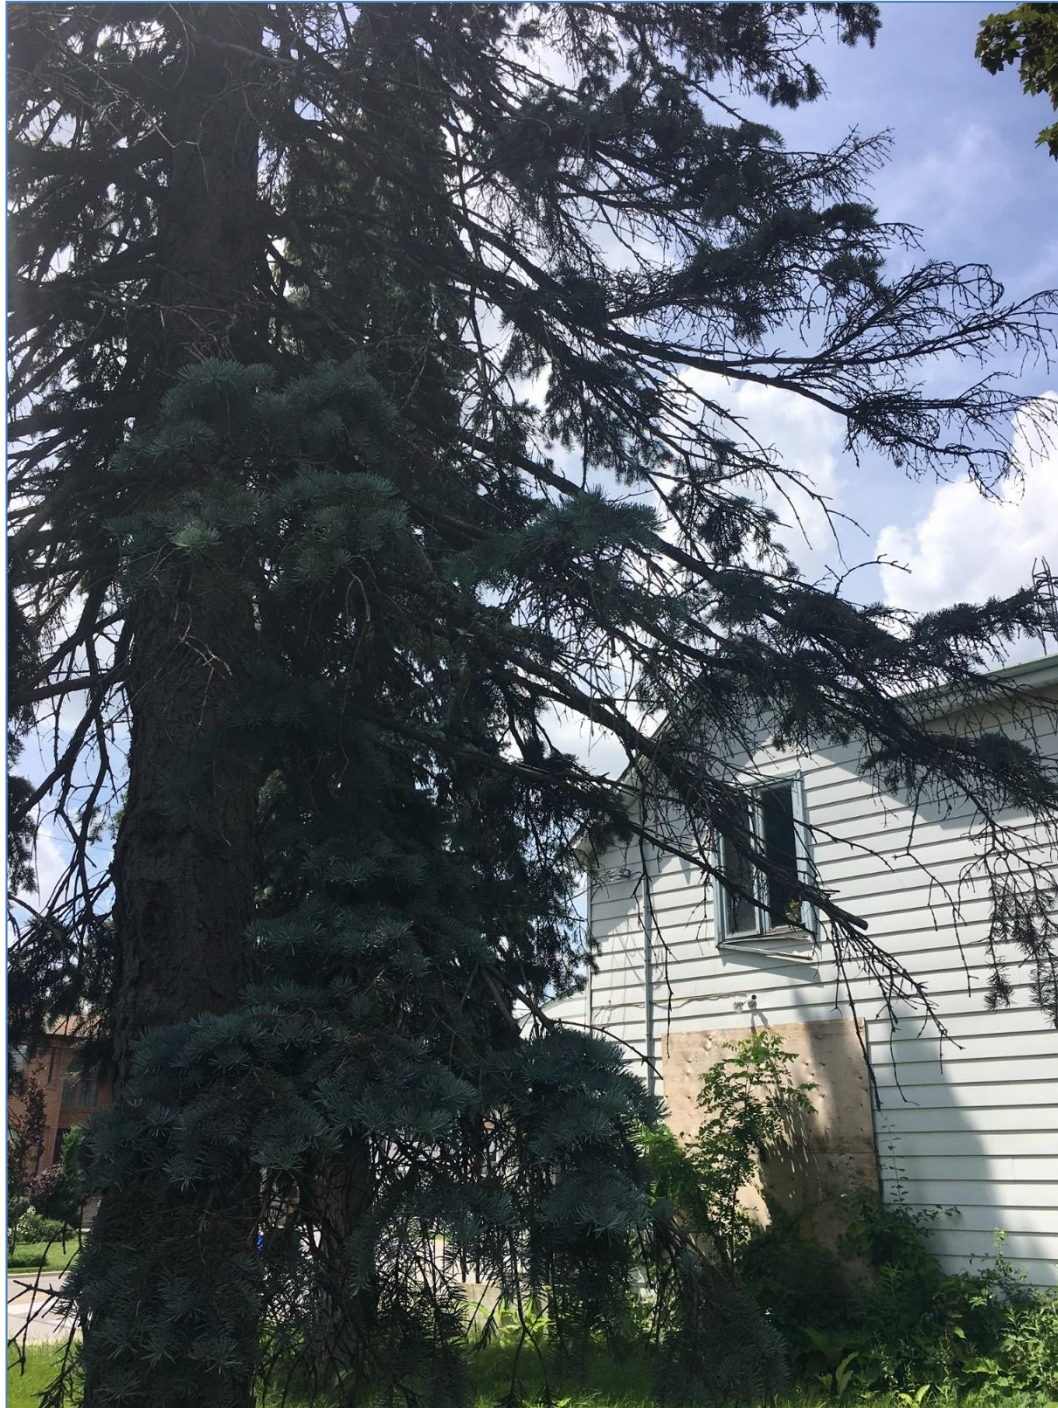
Tree 5: Significant dieback through lower crown

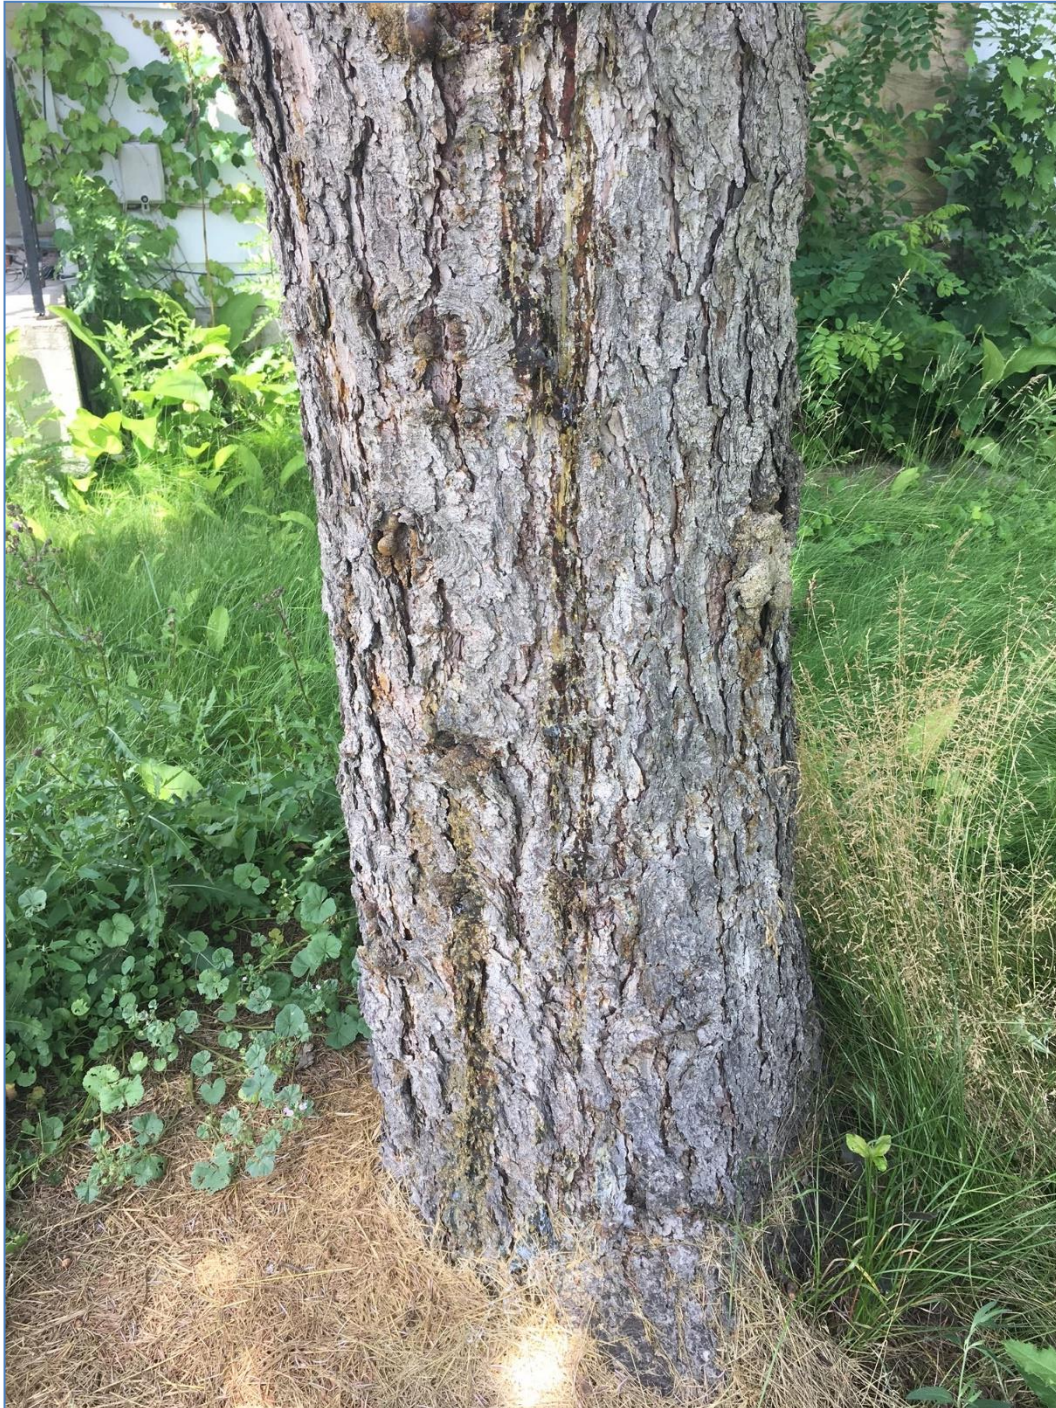
Tree 6: Gummosis on main stem

Tree 6 is a 46-cm. Colorado Spruce in fair-poor condition located within just within the limit of excavation required for the proposed development at 77 Clarence Street. The tree cannot be retained in safe and healthy condition and therefore, we are requesting a permit for removal. For a tree removal of this size (41-50 cm. base diameter), the City of Vaughan requires 3 replacement trees as compensation. Please see the section titled, “Replanting Plan” for more details.

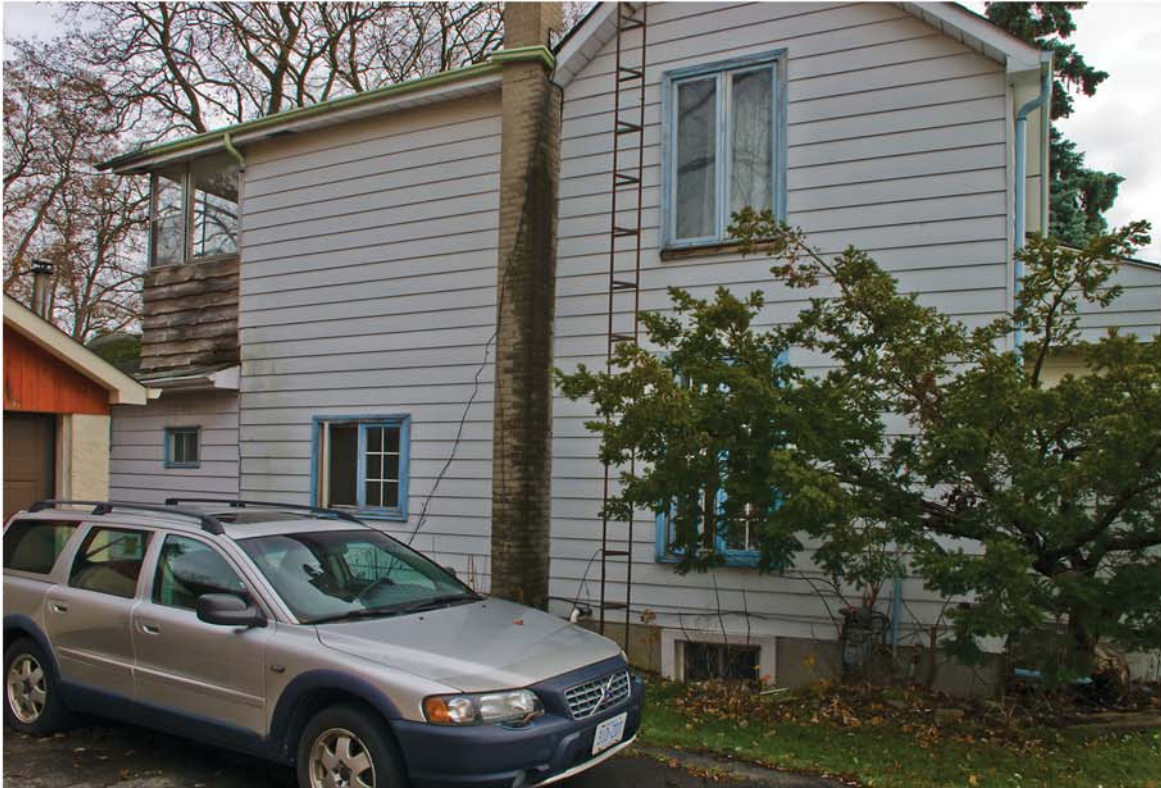
All the original windows have been replaced with casement windows, some with simulated divided lights and some with none. In 1925, the original windows could have been either casement windows with divided lights or double hung windows with or without divided lights. No evidence of the original windows was found, nor was any photographic evidence or reference material located. Some of the windows in some of the rooms are out of scale (too large) with the size of the room. The window openings may have been enlarged when the windows were replaced.

North Elevation Showing Metal Siding, Soffits & Fascia, Enlarged Window On The Second Floor, & Brick Chimney

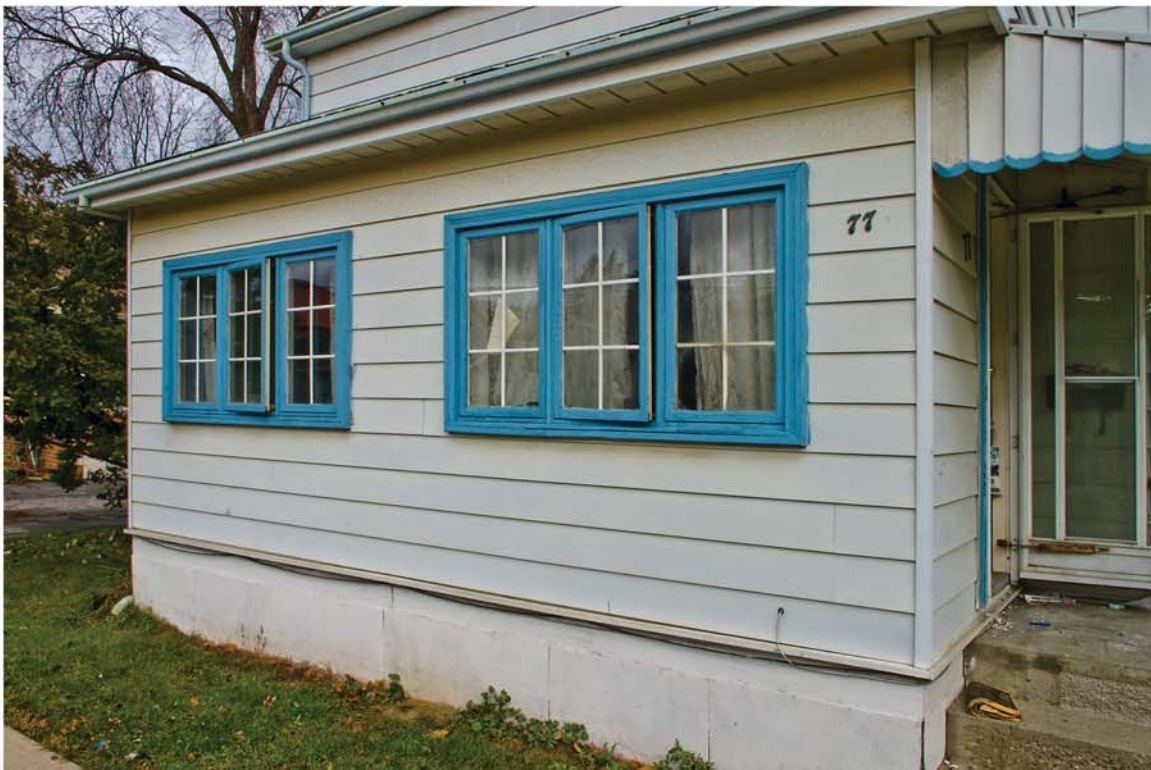
Originally the front porch was an open platform with a roof and railing. The front door to the house came off this porch & was located in the west wall of the house, to the south of the interior stairs. The present front entry door and concrete platform is relatively new and was positioned in its new location on the south elevation of the porch to accommodate the incorporation of the porch into the living room. The original door was not found in the house. Enclosing the porch and adding two windows changed the whole character of the house. The original open porch with its railing provided interesting detail for the entry, and gave the house a welcoming aspect. The very poorly considered design with respect to the placement and size of the windows and the resultant wall space is totally unsympathetic to the house.

The porch was built on posts, and has no foundation. Traditionally, the space under the porch would have been open and vented by a wood trellis enclosure from the platform to the ground. As this space is now under the living room, flimsy panels have been installed to close off this space from the weather, which gives a temporary appearance.

West Elevation Of The Enclosed Front Porch, And A Portion Of The New Front Entry

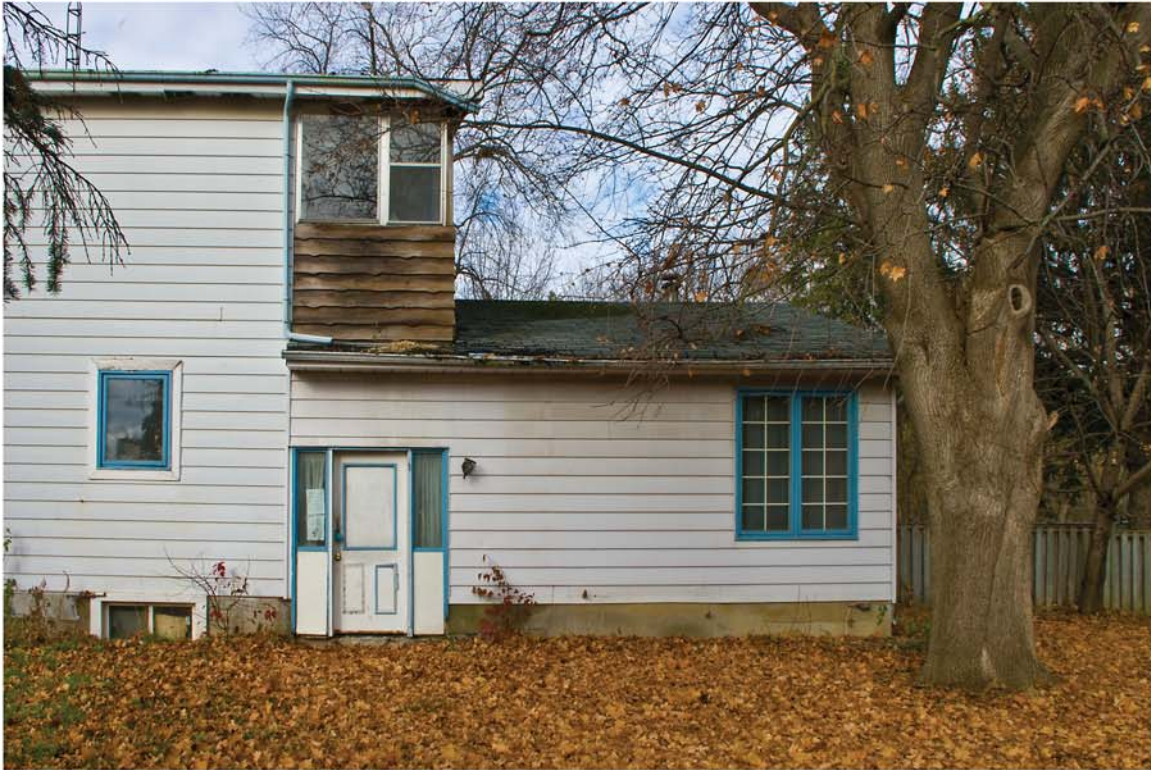
The recent side entry on the south elevation is located at the west end of the one - story addition, and is a poorly constructed door with sidelights. Directly above this is the deck off the master bedroom on the roof of the one - storey addition. It appears to have been built at the same time that the one - storey addition was added, and then enclosed with aluminum windows in a make shift manner at a later date. Its design is a very uncomfortable fit with the house.

South Elevation Of The Kitchen Section Of The Two - Floor House, And The Rear Addition: Showing The Side Entry Door With Side Lights, And The Enclosed Deck Off The Second Floor Master Bedroom

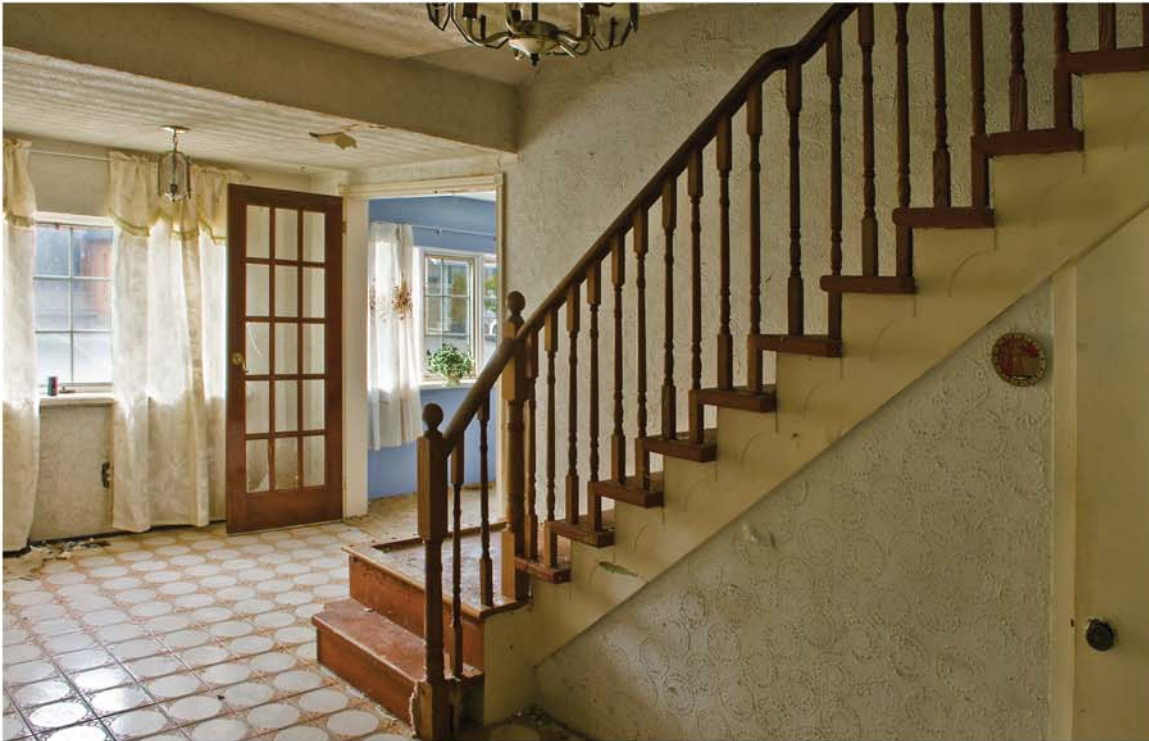
The original first floor plan has been altered by the incorporation of the front porch into the living room and front entry. There are two bedrooms over the original section of the house. The two storey kitchen/dining section with master bedroom above was likely an early addition before the 1974 one storey family room addition to the rear was added. There is no original trim, doors, or baseboard remaining. All of the interior is in very poor condition.

Entry Hall Looking North - West: Showing The Incorporated Enclosed Front Porch Indicated By The Drop In The Ceiling, The Newer Stairs In The Original Location, And No Original Trim

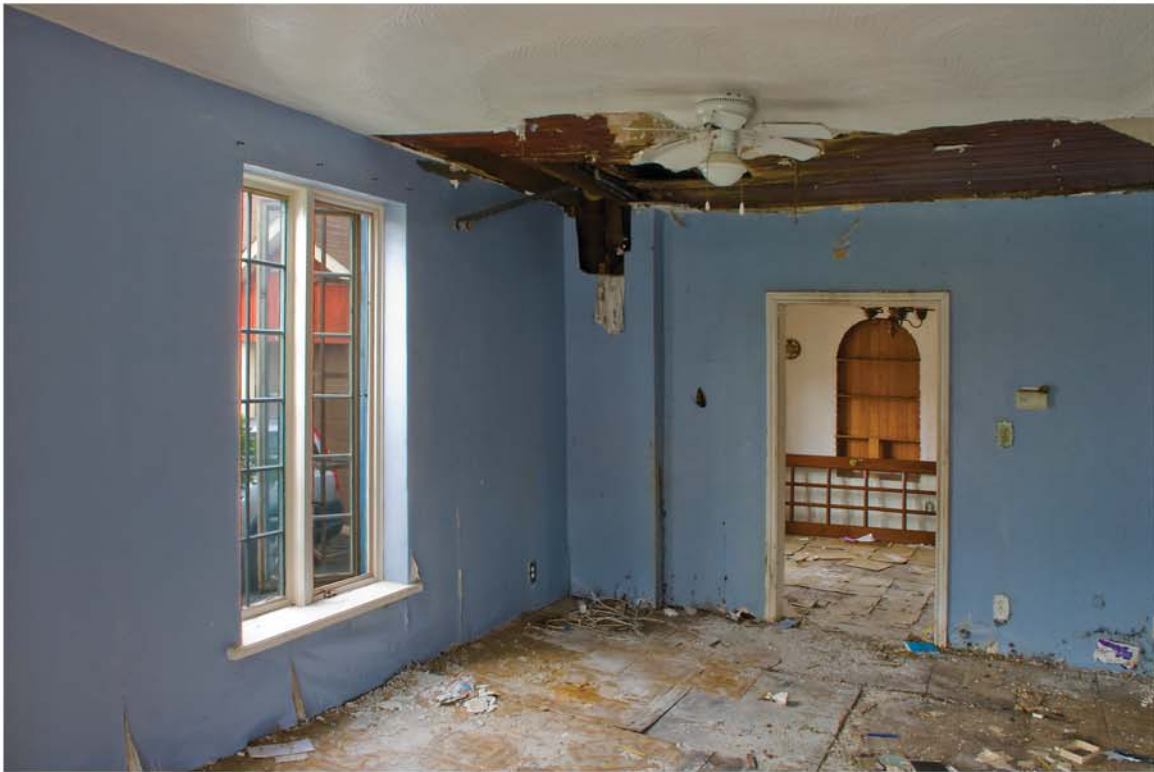
Living Room Looking North - East: Showing Replaced Window, Original Stained Wood T & G Ceiling with Drywall Over, Step Down Entry Doorway To Dining Area, And No Original Trim
