10. NEW CONSTRUCTION – SINGLE DETACHED DWELLING, 77 CLARENCE STREET, WOODBRIDGE HERITAGE CONSERVATION DISTRICT

TITLE: NEW CONSTRUCTION – SINGLE DETACHED DWELLING, 77 CLARENCE STREET, WOODBRIDGE HERITAGE CONSERVATION DISTRICT

CULTURAL HERITAGE IMPACT ASSESSMENT

**77 CLARENCE STREET
CITY OF VAUGHAN, ONTARIO**

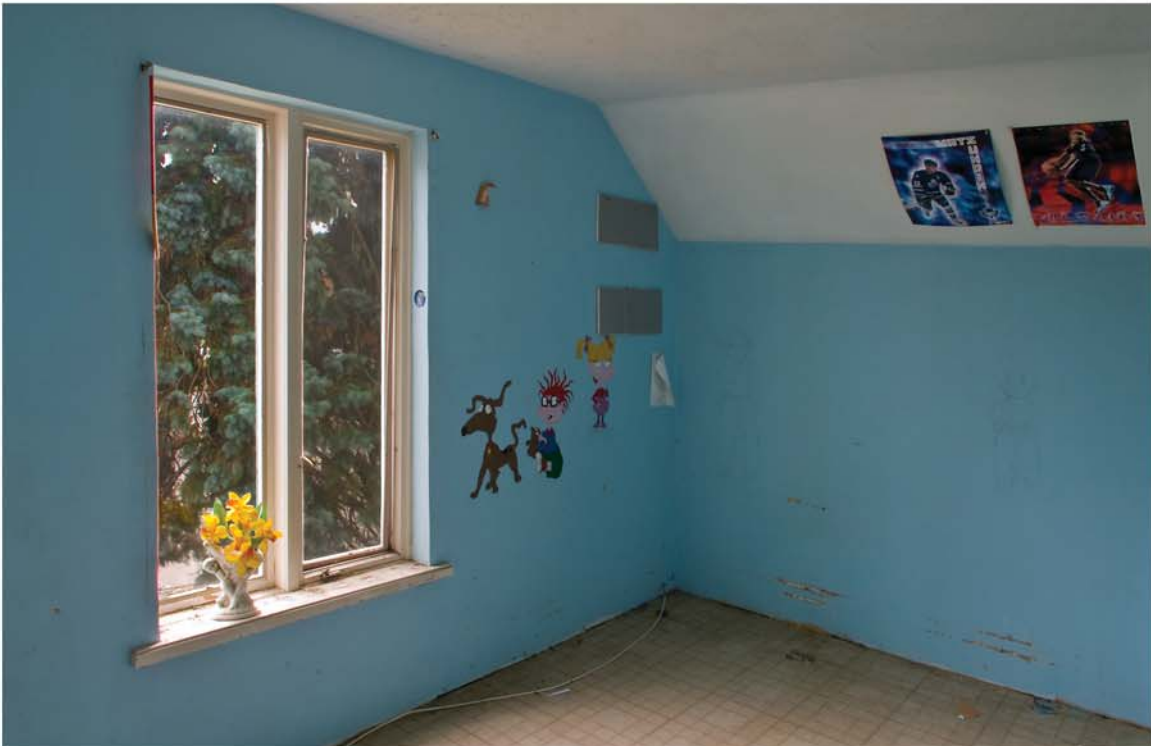
South West Bedroom, Looking South West, Showing New Enlarged Window On The South Elevation, No Window Trim Or Baseboard

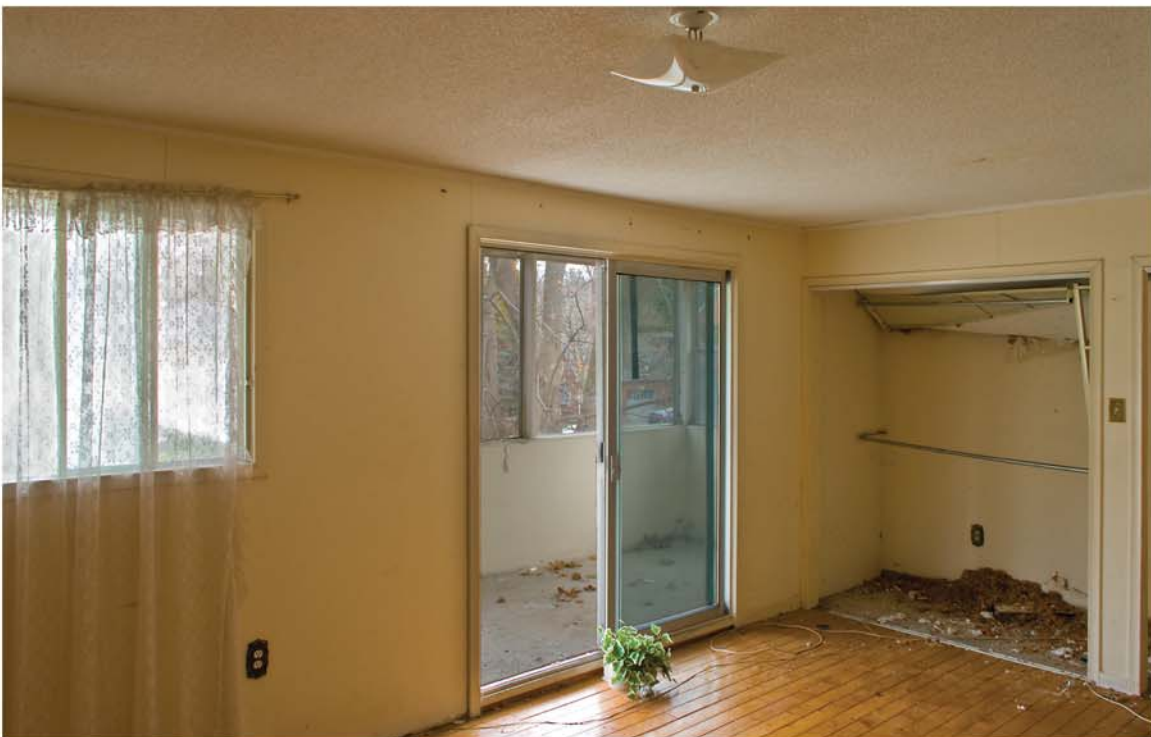
Master Bedroom Looking South East Showing New Sliding Doors To Enclosed Deck On The East Elevation

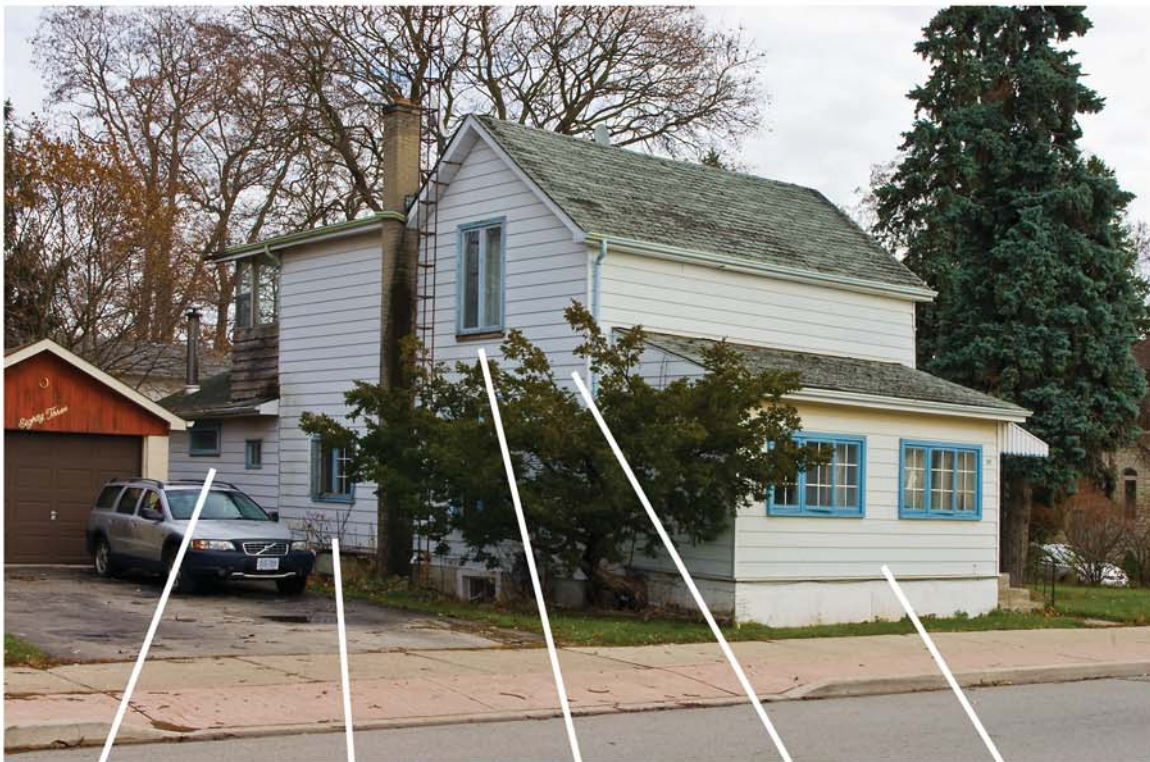
Some of the additions and alterations can be seen in the photograph below. Taking this heavily modified building back to its original form would not leave enough building left to restore.

**One Storey Addition
 Built After 1974**

**1 1/2 Storey Addition
 Likely Replaced An
 Original Kitchen Tail**

As an original workman's cottage, it once contributed to the context of the area. The effect of the extensive unsympathetic modifications, and extremely poor condition of the building, means that it no longer is representative of the time that it was built, and therefore no longer fulfills this contributing role in the district. Hence, it does not contribute to the context of the Clarence Street and Park Drive character area, which is a Designated Heritage Conservation Area under Part V of the Ontario Heritage Act.

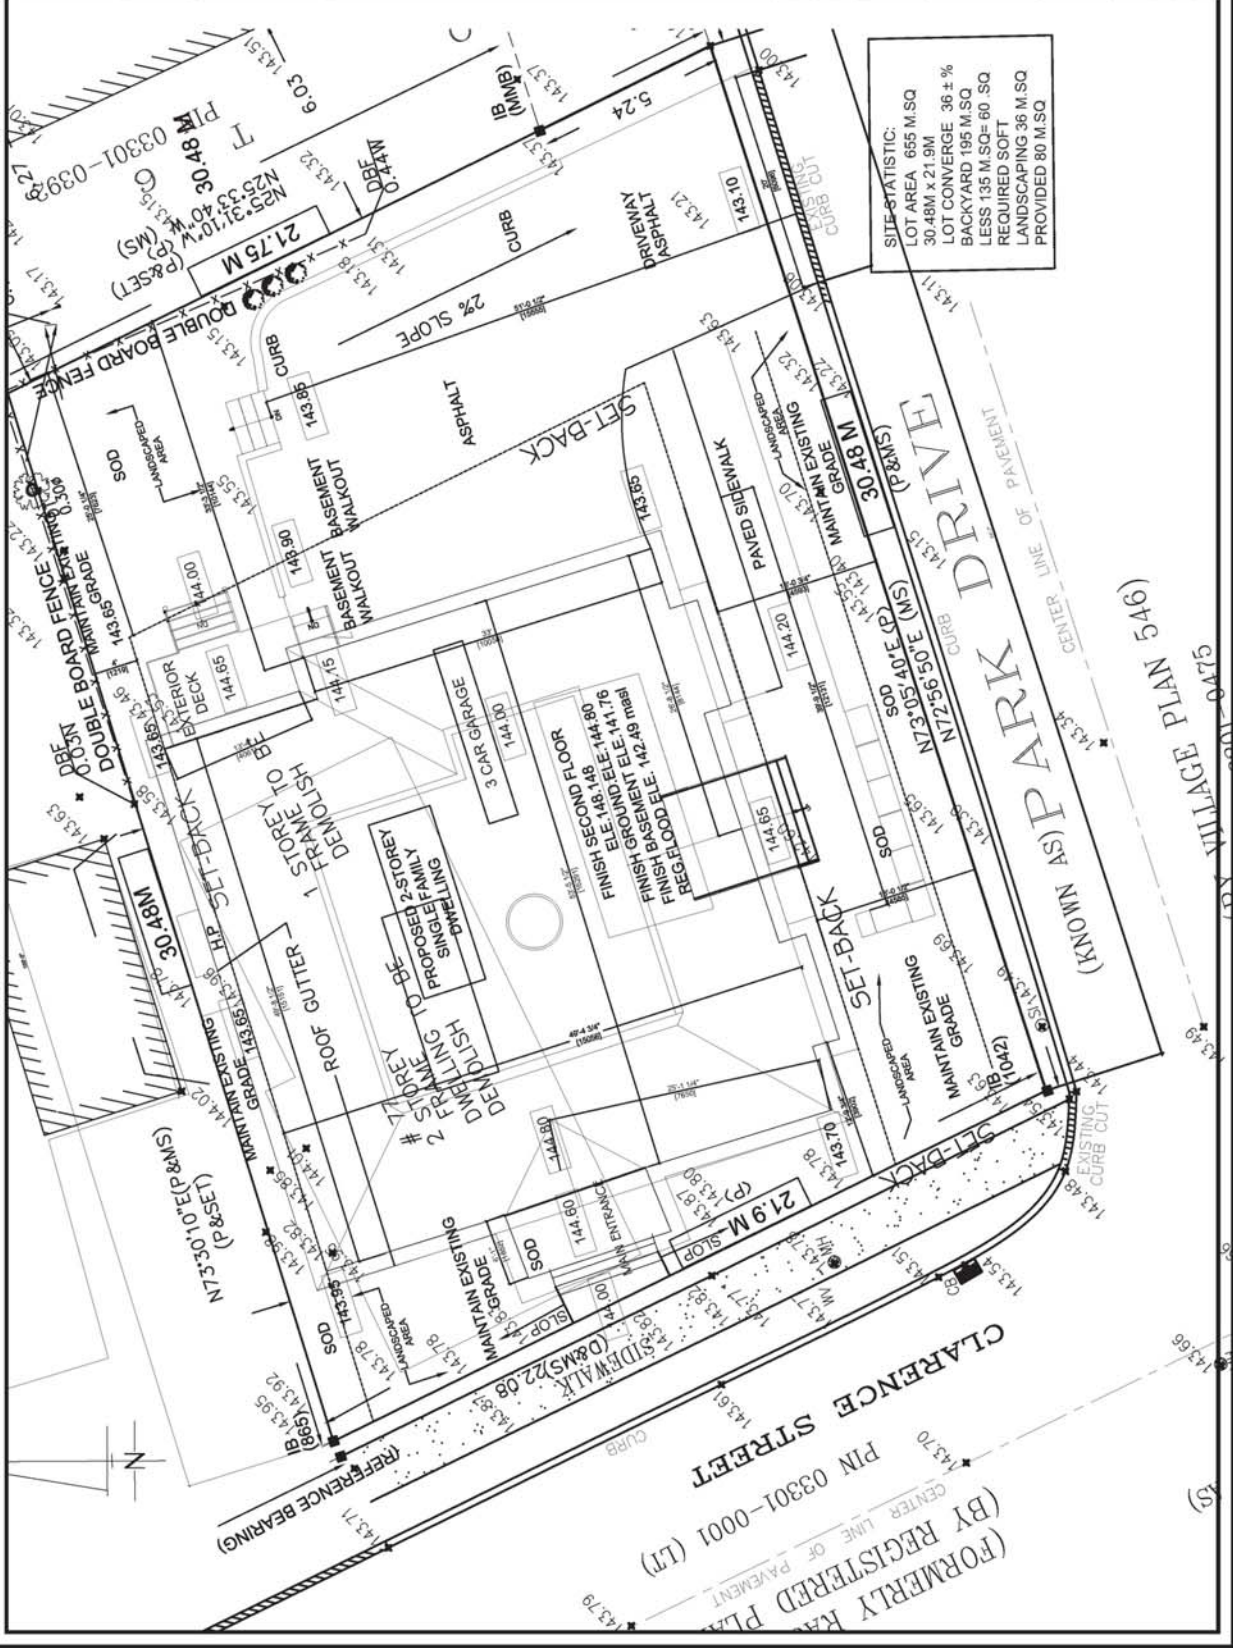
STATISTIC:
 LOT AREA 655 M.SQ
 LOT CONVERSE 36 ± %
 BACKYARD 195 M.SQ
 LESS 135 M.SQ = 60 M.SQ
 REQUIRED SOFT
 LANDSCAPING 36 M.SQ
 PROVIDED 80 M.SQ

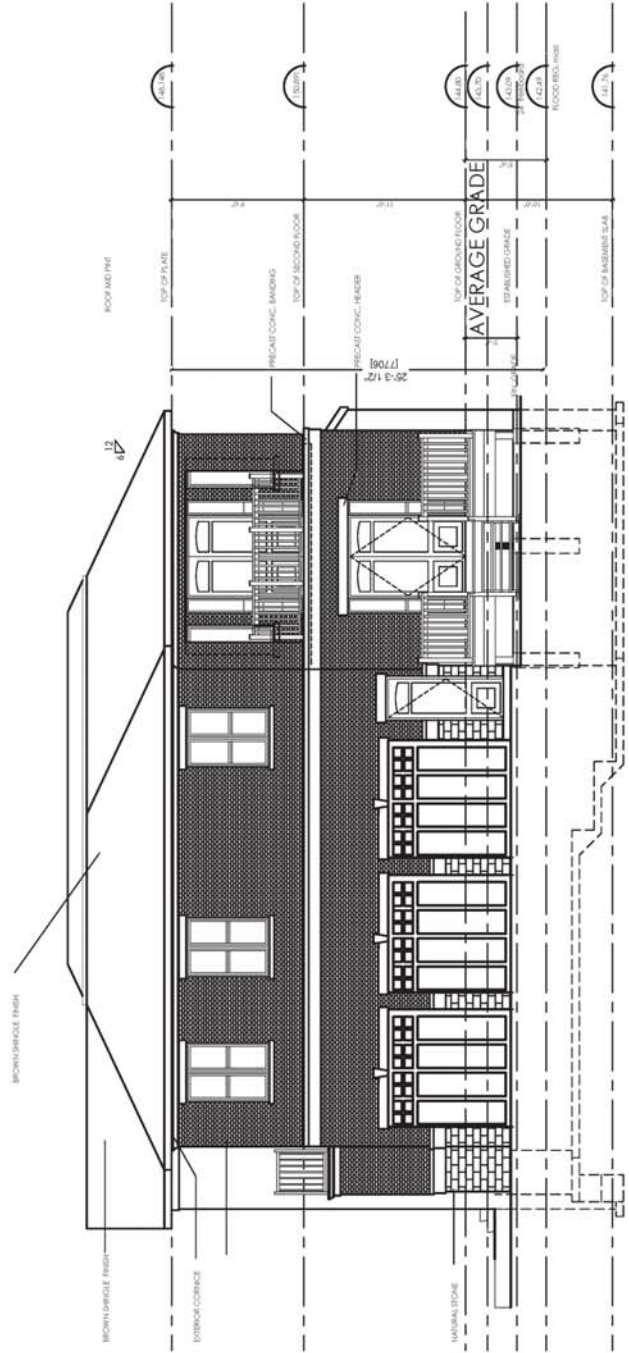
EAST ELEVATION

THE EXISTING HOUSE DOES NOT HAVE A GARAGE THEREFORE THE GARAGE IS HIDDEN AND NOT VISIBLE FROM STREET
 - SQUARE WINDOWS TO MATCH THE HERITAGE STYLE OF THE TIME
 - AND TO MATCH THE EXISTING HOUSE
 - NATURAL STONE TO BRING THE HERITAGE APPEARANCE AT WINDOW BASE LEVEL
