46 CENTRE STREET, VAUGHAN CONSERVATION PLAN

PREPARED FOR
DAVID GRANT-RUBASH
PHAEDRUS STUDIO

REV. II - FINAL

SEPTEMBER 17, 2021

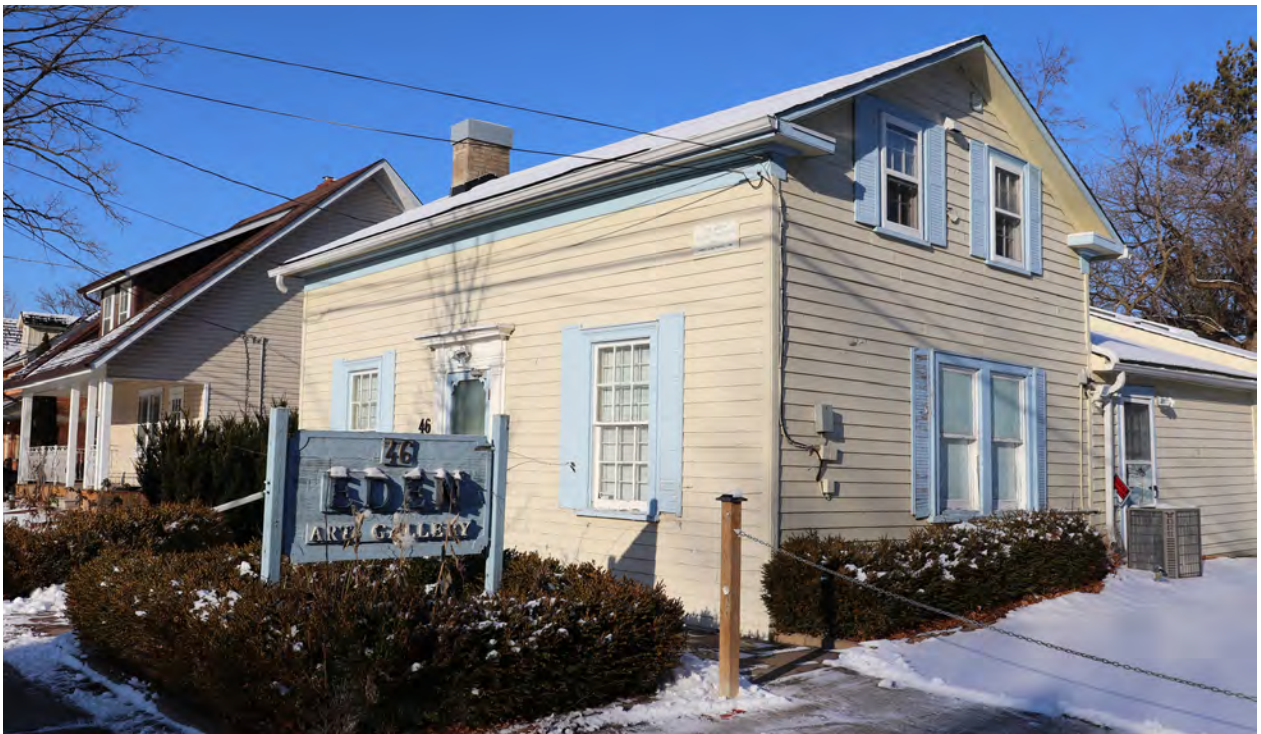
The original settlement house (referred to as Main House in this report) is a 1½ storey wood structure likely constructed prior to 1845 (Figure 4). It has several 19th century additions immediately north, and a larger late 20th century gable-roofed addition (Figure 5). Originally constructed as a residence, the building was converted to support commercial uses and is currently vacant.

Figure 4: Looking northwest, the original Main House construction is comprised of the gabled mass fronting Centre Street (CBCollective, 2020).

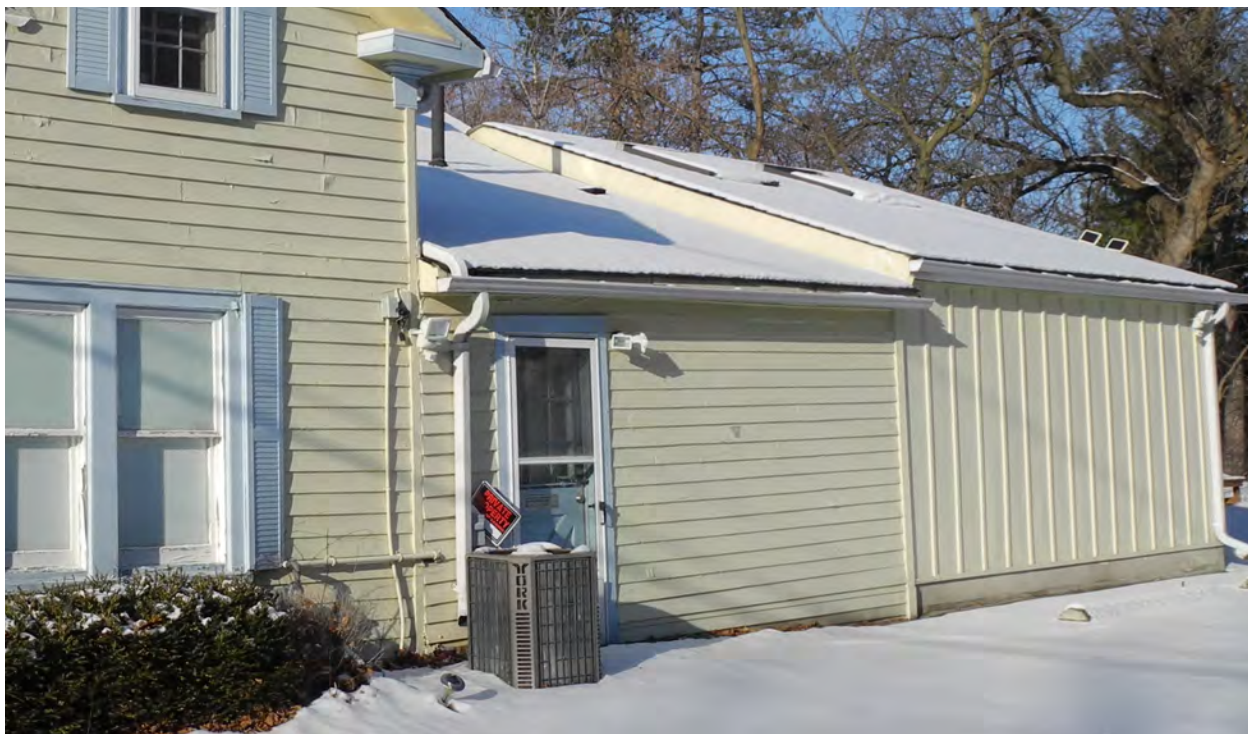
Figure 5: There are at least three different additions to the north of the Main House, two of which are seen in this photograph (CBCollective, 2020).
