CONDITION SURVEY

8204 KIPLING AVENUE, WOODBRIDGE, ONTARIO

KEA Report #20071

July 22, 2020

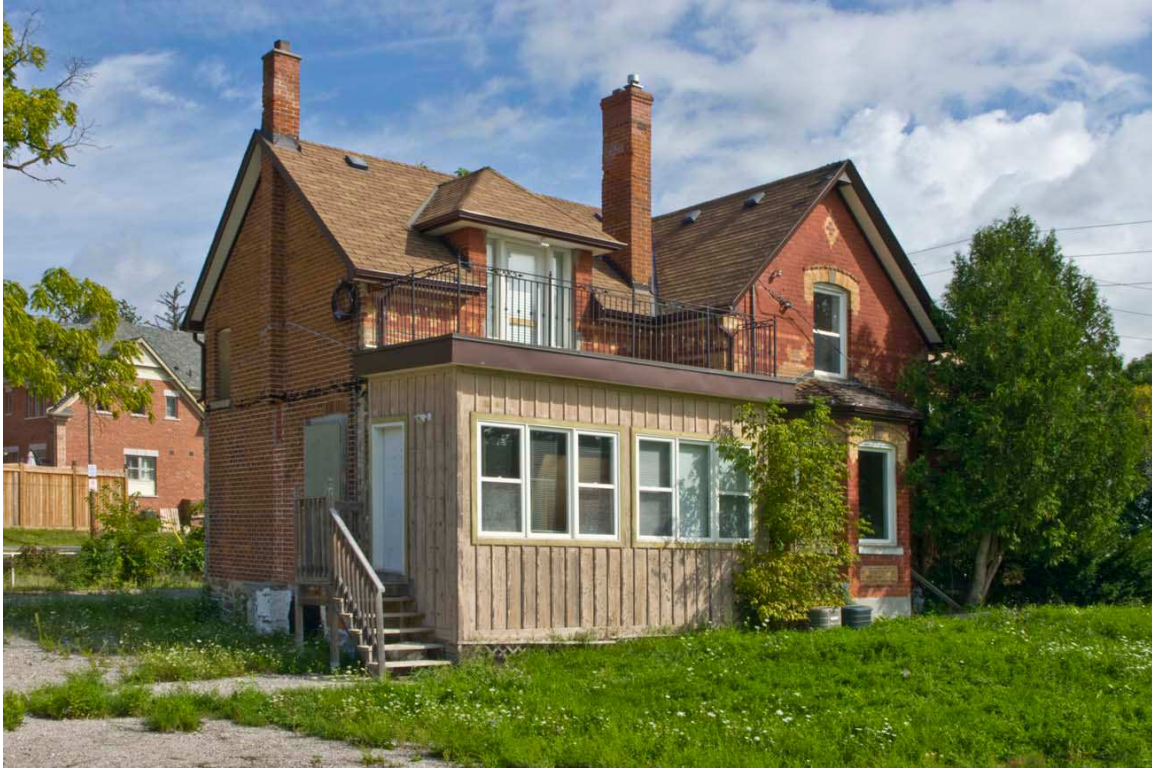
SOUTH ELEVATION

Perimeter Walls -It was noted that all the perimeter walls above ground are of red brick veneered construction with buff brick trim quoined decorative detailing around corners with arches over the windows. See photos 1 to 4
