REPORT

10489 Islington Avenue, City of Vaughan, Ontario
Maintenance Plan

1668503-R02

September 24, 2020

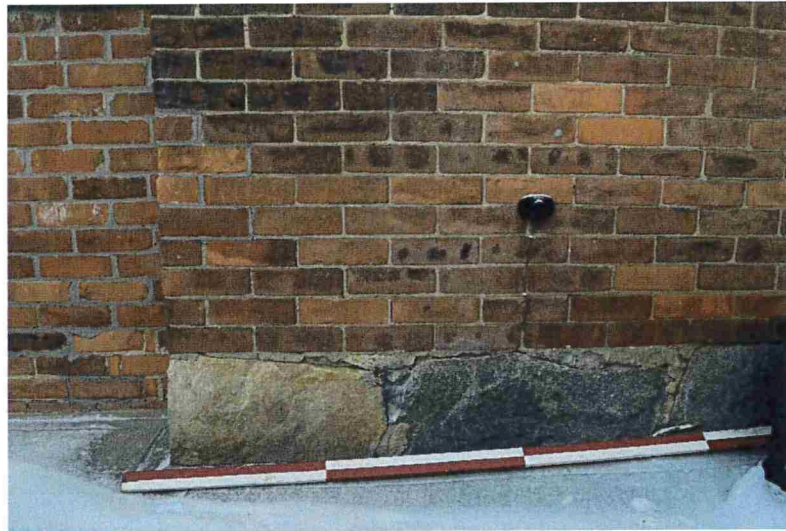
The main block of the house is two-storeys and three-bays with a square plan, with the principal façade oriented to Islington Avenue. The foundation is partially visible above grade and is random-rubble squared fieldstone parged in mortar (Figure 8 and Figure 9). The walls are brick laid in stretcher bond for the principal Islington Avenue, the south facade, and interestingly, only two-thirds of the north wall; just west of the east windows on the latter facade the masonry transitions to one-in-four American or common bond and is capped at the eave by a row of headers. For the east facade the bonding pattern is different again, this time stretcher bond for corner and for the wall below the upper level windows, then one-in-five common bond for the upper level, which are also capped by a row of headers. This indicates a major extension to the east (further seen in the basement, described below) at some point prior to 1925, when the house appears in a photograph little different from its current state. Apart from the varied bonding pattern and window treatments, there are no other wall details.

Figure 8: Random rubble fieldstone foundation and brick masonry at the southwest corner of the house (December 2016).

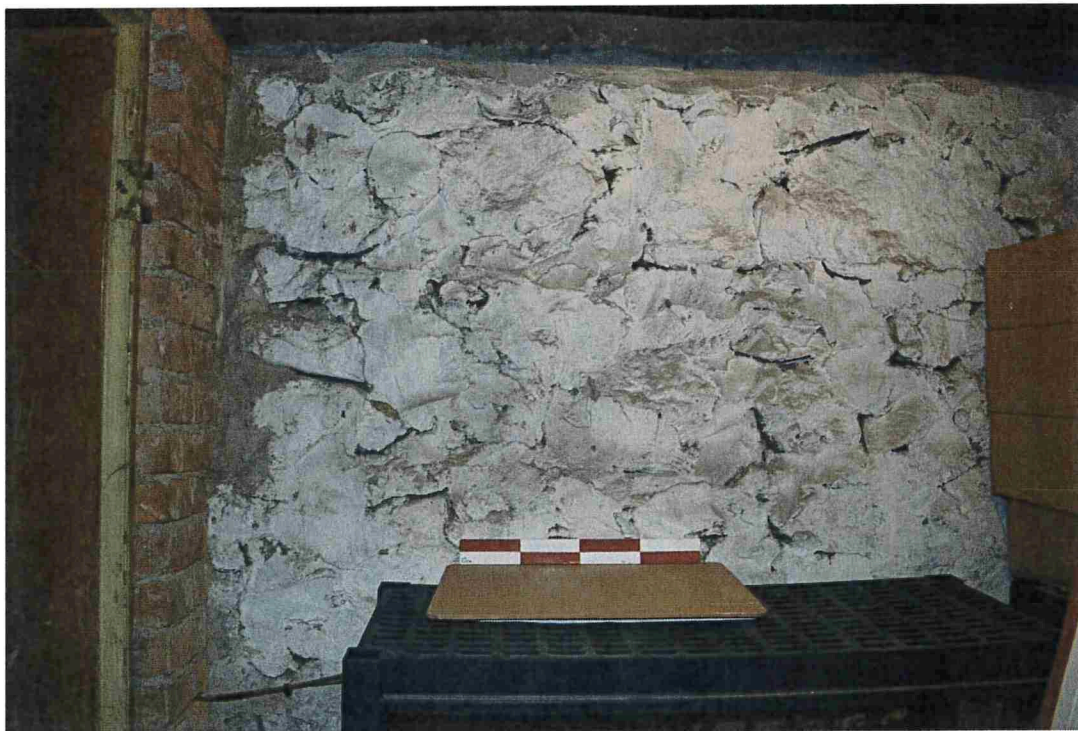
Figure 9: Rubble foundation masonry as seen from the basement (December 2016).

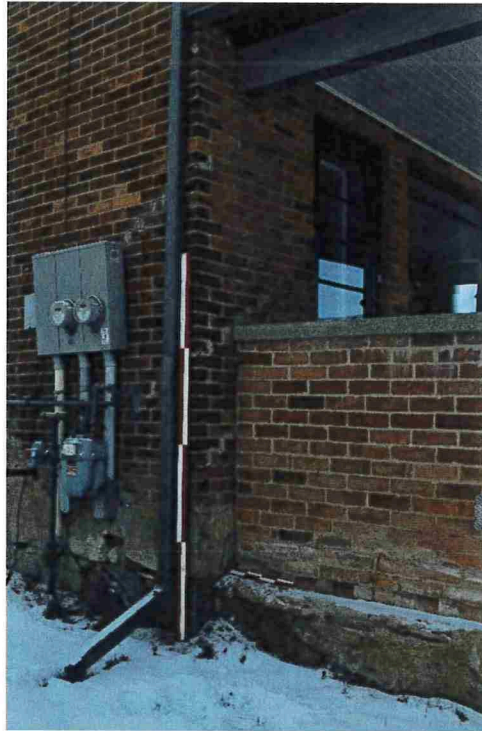
The open front porch has a fieldstone foundation and brick base that is not keyed into the main block wall, and wide brick piers at the corners that support a wide and notched frieze and a hip roof with projecting eaves (Figure 14 and Figure 15). The straight stairs leading to the porch deck are of diminishing width and have a railing combining wood for the top and bottom rails, and steel bar balusters. This balustrade is also used for the railing enclosing the deck, which run from the piers to two smaller panelled wood pillars. Both the decking and tongue-and-groove ceiling planks are wood, and a crown moulding lines the inside edge of the frieze where it meets the ceiling. Overall, the house is representative of the widely popular Edwardian Classicism style (1900-1930), known in the United States as 'Foursquare' (Blumenson 1990; Fram 2003).

Figure 14: Connection between the verandah and house (December 2016).
