HERITAGE UPDATE LETTER

ATTACHMENT 2 15 MILL STREET

RE: HERITAGE UPDATE LETTER, 15 MILL STREET

HERITAGE IMPACT STATEMENT
THE MILL COTTAGE
15 MILL STREET, THORNHILL
CITY OF VAUGHAN, ONTARIO

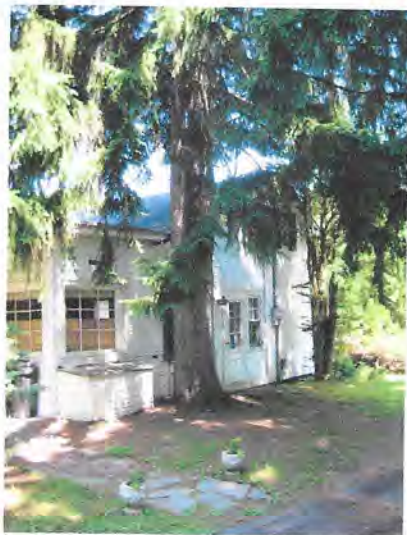
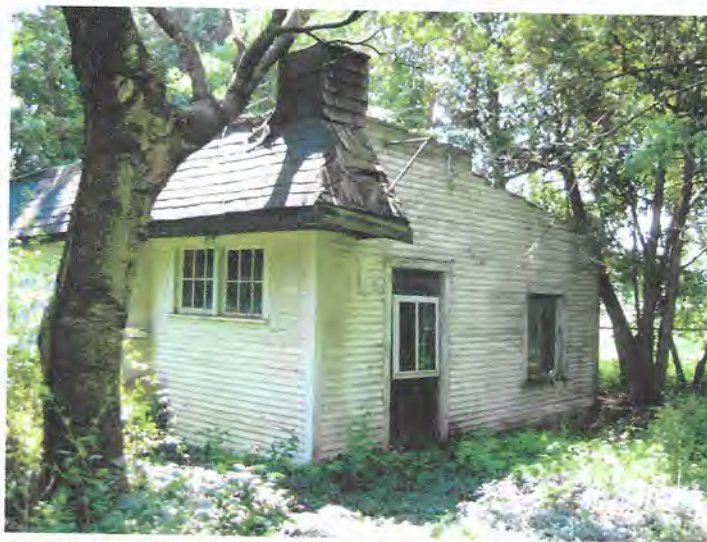
Views of the existing house and garage, showing wealth of mature trees surrounding the buildings.

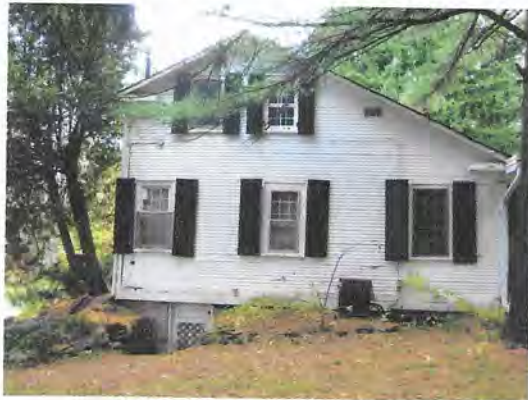
Salt box shape is evident here.

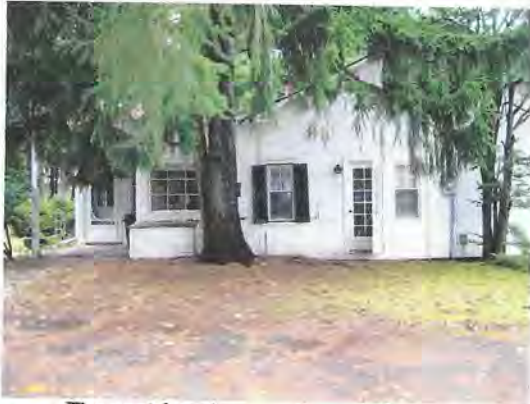
The east façade, seen through the trees

The windows on the east elevation have been altered from the original. The lower windows are 4-over-4 windows and one appears to be missing on the north. The upper windows are 2-over-2 windows. A new door has been added to this façade.

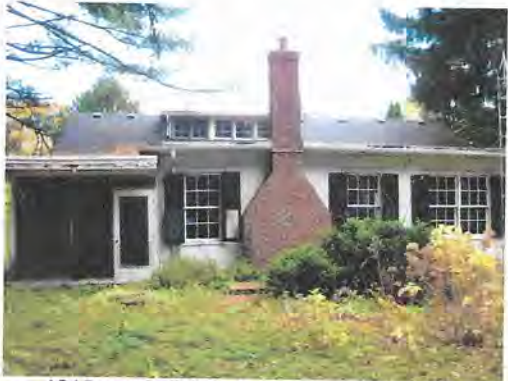
1910 porch, living room and south dormer

Also in 1910, a large new one-storey addition was built to the south. It is 15' x 30' with a low-sloped roof, providing a new large living and dining room area. It has a large brick fireplace with flanking windows facing south. These windows are 6-over-6 with shutters. The newly created room is a sunny room panelled in dark wood. There is a screened-in porch to the west of this room, and an open porch, with an exterior door to the east. The new addition is frame with clapboard siding matching the existing 1825 cottage. The basement under the 1825 house was likely built at this time, and it includes a door to the exterior at the east side. There is no basement under the 1910 north addition.

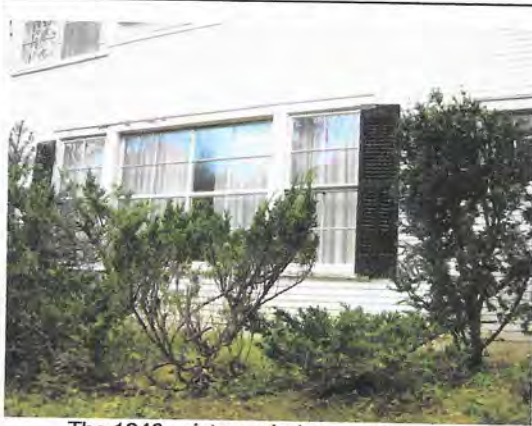
In the 1940's, the chimney and fireplaces of the 1825 cottage were removed and a new "picture window" installed, connecting two existing windows. The new central window is an 8-over-8 fixed sash window.

The 1940s picture window, north façade

2. The existing dormer will be replaced with a new central dormer to reinforce the symmetry of the original house.
3. The west elevation windows will be restored and relocated to original location if it is determined that those locations differ from the existing locations.

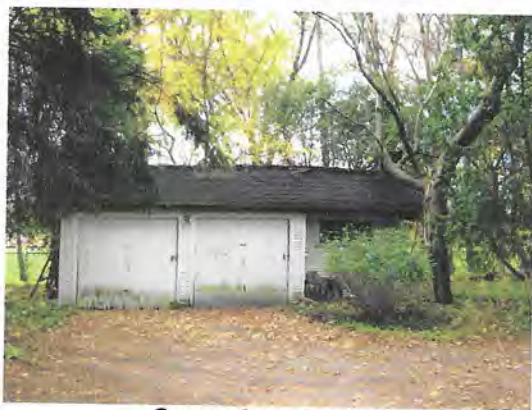
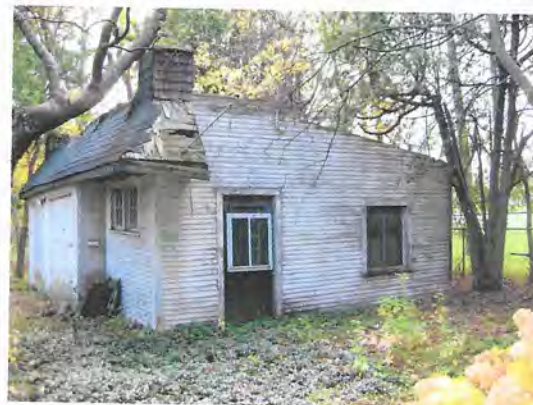
The garage, located at the southeast corner of the property, was probably built in the 1920's, judging from the construction techniques. It is a single-storey structure containing a 2-car garage and a side workshop and is approximately 500 sq.ft. (46.7 m²). It is a wood structure with white clapboard siding and a sloped roof. A steep slope mansard roof extends across the front, accentuated at each end with a finial. This unusual roof feature adds charm to this otherwise utilitarian structure. Two solid garage doors face north and the workshop section on the west of the structure has two high 6-paned windows on the north and two windows on the south. While this building is in poor condition, its location and character add charm to the overall property.
