19. NOTICE OF APPLICATION TO REPEAL THE HERITAGE DESIGNATION BY-LAW OF JAMES DALZIEL HERITAGE HOUSE AT 7230 NASHVILLE ROAD IN KLEINBURG (TRANSMITTAL REPORT)

HERITAGE REPORT

STRUCTURAL CONDITION ASSESSMENT

7230 Nashville Road, Kleinburg, Vaughan

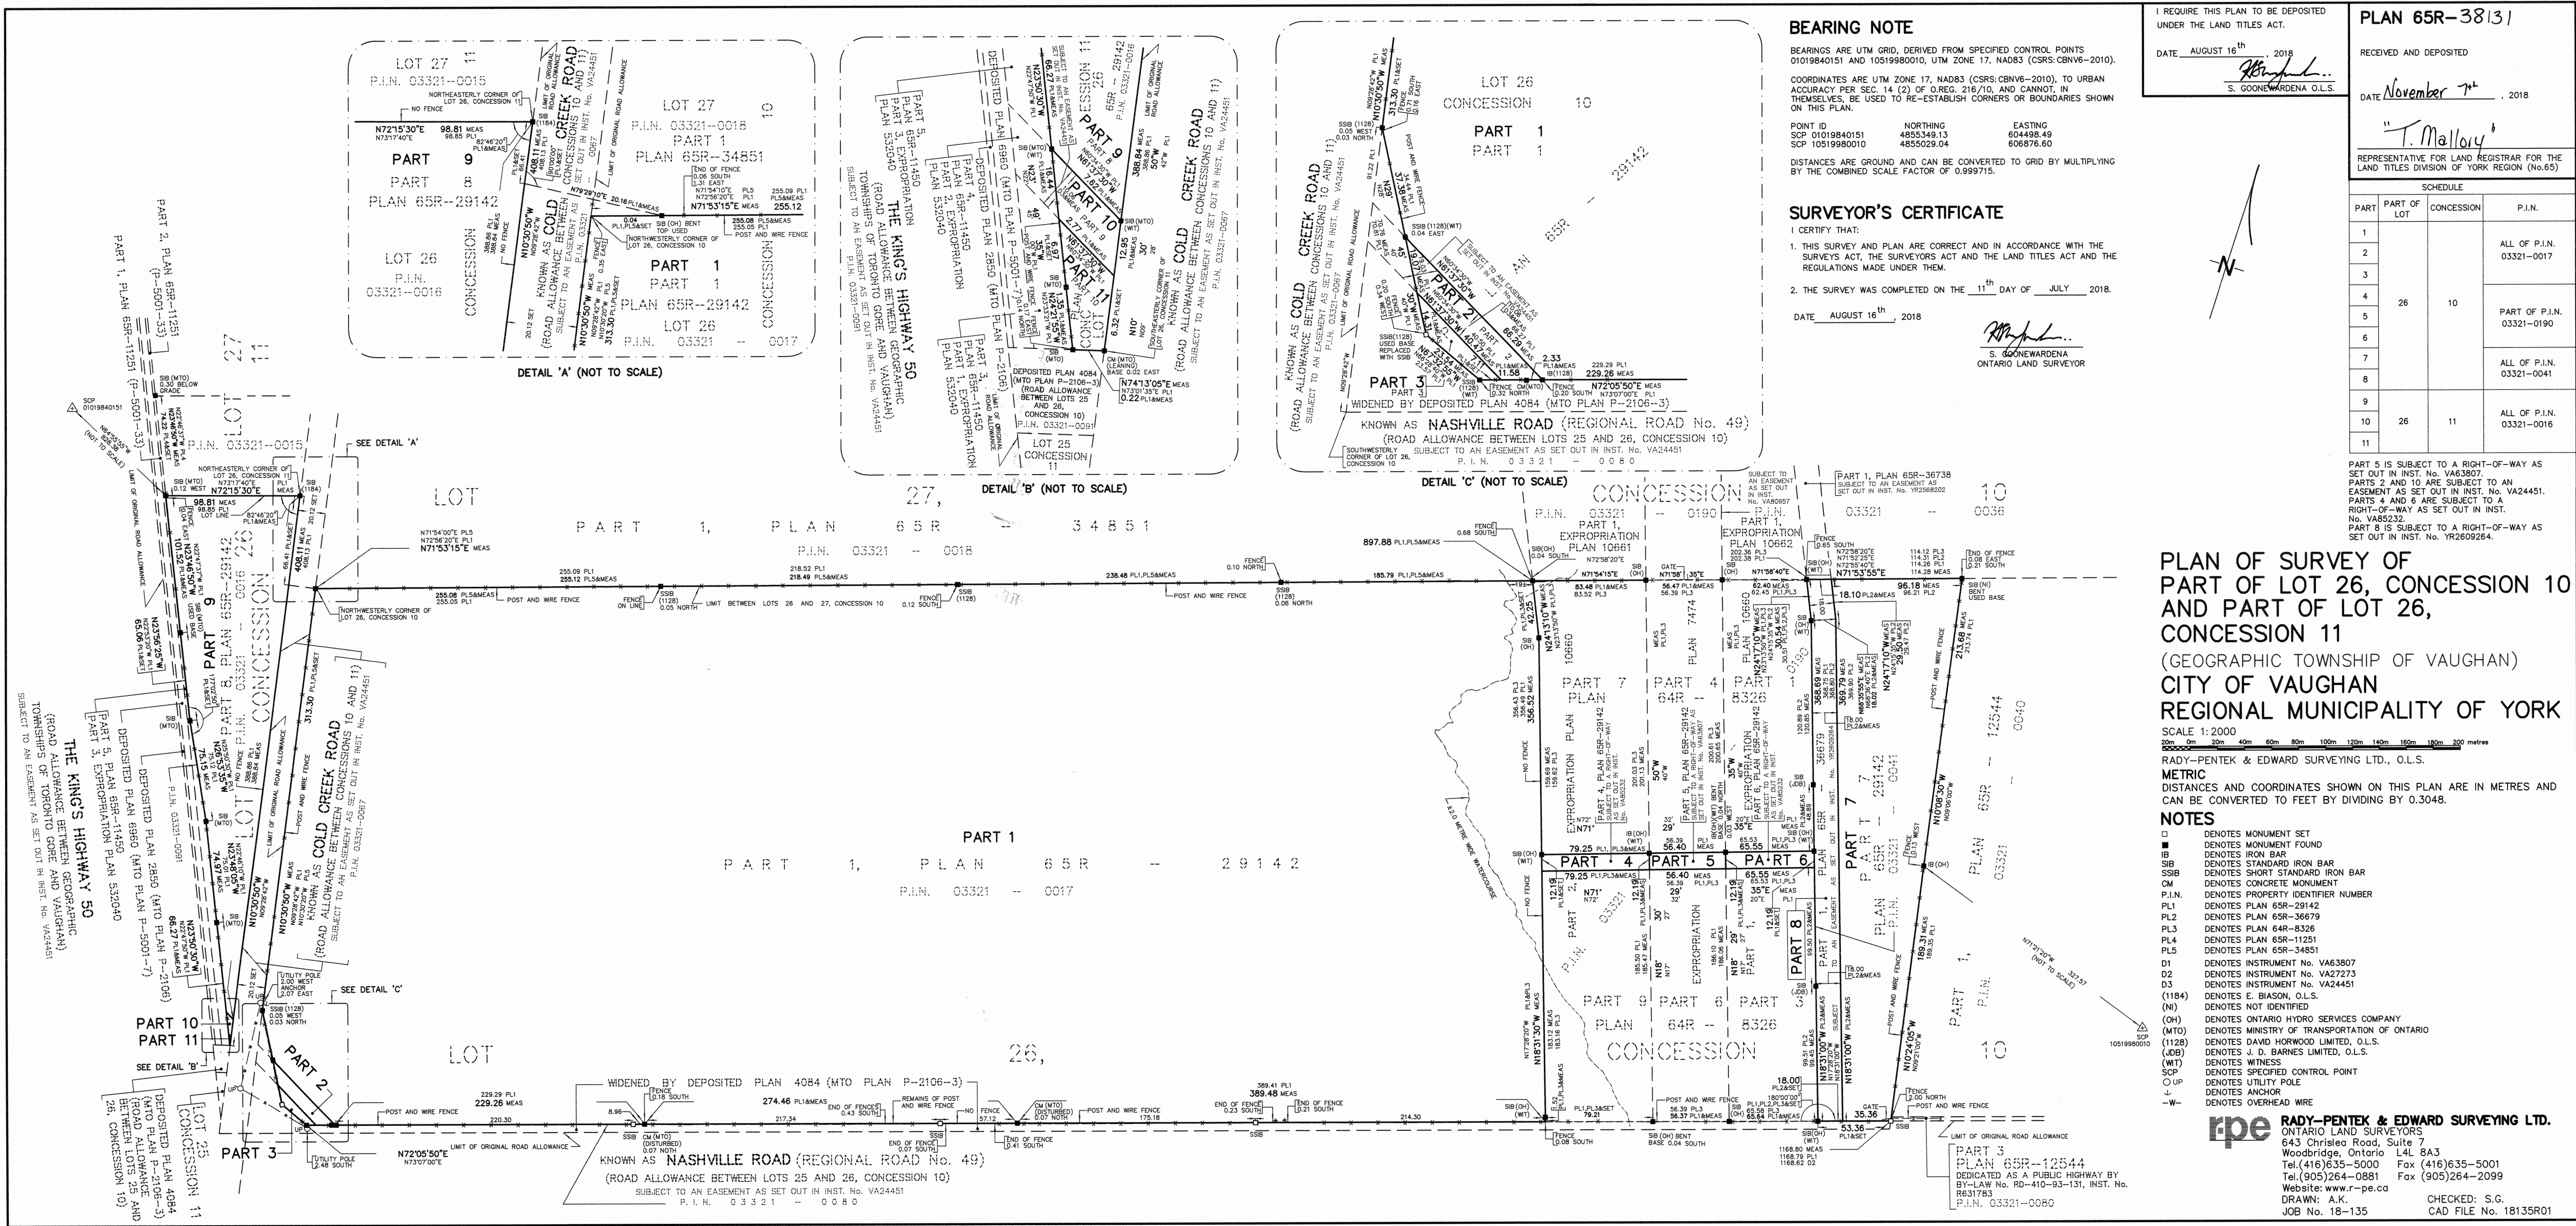
Pic. 11: Submerged Basement of the House Addition on the Northside

9. The house's crawl space was not inspected due to safety concerns and health hazards; however, the basement of the house addition on the north side is visible from the ground floor and is fully submerged in dirty water up to the windowsill (Pic. 11). That makes it inaccessible to inspect the structure's foundation condition from the basement.
