**STRUCTURAL CONDITION ASSESSMENT FOR  
89 NASHVILLE ROAD, KLEINBERG, ONTARIO**

November, 2019  
Project ID: AS19-145

Re: 89 Nashville Road, Kleinberg, Ontario  
Structural Assessment  
Project ID: AS19-145

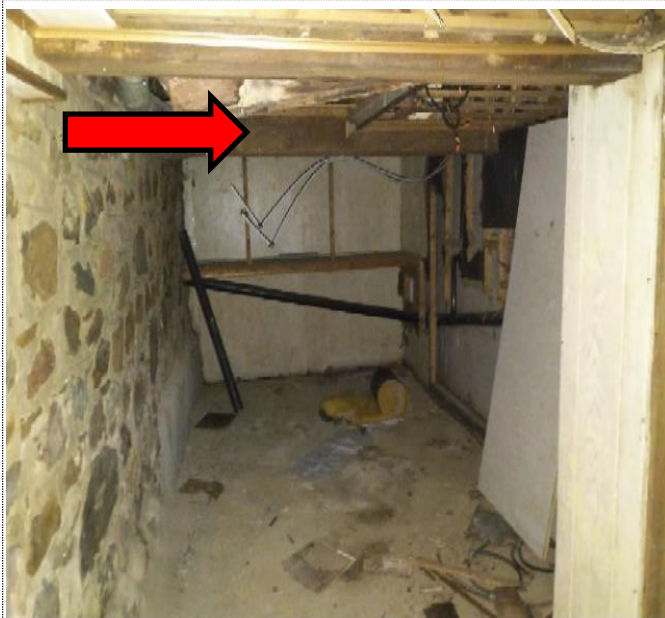
Timber wood beams supporting the wood light framing below the saltbox addition.
