**STRUCTURAL CONDITION ASSESSMENT FOR
99 NASHVILLE ROAD, KLEINBERG, ONTARIO**

Prepared for
STATEVIEW HOMES

November, 2019
Project ID: AS19-146

Re: 99 Nashville Road, Kleinberg, Ontario
Structural Assessment
Project ID: AS19-146

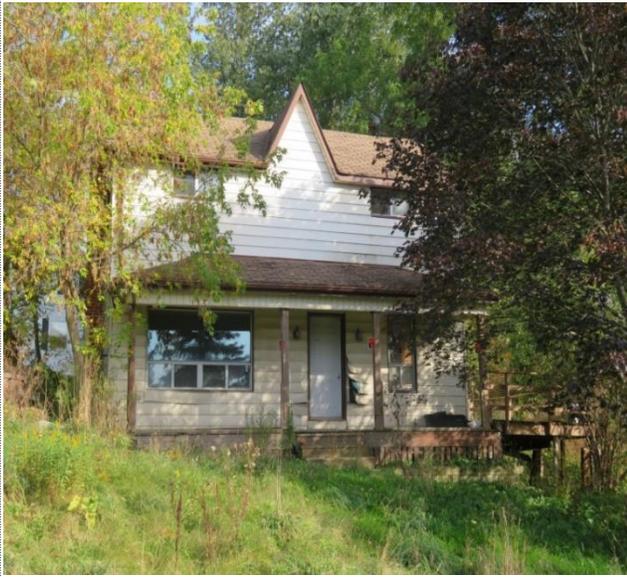
WEST FACE ELEVATION

At the east and south sections as well as a false dormer on the west elevation are later additions. Deterioration was observed at the south-west corner of the basement foundation walls. The field stone repairs at the south-west corner of the foundation appears to be spalling, delaminated and scaling of stone and cementitious repair materials.

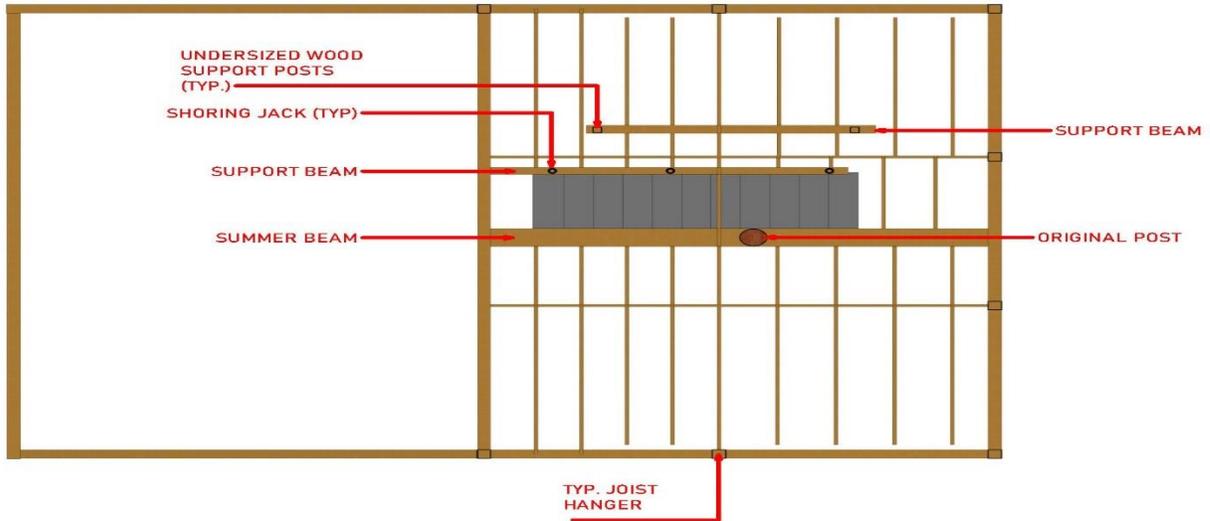
Typical Floor Framing

Several original post and beams have been replaced with undersized lumber. Temporary post shores and concrete block pilasters are in place supporting the main floor level. In general, there is evidence of extensive deterioration sagging floors, beams deflecting and structural elements that show signs of structural distress.

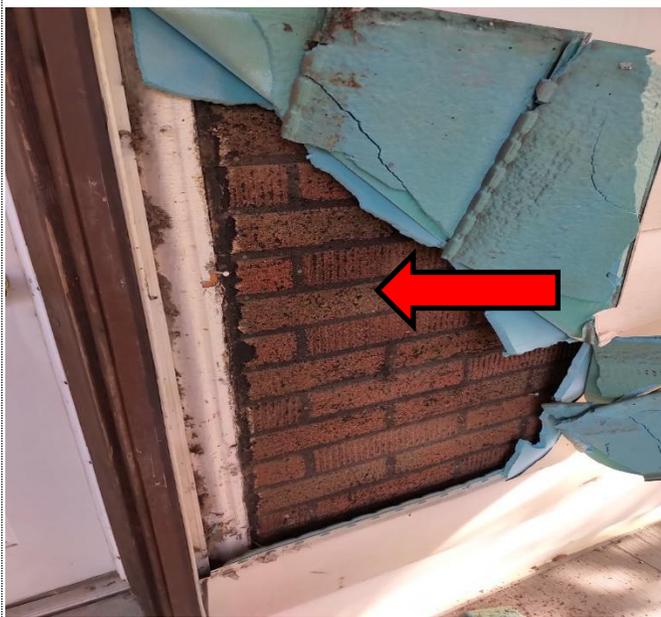
The exterior framing was concealed with insulbrick, as shown in the above photograph.

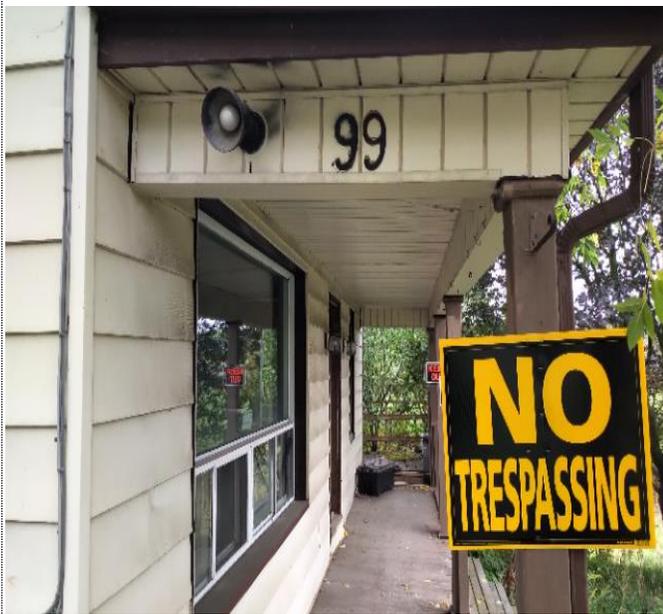
Exterior wood porch concealed with metal siding- North elevation

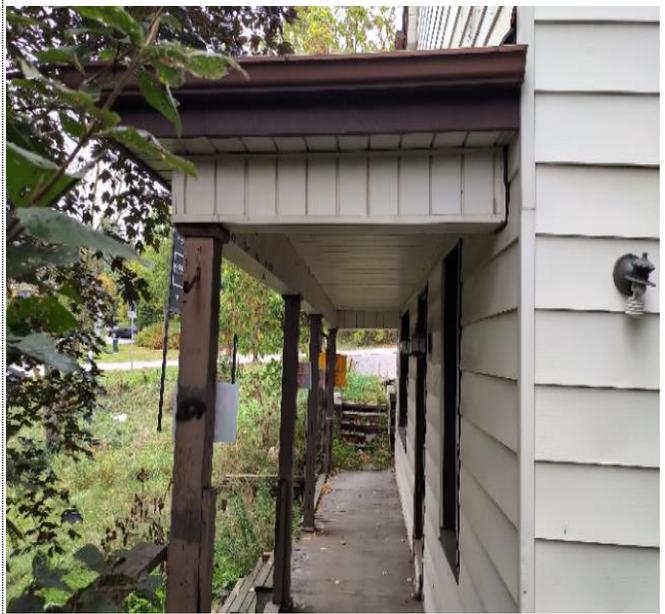
Exterior wood porch concealed with metal siding- South elevation

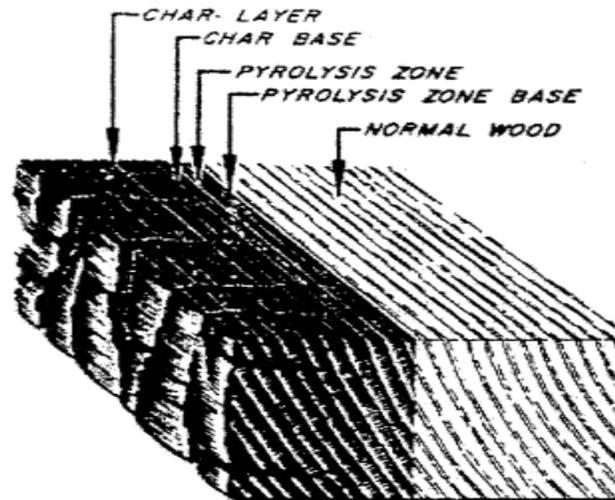
The wood members that have been damaged from fire appear to be significantly charred. The char layer could be scrapped off however, any charred portion of fire exposed wood member has no residual load capacity. The wood beneath the char layer may have some residual load capacity, but this residual capacity will be less than the load capacity prior to the fire.

Sudden surface heating of a wood member in a fire results in surface charring and a steep temperature gradient. Thus, the stages of thermal wood degradation previously discussed become zones of degradation in a structural wood member exposed to fire. In a broad sense, there is an outer char layer, a pyrolysis zone, a zone of elevated temperatures, and the cool interior **as shown above**. These zones of degradation reflect the temperature profile through the cross section.

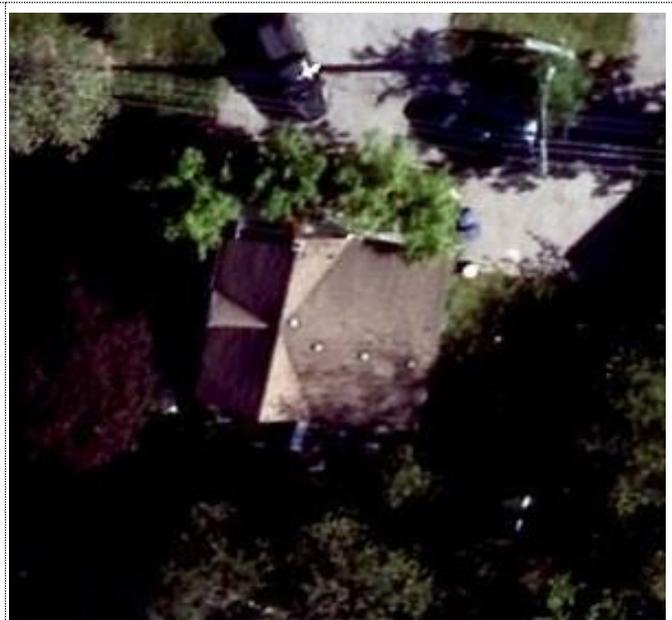
Photographic image of 99 Nashville Road in (2016). Note, east addition as well as the south extension to the original structure has been extensively altered including roof lines and the addition of a false dormer.

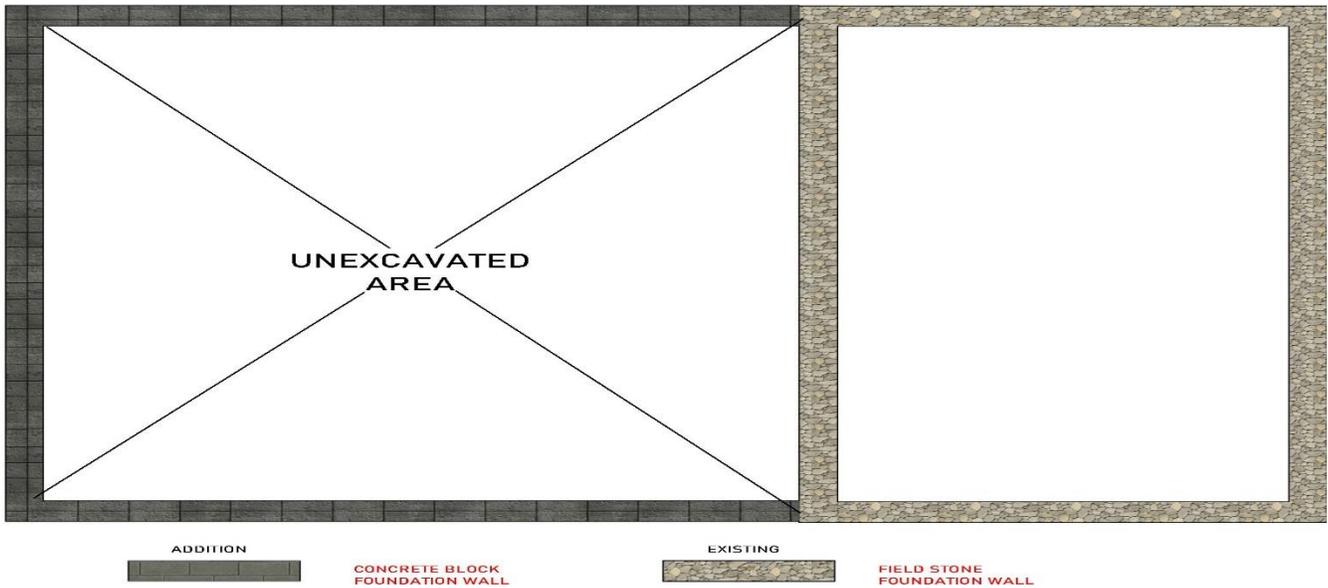
Character and context of modifications carried out to 99 Nashville Road over the years as identified below
