19. DEMOLITION OF EXISTING BUILDING AND CONSTRUCTION OF IDENTICAL REPLICA BUILDING AT 89 NASHVILLE ROAD, KLEINBURG-NASHVILLE HERITAGE CONSERVATION DISTRICT

**STRUCTURAL CONDITION ASSESSMENT FOR
89 NASHVILLE ROAD, KLEINBERG, ONTARIO**

November, 2019
Project ID: AS19-145

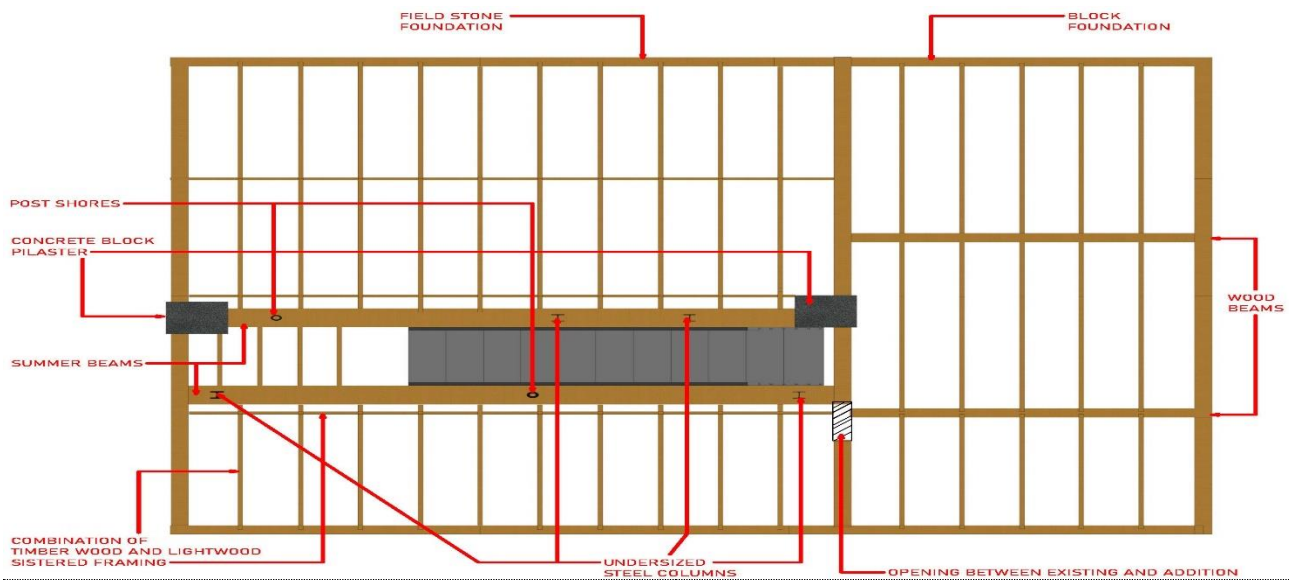
TYPICAL STRUCTURAL FLOOR FRAMING

Several framing members were found to be split and degraded and were supported on structurally unsound concrete block pilasters with 4x4 blocks.

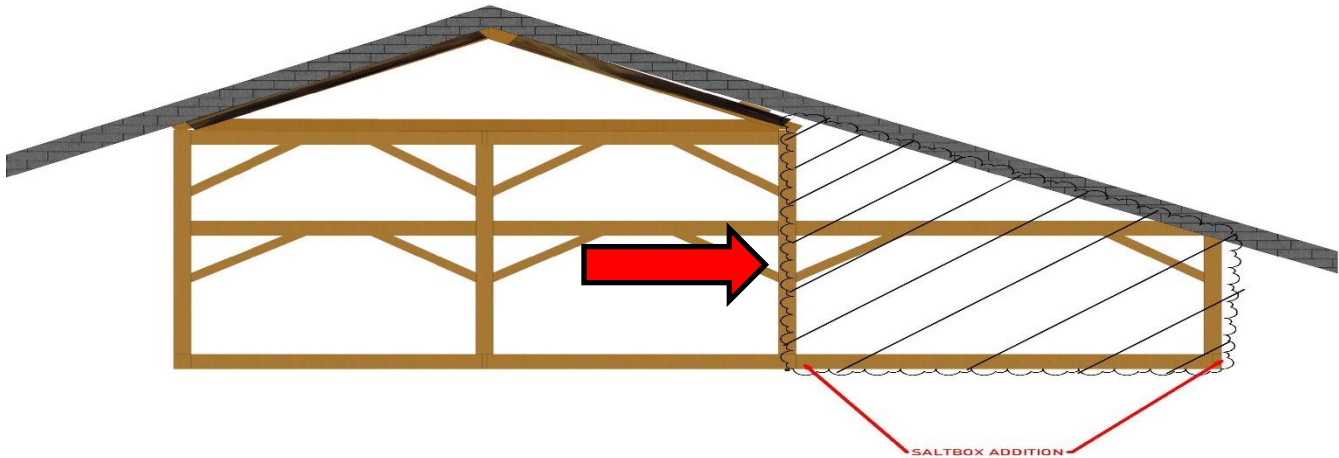
The saltbox alteration to the rear tail of the dwelling unit was constructed at a later date. The saltbox foundation wall is constructed of concrete blocks. The concrete block foundation wall appears to be in fair condition however, the south west corner appears to be settling and heaving. There are step cracks in the block foundation wall. This may be evidence of differential movement in the block foundations. There are some leaks into the block foundation wall as well as vegetation on the exterior face of the block foundations. The framing appears to be light wood construction. The floor framing below this area appears consist of two timber support beams with light wood framed joists. The interior walls have been concealed with plaster lath or gypsum. The exterior walls have been concealed with metal siding and insulbrick.

Rear saltbox framing addition identified in the hatched areas.

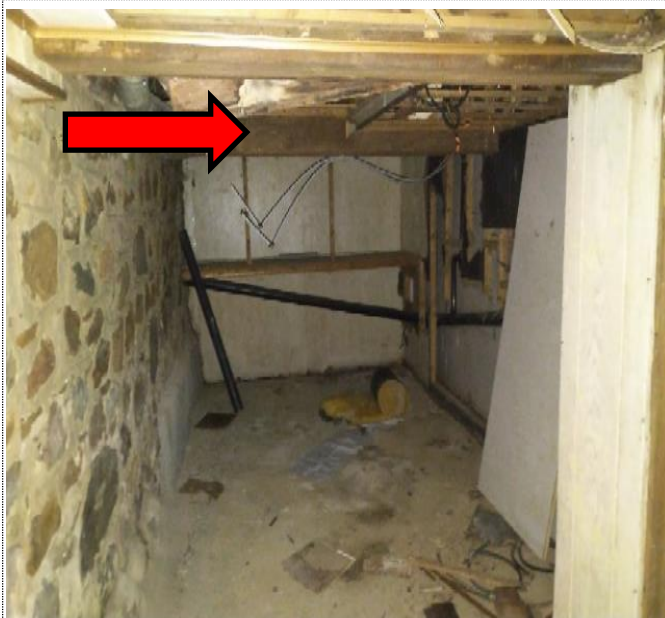
Timber wood beams supporting the wood light framing below the saltbox addition.

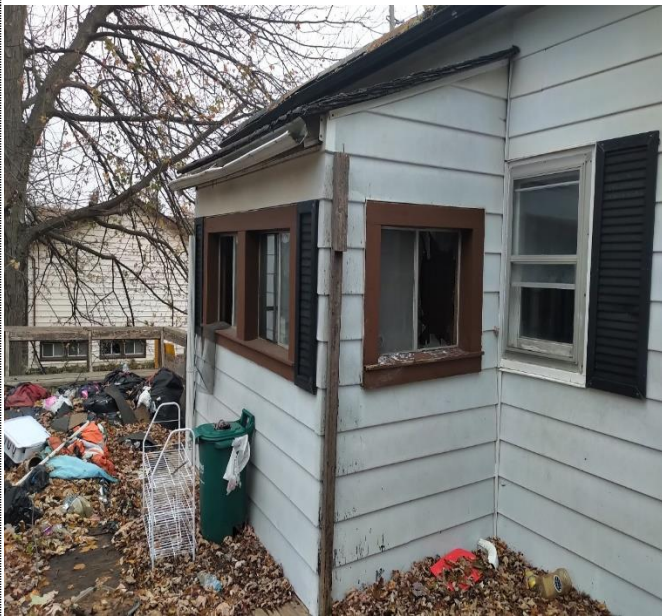
The wood framed addition forms as a mudroom. This structure is bearing on the wood decking at that rear of the dwelling unit. The structure does appear to have settled. The wood framing below the addition is structurally unsound and on the verge of collapse. A portion of the addition also being supported by concrete blocks that are placed above grade. The wood joists forming the decking and support for the addition has decayed and there is extensive deterioration.

Rear addition, concealed with metal siding and roof assembly concealed with asphalt shingles.

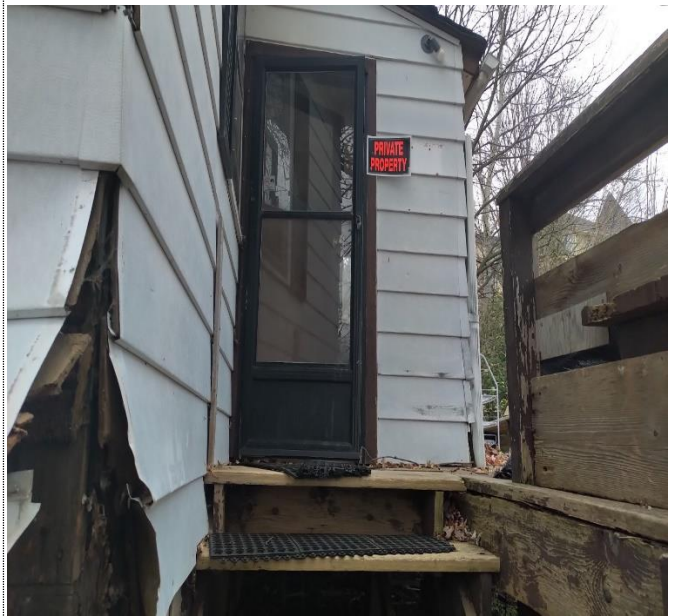
Rear addition bearing on the wood decking and concrete blocks placed above grade.

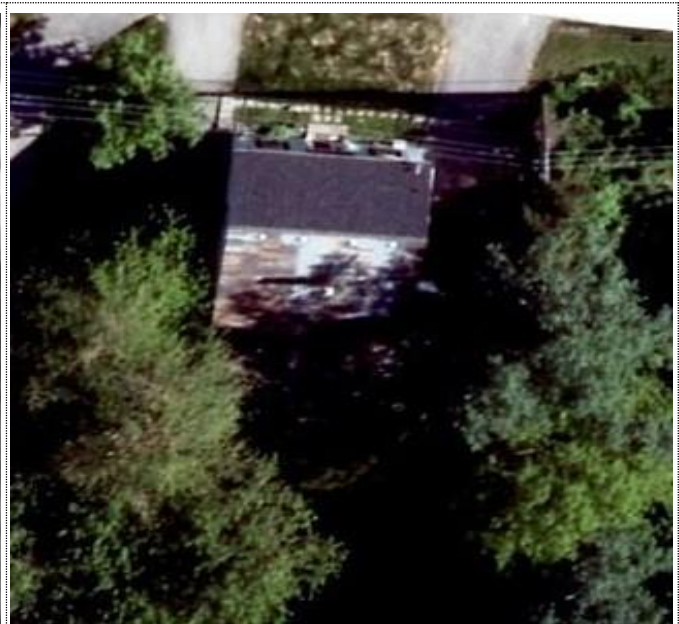
Photographic image of 89 Nashville Road in (2016).

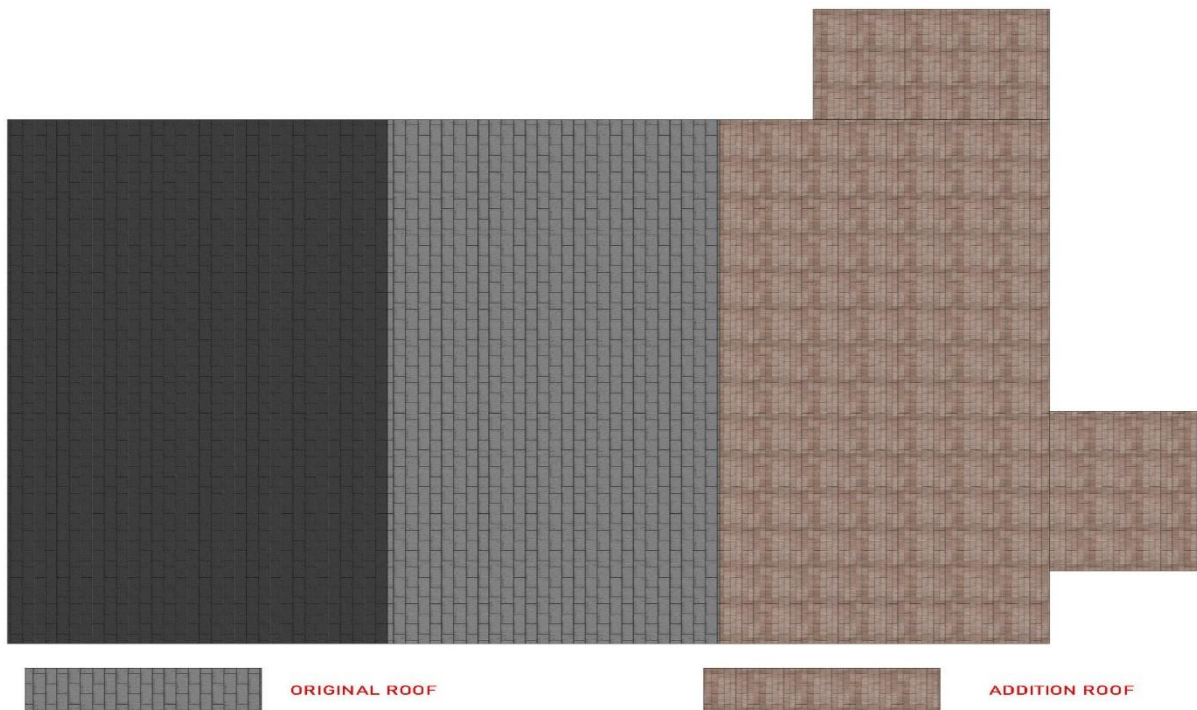
Character and context of modifications carried out to 89 Nashville Road over the years as identified below.
