20. DEMOLITION OF EXISTING BUILDING AND CONSTRUCTION OF IDENTICAL REPLICA BUILDING AT 99 NASHVILLE ROAD, KLEINBURG-NASHVILLE HERITAGE CONSERVATION DISTRICT

**STRUCTURAL CONDITION ASSESSMENT FOR
99 NASHVILLE ROAD, KLEINBERG, ONTARIO**

November, 2019
Project ID: AS19-146

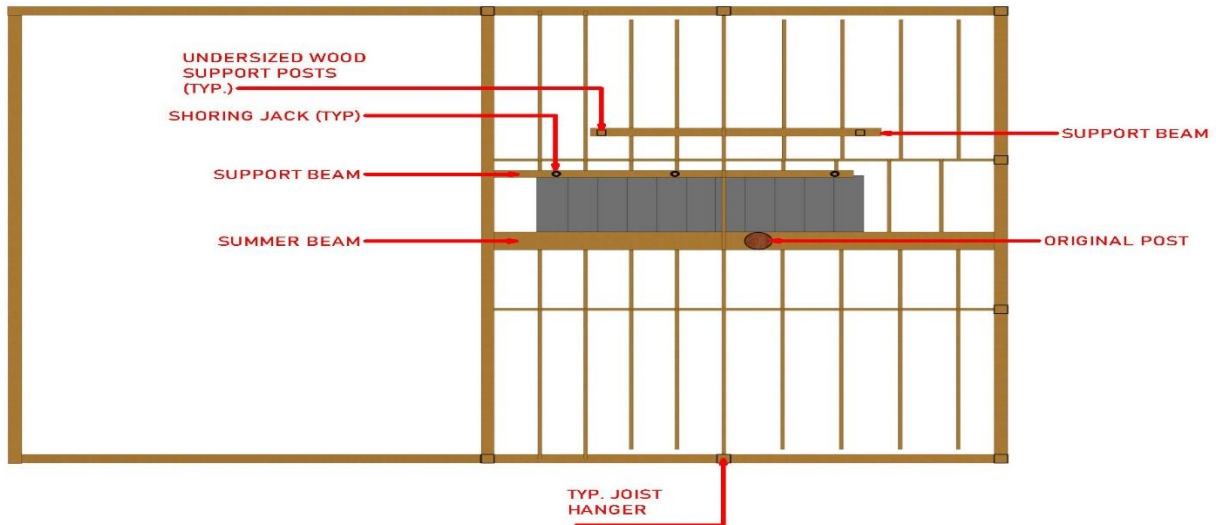
Typical Floor Framing

Several original post and beams have been replaced with undersized lumber. Temporary post shores and concrete block pilasters are in place supporting the main floor level. In general, there is evidence of extensive deterioration sagging floors, beams deflecting and structural elements that show signs of structural distress.

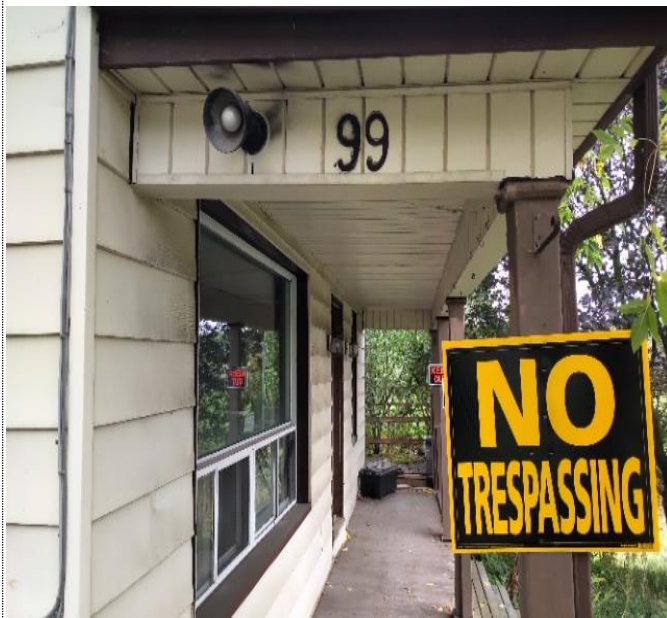
Exterior wood porch concealed with metal siding- North elevation

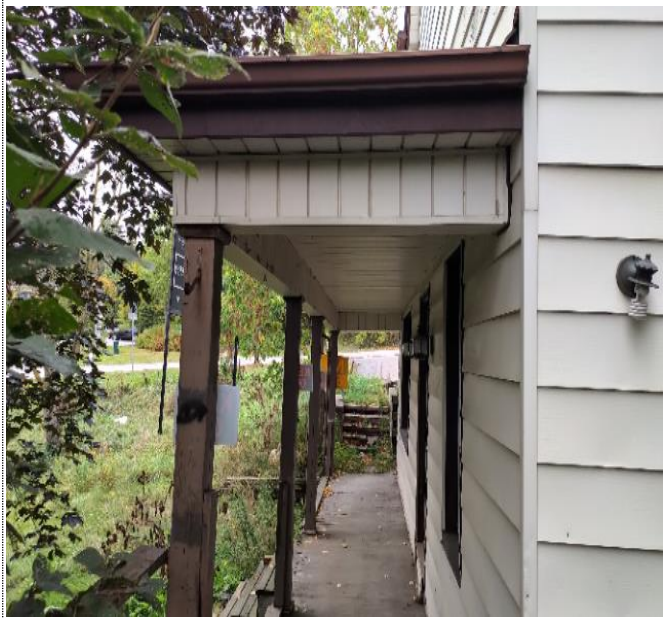
Exterior wood porch concealed with metal siding- South elevation

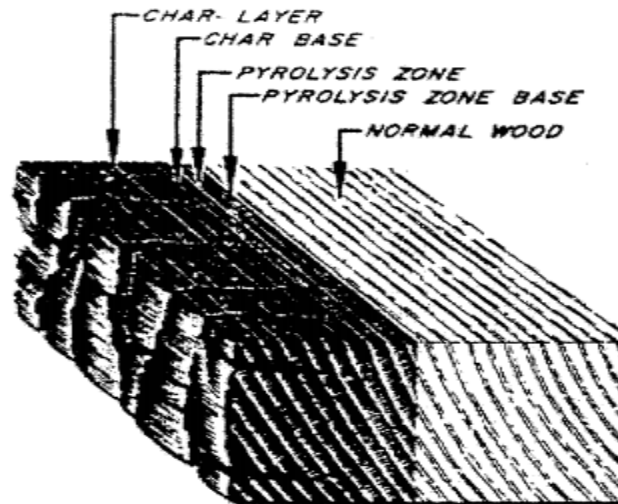
The wood members that have been damaged from fire appear to be significantly charred. The char layer could be scrapped off however, any charred portion of fire exposed wood member has no residual load capacity. The wood beneath the char layer may have some residual load capacity, but this residual capacity will be less than the load capacity prior to the fire.

Sudden surface heating of a wood member in a fire results in surface charring and a steep temperature gradient. Thus, the stages of thermal wood degradation previously discussed become zones of degradation in a structural wood member exposed to fire. In a broad sense, there is an outer char layer, a pyrolysis zone, a zone of elevated temperatures, and the cool interior **as shown above**. These zones of degradation reflect the temperature profile through the cross section.

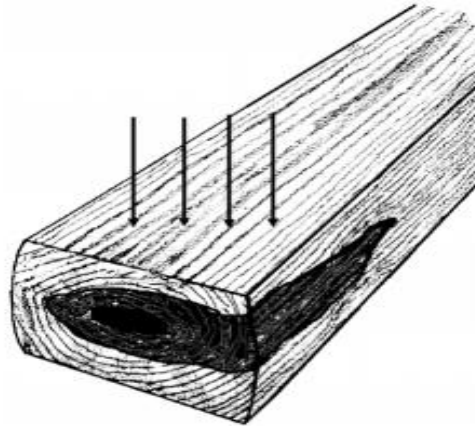
Because of interior deterioration the outer shell can collapse when the timber is stressed in bearing.
