05 May 2020

**ATTACHMENT 3**

Re: Beaverbrook Heritage Home, Vaughan  
Load Review Report

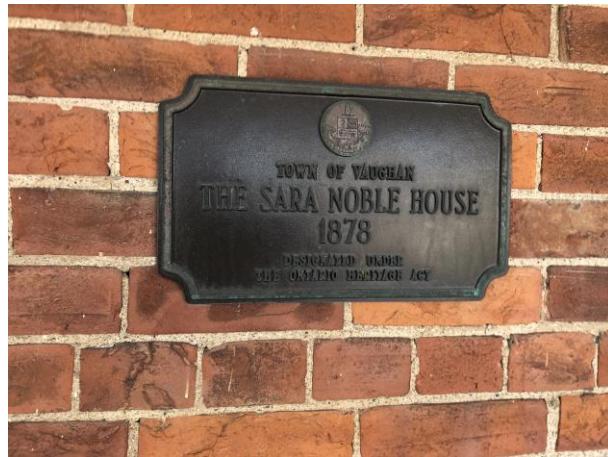
Photo 2- 1878 Dated Plaque

- The existing building was constructed in 1878. Refer to photo 2.
- No original base building drawings were available at the time of review.
- A previous review report done in 2014 by J.R. Jones Engineering Ltd for the proposed office usage. The previous load review was done in accordance to the 2012 version of the Ontario Building Code which specified Live Load for office areas of 4.8 kPa (100 psf) at the ground floor and 2.4 kPa at the 2<sup>nd</sup> floor.
- The previous review report noted that retrofit to the existing ground floor structure, including replacement of existing steel and temporary posts.
